## LEAD-ACID BATTERY TROUBLE CONDITIONS (WITH COLOR PHOTOS)

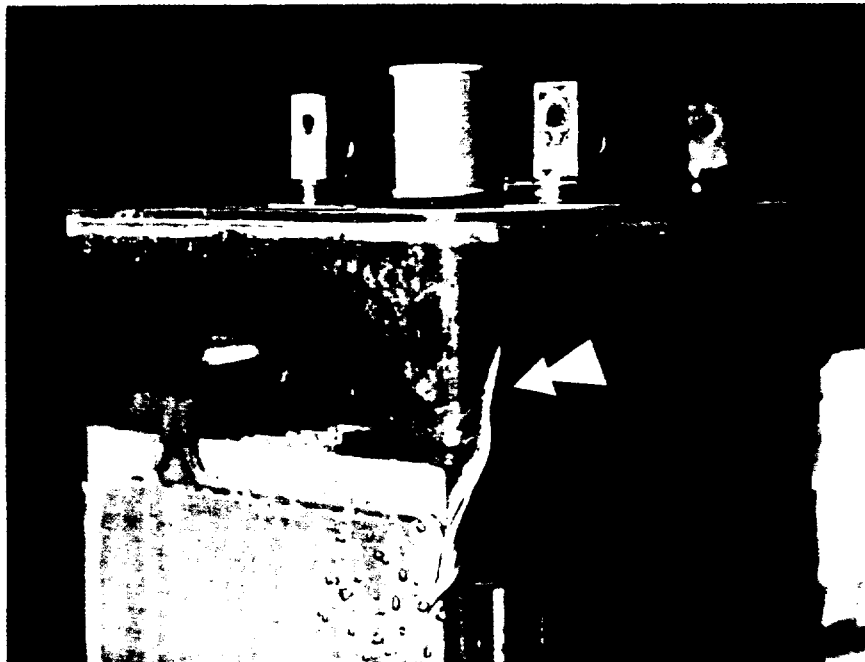
**Fig. 10—Leaking Jar Crack in Strap Area—Typical With C&D Cells**

**2.05 *Crazes and Cracks:*** Fig. 6 and 7 illustrate crazing. Fig. 8, 9, and 10 illustrate crack patterns typical of each supplier's product. Jar cracks are usually preceded by crazing of the jar at the plate or strap pressure point. Compare Fig. 6 with 9 and Fig. 7 with 10. Crazing is hard to see but shows up under a light beam as a group of hairline cracks. For safety, use a flashlight housed in a nonconducting material (plastic or rubber).
