## A Collection of Telephone Tales

written by Herbert Schwarz of Vienna, Austria, European Union

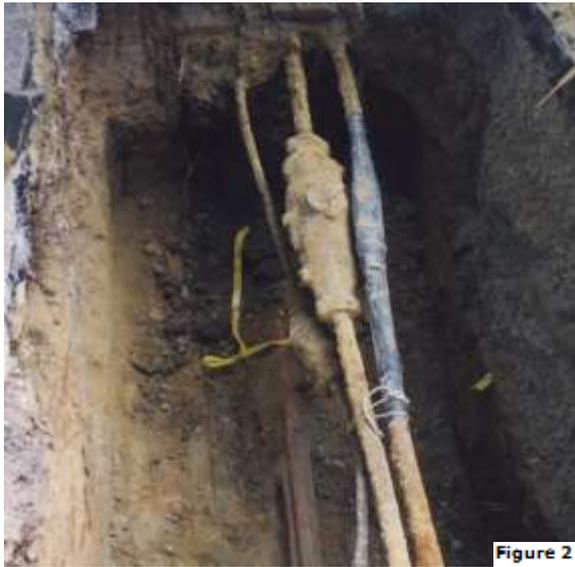
Figure 2

The cases of splices inside manholes are usually made of one or more pieces of pre-formed lead; they're left without further protection and remain filled with air. The cases of splices which are to be buried in the soil receive protection in the form of an outer splice case; this case used to be made out of cast iron (as may be seen to the left here) – nowadays they're made of hard, yellow plastic. The airspace between the two splice cases used to be filled up with bitumen, while today polyurethane foam is used. In the instance of toll cables, the lead splice case was oftentimes filled with a special wax, in order to limit possible water ingress to a single cable length.

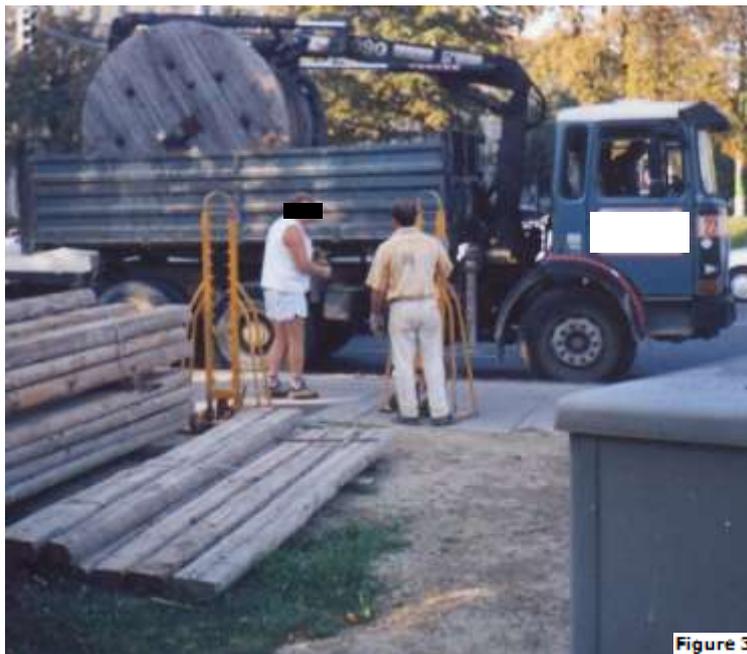
Figure 3

The lower photograph on the preceding page shows a large reel of cable being delivered to one of the manholes. In this case, the truck is that of a private firm which was contracted to deliver the cable to the site; normally, Telecom Austria used their own trucks to haul cables.

The photograph to the right shows the delivery of the other piece of cable involved in the throw. This cable was pulled into a conduit between two manholes.

The red plastic conduits lying on the ground, to the right of the truck, were intended for a new manhole, which was constructed a few weeks *after* the cables referred to in this tale were pulled in and spliced. As an aside: the cable reel stands about 7 feet tall, and the core diameter is equal to the smallest bend radius that the cable will stand. Back around the year 2000, Telecom Austria had their car and truck park painted in a nice, deep yellow color, with just the word "Telekom" painted on the doors.

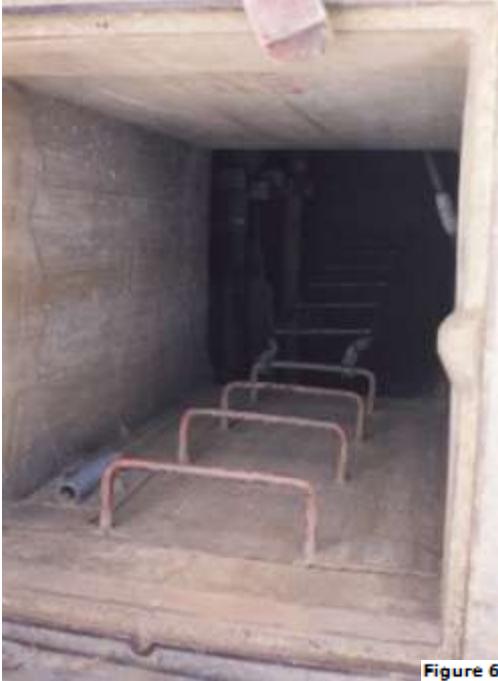
Figure 6

The photographs above and to the right are from this first entry into a manhole on Friday. I felt that being down there was almost like Christmas and Thanksgiving combined ... although I wasn't dressed for the occasion.

The group of conduits shown in the upper right-hand photograph lead to another manhole (which is 111 meters upstream from this one) ... the two conduits marked in red each carry four smaller conduits of 40 millimeters diameter, some of which carry inter-office fiber optical cables. Of the four cables in the bottom row, the first one carries 900 pairs of 24 AWG wire, the other three all carry 1800 pairs of the same gauge.

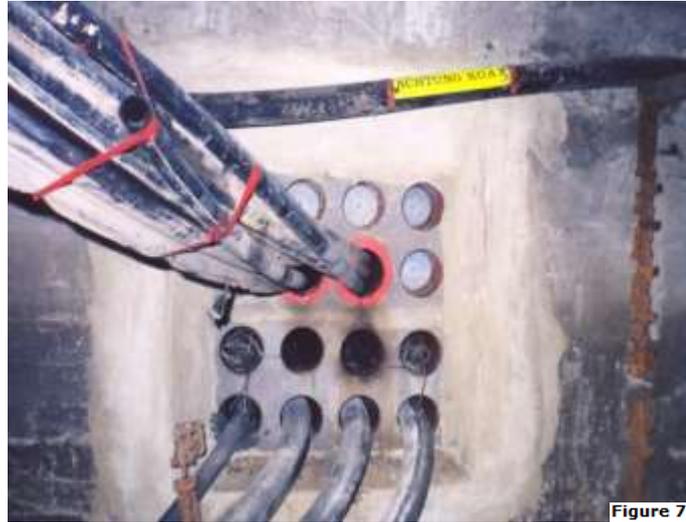
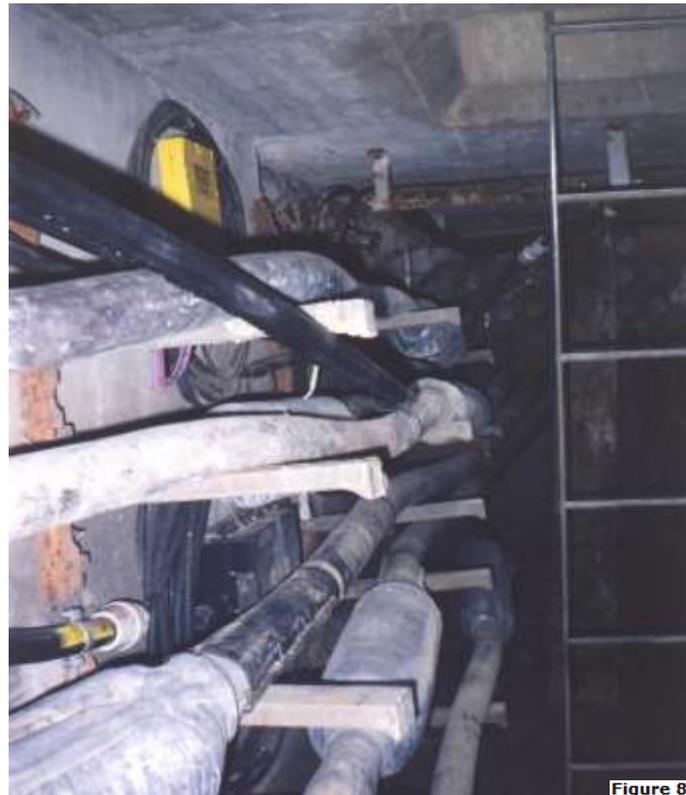
Readers may wish to take note of a few unusual details in the two right-hand photographs: in the upper one, the 900 pair cable in the lower left-hand corner of the conduits is protected against sheath chafing (due to cable creeping) by a cable shield made of zinc, and the splice case in the lower left-hand corner in the lower picture has a portion of "zipper" type 3M® shrink sleeve on the cable adjacent to the splice case. Apparently, the cable sheath was damaged there at some point in time ...

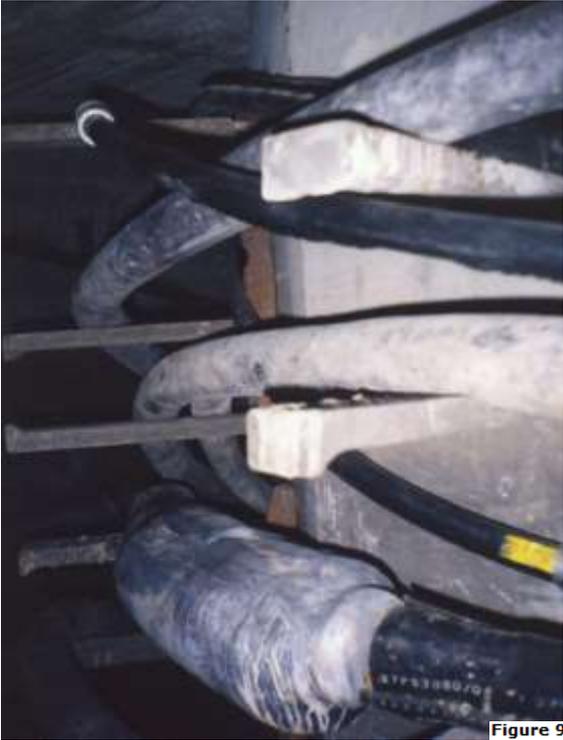
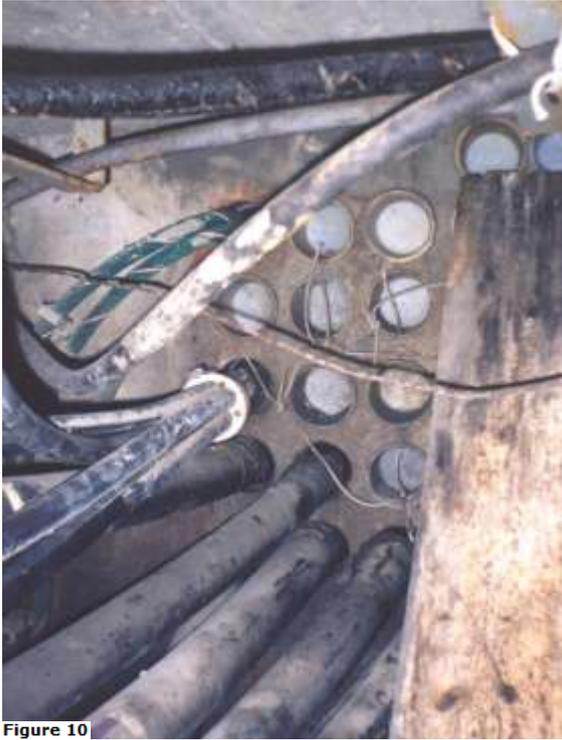
Two more photographs from the first entry into the manhole – they simply show some of the cables which run through. There is a plank standing upright, in the foreground of the picture on the right, which hides some of the conduits. As may be seen, most (but not all) of the conduits which are not in use are sealed with plastic caps ... these are intended to prevent natural gas (from a pipe leak) from flowing into the manhole, as well as to keep water seepage out. The two green cables exiting the uppermost left-hand conduit in the right-hand picture are CATV feeder/distribution cables.

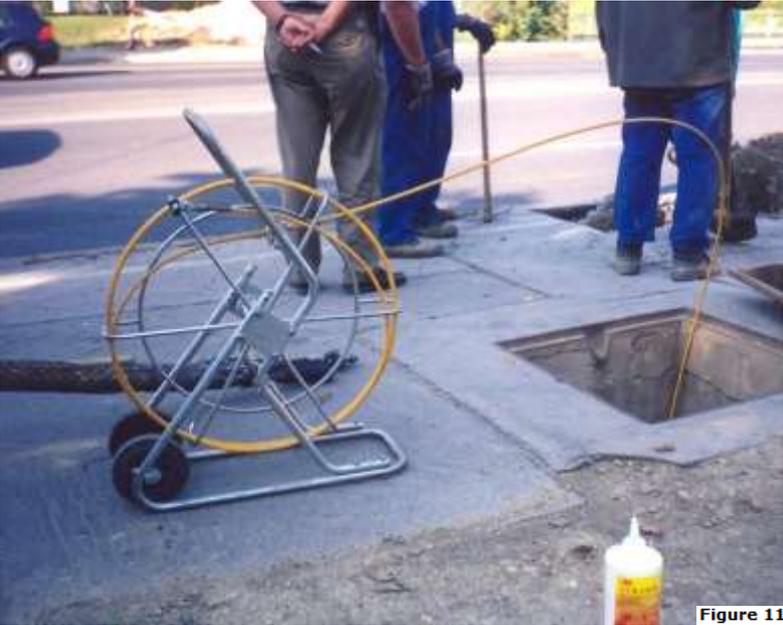
Figure 11

In the picture to the right, one can see the blue cable-pulling rope as it exits the short length of conduit which ends in the manhole shown on the previous page. The slate-colored conduit which may be seen carries two 40 pair cables which belong to the telephone network of the Vienna fire department; 5 of the cables to the right of the conduit are telephone cables – 3 of them are in use, 2 are dead. The other cables belong to the electrical power company.

Two of the live cables will, in the course of the work in progress, be cut and spliced to the new piece of cable about to be pulled in. Fortunately, the folks from Telecom Austria used cable locating equipment to find the two cables to be cut – it would've been *quite* a spectacular sight if they'd accidentally cut a live, 3-phase 380 volt feeder cable by mistake!

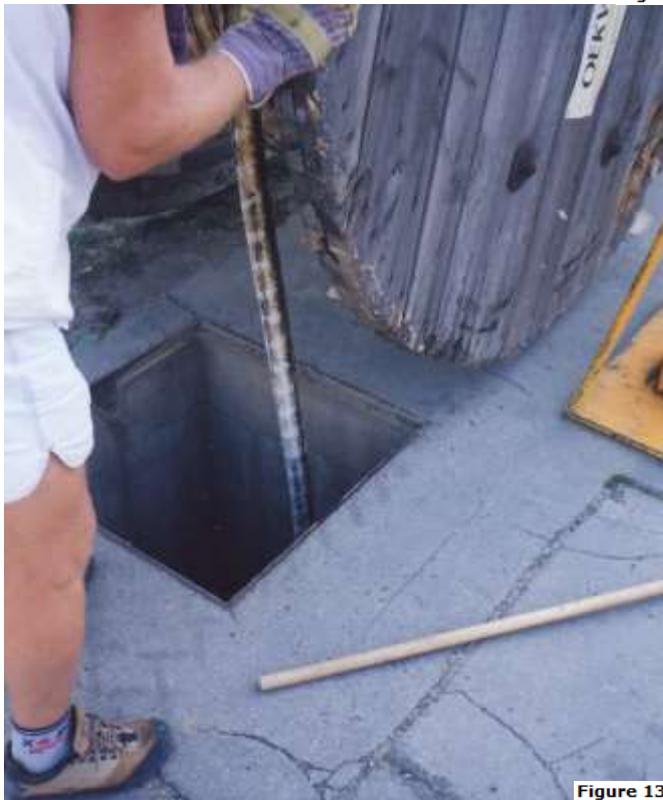
Figure 13

In the picture to the left, the new cable is just being pulled in. There was one man to turn and/or brake the cable drum as the cable was being fed into the manhole. There was another guy, down inside the manhole, pulling and guiding the cable within the manhole and out through the conduit.

The yellow piece of metal to be seen in the mid right of the picture is a part of the cable reel stand.

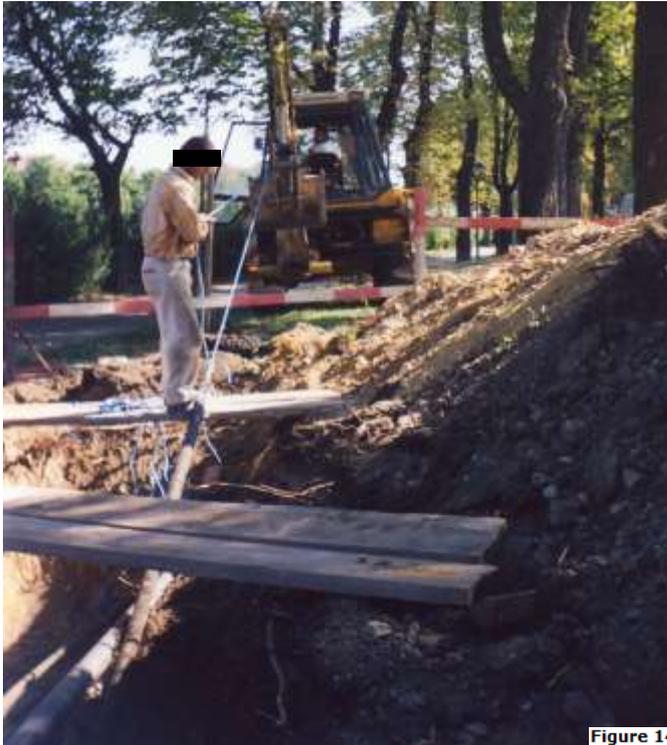
Figure 14

This picture shows how the guys pulled the cable in – with the aid of an excavator! Normally, a special cable winch would be used, in order to prevent the cable from receiving too much stress (which could cause damage to the sheath and/or the cable core) while being pulled in. Obviously, the method depicted here isn't *quite* per Telecom Austria standard practices ....

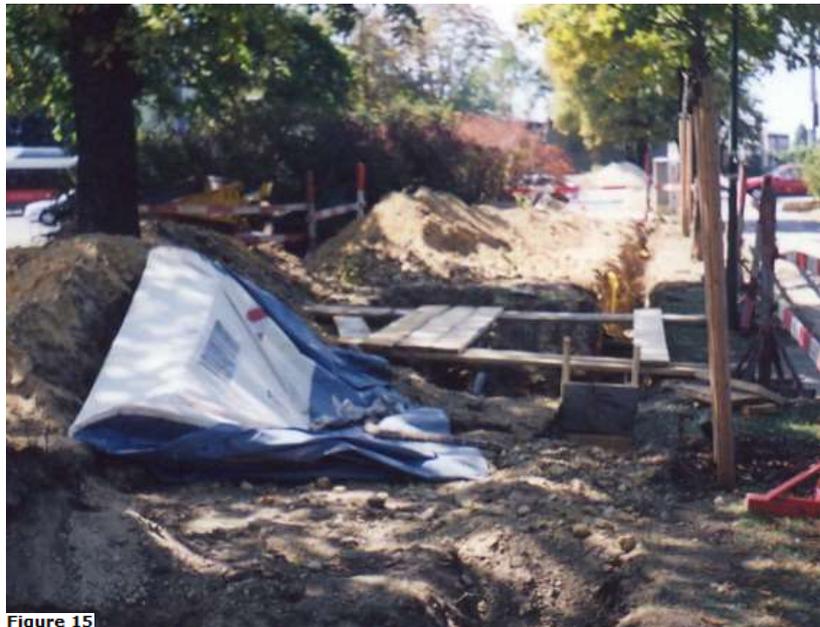
Figure 15

The picture to the right was taken from roughly the same position at which the excavator was standing in the previous photo. The splicing trench is visible; the planks on the left, above it, mark the spot where the new cable enters the trench. Telecom Austria (and others) protect open splicing trenches with tents during inclement weather, and such a tent from Telecom Austria is visible in the left foreground.

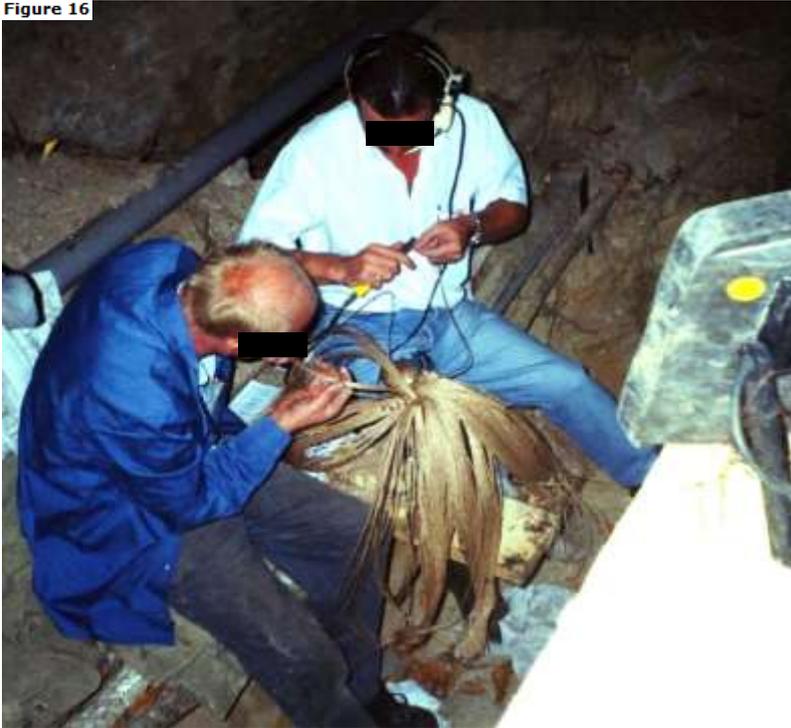
Figure 16

The new cable in the splicing trench is being rung out at the same time it was being spliced to the new cable between the manholes; the latter cable was, at the same time, being spliced to a cut, but already laid, cable which leads to the exchange. Since it wasn't possible for me to photograph all of these operations at the same time, I opted for staying close to the end where most of the work was in progress.

The task of the man seated on the left is to find and separate the tip lead of pair 1 of each quad (counted out counter-clockwise, since we are looking at the cable end distant from the exchange) and handing the quads on to the man on the right. His job is to remove a small portion of the paper insulation from the wire and wait for the man at the other end of the cable to make himself heard; literally, since both men wear a headset, so that they can talk to one another if this should be necessary. If readers look closely, they can see that there is a wire plugged into the back end of the cable splicer's knife – the other lead of the headset is connected to the cable sheath.

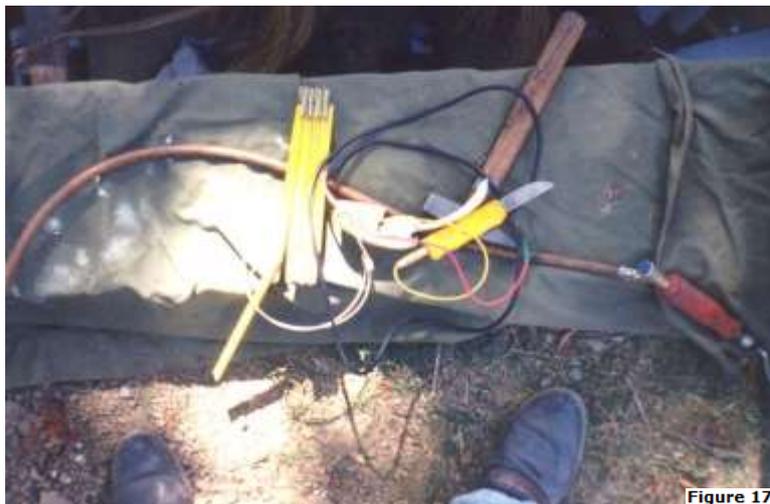
Figure 17

The photograph to the right is the only half-way clear shot of one of the splicer's headsets that I could find. These headsets were originally intended for switchboard operators, but they found their way into cable splicing

operations very soon, since two of them and a battery were *much* cheaper than other wire/cable testers intended for cable splicers.

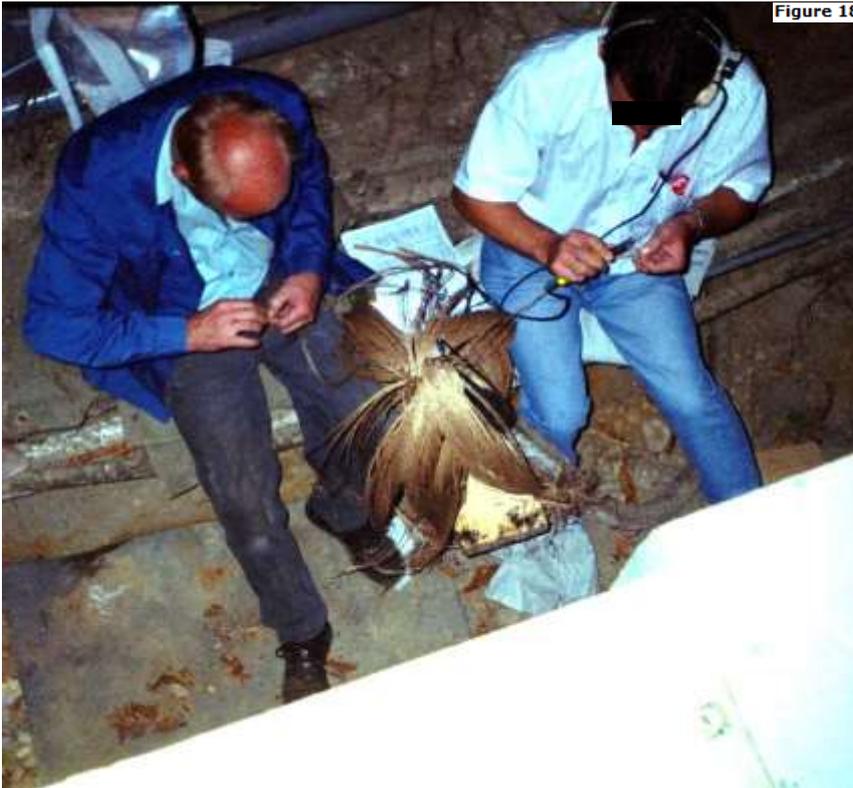
Figure 18

A second photograph of the men in the splicing trench ... luckily for me, the weather was good and the tent wasn't needed (it would've been very crowded and I possibly wouldn't have been allowed inside).

The most interesting detail in this photo is the plastic "bag" draped across the slate-colored conduit behind the man on the left. This is a special type of bag, used to temporarily protect an open splice from moisture. The bag has one closed side, while the three open sides are furnished with double-sided, self-adhesive tape. The

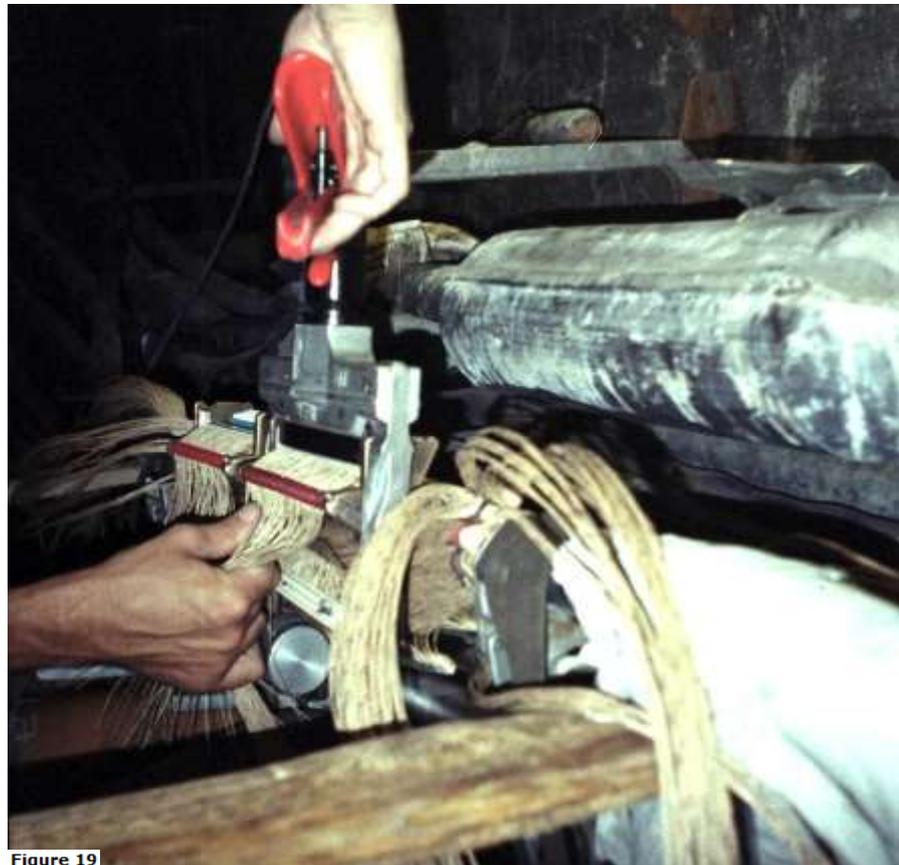
Figure 19

The photo on the right was shot in the manhole nearer the splicing trench and shows the last step in completing a 25-pair splice using the MS<sup>2</sup>® splicing system from 3M®.

The cable in the right-hand foreground is the one which runs to the splicing trench. One can see that some of the quads of the cable have already been fanned out for the next splicing operation.

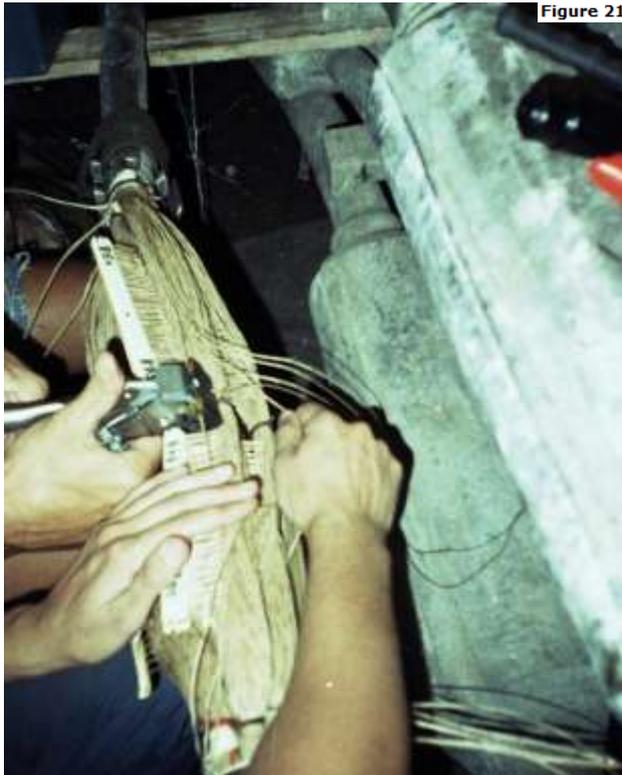
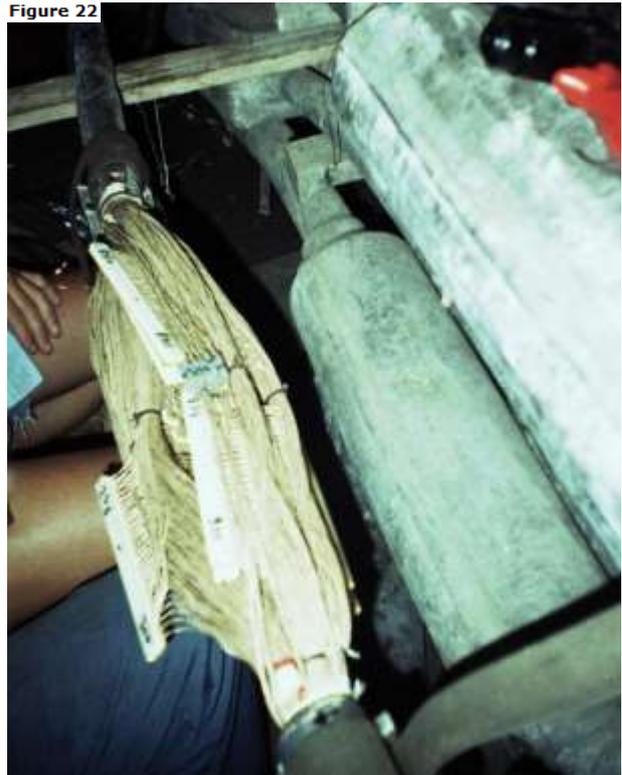
The two photographs above tell the tale of what happens if the splicers don't pay enough attention to what they're doing ... they managed to split the two pairs of one of the quads in the cable. The repair for such split pairs is to cut the four wires off at the MS<sup>2</sup>® splice and re-splice them in the correct sequence, using a hand crimping tool & Picabond® splices.

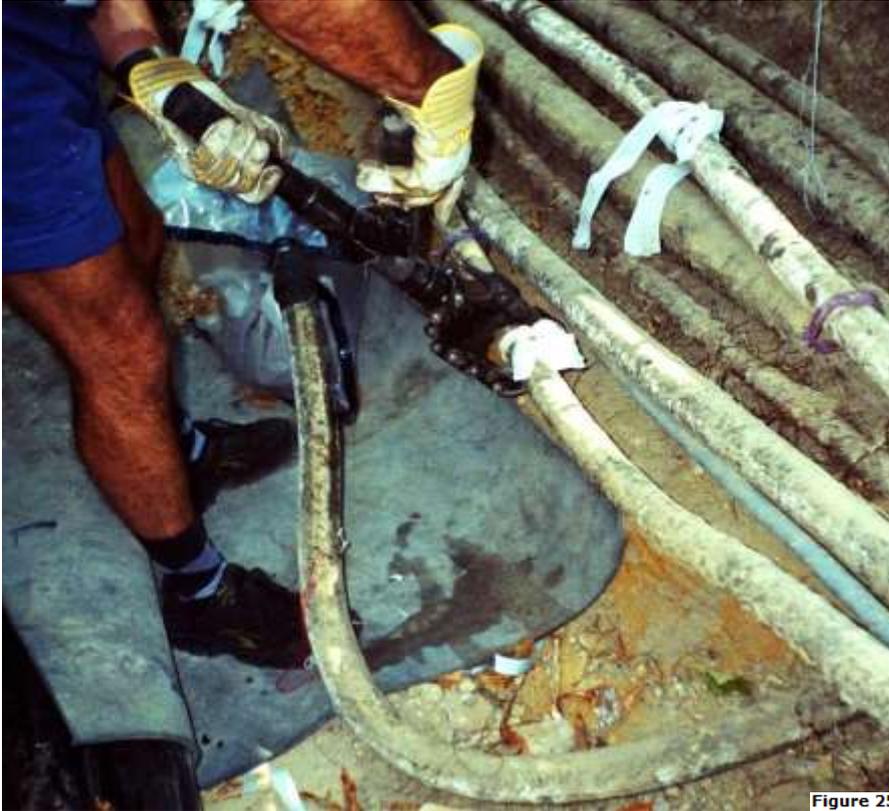
Figure 25

Here, the first of the two cables is just being cut. The new cable, to which it will be spliced, runs underneath and presently ends within a sealed plastic bag.

There isn't much more to be said about the cutting, except to note that the cutter operates by hydraulic power derived from a hand pump, which is integrated into the tool handle.

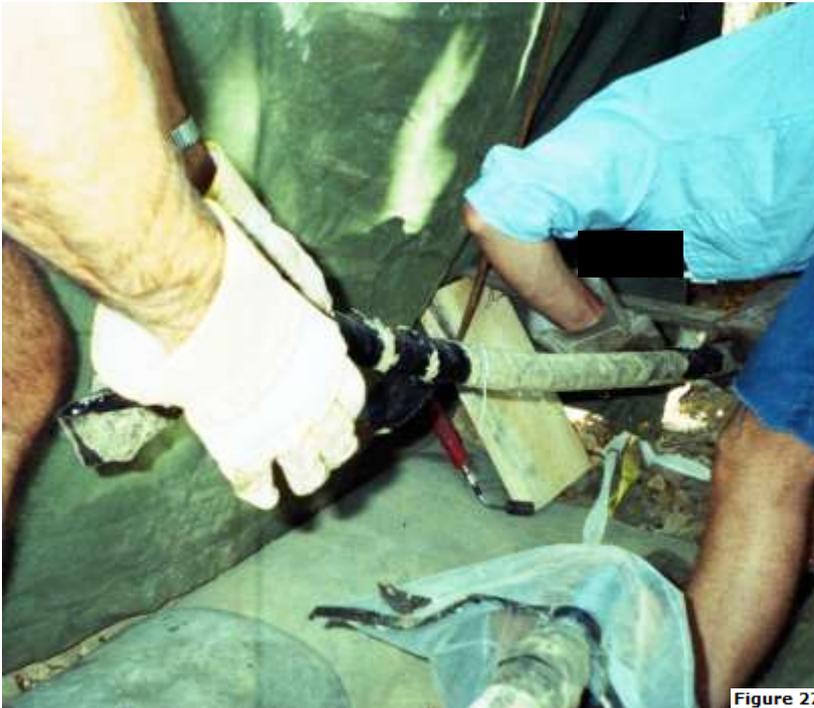
Here we see the outer layer of steel armor tape being unraveled from both ends.

It's easy as pie to do so from the end of the cable, but a bit tedious from "in the middle." The steel tape is deeply scored with the cable knife and then the edge of the tape is grasped with a pair of slip-joint pliers. The tape is then bent upwards at the scoring, and it parts rather cleanly.

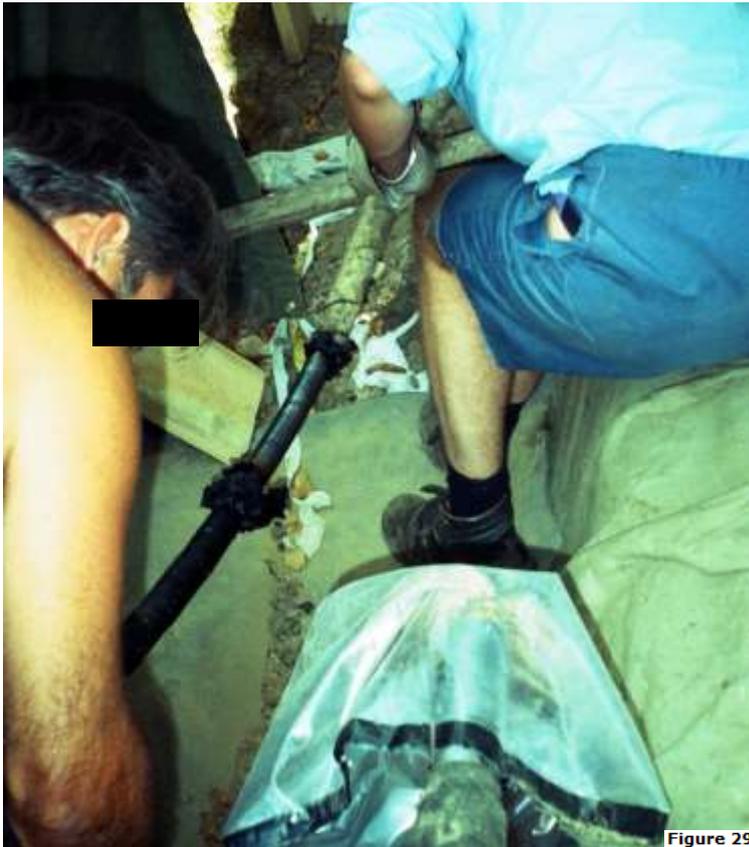
Figure 28

The protective cable coverings have been pulled back just far enough to allow the lead cable sheath to be scored and broken off at the proper point for the splice.

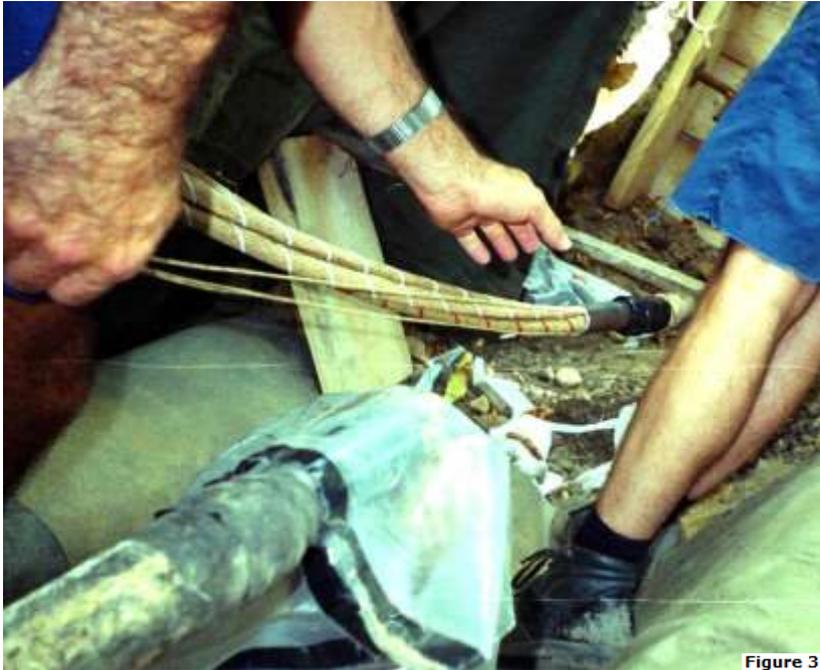
Figure 30

The photograph to the left is simply included to show that the cable is unit stranded, and to demonstrate that the cable contains two *spare* spiral four quads, which are laid in separately from the stranded units.

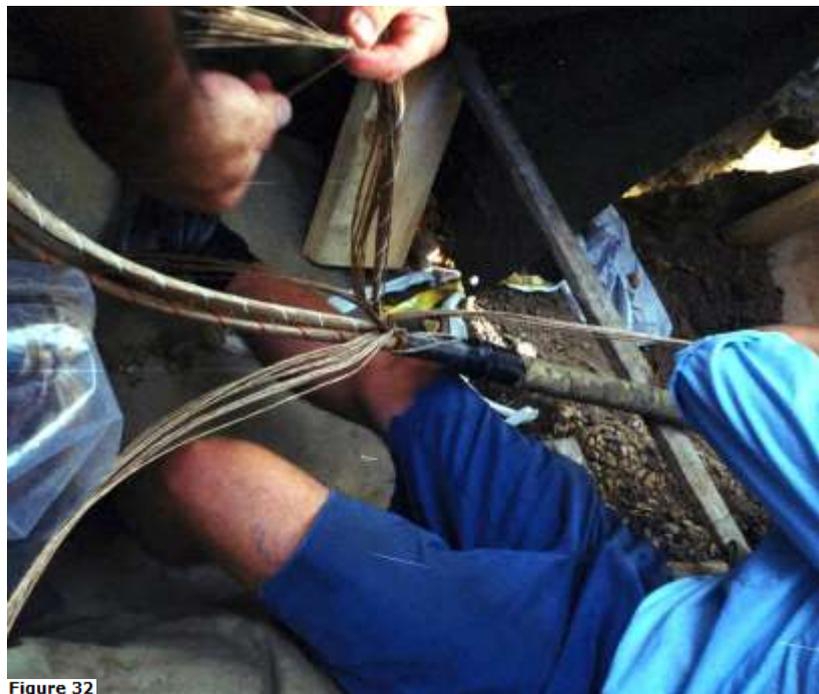
Figure 32

Here, the cable splicers are beginning the work of fanning out and assembling the spiral four quads into their proper groupings for the subsequent splicing operation.

The separate cable units in this instance are marked with plastic ribbon binders; one can see the single red binder which identifies the tracer unit from which counting begins.

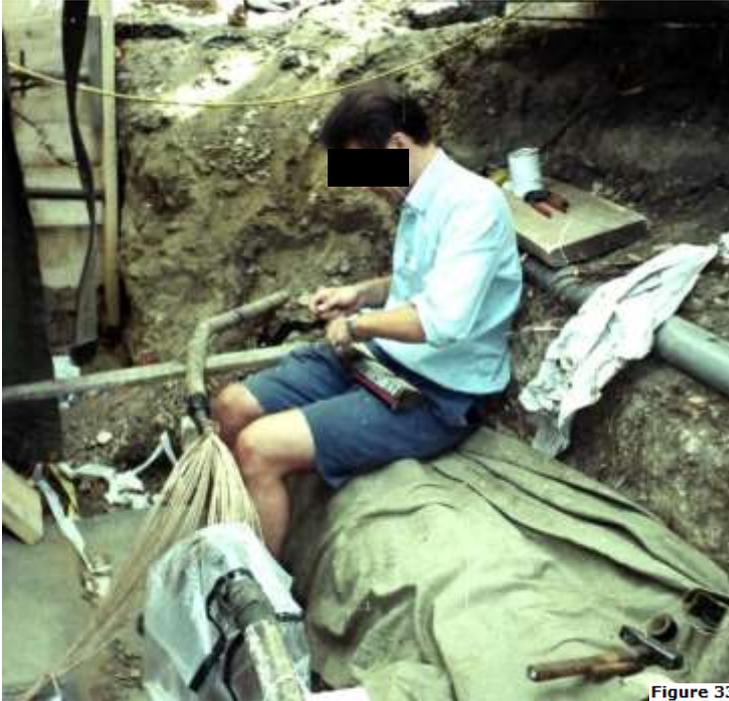
Figure 33

Here, the cable splicer is assembling the lower crimping head for the MS<sup>2</sup>® splices.

This photo also gives the reader a good idea of how deep the splicing trench actually was and under what physical conditions the splicing was being performed ... it was very lucky that it wasn't raining, because otherwise plenty of water would've run into the trench despite the tent which would've been used.

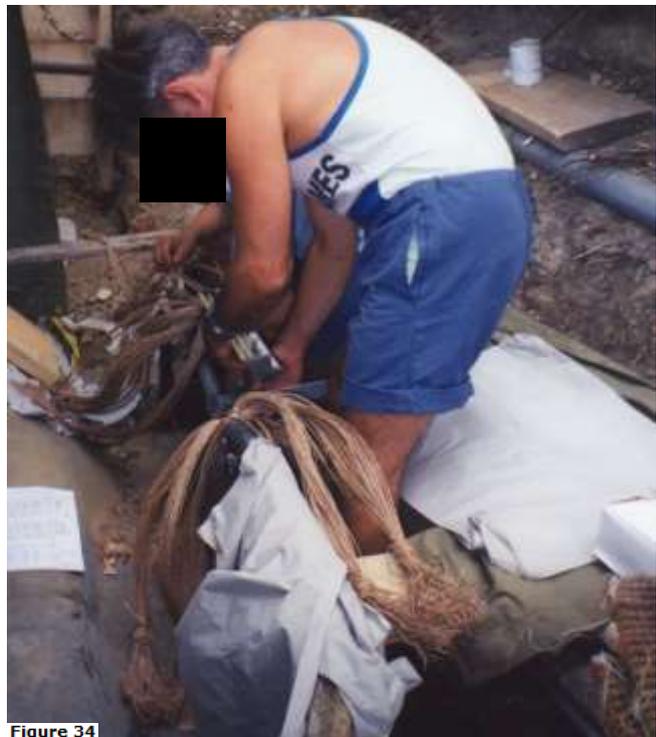
Figure 34

Assembling an MS<sup>2</sup>® splice roughly involves the following steps: first, a splice cap is placed in the crimping head base; then the relevant spiral four quads are fanned out into individual wires and these are run between wire comb teeth and are held in place by these; then the crimp body is inserted into the crimp base and the relevant wires from the other cable fanned out and laid in as before. This stack-up is completed by adding a second splice cap and attaching the upper portion of the crimp header.

The crimp header is operated by means of a small hydraulic pump integrated into the handle. The splice isn't only compressed as the hand pump is operated, but the over-length of all wires is cut off in the process as well.

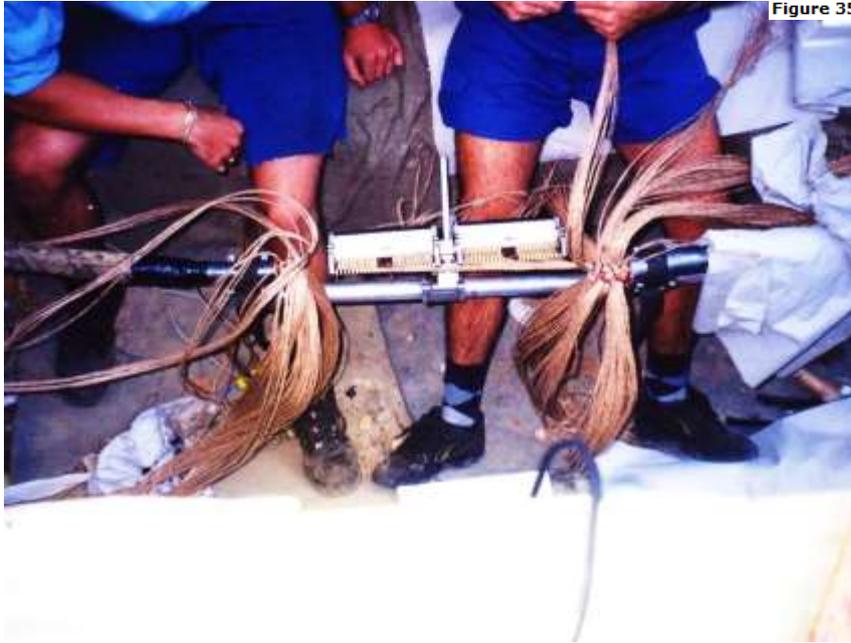
Figure 35

In this photograph, one can see the first splice in a semi-completed state.

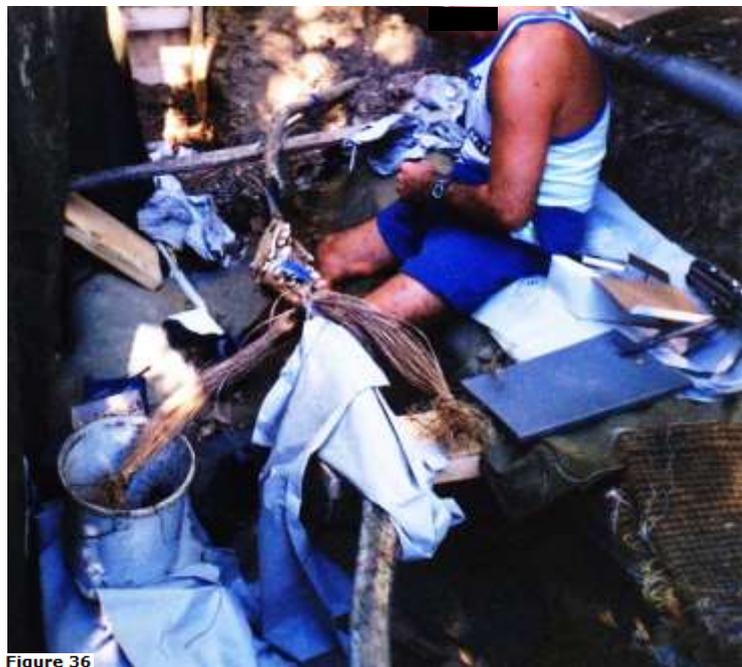
Figure 36

After the first of the two cables was completely spliced to the new feeder, two medium-sized perforated plastic bags of silica-gel were wedged between the wire bundles.

The silica-gel crystals are supposed to absorb any moisture within the splice; they're of a bright blue color when factory fresh and dry, and turn a nice shade of pink when they've absorbed moisture.

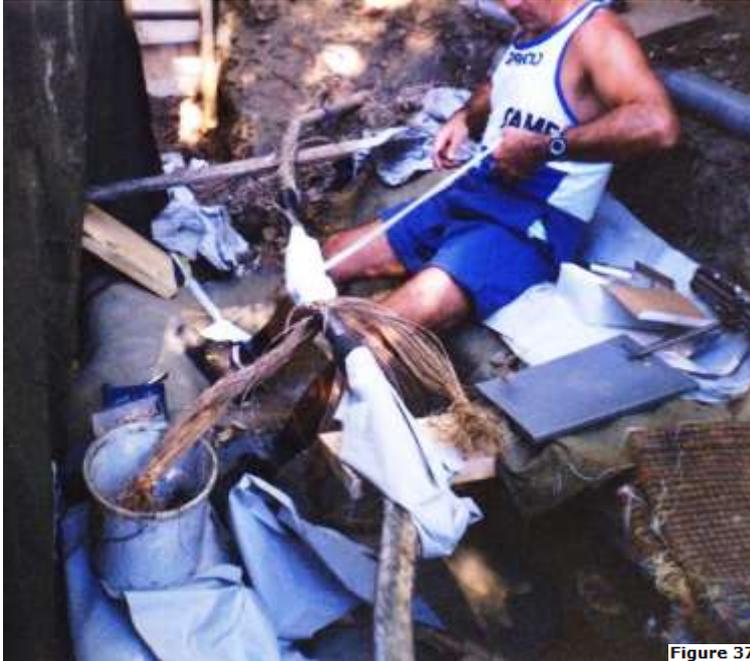
Figure 37

The splice is then thoroughly and tightly wrapped in clean cable splicer's muslin. This is done for two reasons: 1) the muslin helps hold the bags of silica-gel in place, and 2) it confines the splice in the smallest space possible, in order to prevent any of the wires from coming close to (or even touching) the lead splice case. The latter is necessary in order to prevent the paper insulation from scorching to a point where crosses and/or shorts to ground occur while the splice case is being soldered.

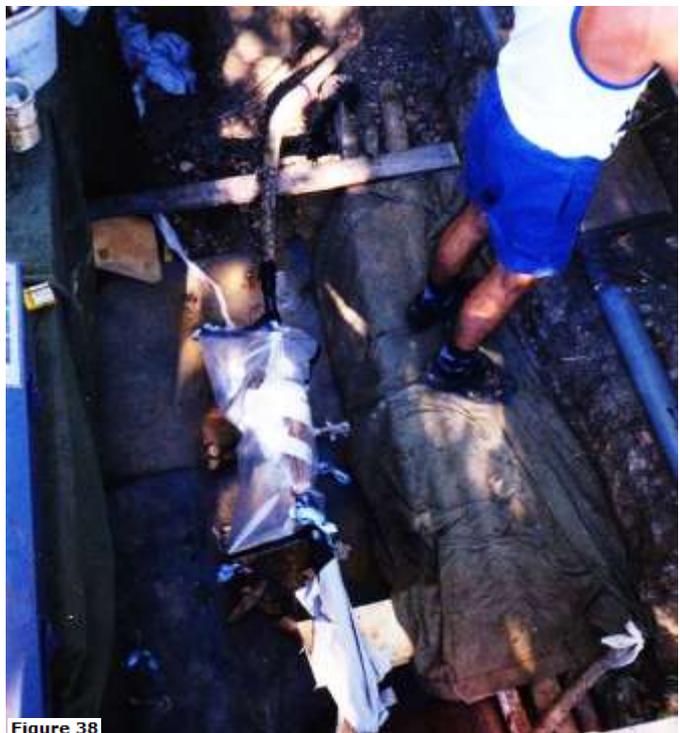
Figure 38

It was just about noontime on Saturday when splicing of the first cable was finished, so the splicer just bundled the remaining wires from the new cable up a bit, tied them to the finished splice and temporarily protected everything with another one of those plastic baggies ....

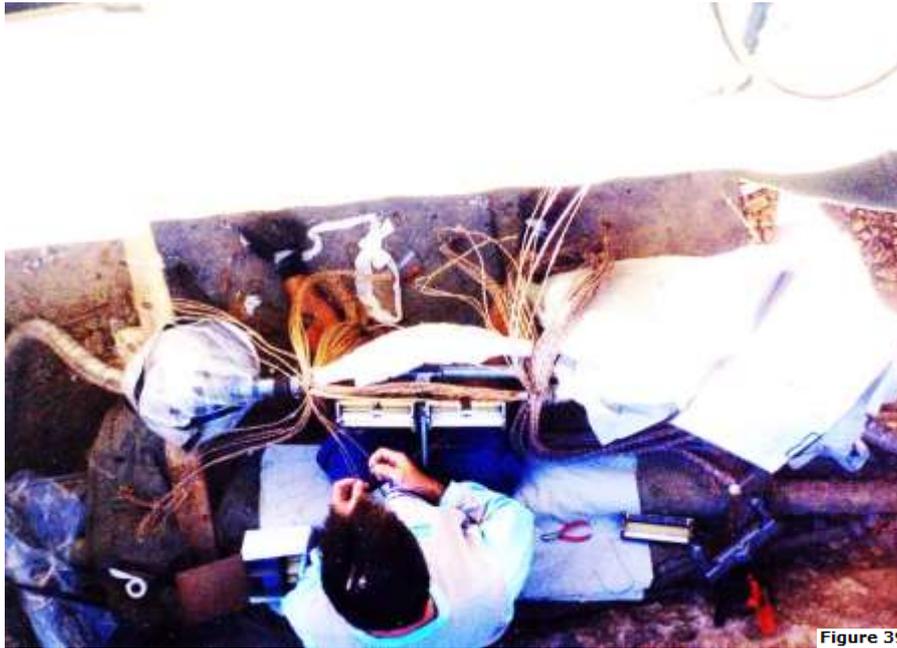
Figure 39

There was no sense in documenting the steps previously described again for the second cable, so I simply shot one photograph during this splicing, just to show that the second cable indeed *was* also spliced (this photo was shot around 9 a.m.) I had other, *much* more interesting things to do that Sunday morning – namely to watch and document how a lead splice case is soldered and wiped to a lead-sheathed cable..

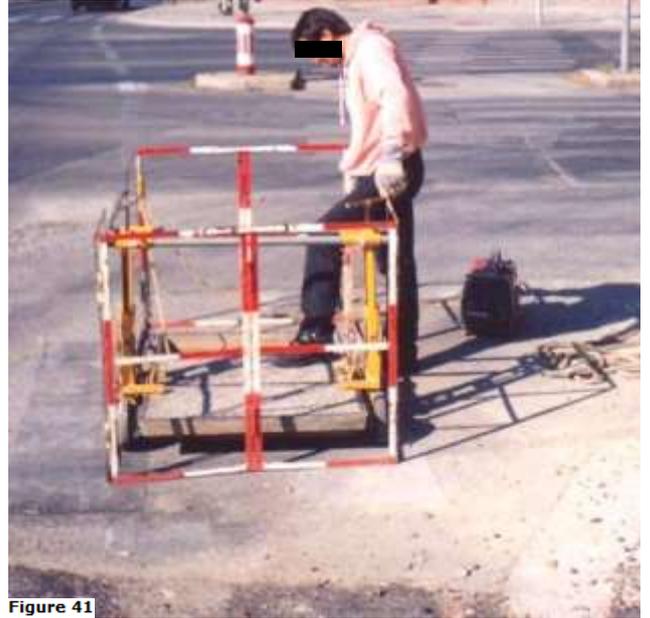
Figure 41

This photograph gives readers a better idea of exactly where the entrance to the manhole was located, and also gives an idea of just how thick the manhole cover actually is (a good 2 inches).

I was very surprised to discover just how different the environmental conditions can be in two manholes which are separated by a scant 300 feet. This one had to be pumped out before splicing operations could begin, while the other one was bone dry.

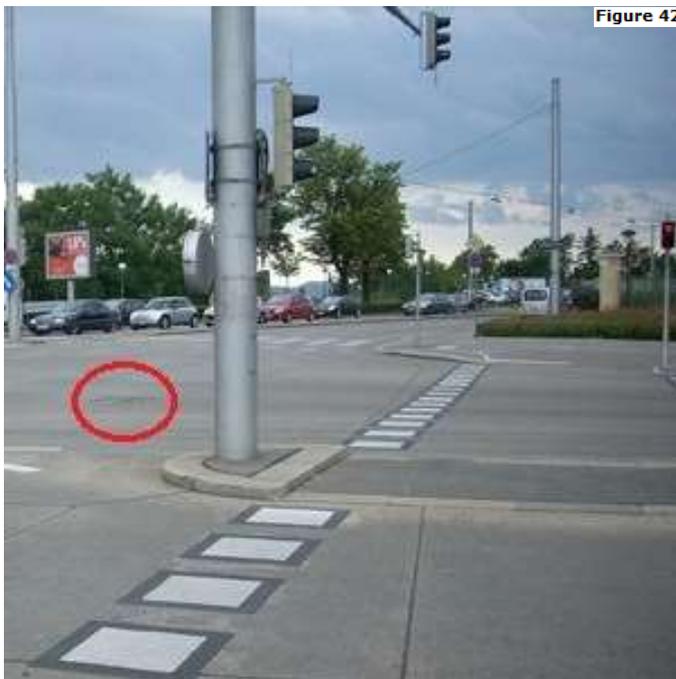
Figure 42

This photo, taken in July, 2012, shows exactly where the manhole above wound up being later on ... right smack in the middle of a traffic lane on the *opposite* side of the street.

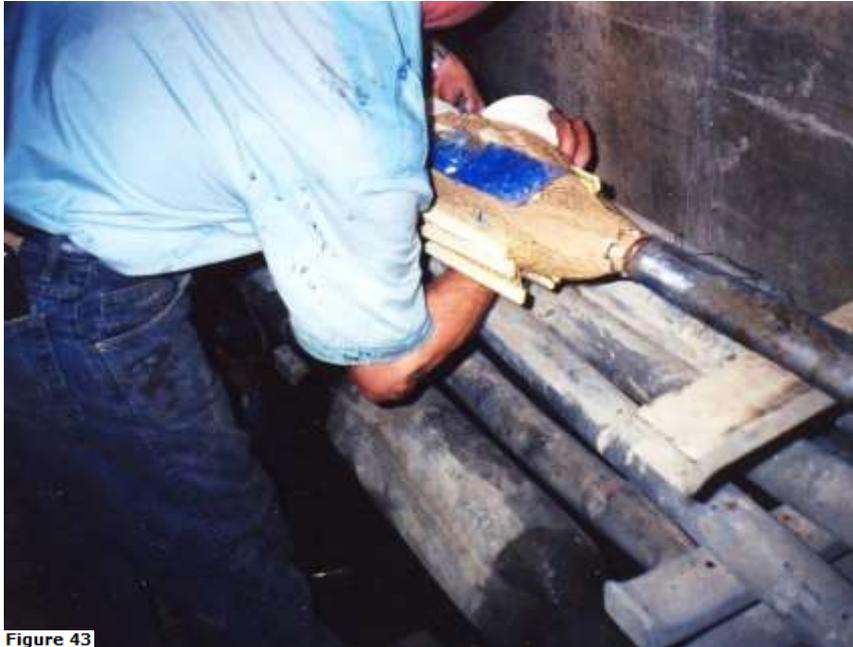
Figure 43

The splice shown here was protected by one of those ubiquitous plastic bags from Friday night to Sunday morning; the cable soldering specialist had already removed the bag and begun to wrap the splice up almost before I had my camera ready. The picture affords a good view of one of those bags of silica-gel being wrapped up in the splice ...

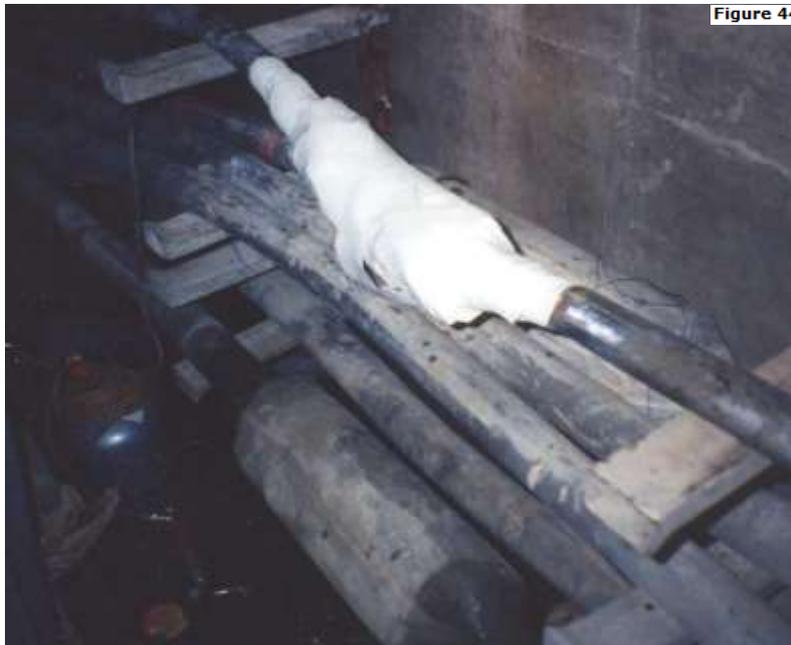
Figure 44

While the muslin wrapping on this splice may not win any blue ribbons for neatness, it's quite sufficient to serve its purpose.

A fact worth mentioning is that the cable supports used are usually of the type as shown here. They have a smallish iron core and are encased in asbestos cement – this is intended to prevent dissimilar metal corrosion between iron and lead. Not *really* very healthy, with what we now know about the hazards associated with asbestos fibers ...

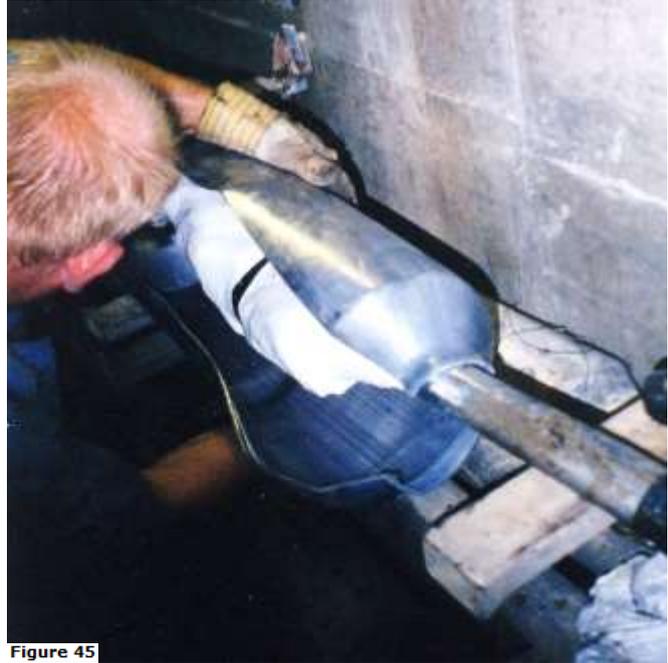
Figure 45

After tentatively securing the case to the cable sheath, he will bang the case into its final shape with a wooden mallet.

Readers may take note of the fact that the lead sheath of the cable has been brushed and scraped until it's bright and shiny where the throat of the splice case touches, in order to facilitate the soldering and wiping operations and in order to ensure that the joints form a hermetic seal.

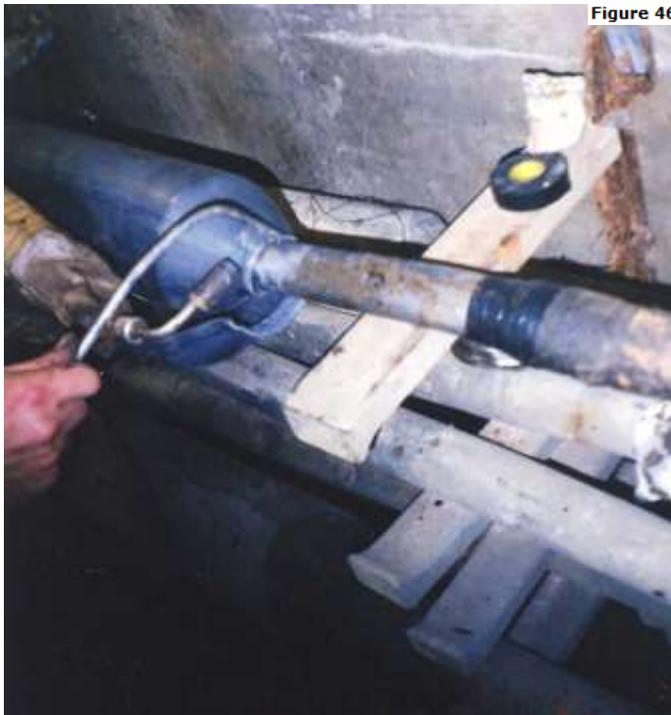
Figure 46

Here, the splice case and cable sheath are being heated with a hot, light-blue propane gas flame, prior to applying some wiping solder to the joint.

As may be seen in the next photograph, the first application of wiping solder is no more than a big, flat blob, which holds the splice case in position while it's knocked into its final shape ....

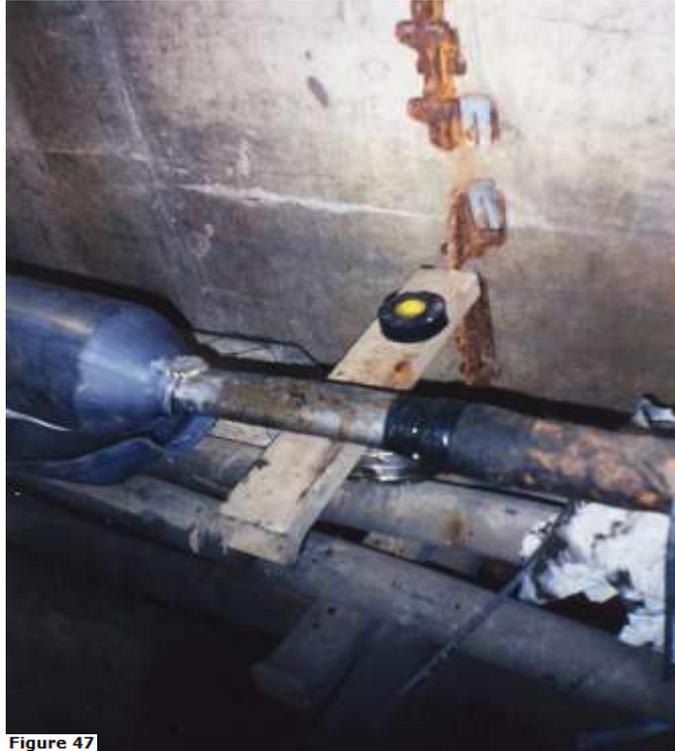
Figure 47

Voila - "le blob" is in its intended place. This photograph shows that a piece of armored cable, normally intended for direct burial in the ground, was pulled into a conduit between the manholes, instead of a section of unarmored cable, as is normally intended for installation in conduits.
