## A Collection of Telephone Tales

written by Herbert Schwarz of Vienna, Austria, European Union

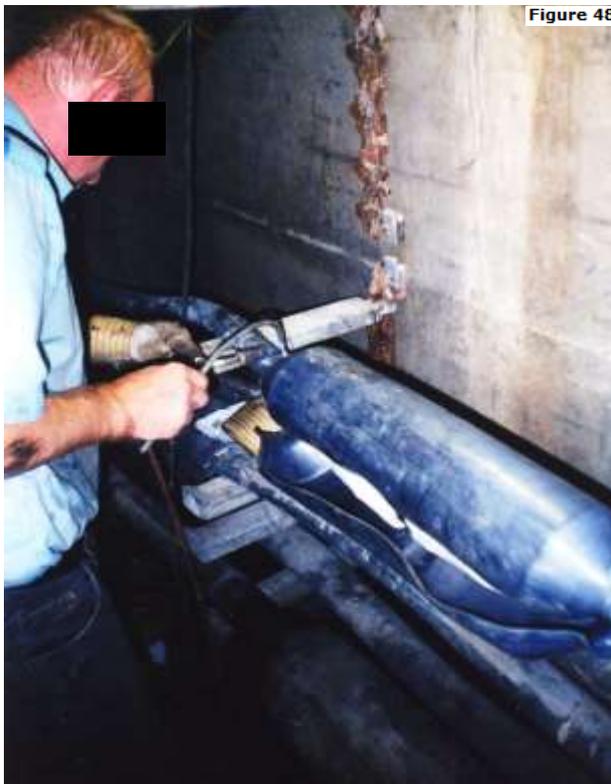
Figure 48

After the blob of wiping solder on the right-hand side of the splice case was allowed to cool, a similar blob was applied to the left-hand end.

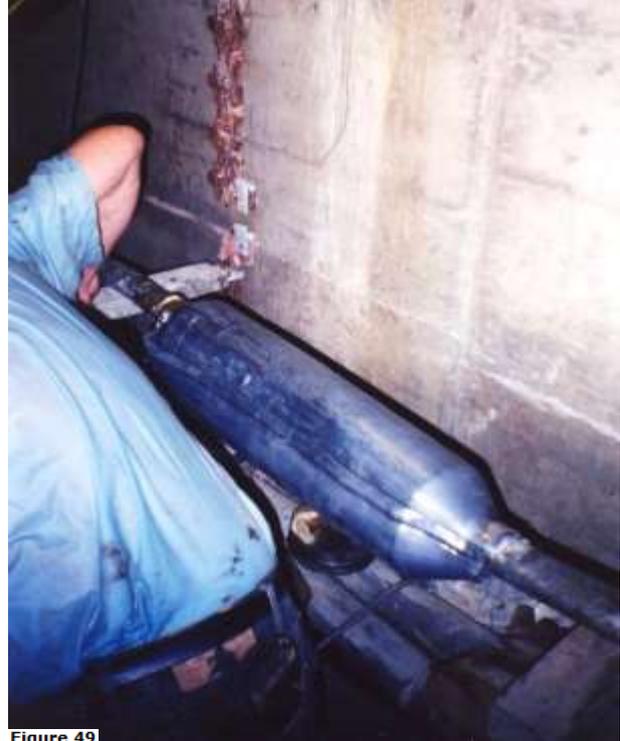
Figure 49

The cable soldering specialist is now in the process of forming and wiping the seal on the left-hand end of the splice case, after first having literally knocked the splice case into shape.

The seal has already attained the approved form and size, being about 1 centimeter thick at its highest point, and about 2.5 centimeters (roughly one inch) wide at the base.

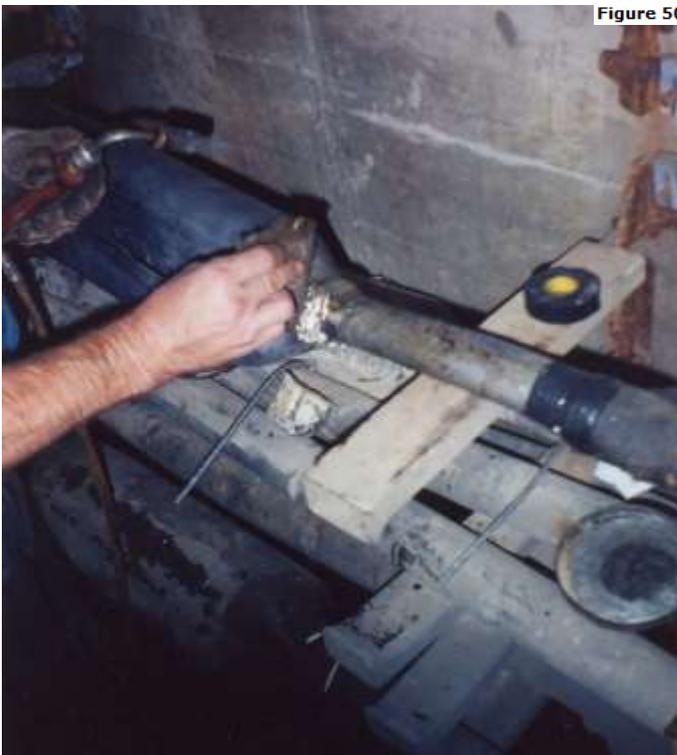
Figure 50

Now the cable soldering specialist is in the process of forming and wiping the seal on the right-hand end of the splice case.

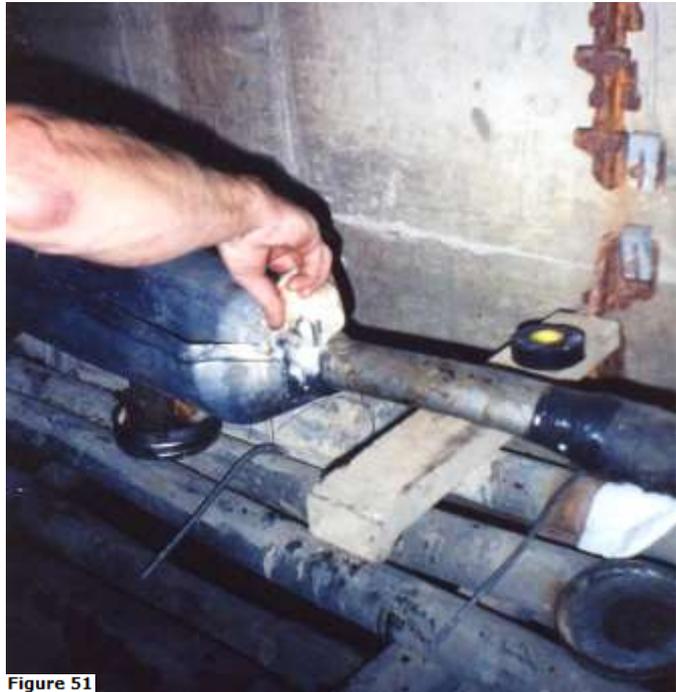
Figure 51

After the wiped solder joint has attained the desired shape, it's cooled by pressing and rubbing a block of stearin against it.

The stearin actually serves a twofold purpose, namely to cool the joint, and also to remove any oxides which may have formed during the wiping process.

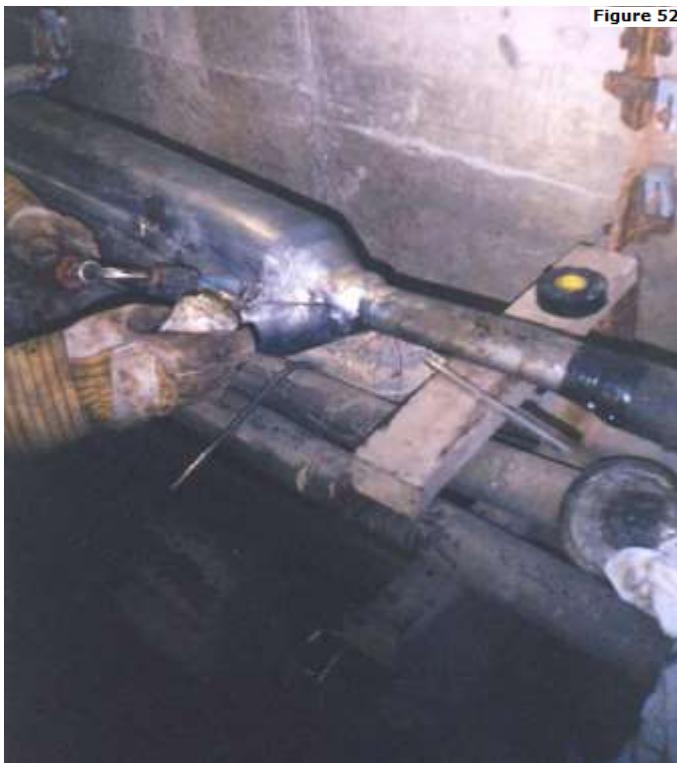
Figure 52

After both end seals have had time to cool down completely, the seam is gently heated and stearin is applied in order to clean the lead prior to the soldering and wiping operations.

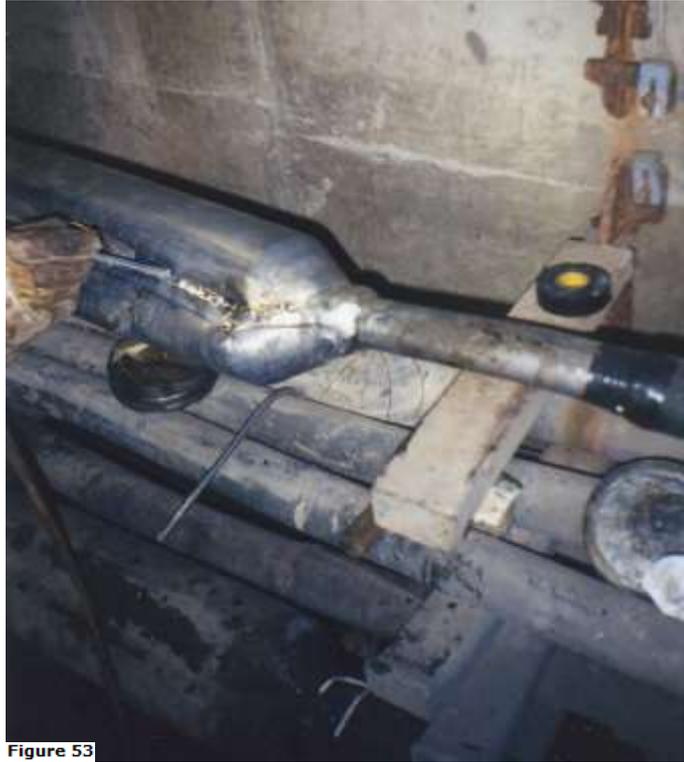
Figure 53

In the photograph to the right, the soldering specialist is in the process of more or less "dripping" the wiping solder into the seam of the splice case.

It's interesting to note that the seam isn't soldered/wiped closed in one fell swoop, but is rather done up in short segments.

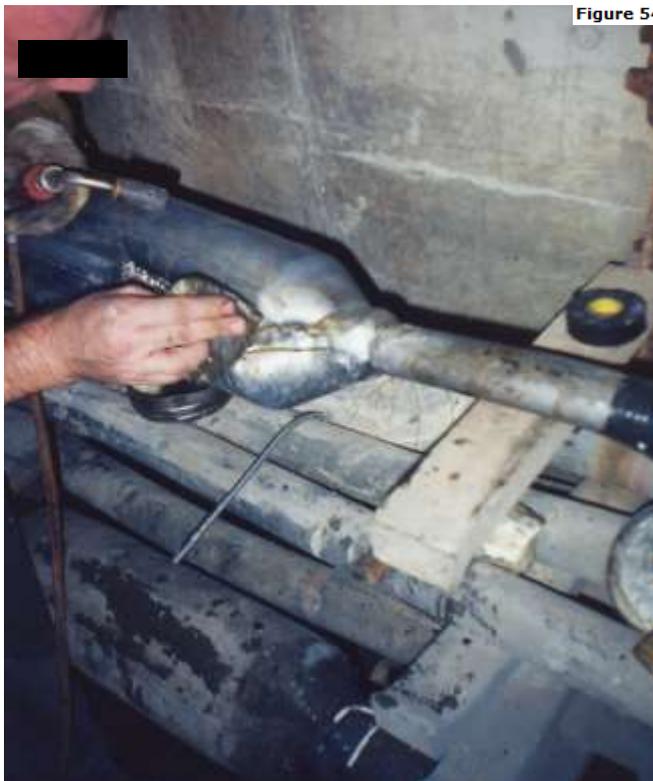
Figure 54

The cable soldering specialist had just begun to wipe the lead into the first portion of the seam when the photograph to the left was taken.

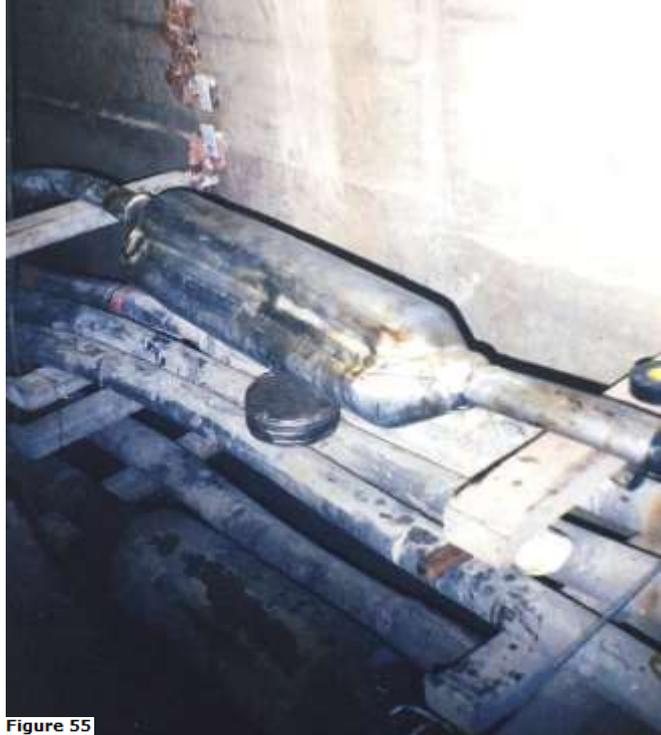
Figure 55

At first, I thought that the picture showed the splice case after the first third of the seam was wiped, but since the tin can with the tallow (below the splice) is closed, the job must have been finished.

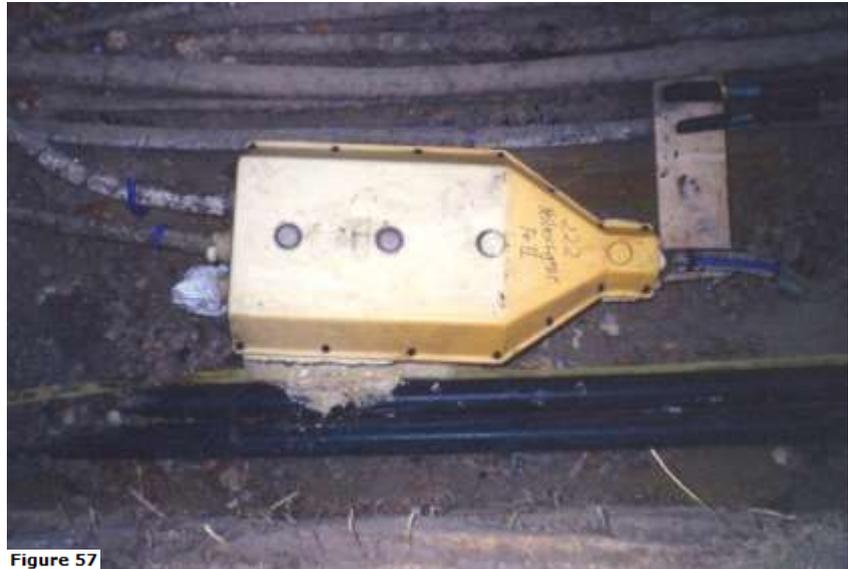
Figure 57

They'd attached the lead splicing case to the three cables and sealed this case in an outer shell of hard and durable plastic. Polyurethane foam was used to fill the airspace between the two splice cases. Some of the brown foam spilled out.

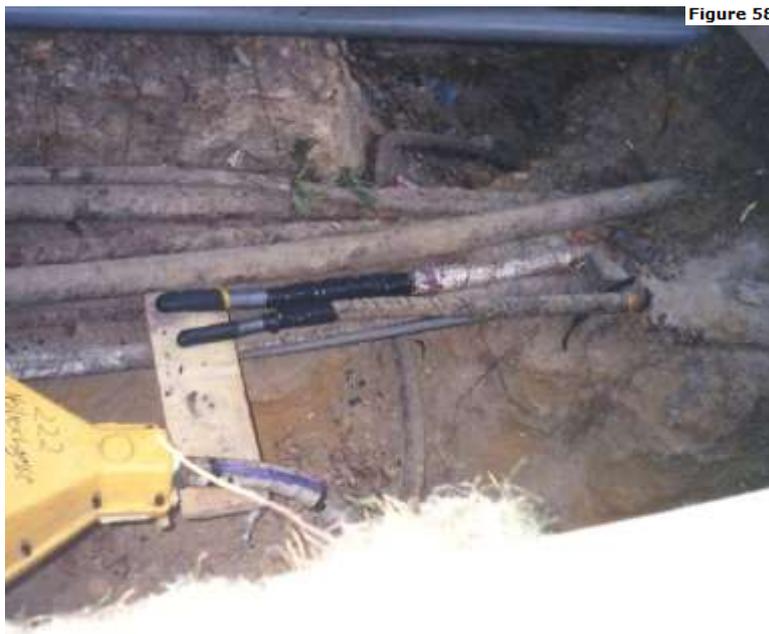
Figure 58

The remains of the two old cables were dead-ended with heat-shrinkable caps, and were buried without concern that the blank lead sheathes might start to corrode one of these years.

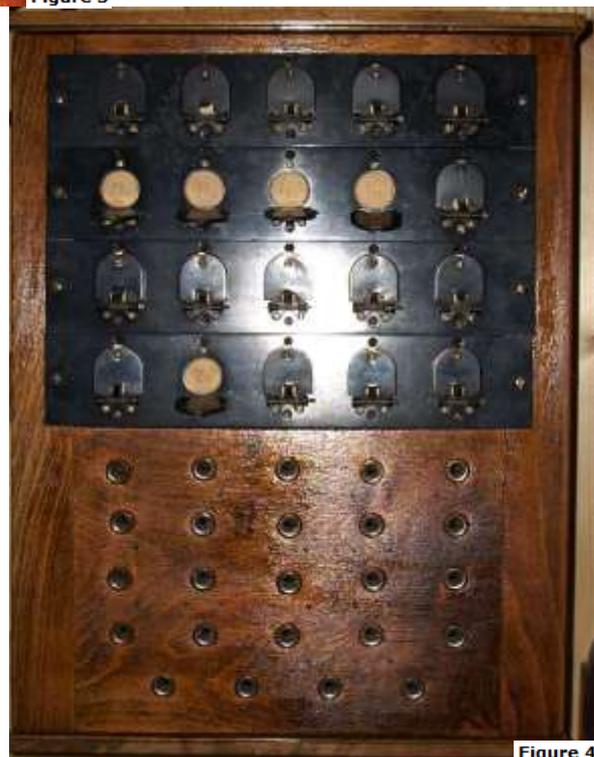
Figure 4

This magneto switchboard was one of those referred to on the previous page ... after its useful life as a small village exchange, it was used in the MDF room of an unknown exchange in Vienna and later found its way to a flea market in Austria.

In its latter capacity, there was no need for the original plugs and cords, so these were simply scrapped. However, I have managed to lay my hands on enough original plugs and modern (but cloth-covered and original style) cords to be able to restore this board to its former glory one of these years, when I'm *really* bored.

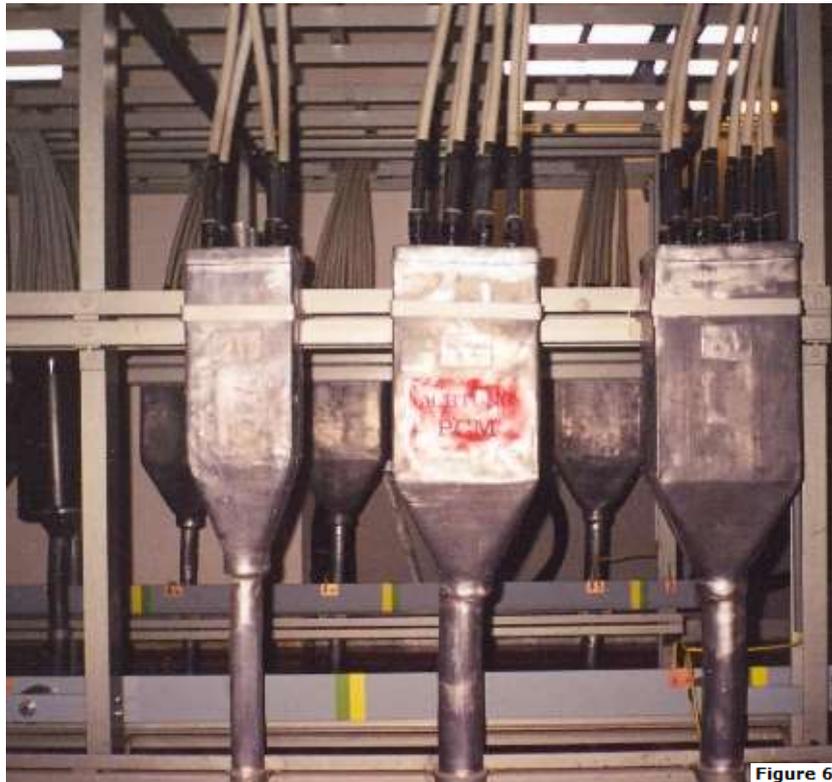
Figure 6

The slate-colored bars with the vertical yellow & green stripes are copper

grounding bars to which the lead sheaths of all the cables are bonded; two such bars may be seen in the above photograph ... *electrical* grounds in most of Europe are identified by combined yellow & green stripes, while *telephony* ground is red; however, the red color on the fanning case in the middle foreground of the picture was apparently applied to identify the cable as belonging to a PCM system.

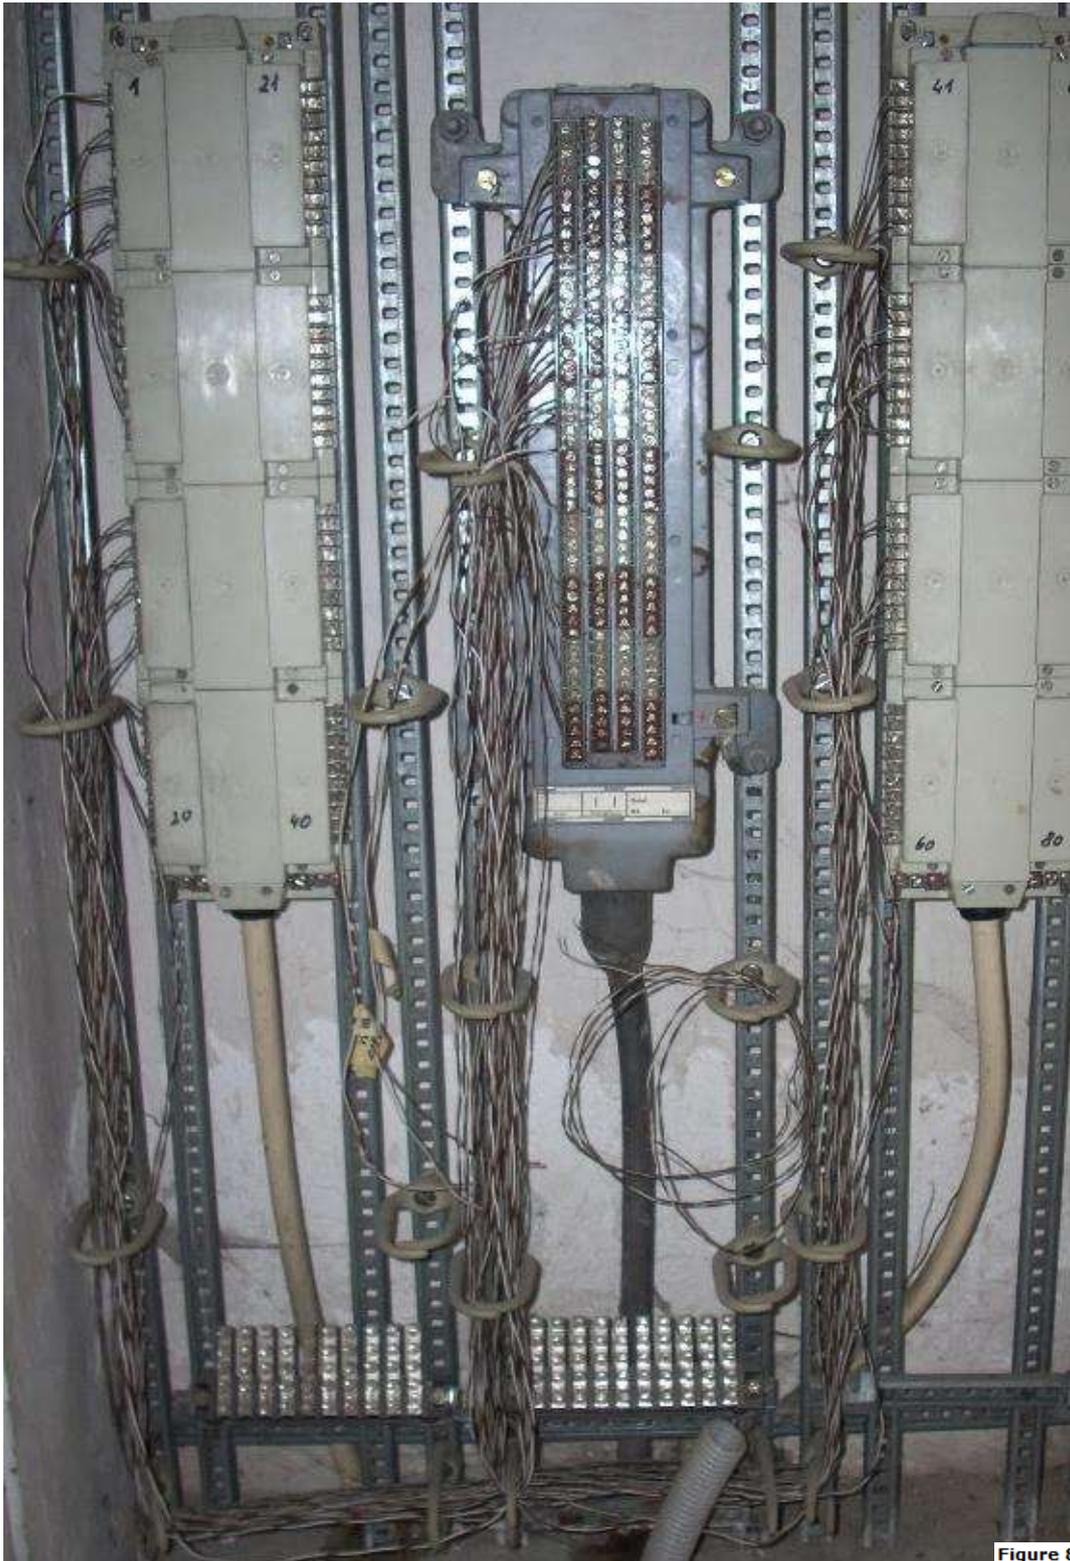
Figure 8

A 50 pair lead-sheathed, paper-insulated cable is terminated on a screw terminal of 100 pair capacity in this cross-connect cabinet, and distributes the pairs to a maximum of 4 buildings. The 100 pair terminal is potted in order to keep moisture out of the paper-insulated feeder cable, while the two cables (on the left and right) exiting the cabinet are good old PVC-insulated stuff. The 100 pair terminal is divided into brown and white segments, which allow for simple counting of the pairs (and have nothing to do with the identification of tip and ring).

The terminals for the two PVC cables are of a modular type, which can be expanded in steps of 10 pairs; they're not filled with any sort of potting compound. As previously mentioned, the jumpers within this cross-connect cabinet are of the older, brown-white style – it'd simply be too much work, and be too costly, to want to go and replace all of these old jumpers with new ones, just for the sake of consistency. However, any *new* connection made in such a cabinet is made with green-white jumper pairs.

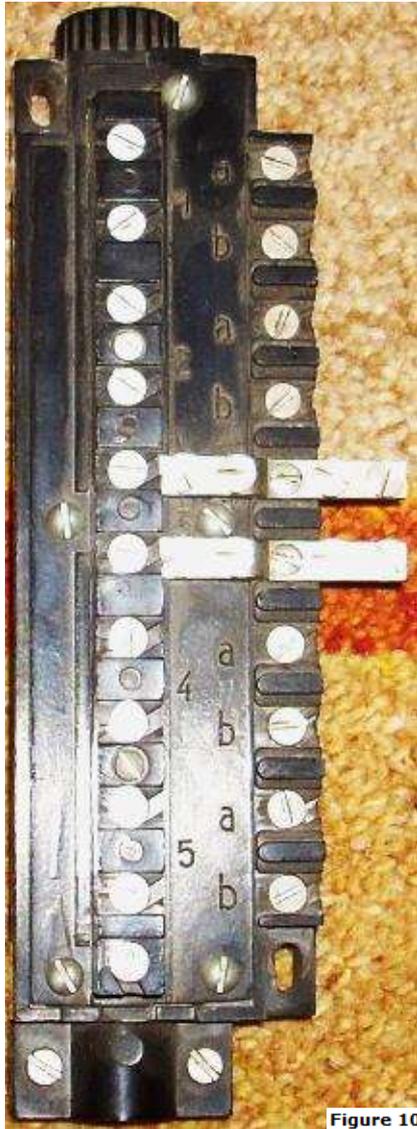
Figure 10

Here we have a Bakelite cable terminal, model 1948, which is a type that is still in widespread use throughout Austria. The one shown here was intended for a maximum of five private (single) line subscribers, since the legends 1 a/b thru 5 a/b are embossed on the cover ("a" = tip). These terminals were built with 5, 10 or 20 pair capacity, with the 10 pair type being the one most commonly employed. The five pair terminal shown here was manufactured in 1958 and is dusty NOS.

The top end of the cable terminal has a screw-on cap ... after the paper-insulated wires were terminated on screw connections inside, and the cover had been reinstalled, this type of terminal was filled with a potting compound for moisture protection.

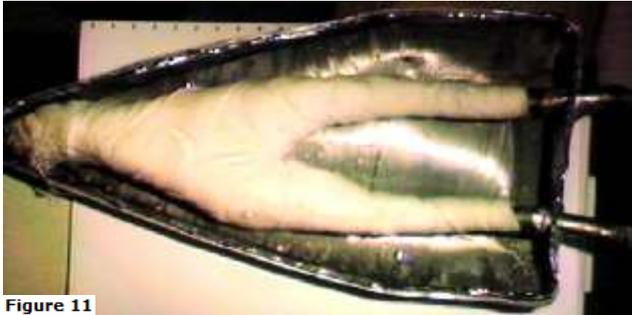
Figure 11

This is a wye splice of a 300 pair cable into 2 100 pair cables which led to two cross-connect cabinets ... I dragged it home from a junkyard and cut it open for a looksee.

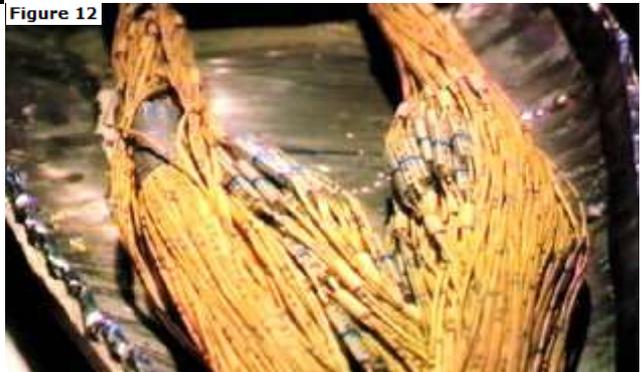
Figure 12

The photo to the right shows the splice after the muslin wrappings were removed. In this case, TYCO® Picabond® splices were used; as may be seen, there are 50 quads dead-ended within the lead splicing case, so that there were plenty of reserve pairs available at this last distribution splice along the line.

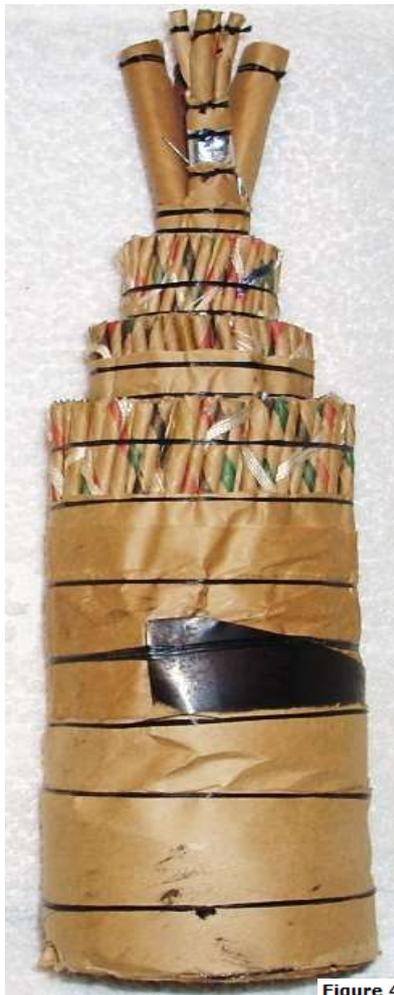
Figure 4

The cable core shown to the left is a piece of a DM toll cable. However, it was a *very* special toll cable, known as "war cable." Yes, this stuff was manufactured during WWII and, accordingly, has *aluminum* wires instead of copper.

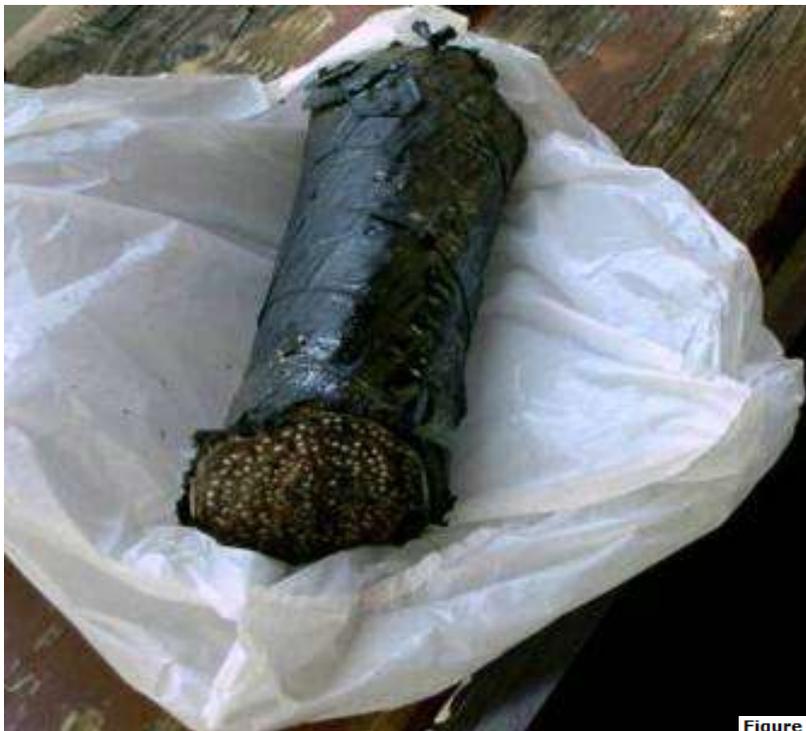
Figure 5

This photograph shows this intact piece of cable, just as I received it. The lead sheath was protected by two layers of paper soaked with bitumen, on top of which there originally was some armor in the form of flat iron wires, wrapped around the cable in a spiral pattern, imbedded in rotting jute roving's.

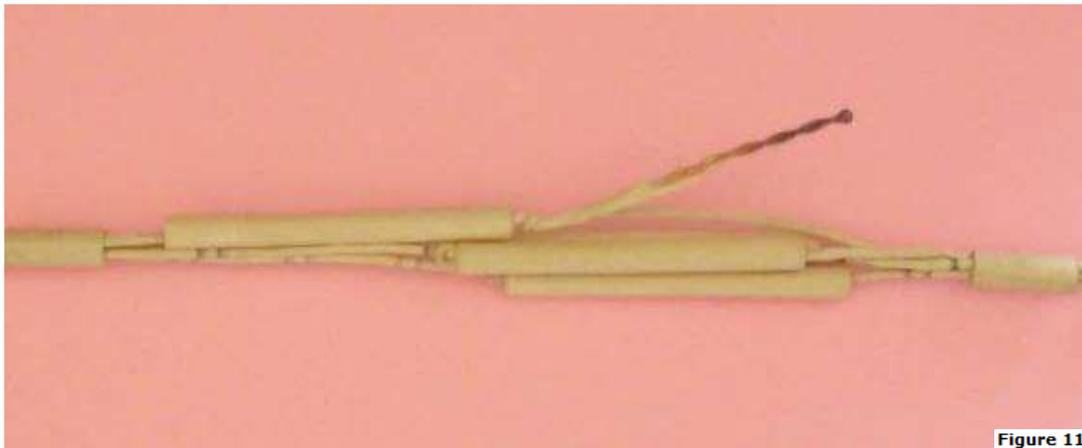
Figure 11

Toll cables with copper conductors of larger diameter (circa 2 millimeters and upwards) were usually spliced by inserting the bare ends of the wires into short copper tubes and being soldered. The copper tubes were slit lengthwise in order to allow the solder to flow better.

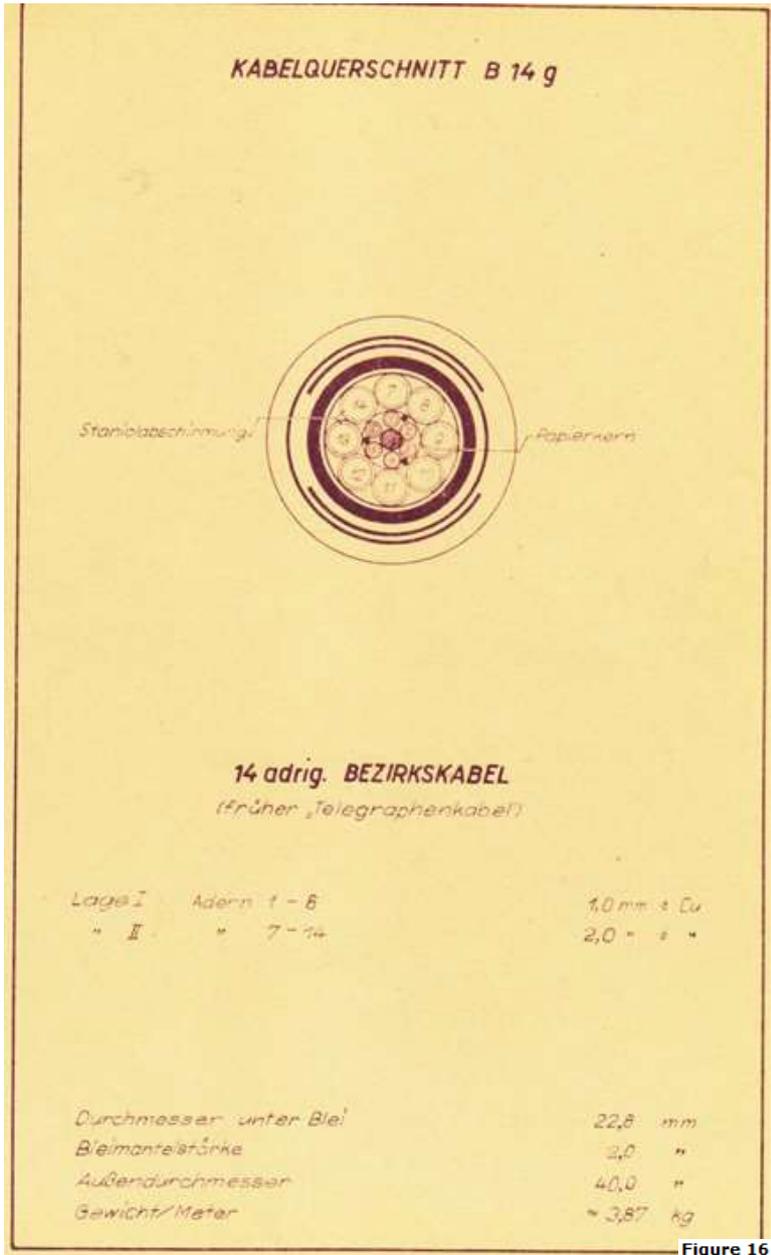
Figure 16

The cable illustrated here is interesting because it's designated as a "14 conductor district cable, previously 'telegraph cable'."

The first thing one notices is that this specific cable doesn't adhere to the standard manner

in which the identifying rings are printed on the paper insulation. I was surprised to discover that this particular cable wasn't of Austrian origin, but was rather manufactured in Delft in the Netherlands.

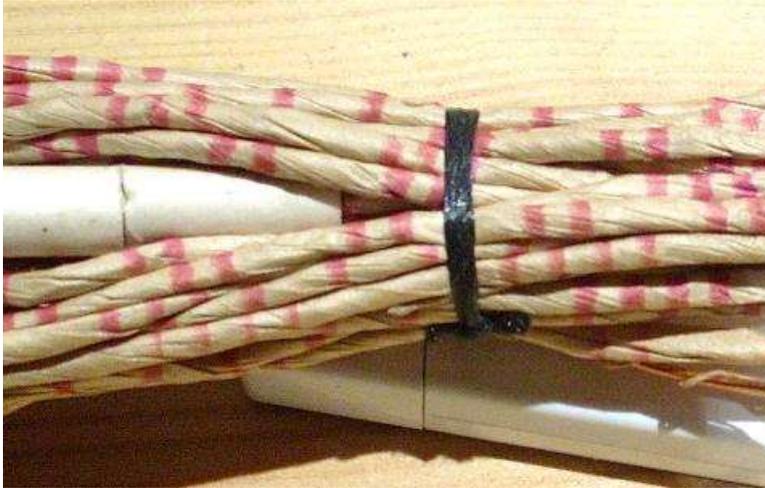
This close-up shows that the four wires of each quad are simply marked with one, two, three or four equally spaced rings in red. The two bits of white cardboard to the left of the tie are group rings, which are used to mark the individual quads; in this specific case they're on the number one quad in the core.

Although this piece of cable is from an older toll line, the quads are not laid up as Dieselhorst-Martin quads, but

rather as regular star quads. Thus, this cable was built up to conform to the so-called "St-I" specification, while all subscriber cables were built to "St-III" (whereby the "St" is the German abbreviation for "Stern" = "star").

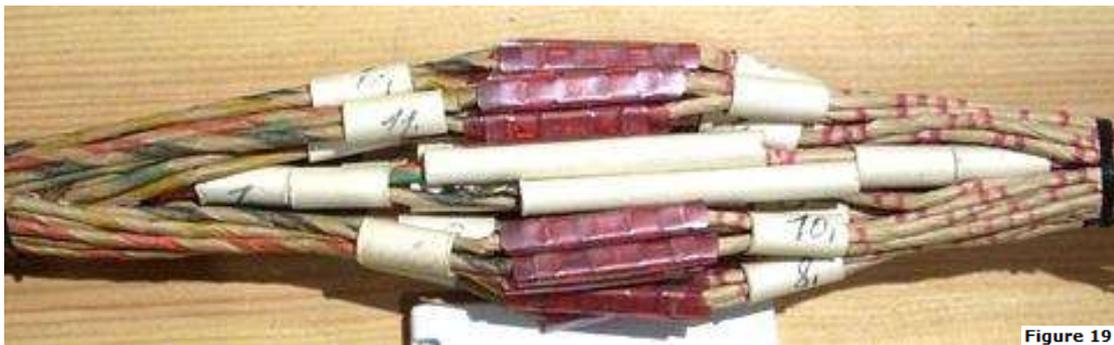
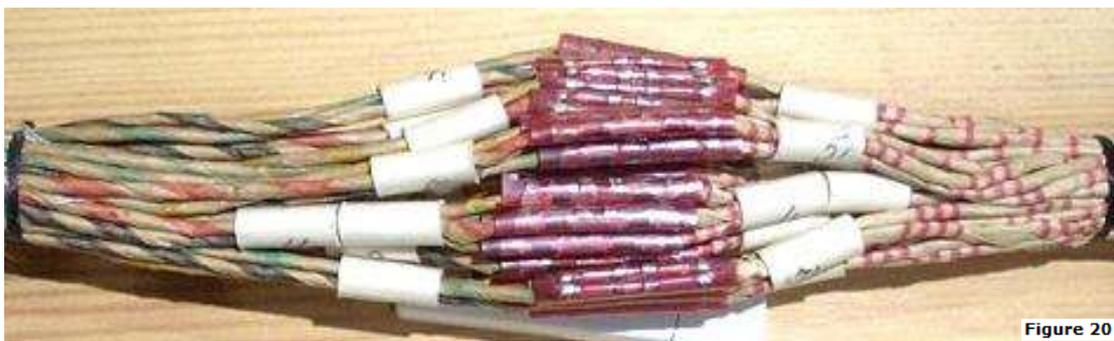
The two photographs above show both sides of one of the splices cut out of the cable during recovery; as can be seen, the cable on the left conforms to the "old" standard, having stripes in red, black, green and yellow. There are 12 quads in both cables; quads numbers one and four are marked with two group rings, and the wires are connected with standard TYCO® Picabond® splices.

The *core* quad is spliced the old-fashioned way, using solder to achieve a perfect, low resistance splice, which will remain stable over a very long time. This was done so as to always have a good quad for measuring purposes, even if the cable core was wet.

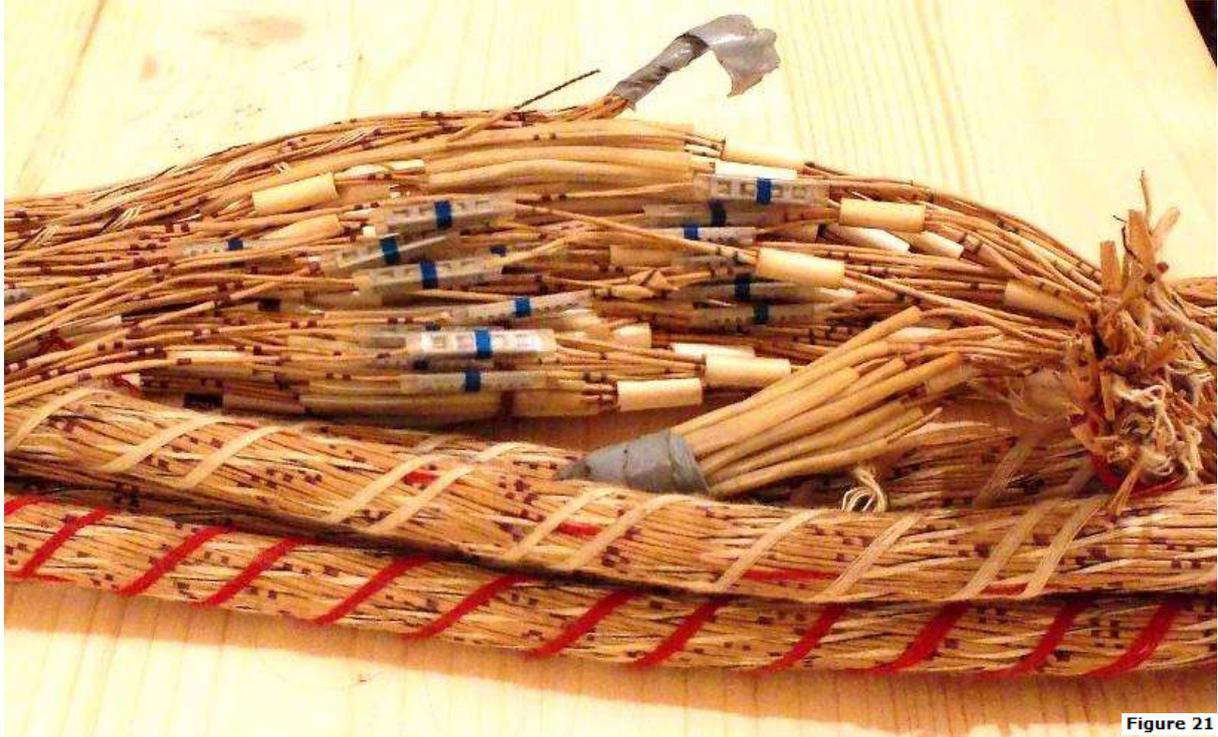
Figure 21

Shown above are some splices which were cut out and redone with standard TYCO® Picabond® splices. The interesting thing here is that the four wire bundles in the foreground (of which three are visible) run straight through the (removed) leaden splice case, while the spliced wires branch out into a separate cable.

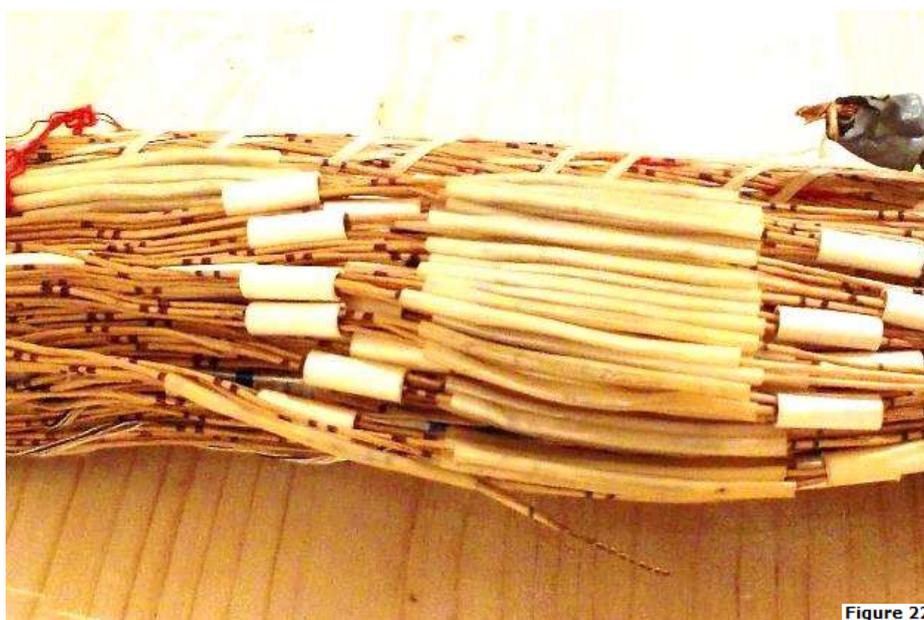
Figure 22

Shown below is a bunch of wires where the splices are insulated with PVC spaghetti; in some instances, the PVC spaghetti became hot enough (during the soldering of the splice case) that the individual pieces adhere to each other.

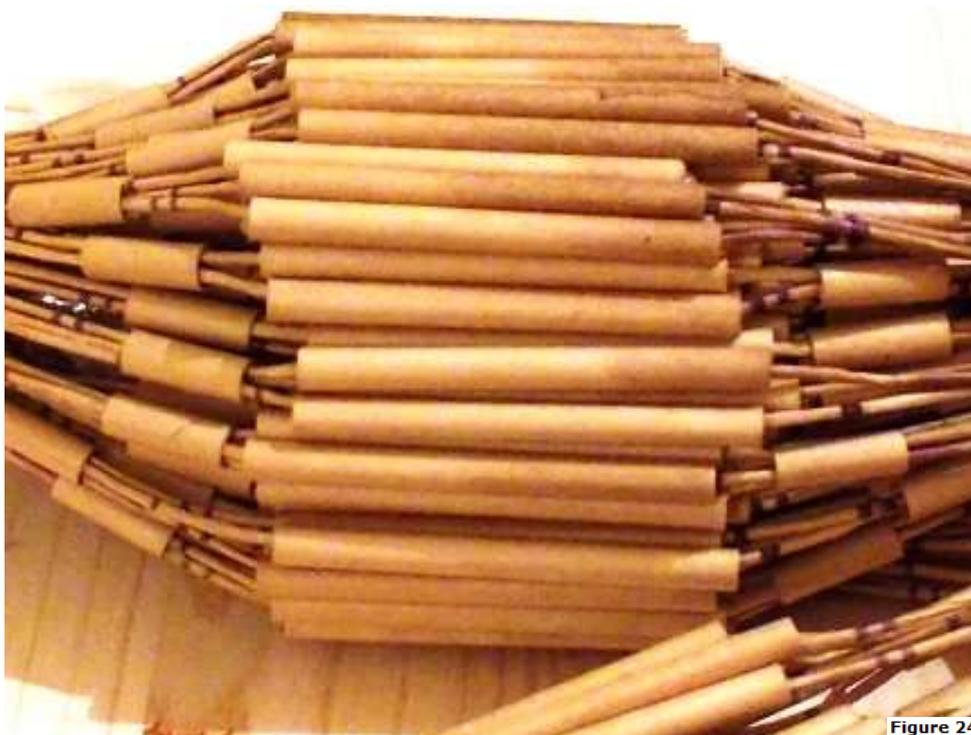
Figure 24

Here we have a nice bundle of splices protected with small-diameter cardboard sleeves, as was standard practice for many decades. Some of the sleeves are a tad darker on the right-hand side – this indicates that the leaden splice case was overheated while being soldered closed.

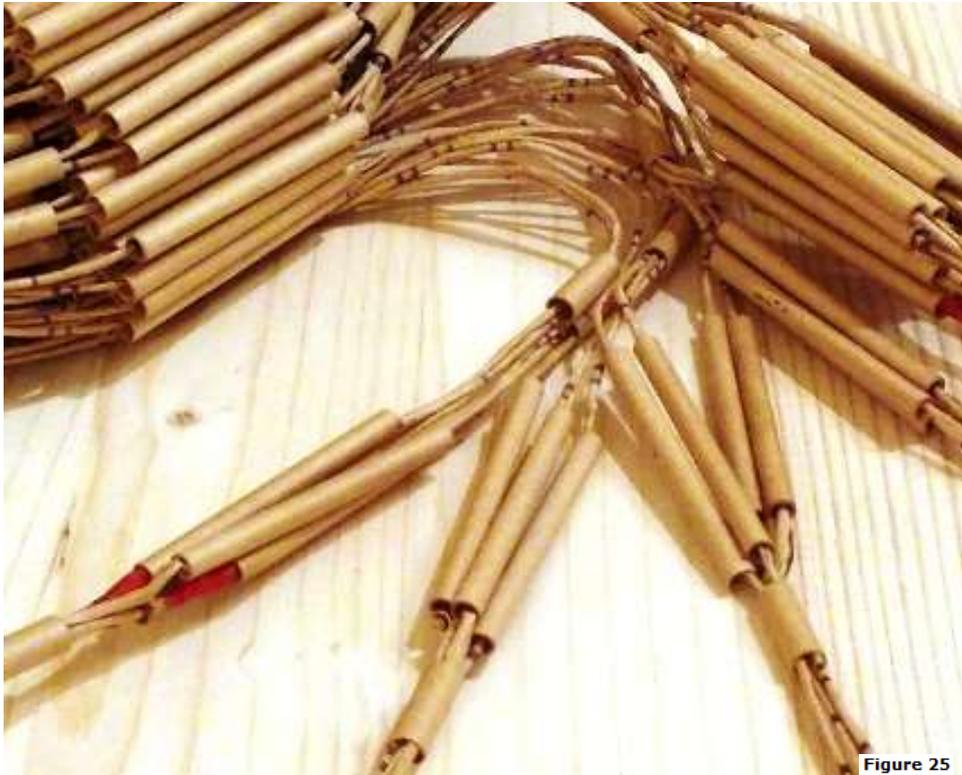
Figure 25

The photo below shows the unusual method by which a portion of the main cable was branched out into a separate feeder cable. Instead of splicing the star quads on a 1:1 basis between the two cables, the quads of the main cable were *split* into their component pairs and these were spliced onto the quads of the feeder cable in a zigzag pattern.

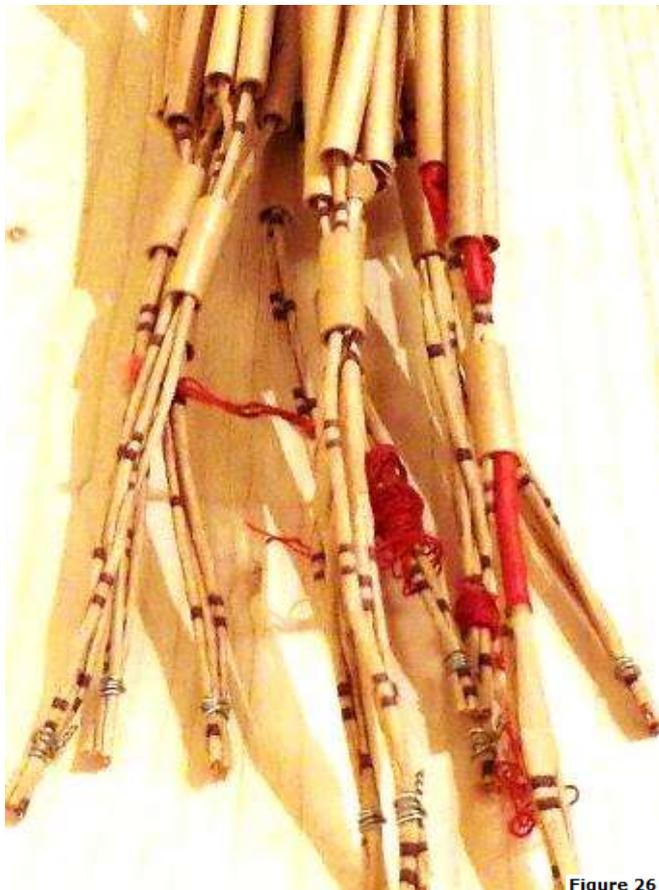
Figure 26

Here we can see one of the major drawbacks of wires which are insulated by means of a single layer of spiral paper ribbon ....

The red stuff is plain insulation tape, which was applied to the wires wherever the paper insulation was torn (or otherwise damaged) during the splicing process - and there was quite a bit of insulation tape on the splices of the small feeder cable, all of it on that side of the splices which belong to the feeder.

It's very likely that the core of the feeder cable was overheated during the baking process, which was intended to dry the core out prior to being wrapped and encased in a lead sleeve; overheated insulation paper has a tendency to become brittle and easily tear apart.

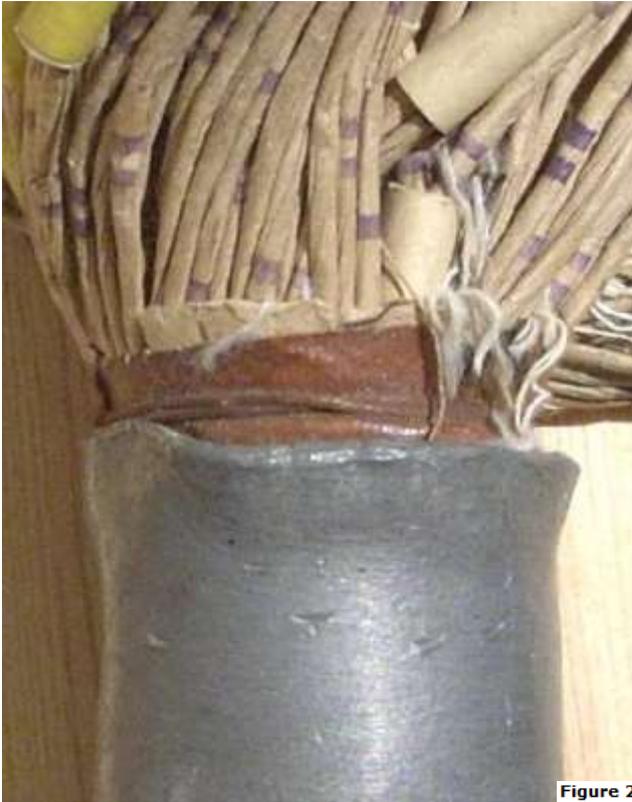
Figure 27

This is the only bit of cable I was able to recover from a splice with its sheath; the cable stubs on all the other splice cases I opened up were so short that the sheaths slipped off the cores right away ... and it's next to impossible to stuff a paper insulated core back in its sheath.

This tape serves two purposes: 1) to protect the cable core from damage during splicing, and 2) to prevent a flashover between core and sheath in the event that vagabond currents from nearby lightning strikes were to be conducted by the sheath.

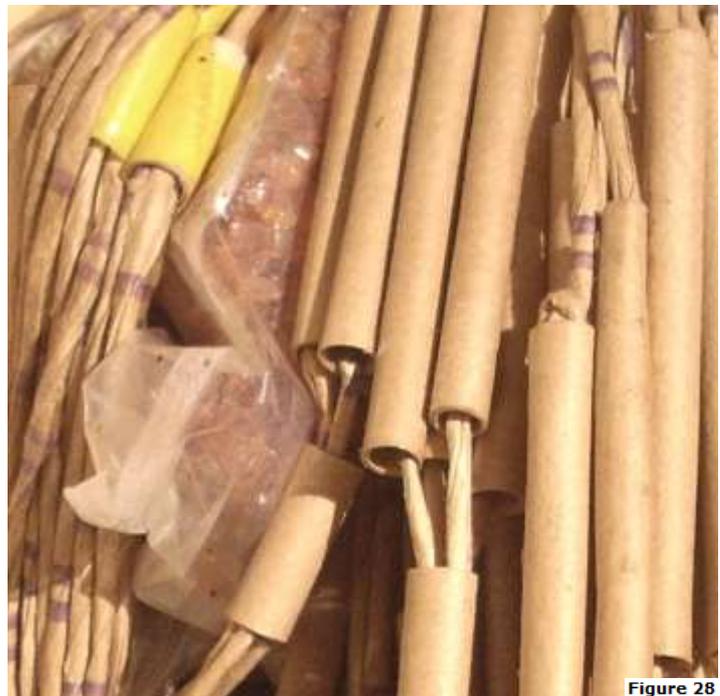
Figure 28

There are various details to be noted in the photo on the right; there is a mixture of group rings to be found on the spiral four quads – most are plain cardboard, while others have yellow insulation tape wound around them. This indicates that the splice case was opened for a rearrangement of connections at some time while still in service. One can also see a bag of desiccant wedged between the wires.

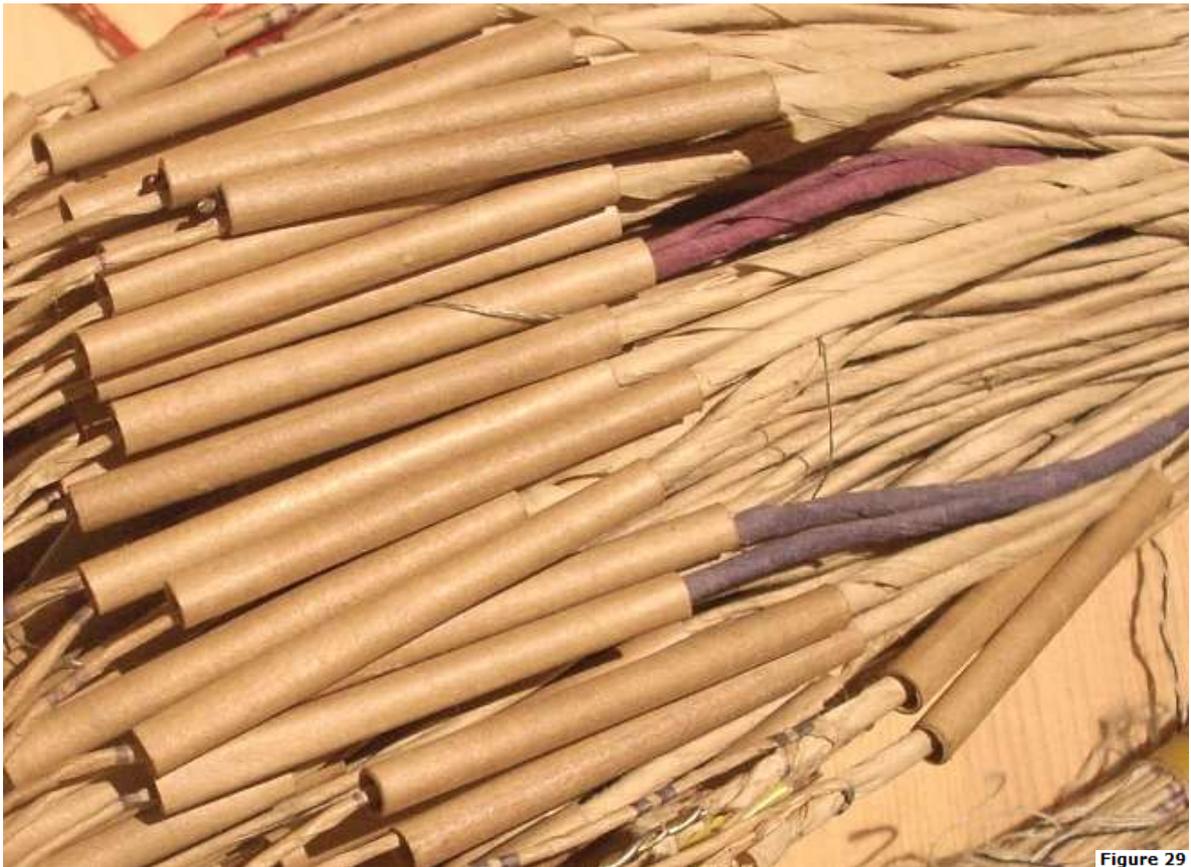
Figure 29

As may be seen above, one of the cables in this particular splice is different from the others; most of the wires have plain paper insulation without distinguishing marks, with an occasional pair with red or purplish-blue insulation. Cables of this design were manufactured in Austria only prior to 1931, and have twisted pairs (instead of quads) which are laid up in concentric layers. There is a single pair with colored insulation in each layer – this tracer pair is the one from which all other pairs in the layer are counted out. One wire of each pair is tinned copper (the “b” lead = ring), while the other one is bare copper (the “a” lead = tip).

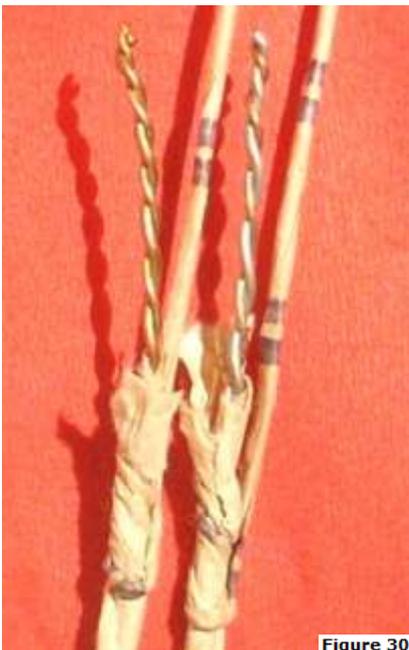
Figure 30

I took a good dozen pictures of the twisted splices shown to the left and only in one was it even barely possible to tell the wires apart. The left-hand wires are both bare copper, while one of the wires on the right is tinned.

The twisted splices are in excellent condition, without the slightest bit of tarnish or signs of corrosion. This is rather remarkable when one considers that one of the cables is at least 80 years old.

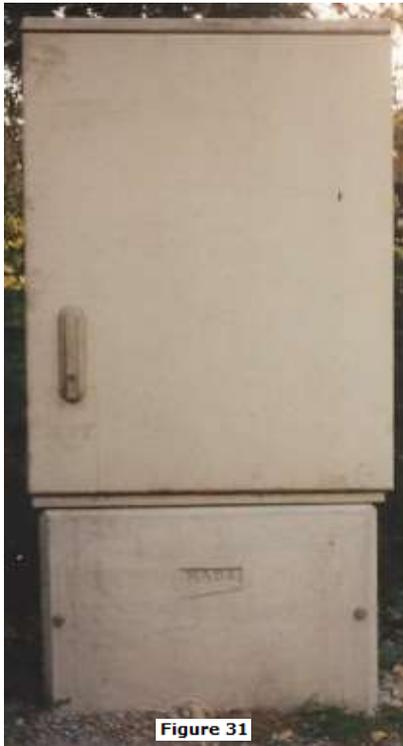
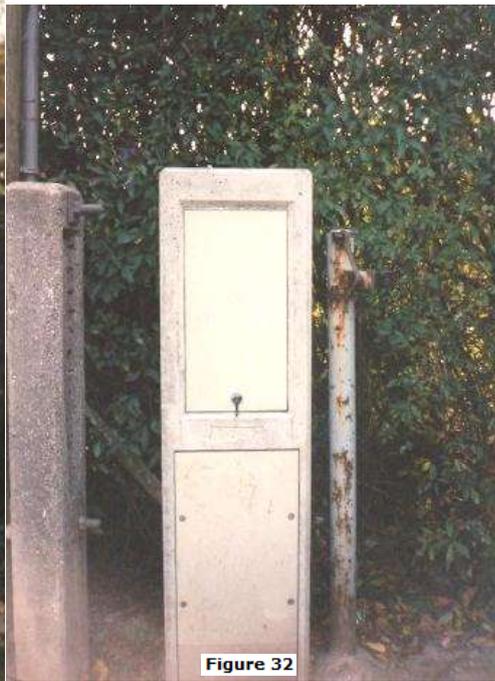
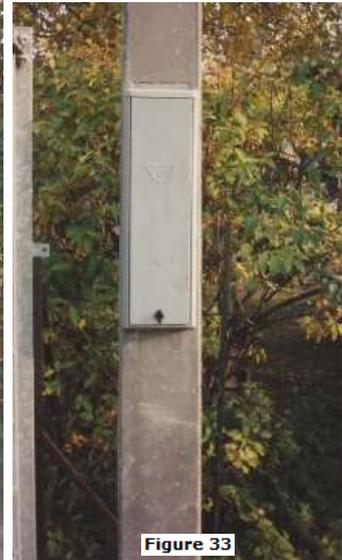
The three most common types of outdoor subscriber cross-connect pedestals or cabinets in use today are shown above. The largest one can handle up to 800 pairs and is often used to split cables up, prior to their runs to pedestals or cabinets as those shown in the other two pictures. The pedestal shown in the middle can handle circa 100 pairs, and the cabinet on the right (mounted in a concrete mast) up to 200 pairs.
