## A Collection of Telephone Tales

written by Herbert Schwarz of Vienna, Austria, European Union

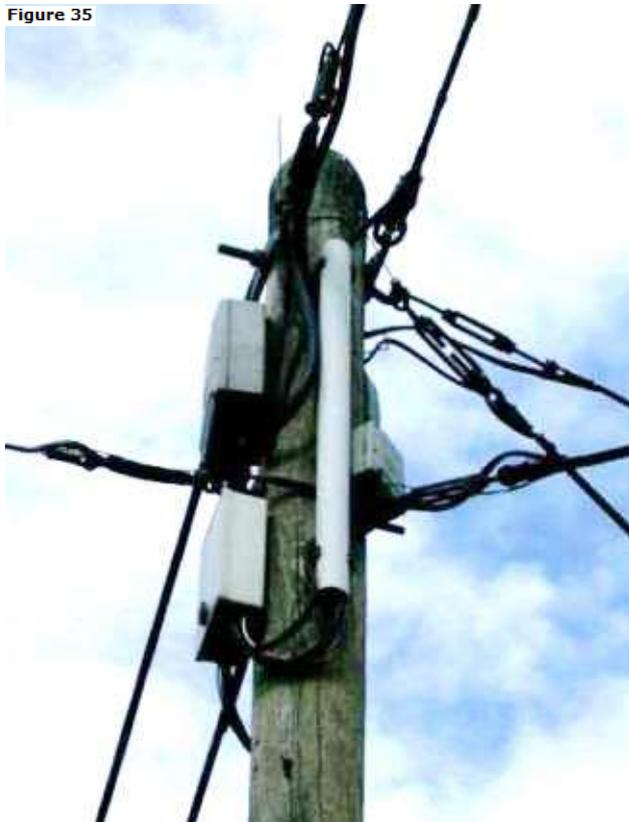
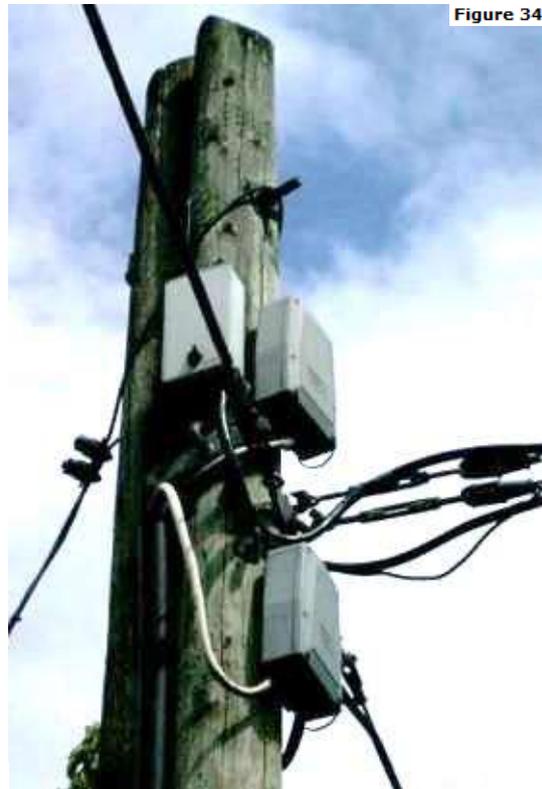
Figure 34

The distribution cables are of a type with an integrated messenger strand, which is molded into a separate polyethylene jacket and attached to the jacket of the cable by a thin, continuous web; such cable is commonly referred to as "figure 8" cable in the States.

The wires inside these self-supporting cables are "St" type III quads, with polyethylene insulation. The quads are protected by a spiral wrap of clear polyethylene foil, covered by an aluminum shield which has its own electrostatic drain wire.

This pole is another one used for distributing cables coming from a cross-connect pedestal. In this instance, the pole is also used to support and terminate two subscriber drop cables – the two cables sloping downwards towards the right in the picture.

Following standard practices, the two drop cables are terminated in their own tiny distribution boxes, as may be seen to the right of the slate-colored, vertical bit of plastic pipe on the pole.

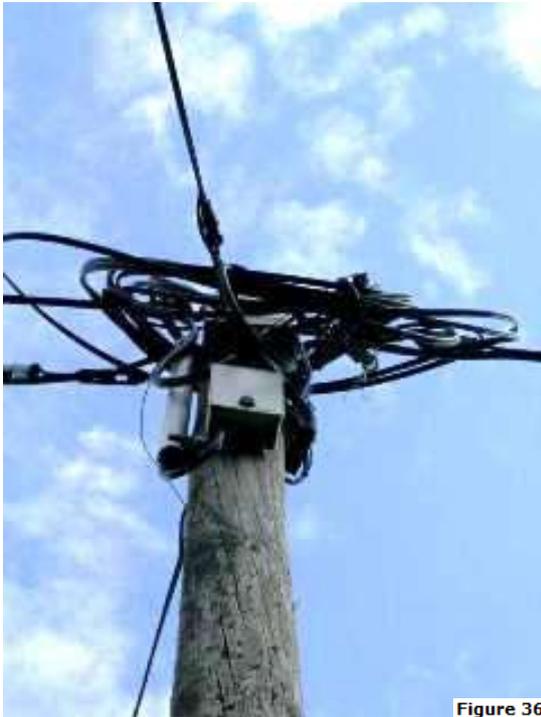
Figure 36

Sometimes it happens that a distribution cable is temporarily taken out of service – like the one shown here; the end pole to which the cable was originally attached had to be removed due to construction work on the plot of land on which the pole originally stood.

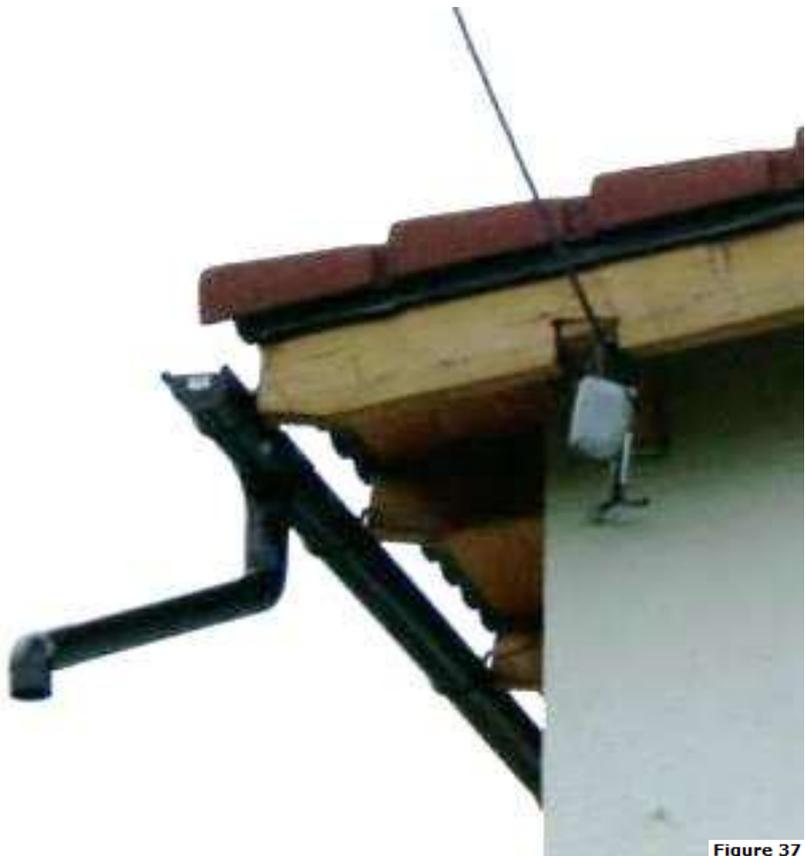
Figure 37

This is what happens when the folks from the Austrian PTT and homeowners don't really talk to each other before the drop cable is installed ....

Not only is the termination box dangling away from the wall & upside down, so that rain water could enter, but they also had to chop a bit out of the gable to make room for the drop attachment. A *really* smart bit of work on someone's part.

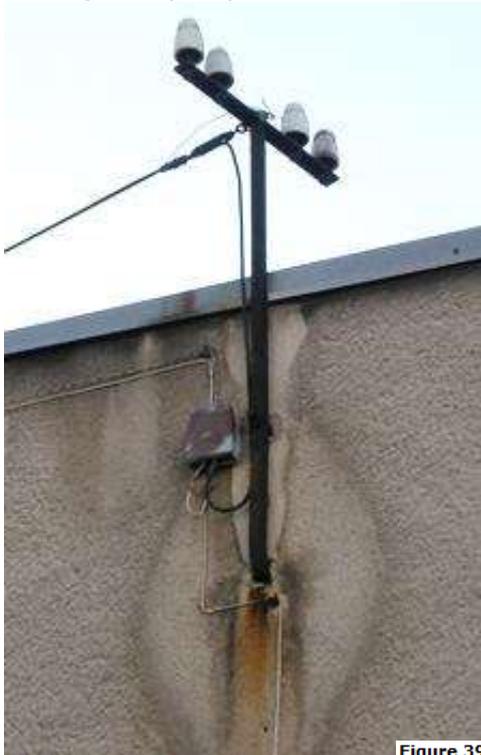
Figure 39

The clamp strip at the bottom of the terminal not only holds the cables securely, but is also intended for terminating the electrostatic drain wires (for use as a ground), way back when, at the time when party-line service was still available.

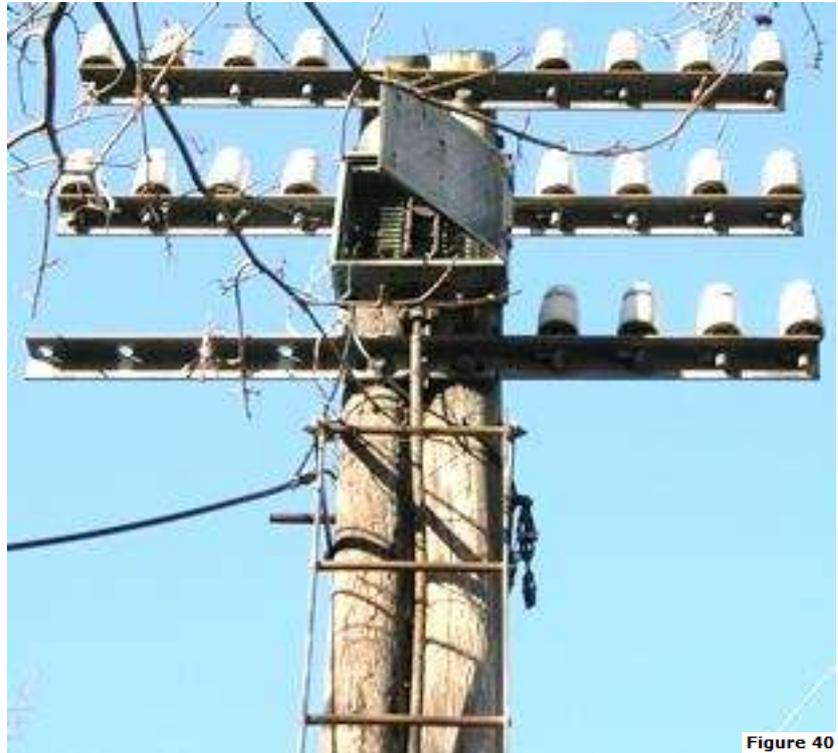
Figure 40

This is another nice example of an old, open wire line where the PTT didn't bother to remove everything when converting to cable service.

It is very interesting that the original buried cable terminal not only survived, but that the door is open as well. If one looks really carefully, it's possible to see the remains of the cable protection (fuses and carbon discharge blocks) still inside.

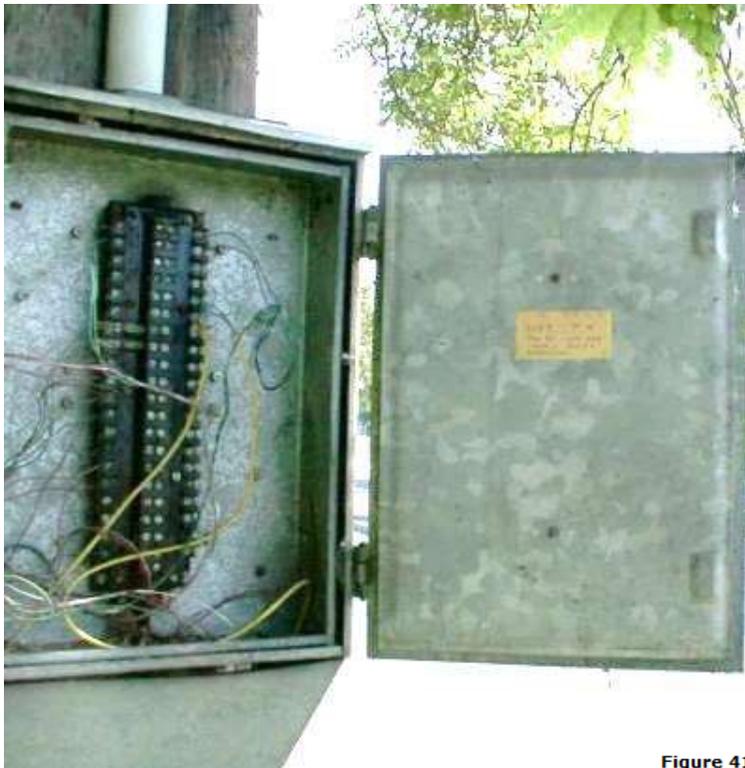
Figure 41

This is a *disused* and open cable terminal box (where buried cable was connected to aerial cable) which I once discovered in an outlying district of Vienna.

The cable terminal is for 20 pairs in this case, complete with the grounding bus bar for party-line service. It's just possible to see that the fourth pair of terminals on the left side is equipped with party-line distribution strips, such as those shown on page 43.

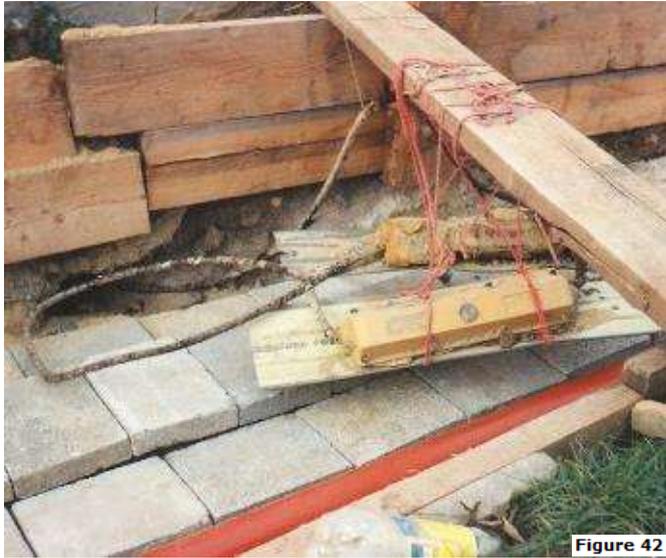
Figure 42

Yes – that is but a single cable with two splices not more than eight feet apart ... as can be seen, one of the exterior splice cases is of the old, cast-iron type, while the second one is of the newer plastic type. Telecom Austria didn't rectify this situation by cutting out the two splices and replacing them with a single one before this cable was buried again.

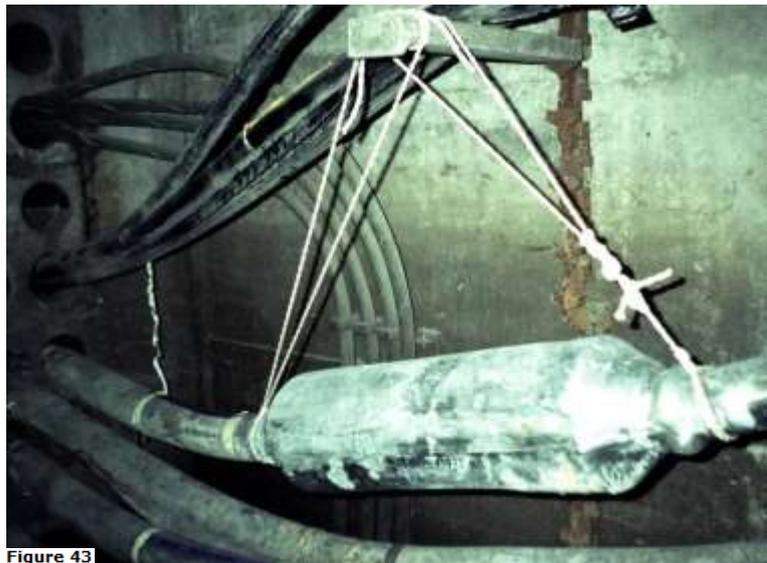
Figure 43

Here is another way of dealing with splice cases ... heaven knows why anyone would place a splice beneath a single cable holder, instead of between two, which would be standard practice.

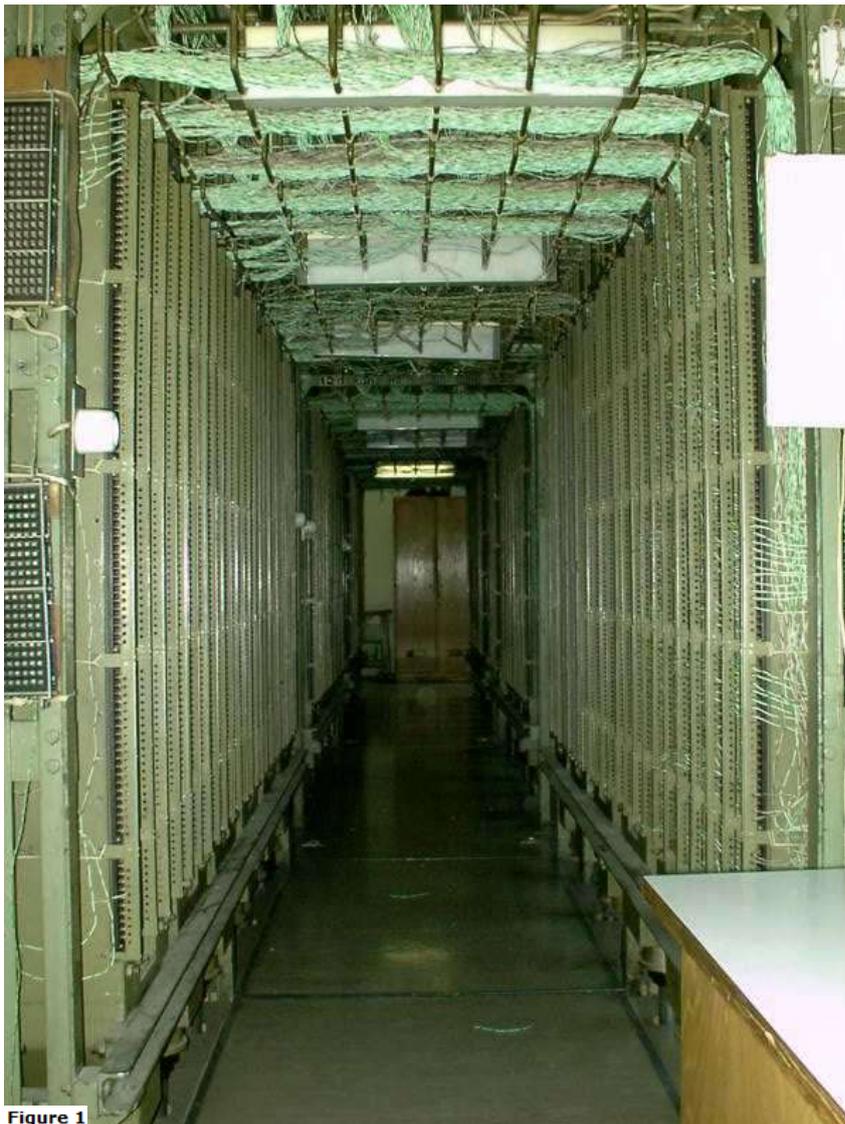
Figure 1

The photograph to the left was shot looking down one of the corridors of the toll office MDF in Vienna, towards the front of the room; there are cross corridors at 1/3 and 2/3 the length of these corridors.

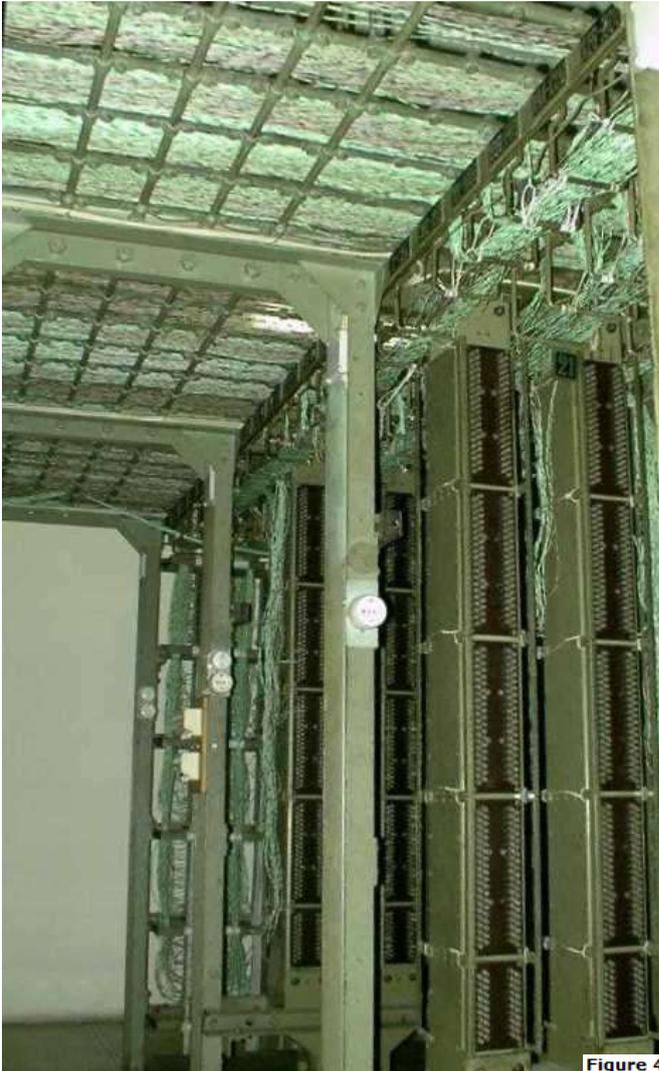
Figure 4

This picture was obviously shot from one of the cross corridors and gives a very good view of the overhead wire racks.

If readers examine the photo in detail, one can see that not all of the jumpers are of the "digital switch" green-white pairs, but rather that a goodly portion are of the older, brown-white pairs ... this was intentional, since at the time the pictures were taken (circa the year 2000), some portions of the toll exchange were still analog switching equipment, not yet replaced with (modified) Nortel DMS switches.

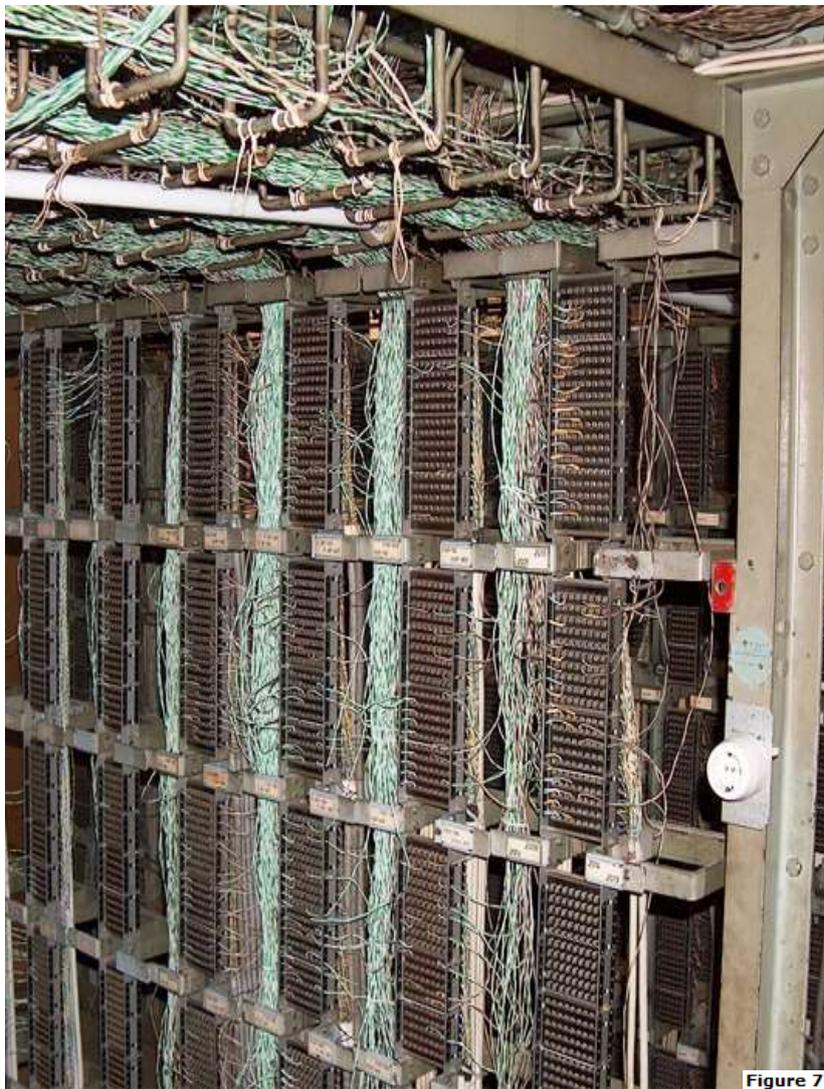
Figure 7

This is the "other end" of the bower MDF, where the system cables are terminated. The cable terminals here are 8 pairs wide by 20 pairs high (= 160 pairs each), with solder lugs on the back and screw terminals on the front.

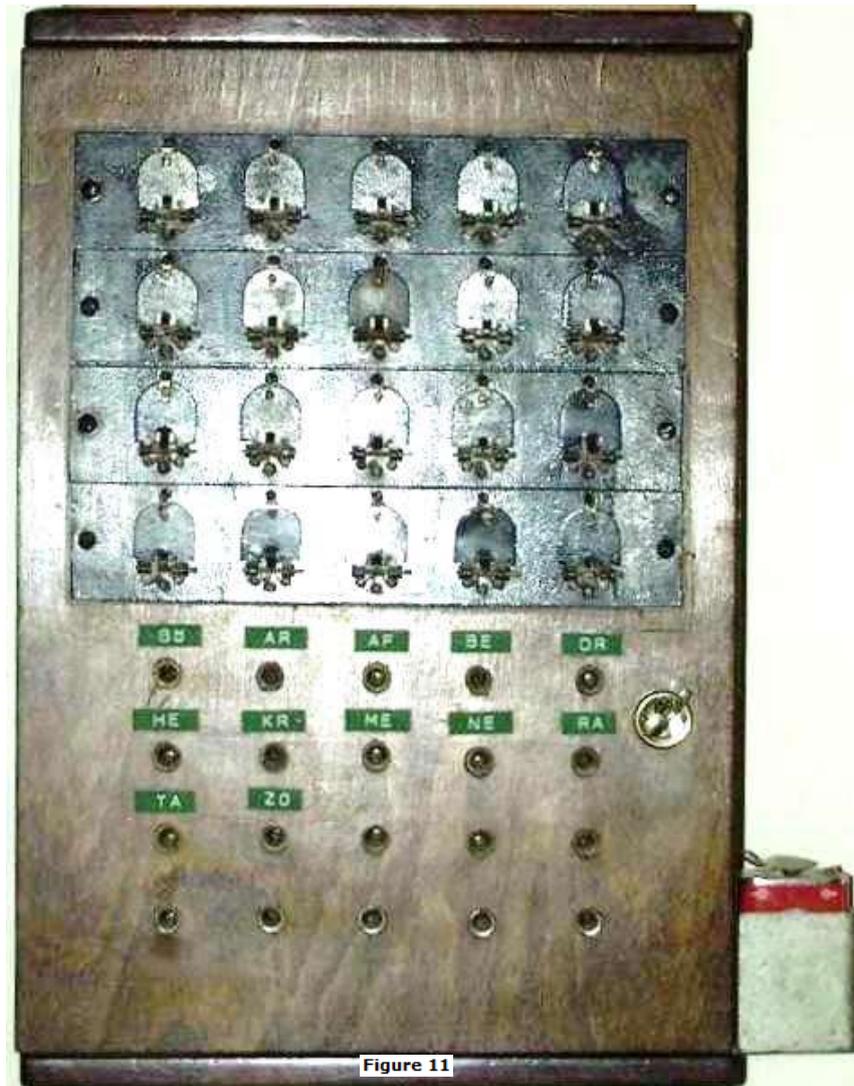
Figure 11

The Vienna toll MDF room is crammed full of cable terminals – from what I heard, there is very little space for anything else, and therefore the toll test boards are located elsewhere in the building. However, there is enough room on one of the walls for a small, 20 line magneto wall switchboard – it's of a very similar design as the one shown on page 38, but this one is a reconstruction which uses old parts.

By no means does this little magneto board have a line to each and every local exchange in Vienna, but it is connected to the most important ones, among them the old Vienna stock exchange (where the international toll transit exchange was located), the old Viennese military arsenal (where a large microwave tower and satellite dishes [for TV transmissions] are to be found) and to the exchanges "Zollergasse" and "Taubstummengasse," where most of the local plant test boards were located.

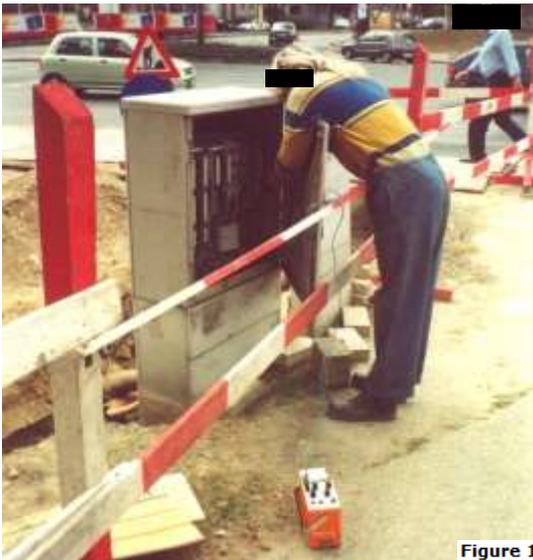
Figure 1

When confronted with a whole bundle of cables and isn't sure which are the correct ones, then the best bet is to use cable locating equipment. In the photograph to the left, a technician from Telecom Austria is busy connecting a locator tone generator to a pair in one of the cables sought. The cabinet in question is the old one, which was completely removed when the new one was wired up.

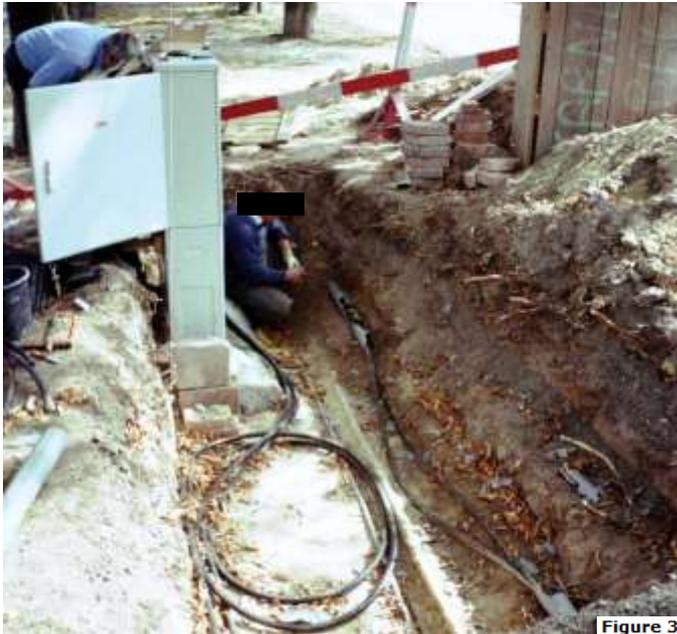
Figure 3

Ah, sweet success at last! The cables have been “liberated” from their conduit and will soon be cut for splicing into some new P.I.C.

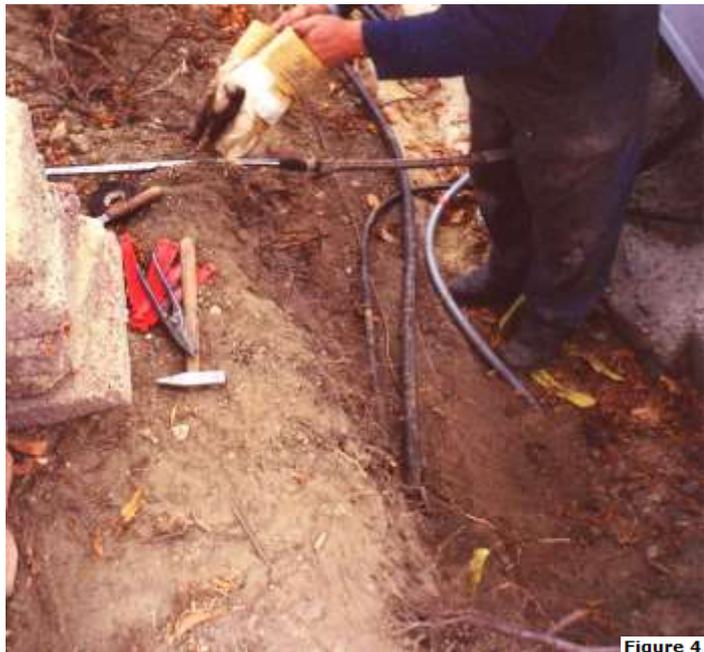
Figure 4

I have already mentioned the fact that Telecom Austria uses ID rings colored purple, orange or off-white to mark their different types of cables ... as may be seen in the photograph above, the fire department uses ID rings in red. (After all, what color could be more appropriate?)

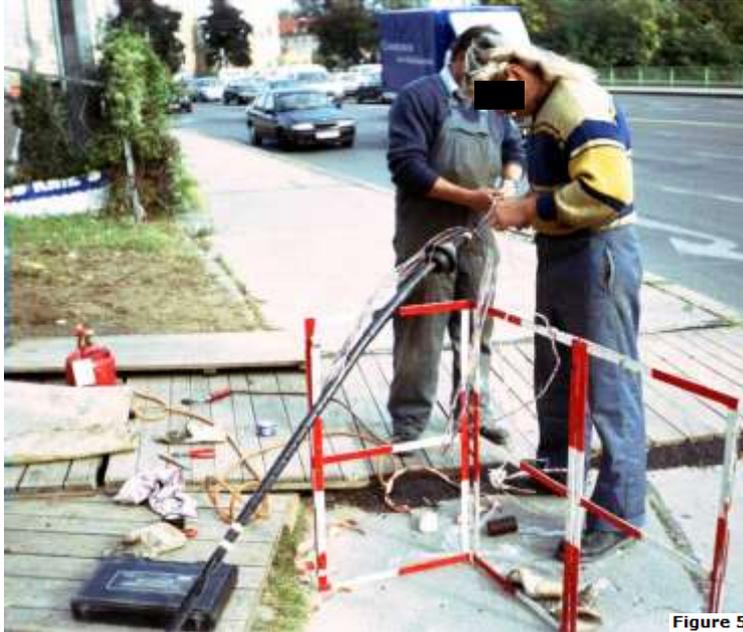
In the snapshot to the left, two cable splicers from Telecom Austria are busy prepping the end of one of the "extension" cables at the far end of the new cross-connect cabinet.

At this point, the rubber boot (which will later form one of the seals with the splice case) has been pushed onto the cable, and the men are busy fanning out the spiral four quads in the polyethylene-insulated cable (P.I.C.) These quads have the individual wires insulated in the following colors: red, green, blue and translucent. The tracer quad from which counting is begun in each layer is the one

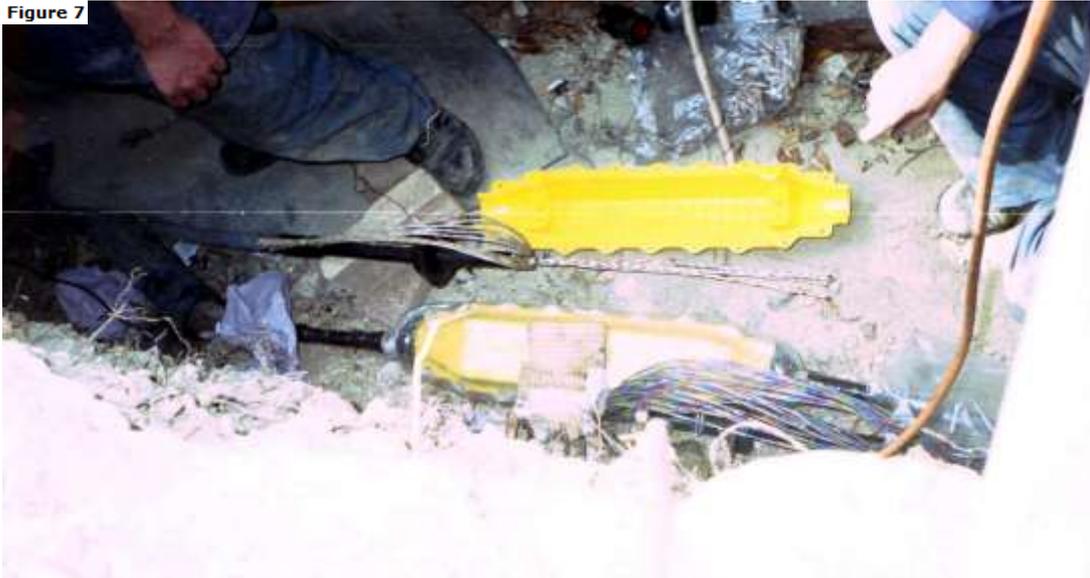
Figure 7

In the photograph above, the old cable has been prepped for splicing. Since the splicers were a bit exuberant in removing the protective covering from the old cable, they overdid things a bit and had to shrink a length of sleeve over the exposed lead sheath, almost as far as the bare cable core.

The sealing boot has also been installed onto the cable, and the outer quads of paper-insulated wires have been folded back, exposing the two quads in the core. Interestingly enough, these two quads are color-coded as if they belonged to a toll cable, as explained in a previous tale.

Referring to the lower photograph on the previous page, readers should closely observe what the splicer on the right is doing. Yes – he is slipping a *cardboard* sleeve onto the paper-insulated wire (and he will be doing so for all of the wires belonging to the two quads in the cable core). The reason behind this is that the core wires in the old cable were of 1.8 millimeters diameter, while all of the wires in the P.I.C. are of 0.8 millimeter diameter; the difference is larger than any single, mechanical splice (such as a TYCO® Picabond® or a MS<sup>2</sup>® from 3M®) can handle, so the splicers were forced to resort to the hoary old splicing method of yesteryear.

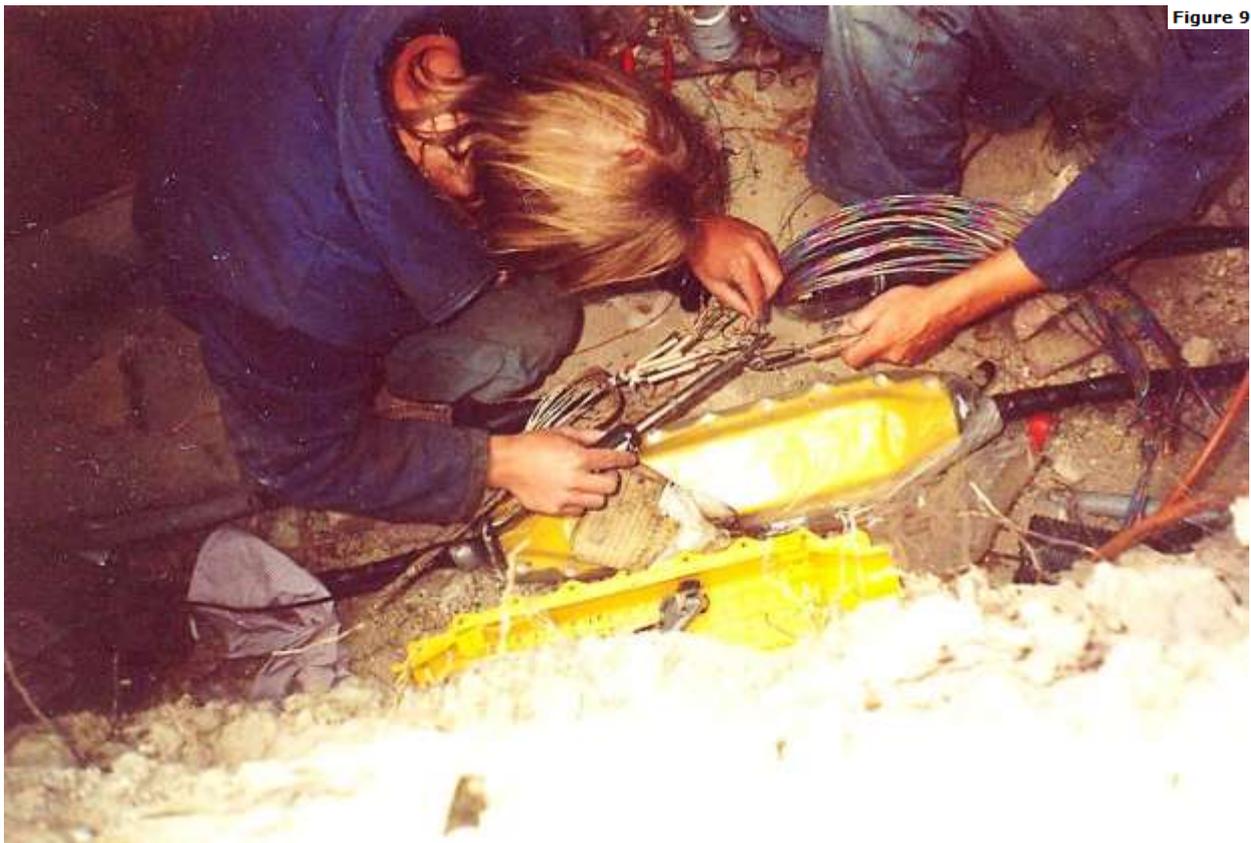
Figure 9

After the cardboard sleeves were placed on the 8 wires in the core of the old cable, the appropriate wires of the old and the new cable were stripped, the bare ends were twisted together and soldered (with an electric soldering iron powered by a portable generator), as may be seen above.

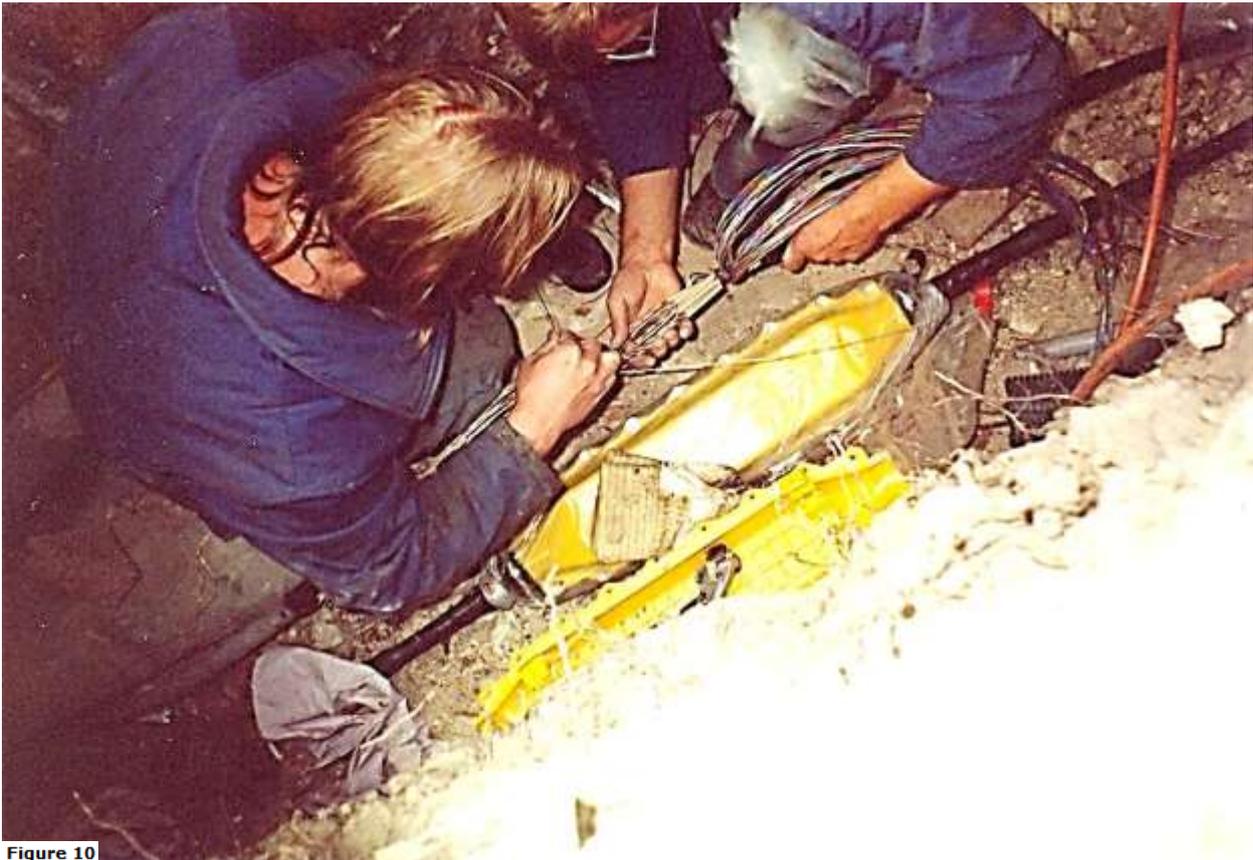
Figure 10

All eight cardboard sleeves now protect the soldered splices of the core wires belonging to the old cable, as may be seen in the photograph above.

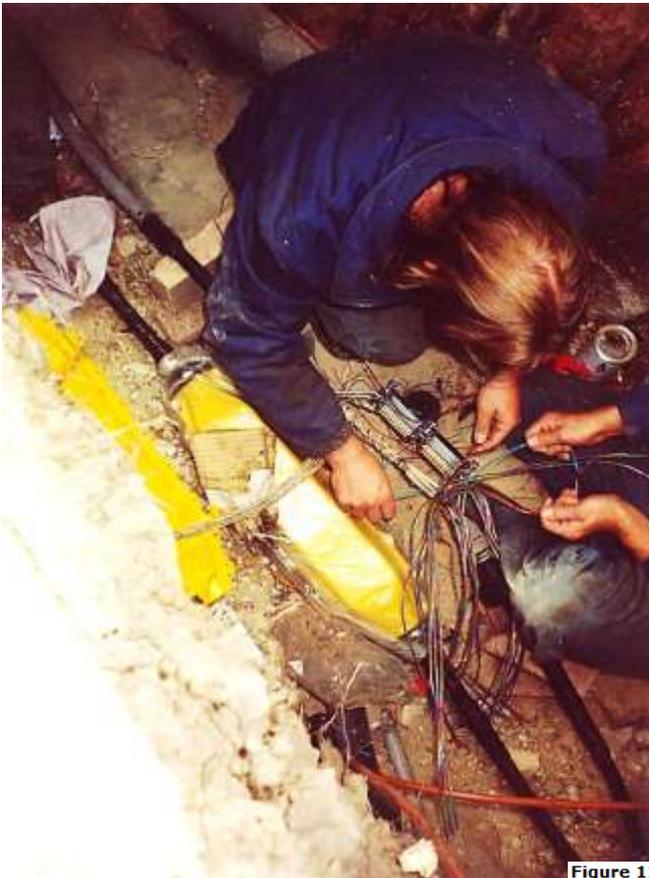
Figure 11

The remaining quads from the old cable, being of the same diameter as those of the "extension" cable, were spliced using MS<sup>2</sup>® splices from 3M®.

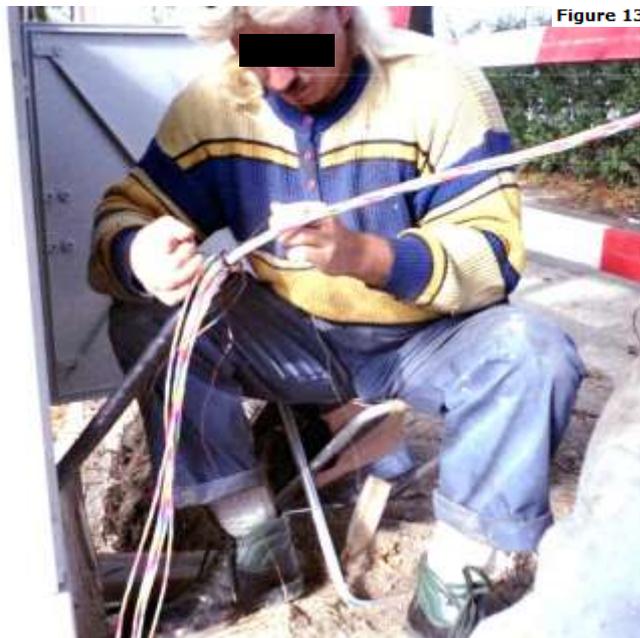
Figure 13

While the old cross-connect cabinet contained a mix of cable terminals, four with screw connections and one modern one using a group of IDC punch-down connecting blocks, the new one only contains IDC punch-down blocks, manufactured by the German firm "Krone" ("crown" in English).

The electrostatic shield (copper in the case of the P.I.C. and steel in the case of the one PVC cable laid in) of all of the cables will be terminated on a separate grounding punch-down terminal block. In the photograph above, the cable splicer is busy tying down and securing the second layer of quads in one of the new cables.

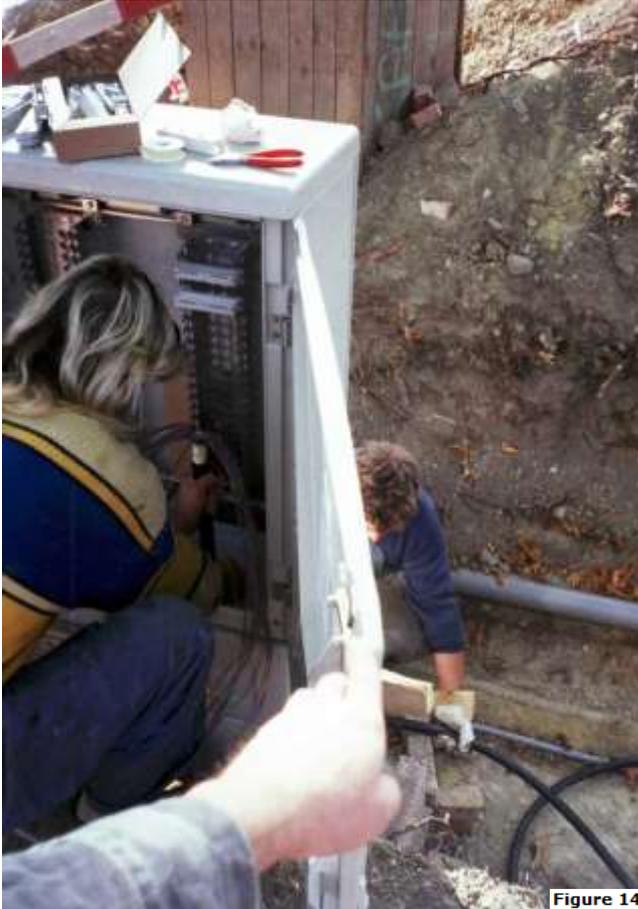
Figure 14

As may be seen to the left, the first of the cables is being adjusted to its final position, prior to being clamped to a securing rail and the wires being fanned out and punched down on the IDC terminal blocks.

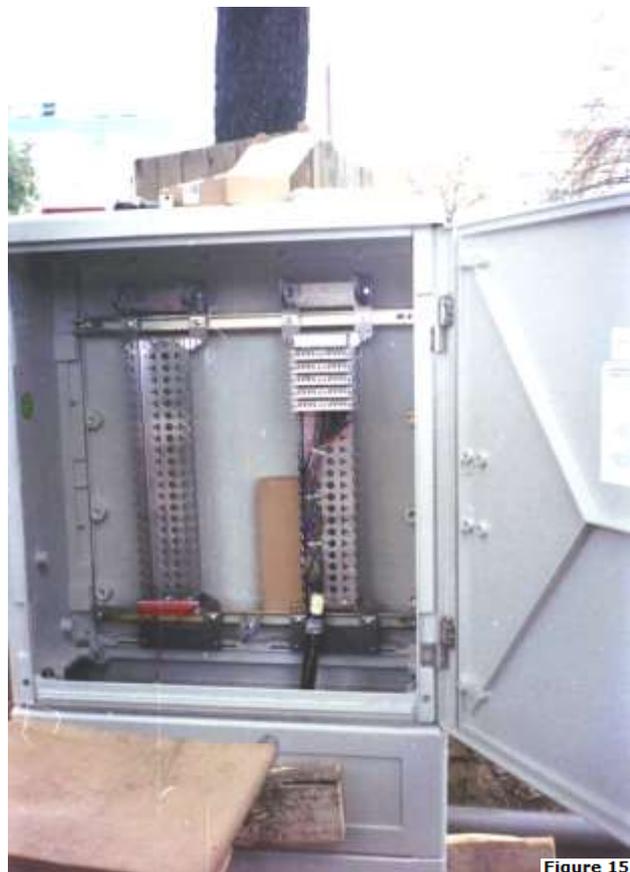
Figure 15

The red terminal block in the lowest position on the left-hand side is intended for the termination of the electrostatic shield of all of the cables.

Red = ground? This is just as valid for a magneto telephone network (which doesn't rely on a CO battery power source) as it is for any automatic telephone network in most of Europe.

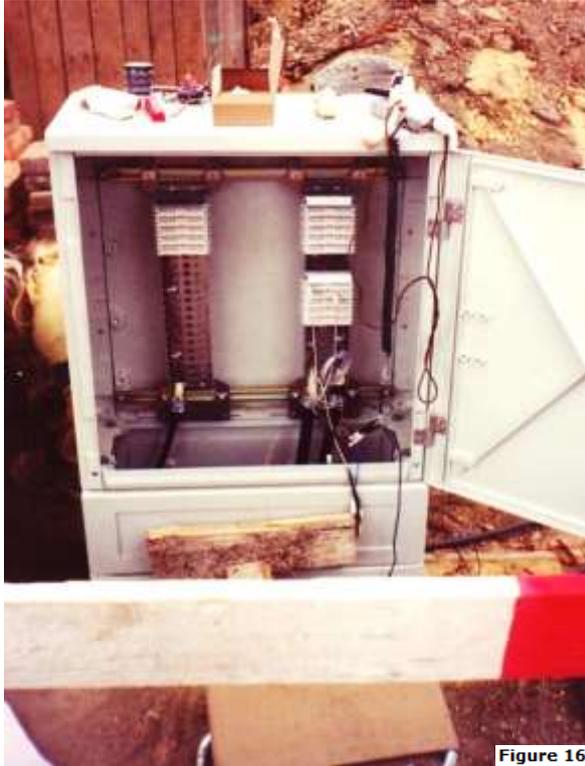
Figure 16

Oops – looks like the cable splicer made a mistake ... the grounding terminal block was obviously in the way of the cables which are to be terminated on the left-hand side.

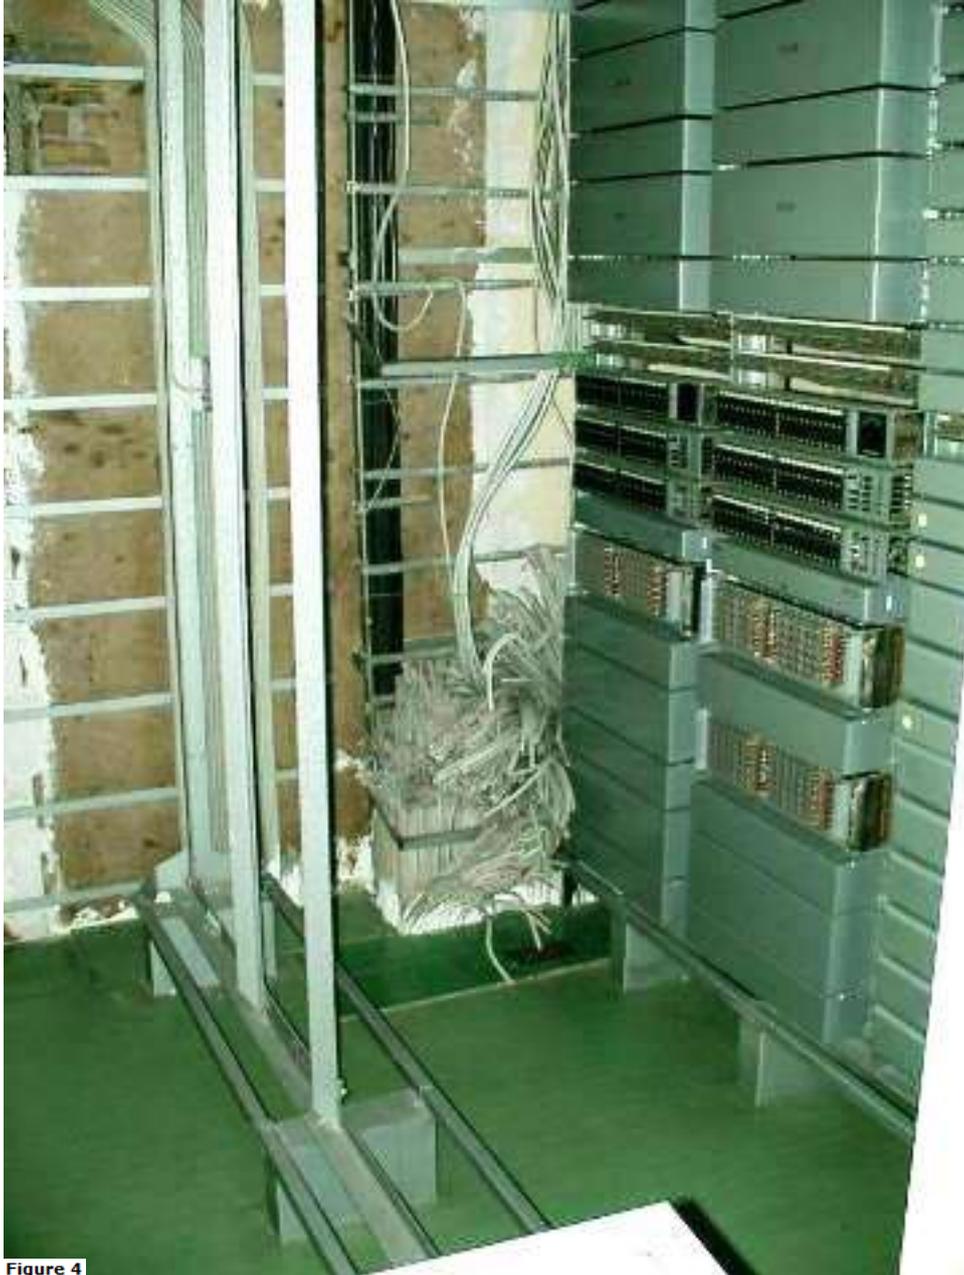
Figure 4

One of the first things that was done when a portion of an old switch was retired from service was to sever the interconnect cables in such a manner as to preclude *any* chance of reconnecting the equipment – sort of burning ones bridges, in a technological sense of the word.

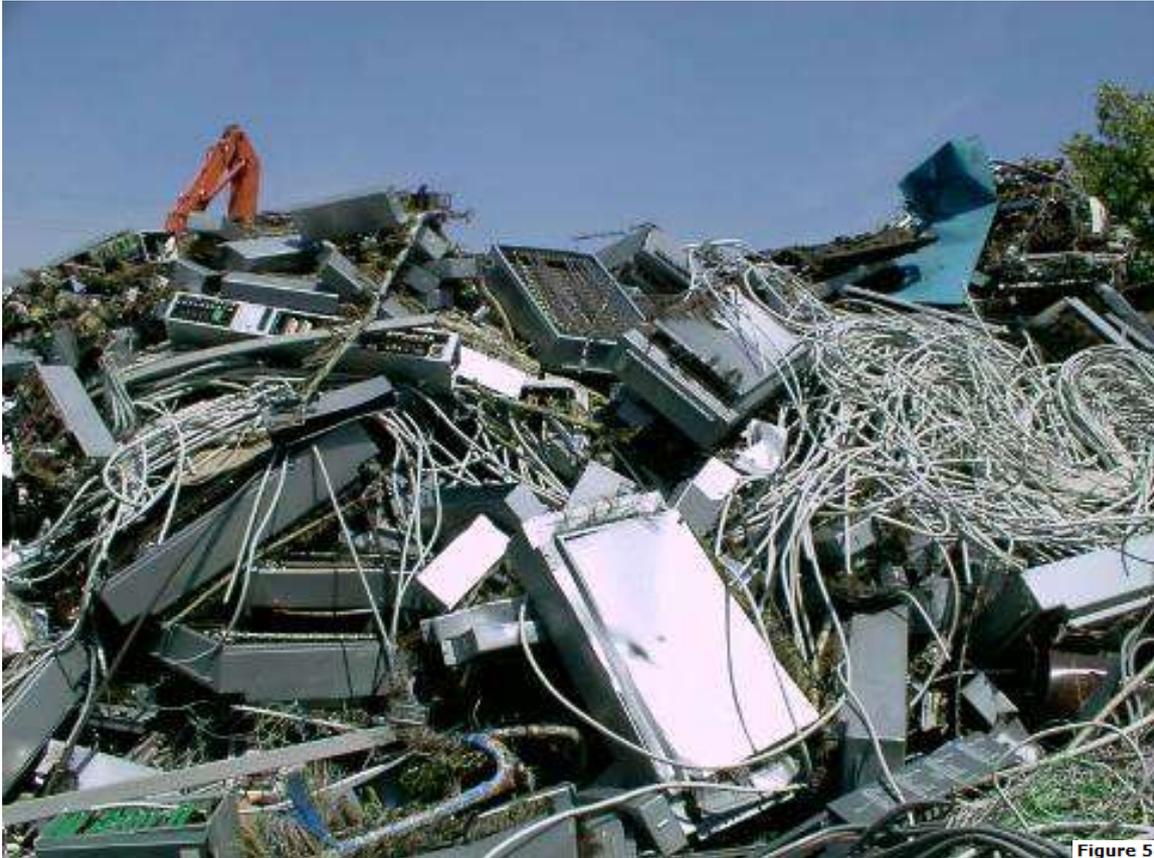
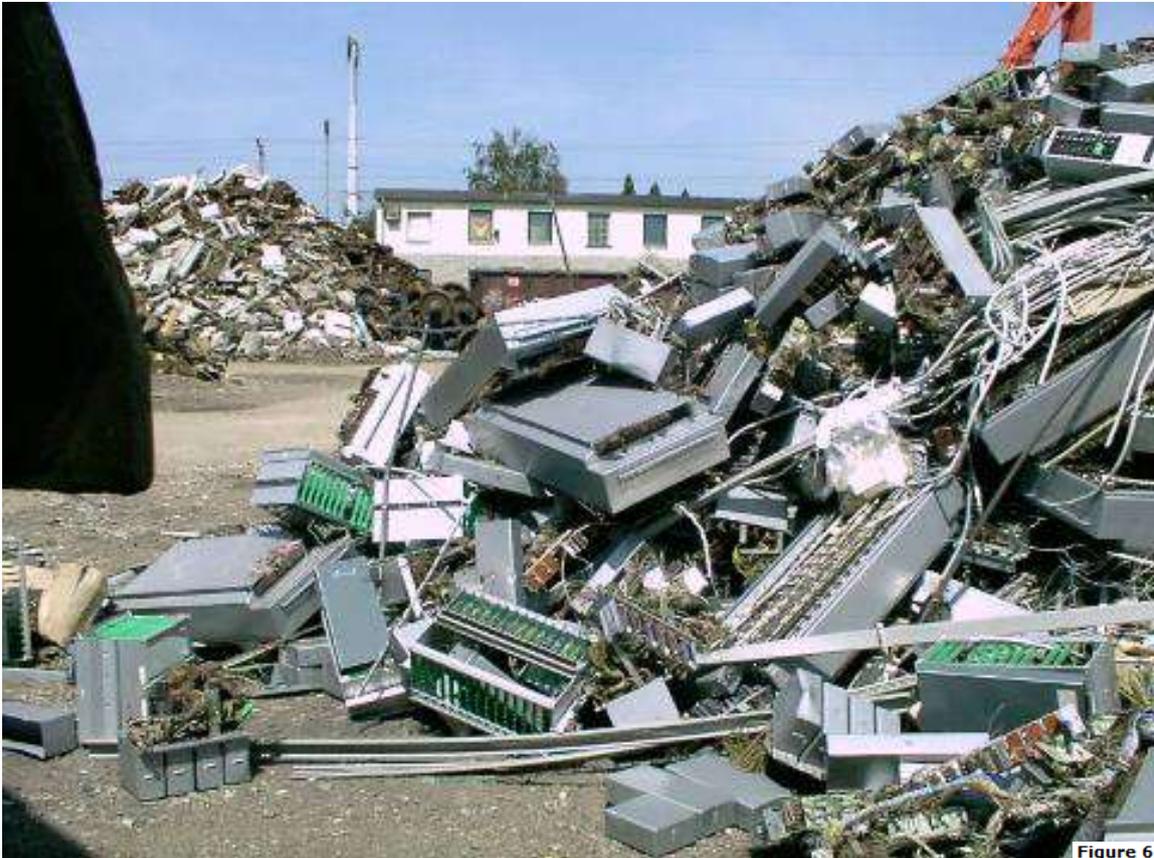
These two photographs show the remains of a crossbar exchange, found at one of the largest junkyards in Vienna.

A sad, sad sight indeed – the frame in the center of the photograph above is party-line equipment, each individual unit in the frame supported 2 x 4 subscribers ... and, in the photograph below, the main feature are some model 1980 pay phones, surrounded by more frames of party-line equipment. The junkyard was legally bound to *destroy* this equipment, so it wasn't possible to buy so much as an ounce of the stuff.

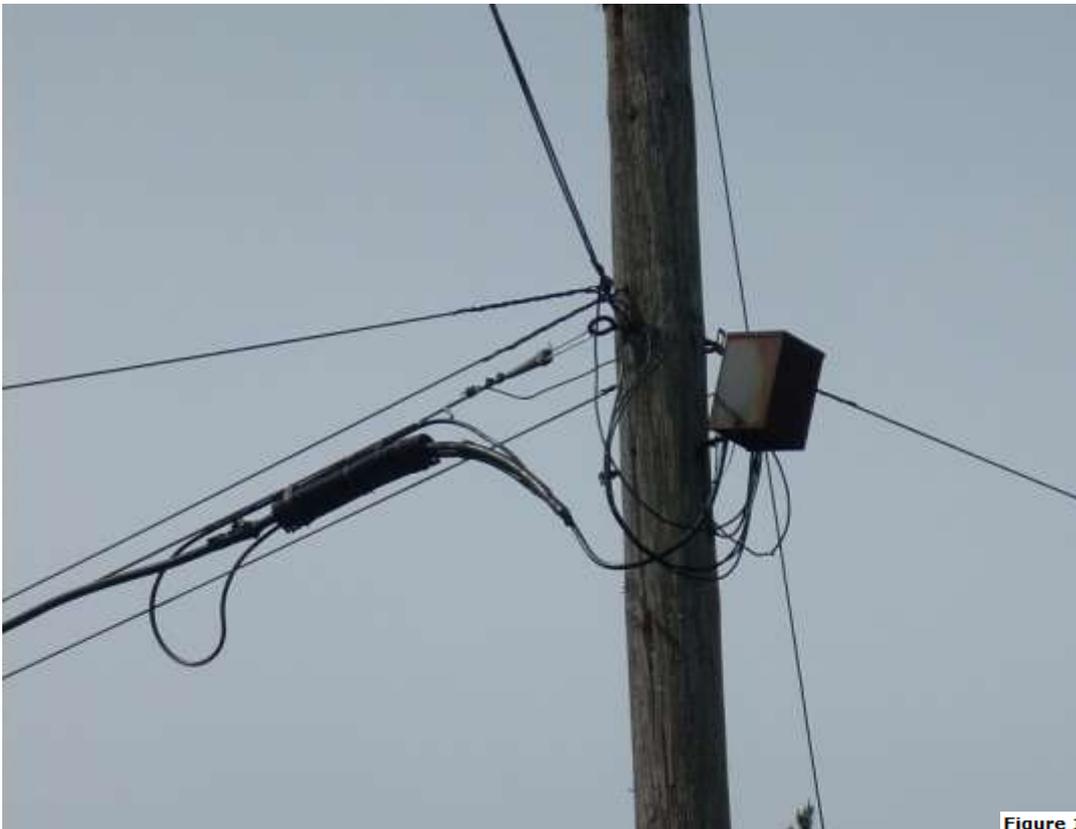
Figure 1

The first view of the aerial cables I found is shown above. The feeder cable peters out in a splice case, which is practically nothing more than a bit of large diameter, corrugated plastic pipe. The cable stub, which runs to the distribution box (which is hanging on the pole rather haphazardly), exits the splice case from the *left* end, while there are two cable *stubs* exiting on the right-hand side ... these stubs are sealed off with PVC insulation tape. It appears that 5 or 6 subscribers are terminated at this particular distribution box, which is obviously of an older design.
