## A Collection of Telephone Tales

written by Herbert Schwarz of Vienna, Austria, European Union

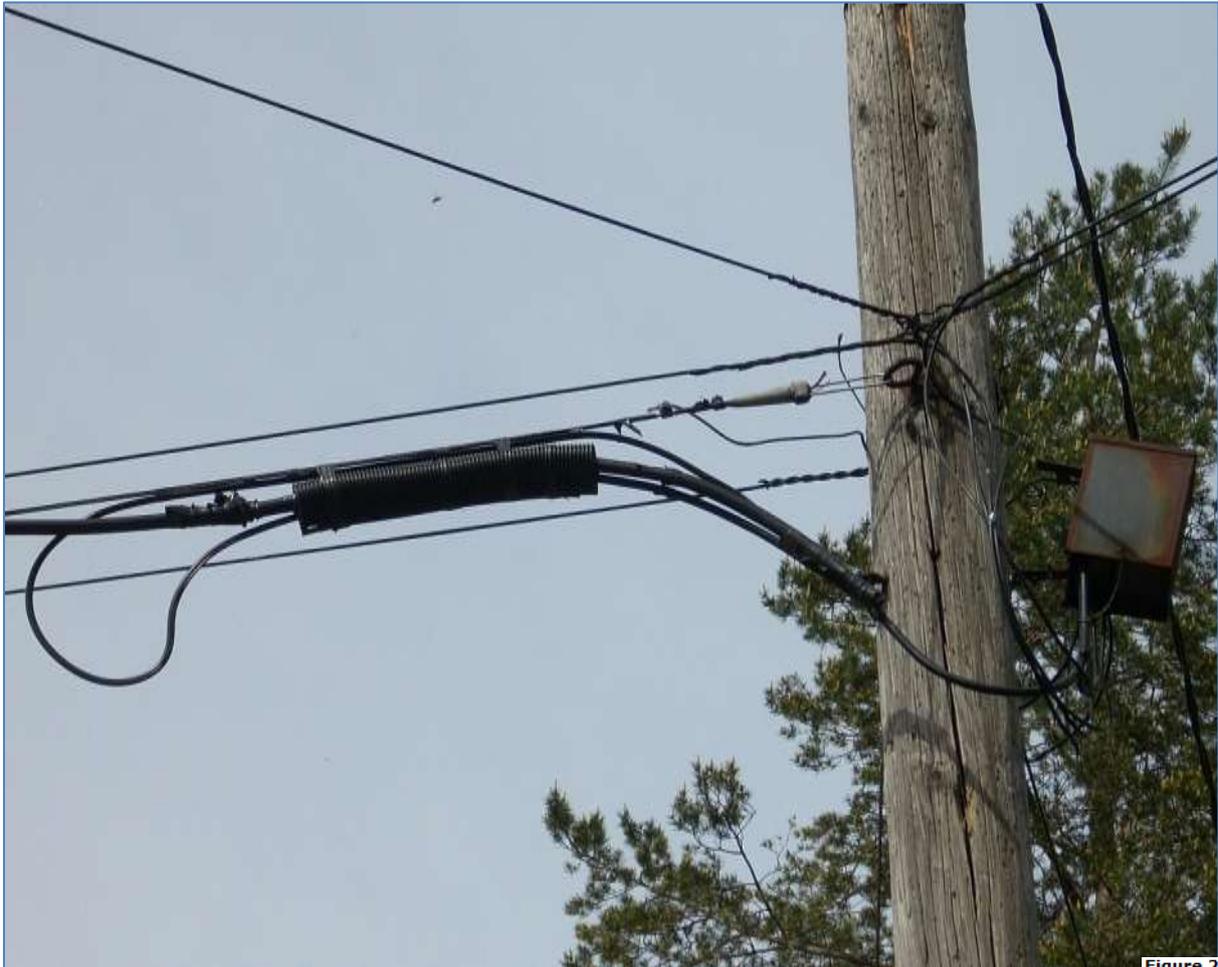
Figure 2

This is a better view of the splicing case shown on the previous page. The method by which the messenger strand is attached to the pole is unusual; the eye-bolt is offset from where one would normally expect it to be attached to the pole by 90°, thus placing an unnecessary strain on it (especially when one considers how long, frosty and severe winters are so far up north).

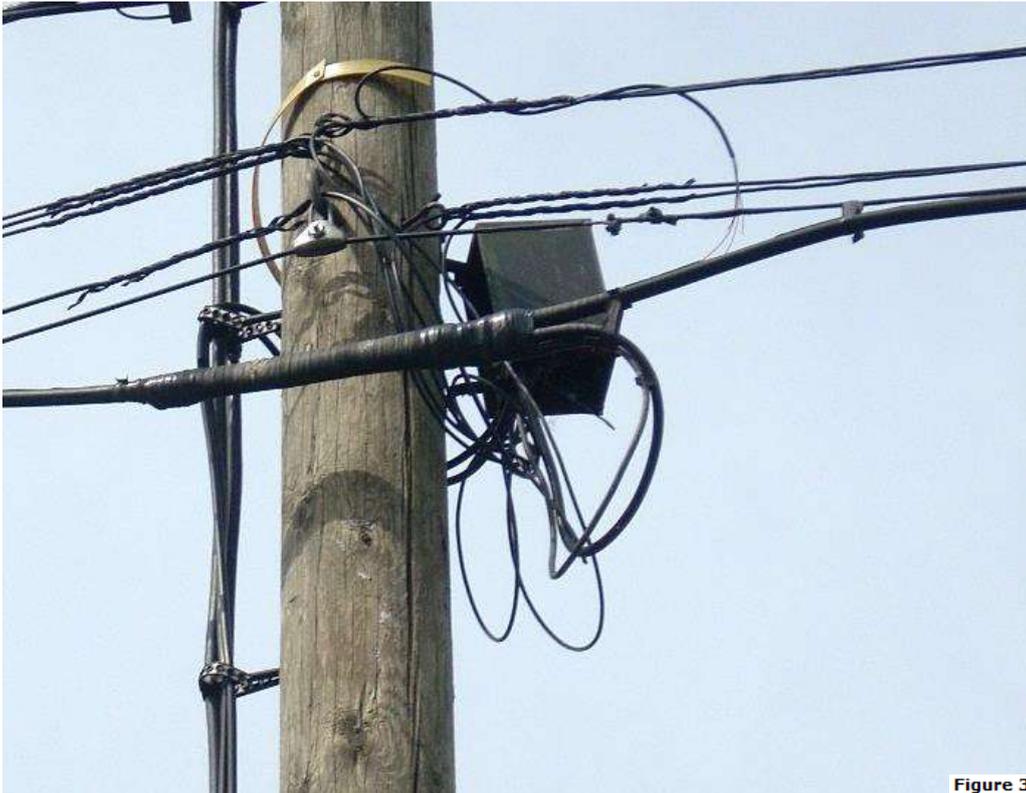
Figure 3

The Finnish PTT doesn't really seem to apply any specific standard when branching and splicing cables. In this instance, the entire splice is simply wrapped with insulation tape, with the insides possibly filled with a moisture-proof jelly or putty.

One of the subscriber drops at the top right on the pole has been disconnected, but left in place for future use. The drop cable contains four conductors; if I recall correctly, the colors are red, blue, black and yellow and the wires are solid copper, roughly 20 AWG, arranged as a spiral four quad. The sheath is very thick for the cable size (the outside diameter of the cable is roughly equivalent to a number two pencil) and appears to carry the greatest part of the mechanical load.

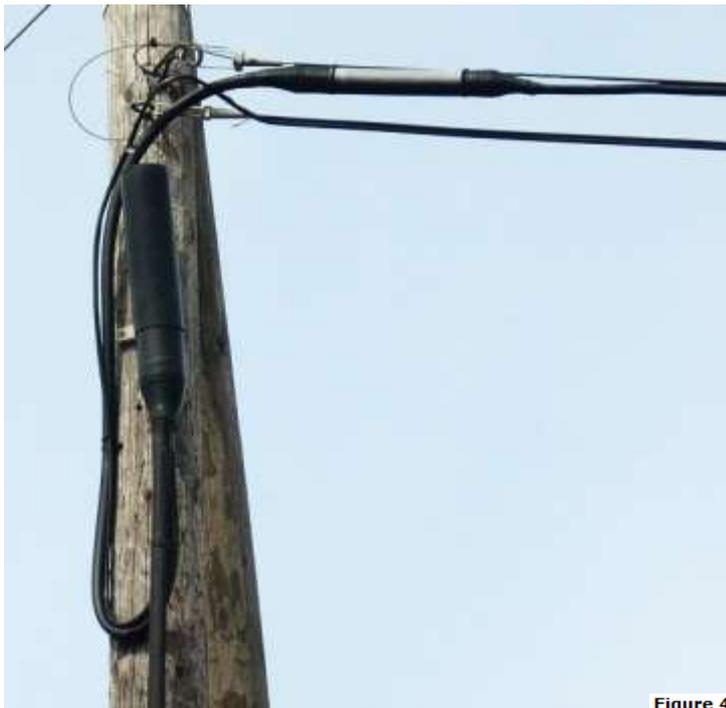
Figure 4

The *other* end of this particular distribution run is fed by an underground cable. The feeder cable branches out into two smaller cables, one of which is spliced after exiting the "octopus" style splicing case.

As can be seen, at least two of the distribution cables are spliced to stubs exiting the octopus splice (this appears to be a second cable splicing standard, because the likes are also to be seen on the previous page).

The in-line splices are, once again, simply wrapped with insulation tape and are also attached to the messenger strand with tape, instead of something more robust, like a tie-wrap or a cable clip.

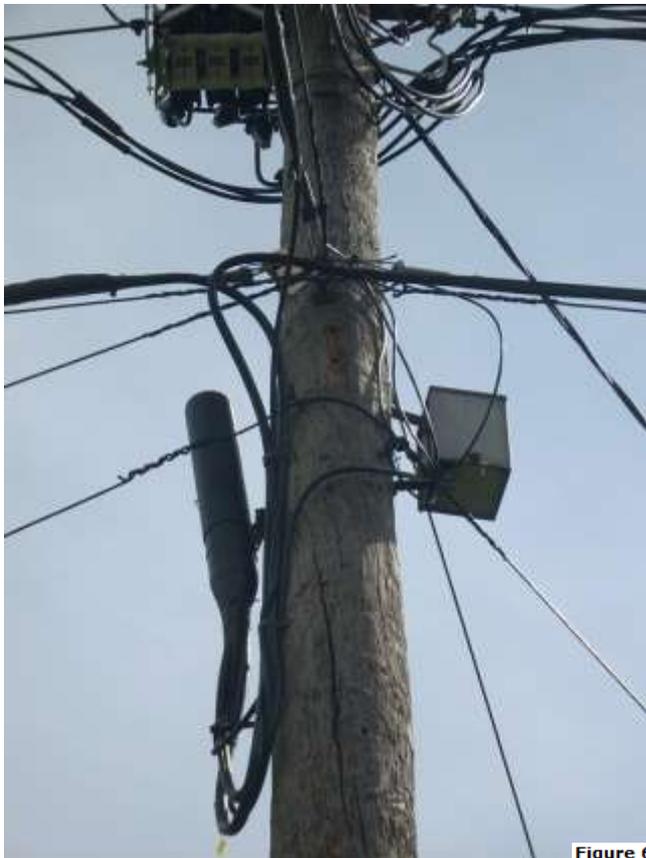
Figure 6

A second view of the distribution setup shown above ....

The octopus splice for the feeder cables is attached to the pole with a single tang and lug – despite its obvious weight. The subscriber distribution box is properly attached to the pole here, with two lag screws, so that it doesn't sway around in the wind.

This photograph also makes it obvious that the poles are joint use and also carry electrical power cables and the wires for the street lights.

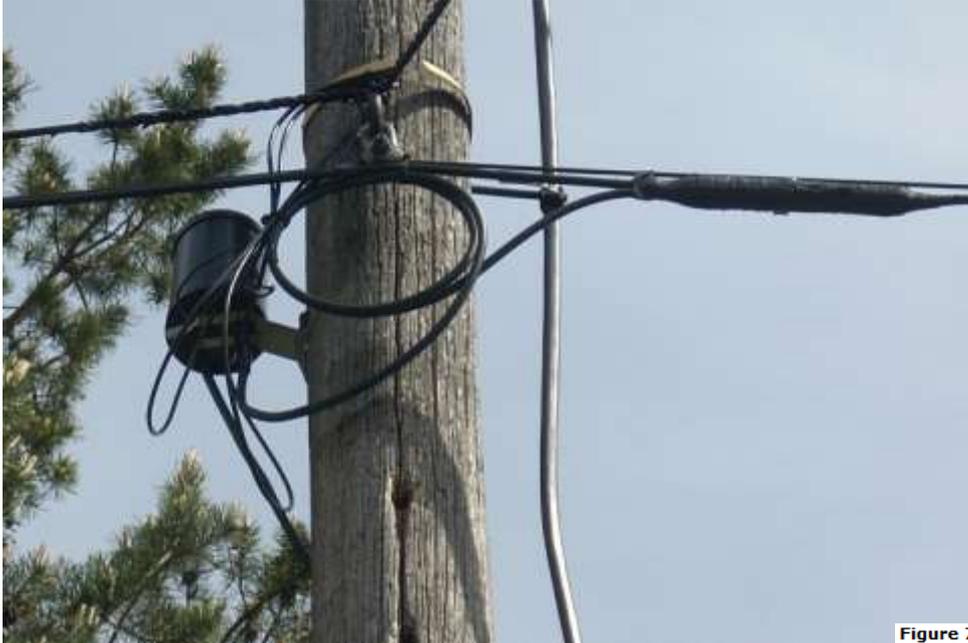
Figure 7

Finally, a more modern subscriber distribution box (!). And *another* one of those “standard,” taped, break-out splices. It rather looks as though the stub cable wound up being a bit too long, and this raises the question as to why this should be so? Alas, I wasn’t able to find anyone to ask, but one could almost believe that the Finnish PTT has folks who only splice cables and stubs, and other folks who wire up distribution boxes and subscriber drop cables. At least, I can’t come up with a better explanation.

There seems to be plenty of reserve for future growth at this particular pole, but the opposite is actually true – many subscribers have given up their land-line phone in favor of a cell phone, thus leaving very many spare pairs.

The feeder cable is much thicker than an average mans’ thumb, and the cable stub exiting the octopus splice isn’t really much thicker than the subscriber drop cable. The folks from the Finnish PTT must have had fun trying to seal those measly little cables at the bottom of the octopus splice case.

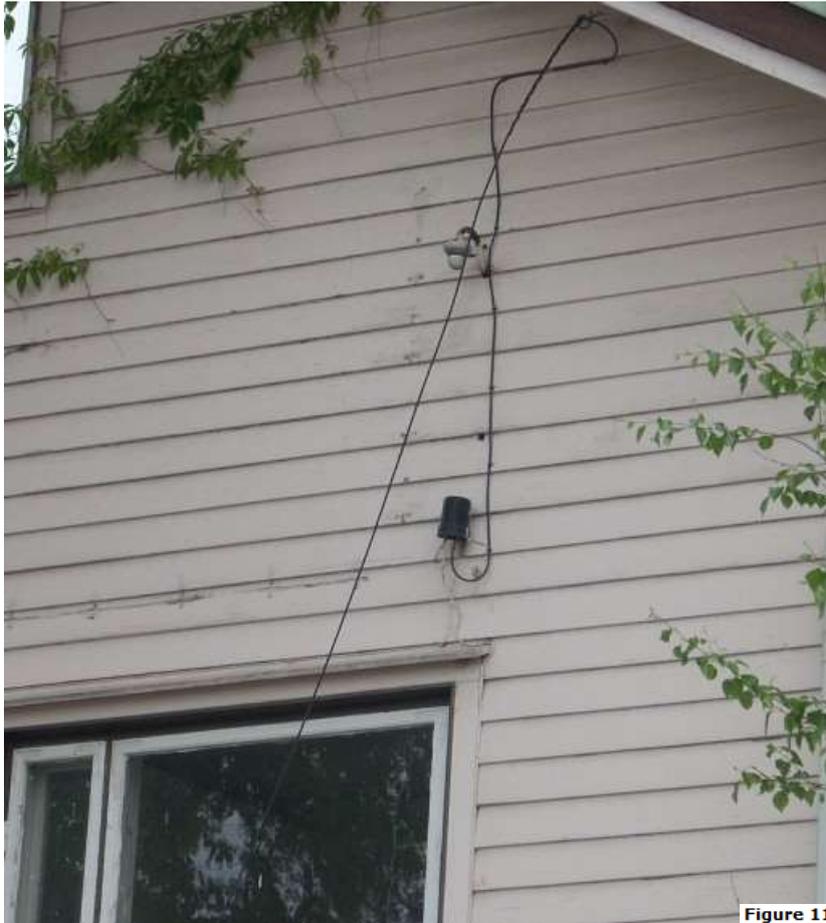
Figure 11

The subscriber drop terminal on the front of the derelict house.

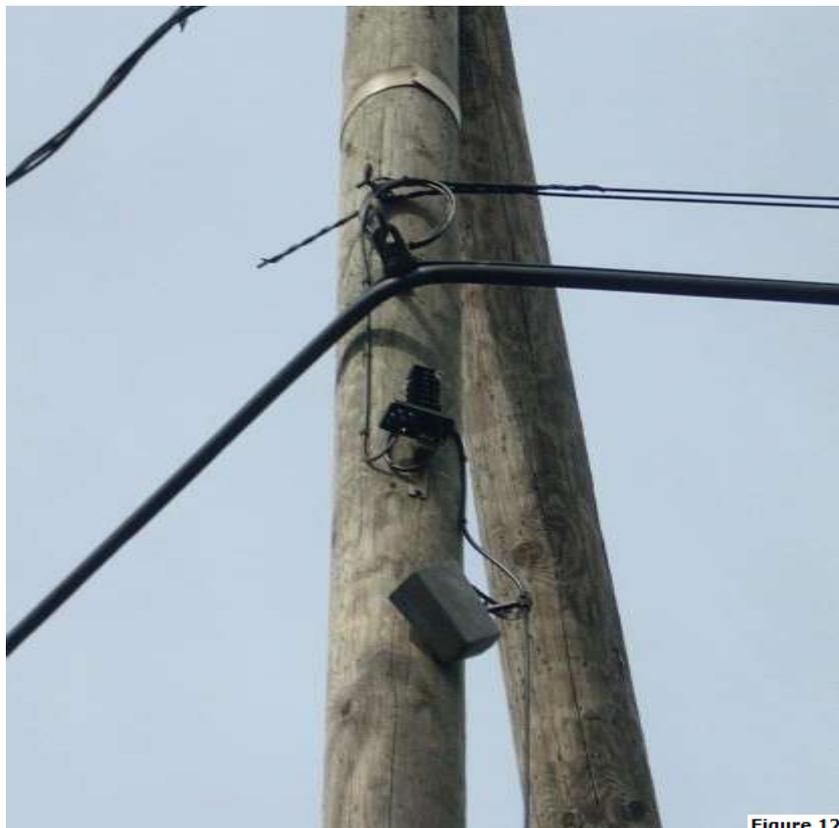
Figure 12

One thing I am always thankful for is when the local PTT forces manage to forget to replace a cover somewhere.

The situation shown here is rather interesting: there is a 4 (or 6?) pair feeder cable running up the pole, and the distribution box currently serves but a single subscriber.

One wonders if it wouldn't have been less expensive to supply service from some other distribution point.

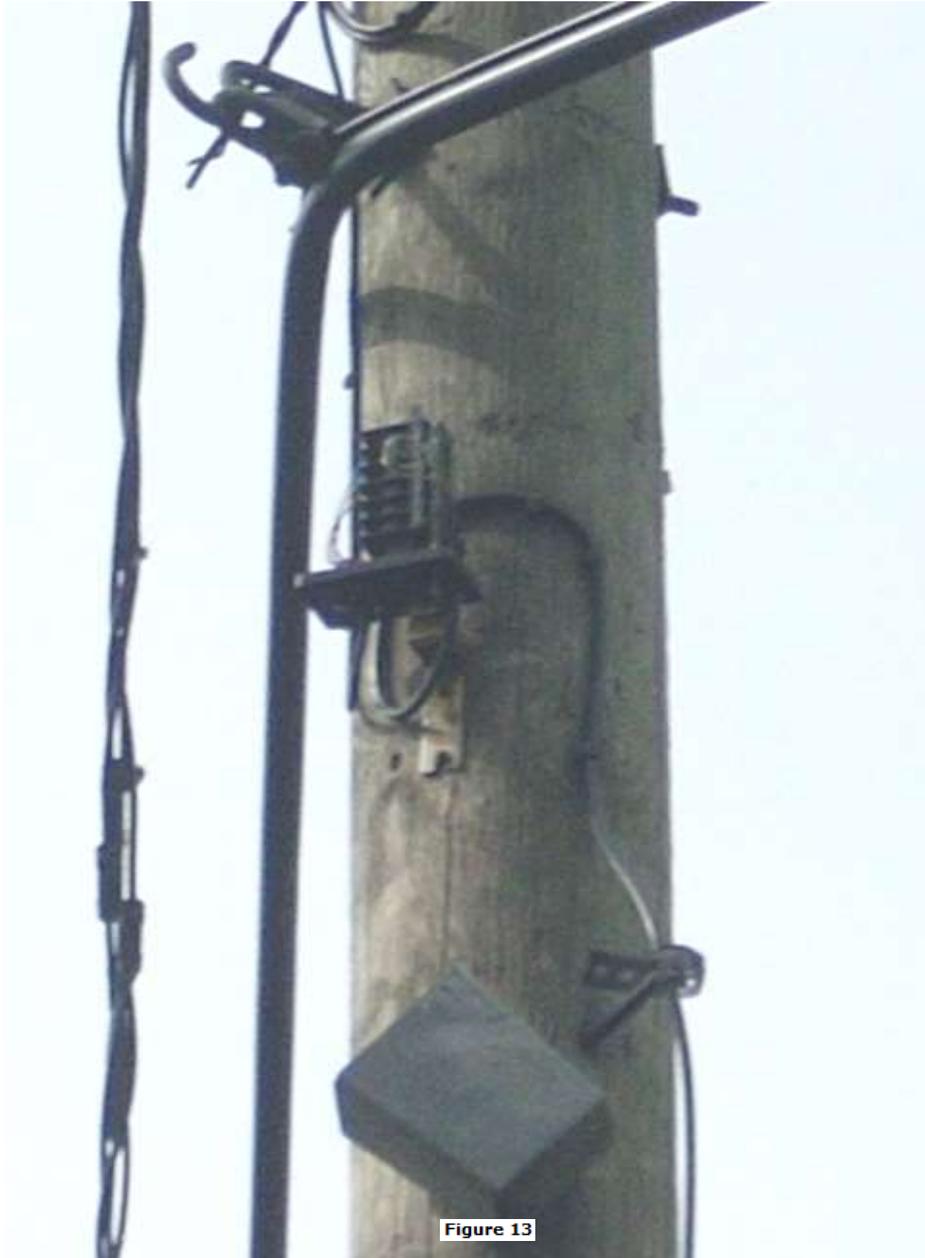
Figure 13

A very nice, albeit slightly fuzzy, close up of the open subscriber distribution box from the previous page. The connection strip looks like some sort of "plain Jane" barrier terminal strip, and it obviously has no more than twelve screw terminals. Possibly, though, sneak current fuses are installed, owing to the unusually wide gap between the terminals on the left and right sides. It's a sad thing that TCI doesn't have any members living in Finland, because then it would've been possible to obtain 100 percent correct data on such things.

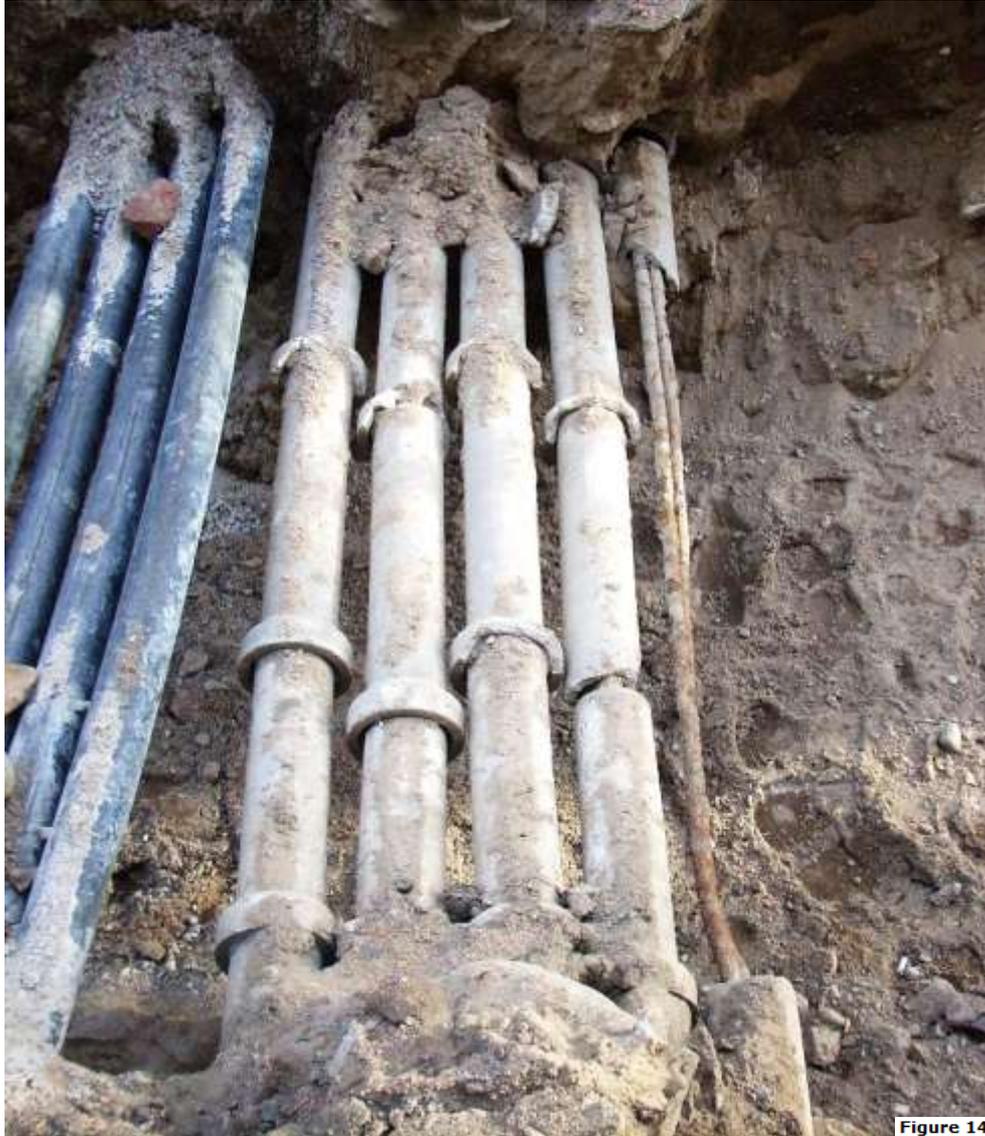
Figure 14

Here we have a nice example of modern, plastic conduits next to older, cement conduits which remind one of sewer pipes. As can be seen, the latter didn't hold up too well during excavation.

At the very least, the two cables which may be seen at the right-hand end of the cement conduits are probably phone cables, since their diameter is too small for proper power feeders.

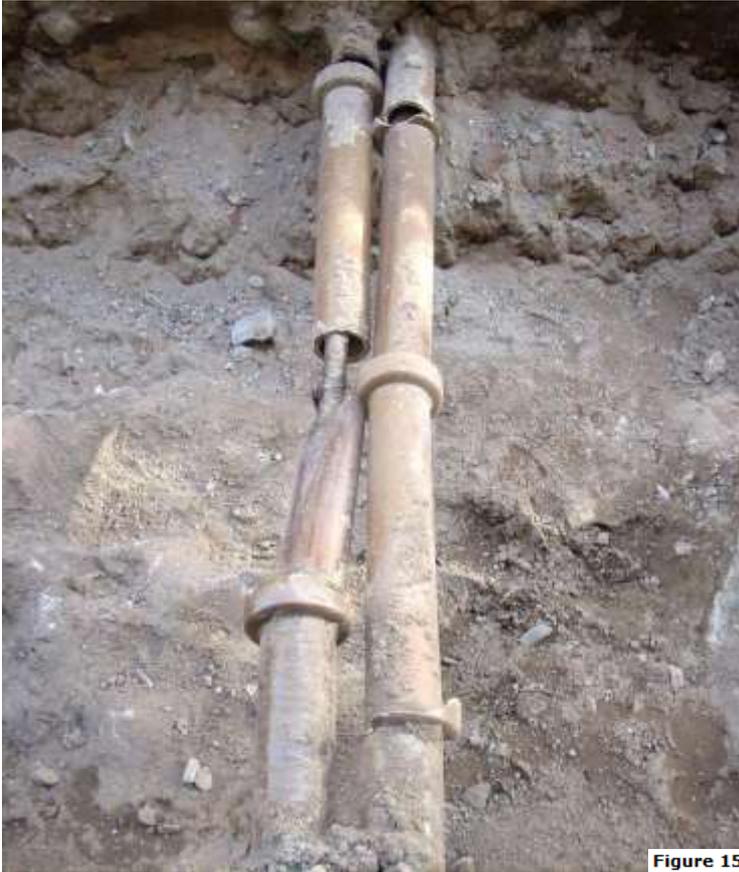
Figure 15

Very nice, old conduits made of vitrified clay. These were much more expensive, from a material point of view, than those made of cement.

I sure would've liked to know whether the nice, thick cable in the left-hand conduit was a power feeder or a phone cable.

Interestingly enough, there don't appear to have been any sort of plastic "signal" or "warning" ribbons buried in the ground, above the conduits, as is standard practice in some European countries (such as in Austria, for example).

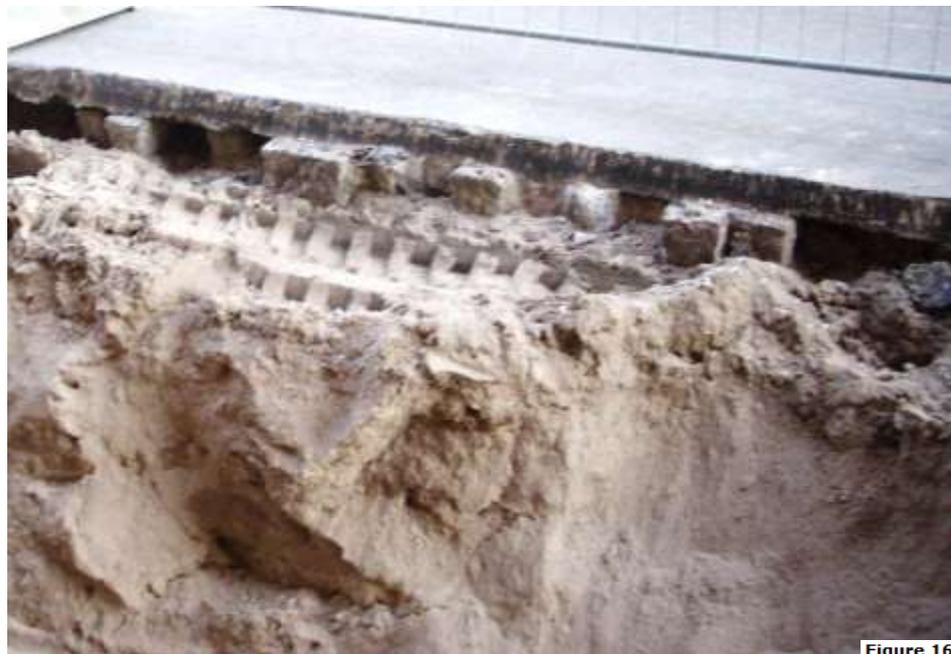
Figure 16

I only included this snapshot in order to show the construction of an average street in Helsinki – they didn't bother to first pull up the old cobblestones before converting to an asphalt roadbed.

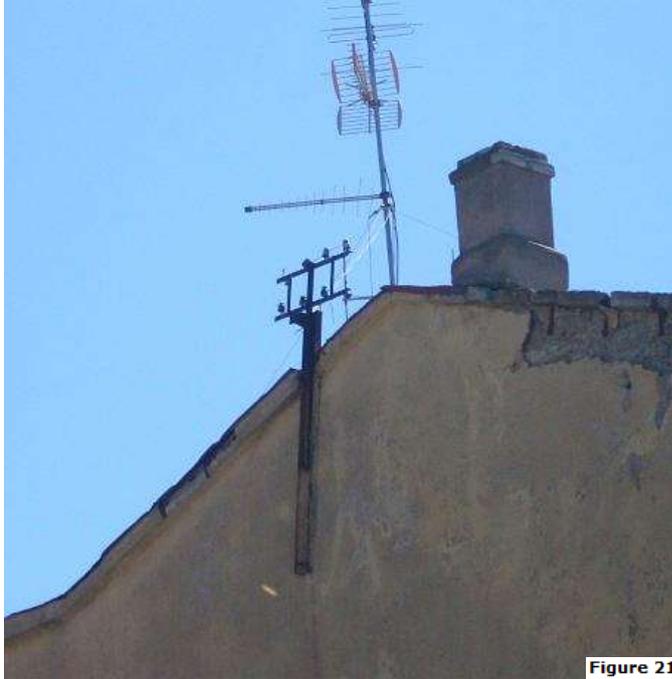
Figure 21

Although next to impossible to see in the photograph, the insulators are definitely of a type more commonly used with open wire telephone lines than with electrical power.

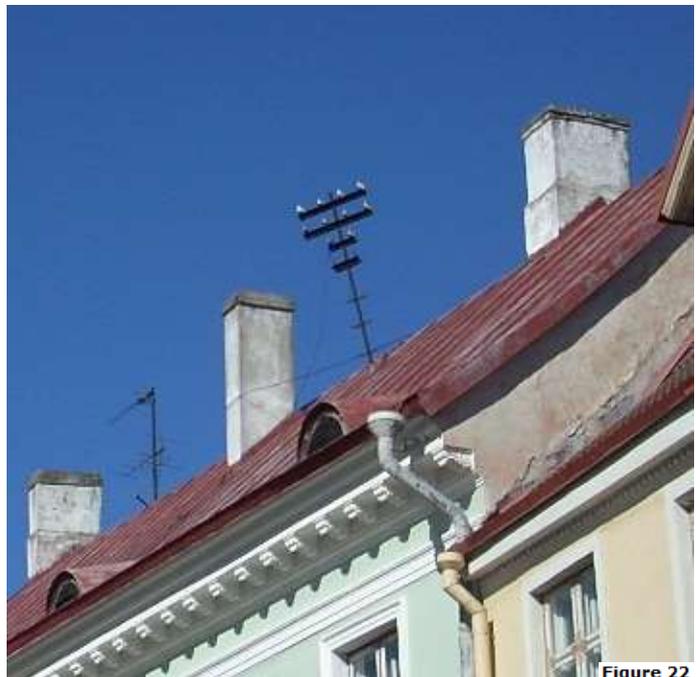
Figure 22

Another old, open wire mast, but for 6 subscriber pairs in this case. Although it looks as if the two lower crossarms are steps, one would be hard-pressed to imagine anyone climbing up such a slim and shaky mast.

What is really strange, though, is that the uppermost positions carried more wires (and thus more strain) than the lower positions ... this appears to be contradictory to any standard practice I am familiar with.

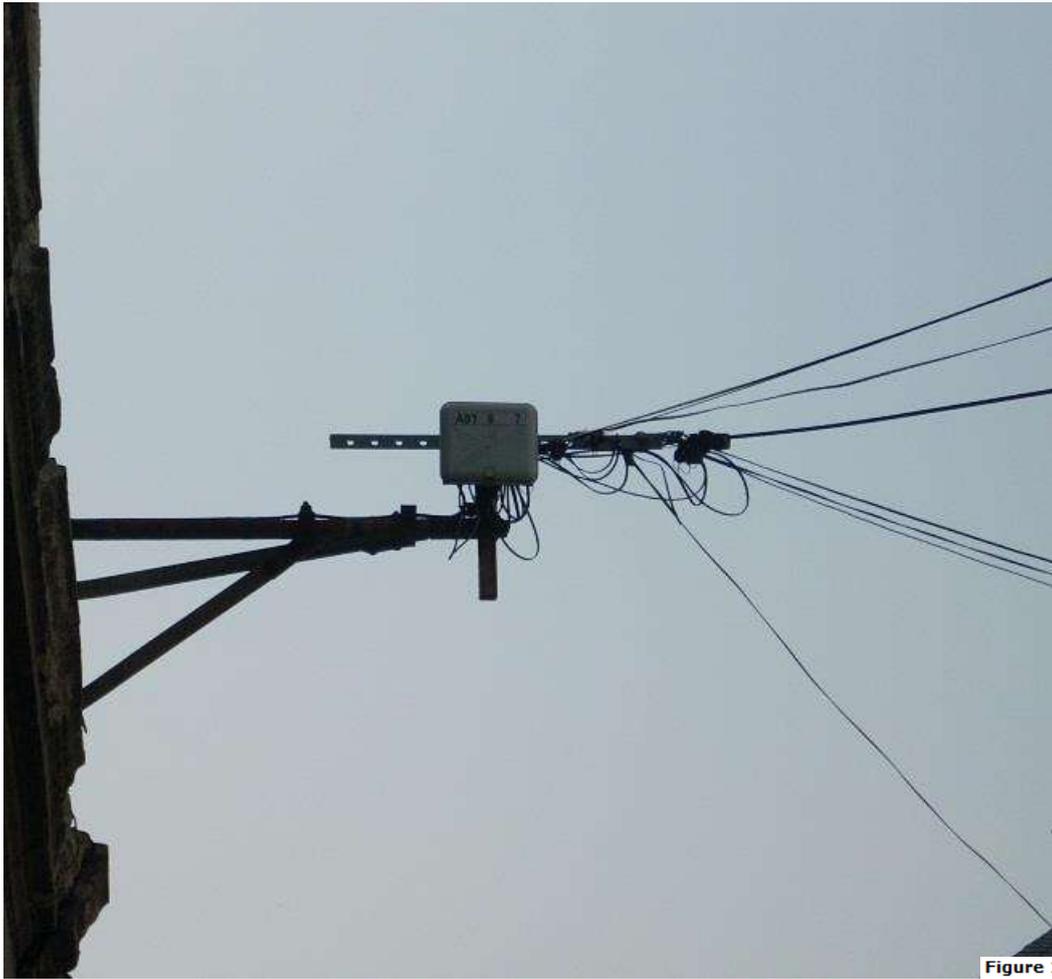
Figure 1

Talk about being out on a limb; this subscriber distribution box is mounted about 3 feet away from the outside wall of a building, directly *above* a busy street. At least 6 subscriber service drops are attached, as well as one thin feeder cable (the third cable from the top at the right.) I discovered that *most* of these distribution boxes carry a unique code number, in this instance "A07 6 7."

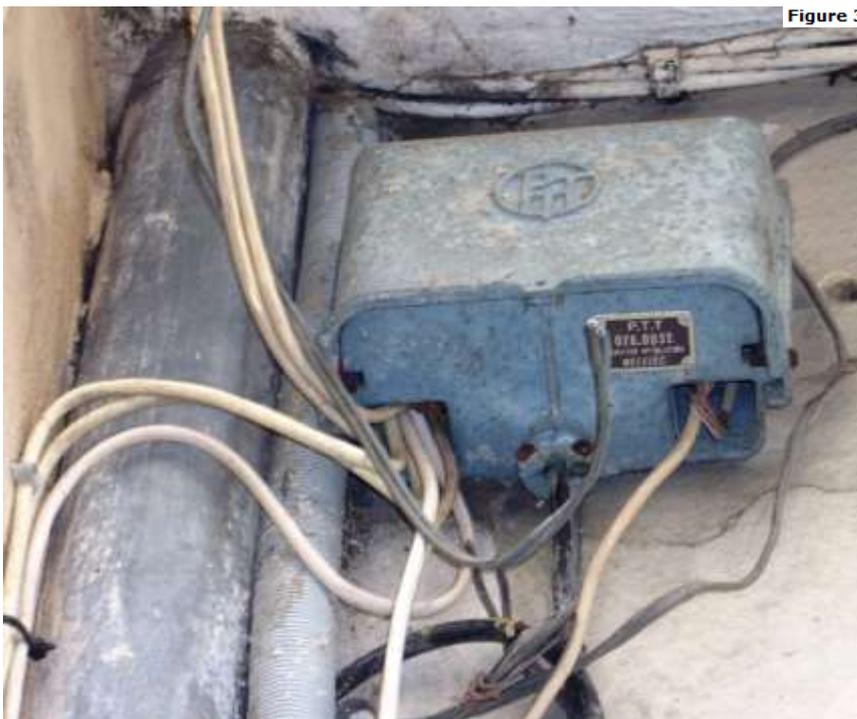
Figure 3

A very unusual type of distribution box; the feeder in this case is the white cable attached to the wall, while the subscriber drop cables fall away to the left. The feeder is attached to the wall with plastic cleats which aren't really all that strong – if one gives the cable a good yank, it'd be easy to pull it right off the wall.

The bridle ring supporting the drop cables is screwed into a plastic expansion sleeve which is none too securely driven into a crack between two blocks of concrete.

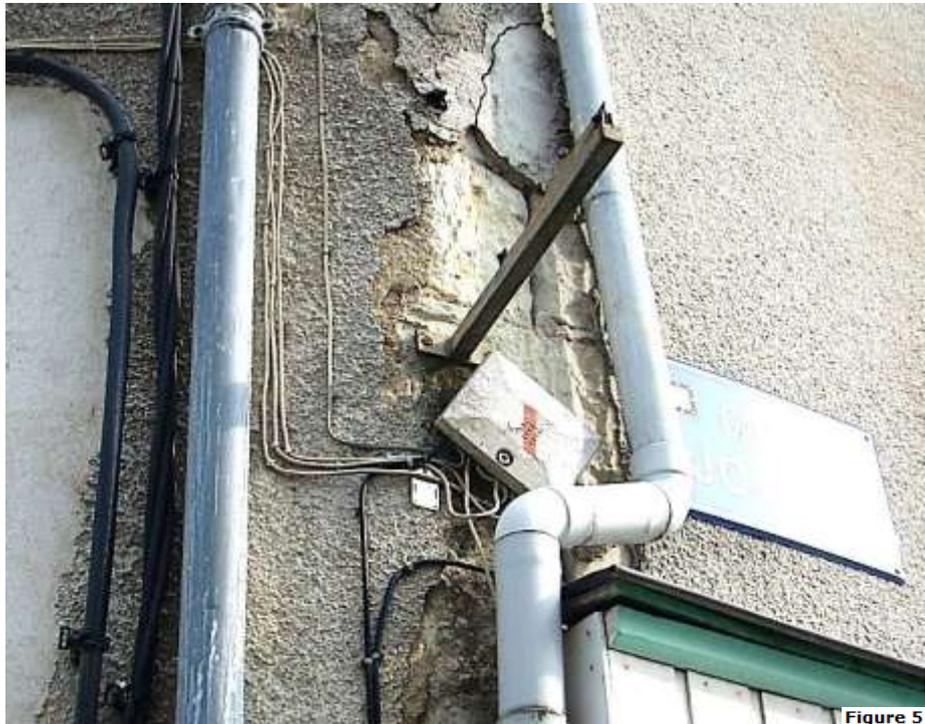
Figure 5

The distribution box shown here is apparently an older variant of the one shown in the picture on the first page of this tale.

It's rather funny that the box is marked with a big, red "X" (as in: "ex marks the spot") – although it is obvious which of the many boxes on the wall belongs to France Telecom.

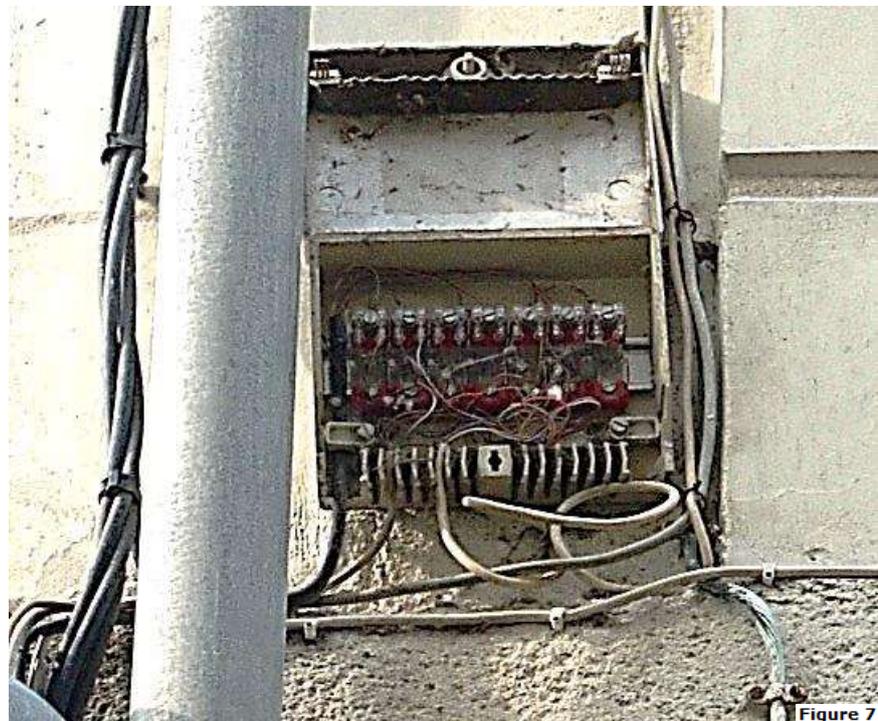
Figure 7

I was relatively certain that I'd be able to find an open telephone distribution box if I kept my eyes open long enough ... and here it is!

Counting out the screw terminals, this box is equipped to serve 7 pairs. The wires from the black feeder cable are fanned out along the inside top of the box, with the subscriber cables being connected immediately below.

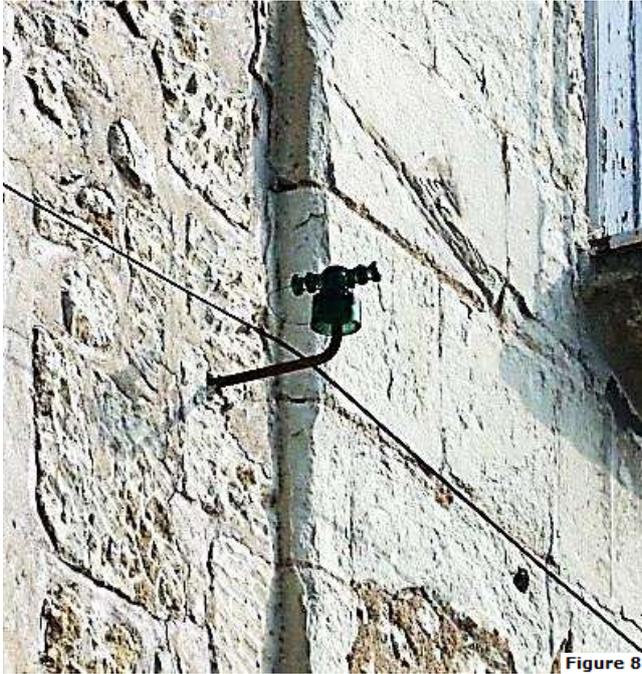
Figure 8

In this case, I found myself in the courtyard of one of Châtelleraut's oldest buildings, where I discovered the nice glass telephone insulator shown to the left.

As has been found in similar cases elsewhere, the old supports the new; however, if one takes a *really* close look at the picture, one can see that there is a small bit of the old bronze wire still attached to the left-hand "nose" of the insulator.

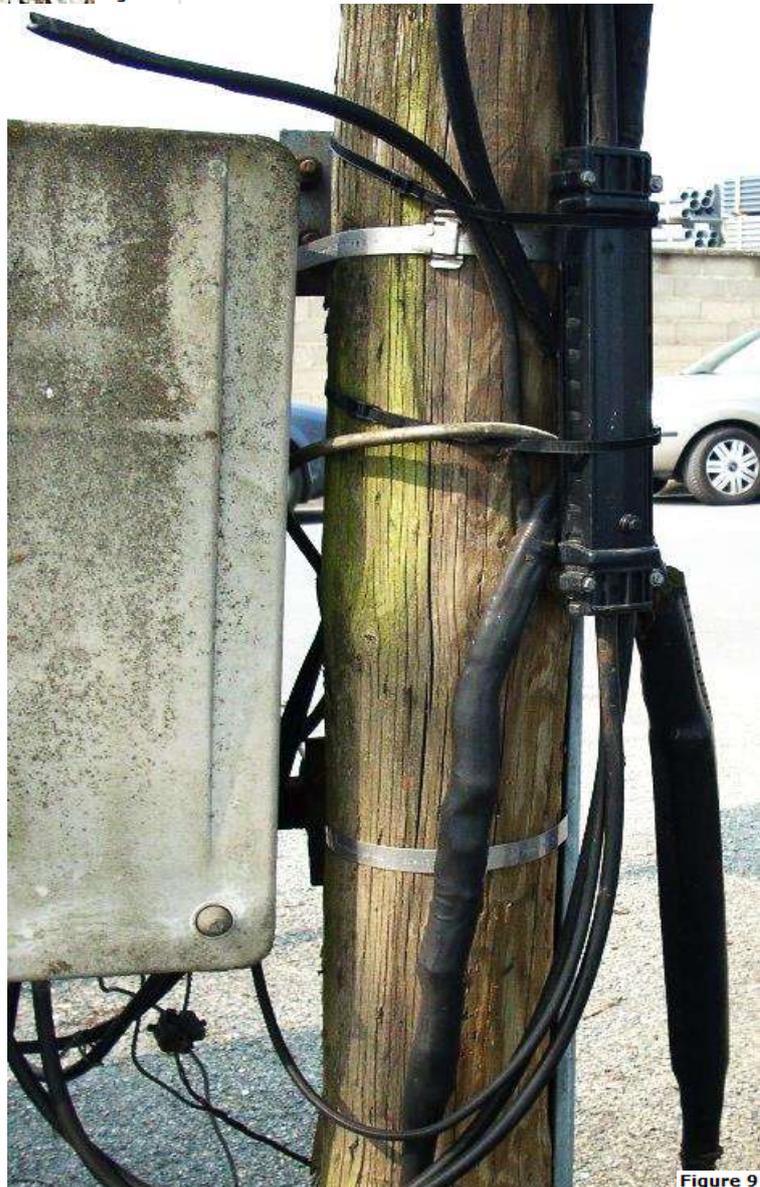
Figure 9

And I found this wonderful trio of splices on a pole right across the street from the restaurant; a most interesting group, actually, showing the expedient, the tidy and the "official" way of splicing a phone cable in France.

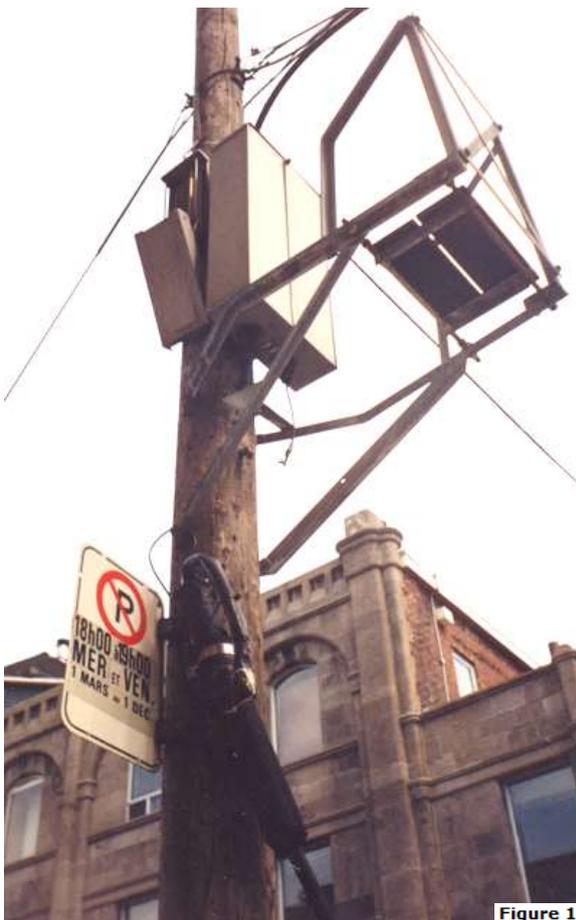
Figure 1

As can be seen, the underground feeder to the cable terminal (cross-connect cabinet) was chopped through, and a section of the cable removed as well. Everything else was left in place to be tidied up at some later date – the main thing is to *make sure that it won't work again*.

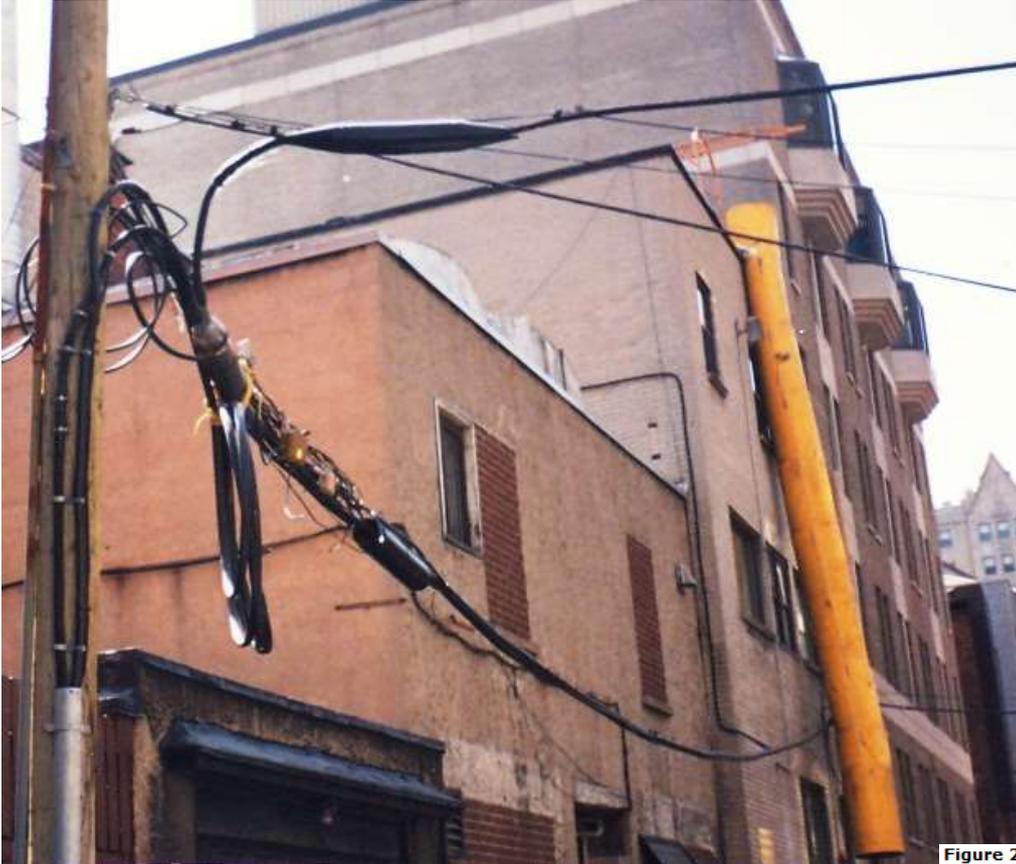
Figure 2

I certainly wouldn't have wanted to park my rented car underneath this bunch of dangling cables – they'd probably turn a limousine into a compact car if they actually dropped down (luckily, though, this lot of cables was in an alley where no sane person would park a nice, new car anyway). At least I now know why they call it a cable *throw*.

The orange-colored warning flag hanging down from the pole balcony caught my attention; more than one truck had obviously backed into it in the past.

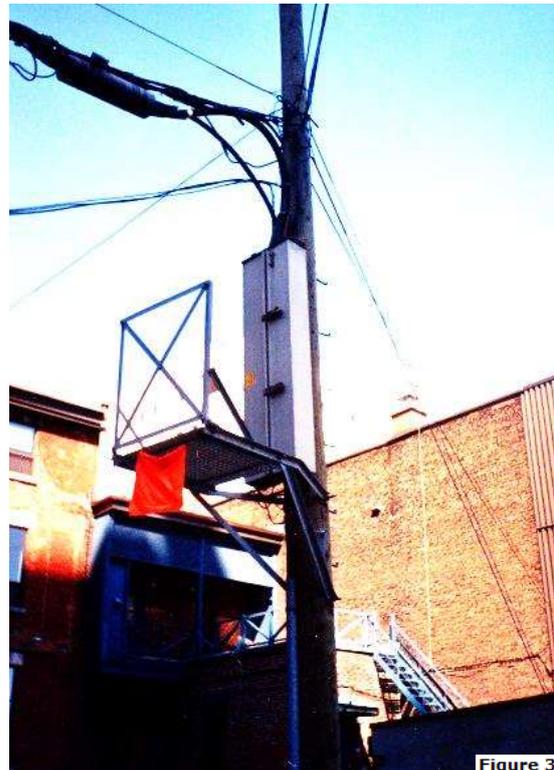
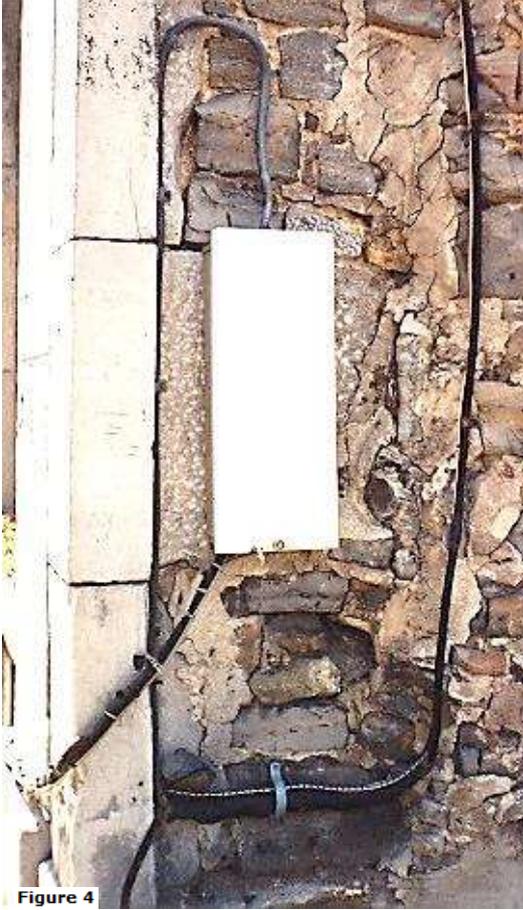
Now here's an interesting sight – a distribution (or fuse?) box with a lead-sheathed cable stub exiting from the top, where the stub is wye-spliced into P.I.C.; and not only that, but the second cable exiting the box is spliced about one foot away from the same as well.

From the look of things, one could almost imagine splicing the two cables together and doing away with the box for good – after all, it looks as if one cable enters the box and one cable exits, so why bother with possible corrosion on 100+ stud and nut terminals?

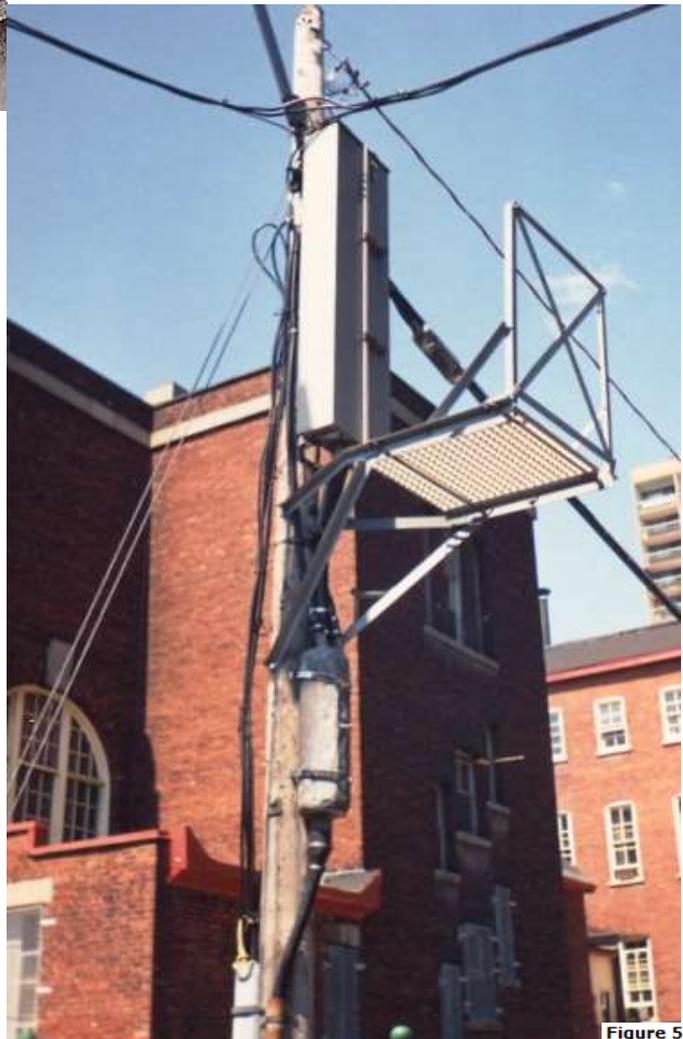
Figure 5

Another nice, *tall*, cross-connect cabinet on a pole – but what really interested me was the very big, lead splice case *beneath* the pole balcony ... now *that's* a whopper!

The most curious thing about this splice case, though, is that all of the cables are P.I.C., instead of being lead-sheathed. Although most unusual, this *was* the approved Bell method by which "alpeth" cables were originally spliced, circa 1950 (readers may wish to refer to Bell Telephone Magazine, Volume XXVII, 1948, page 85 for more info).

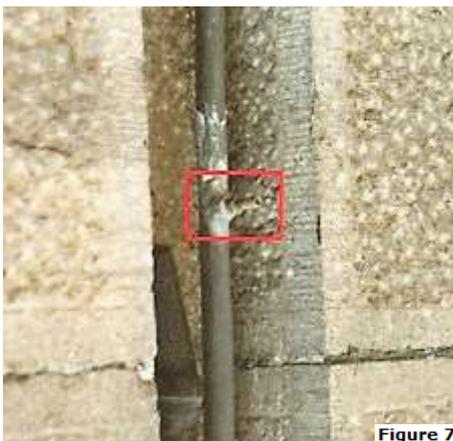
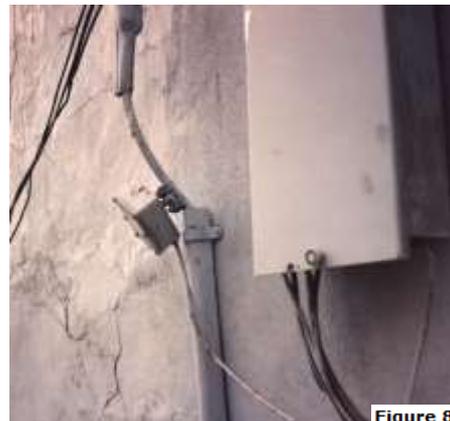
Once upon a time, it was standard practice to pressurize lead-sheathed, paper-insulated phone cables in order to prevent water from entering.

I was pretty surprised to discover a bicycle stem valve soldered to a lead-sheathed cable (for pressurization), as well as a pressure switch attached to another lead-sheathed cable (for remote sensing of pressure loss).

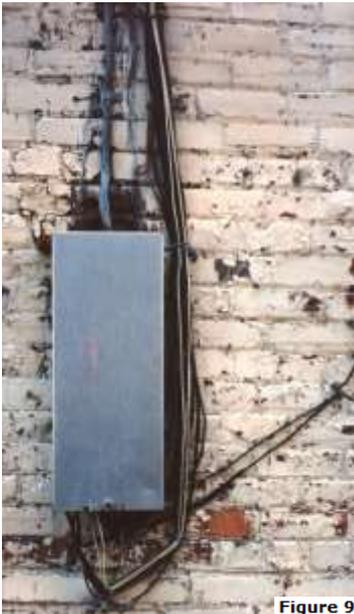
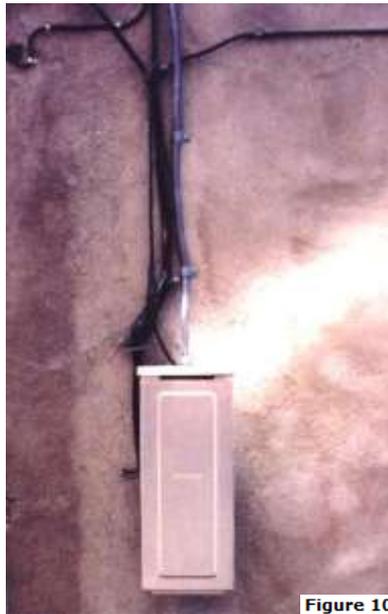
Three more fine examples of subscriber distribution boxes with lead-sheathed cable stubs; the distribution box in the right-hand photograph has its stub spliced to a lead-sheathed feeder cable, and the splice case is leaden as well.

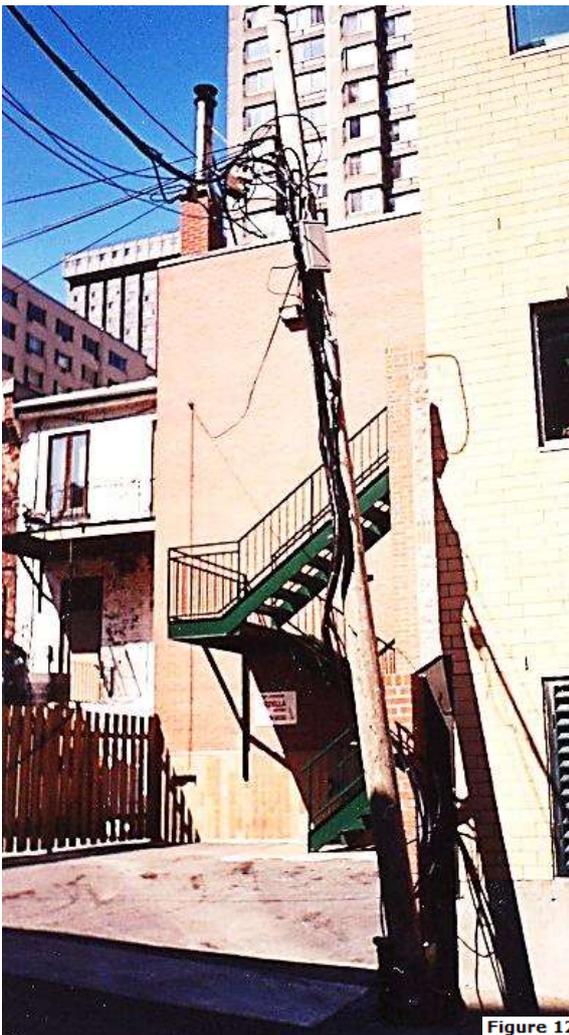
Figure 12

Another pole I was fond of ... not just because it's leaning over like a drunk, but also because the buried feeder cables wrap themselves around the pole in a majestic, loose spiral – practically without any visible means of support until nearly halfway up the pole.

To top it all off, the distribution box near the top has a lead-sheathed stub which is terminated in a lead splice case which is circa 2 feet below the box itself.

It seems odd that the pole isn't leaning in the direction of the aerial feeder cable which disappears in the upper left-hand corner of the snapshot, but rather in the direction of four measly subscriber drops. One would normally expect the pole to lean in the direction of the greatest strain, but this one defies logic.

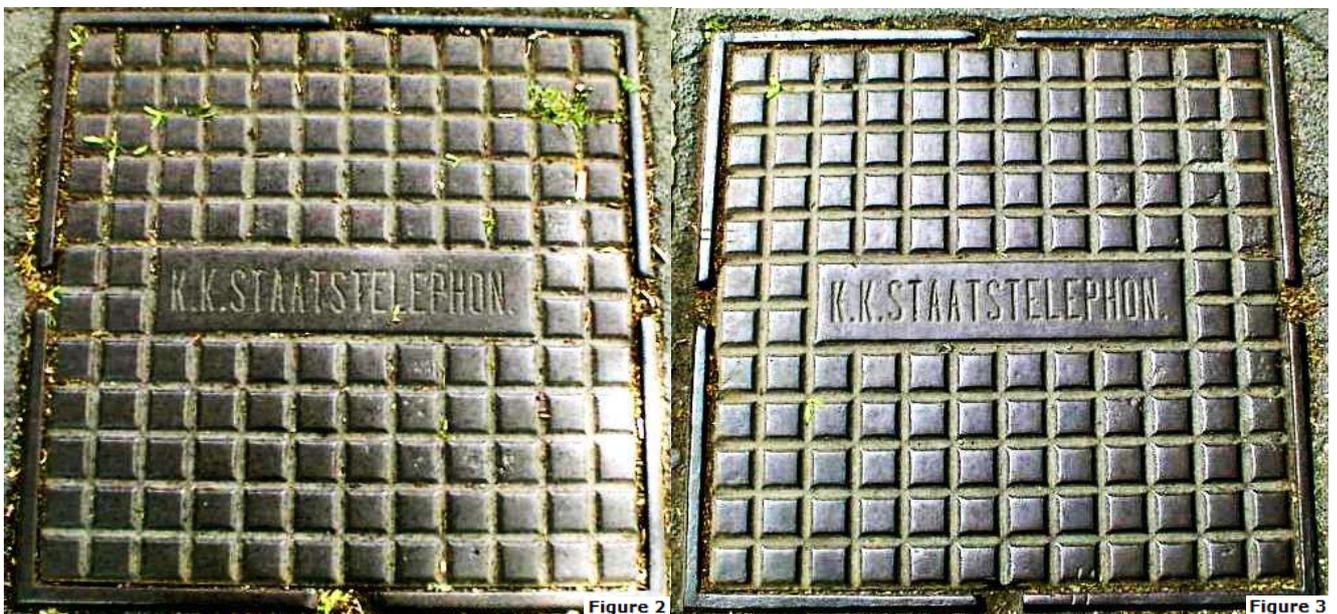
These photographs were taken in the year 2012, but I have not walked along the Ring in the years since and can't guarantee that these manhole covers still exist, but at the time the pictures were taken, both covers were over 90 years old. The wording on the cover translates to "Imperial-Royal State Telephone."

These were the only two *really* ancient manhole covers to be found along the Ring. It may be of interest to readers that neither the cover frames, nor the covers themselves, exactly match the design as shown in the scan on the previous page ... the frames only have four notches (instead of eight), and the two lifting links are missing. I didn't attempt to lift one of these covers and check whether or not the inner, wooden, cover was still in place.

It's rather surprising that these two manhole covers should show such little wear and tear, considering how many people must have walked over them in the past nine decades.
