## A Collection of Telephone Tales

written by Herbert Schwarz of Vienna, Austria, European Union

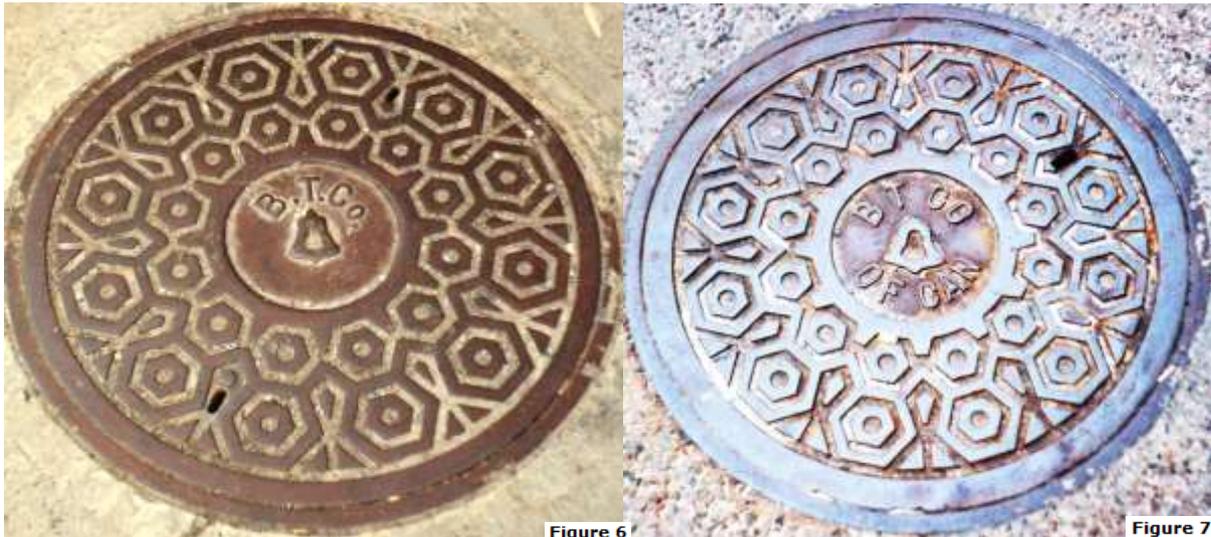
Figure 6

The manhole cover to the left below is the oldest one which I came across while wandering through Montreal. "B.T.Co." can only mean Bell Telephone Company, and it certainly has been a while since the Bell System went by that name. As to age, I feel that this one could actually rival the oldest ones I found in Vienna ... apparently, there was no separate Bell Telephone Company of Canada at the time, and this cover may have been imported from the USA.

In the progression of things, I believe that the manhole cover on the right is the next iteration, seeing as how this one proudly proclaims to belong to the Bell Telephone Company of Canada. It'd be interesting to be able to compare the two covers as to their weight, because the one on the left has two slots for lifting hooks, while the one on the right only has a single slot – or was the only difference one of convenience?

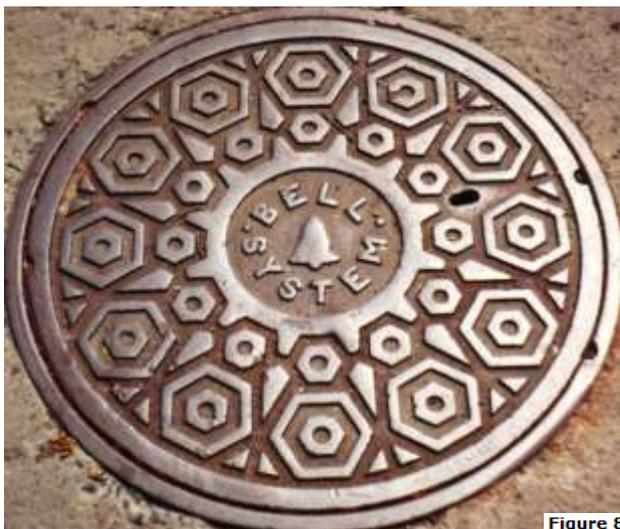
Figure 8

This particular manhole cover could be another import from the USA, since it belongs to the "generic" Bell System, without specifically stating that it belongs to Bell Canada. It's also interesting that the non-slip design of the cover is slightly different than that of the two previous covers. A rather marked change is that the "cogwheel" or "gear" which surrounds the central logo is offset – on the previous covers, one of the teeth was vertically aligned with the center of the bell.

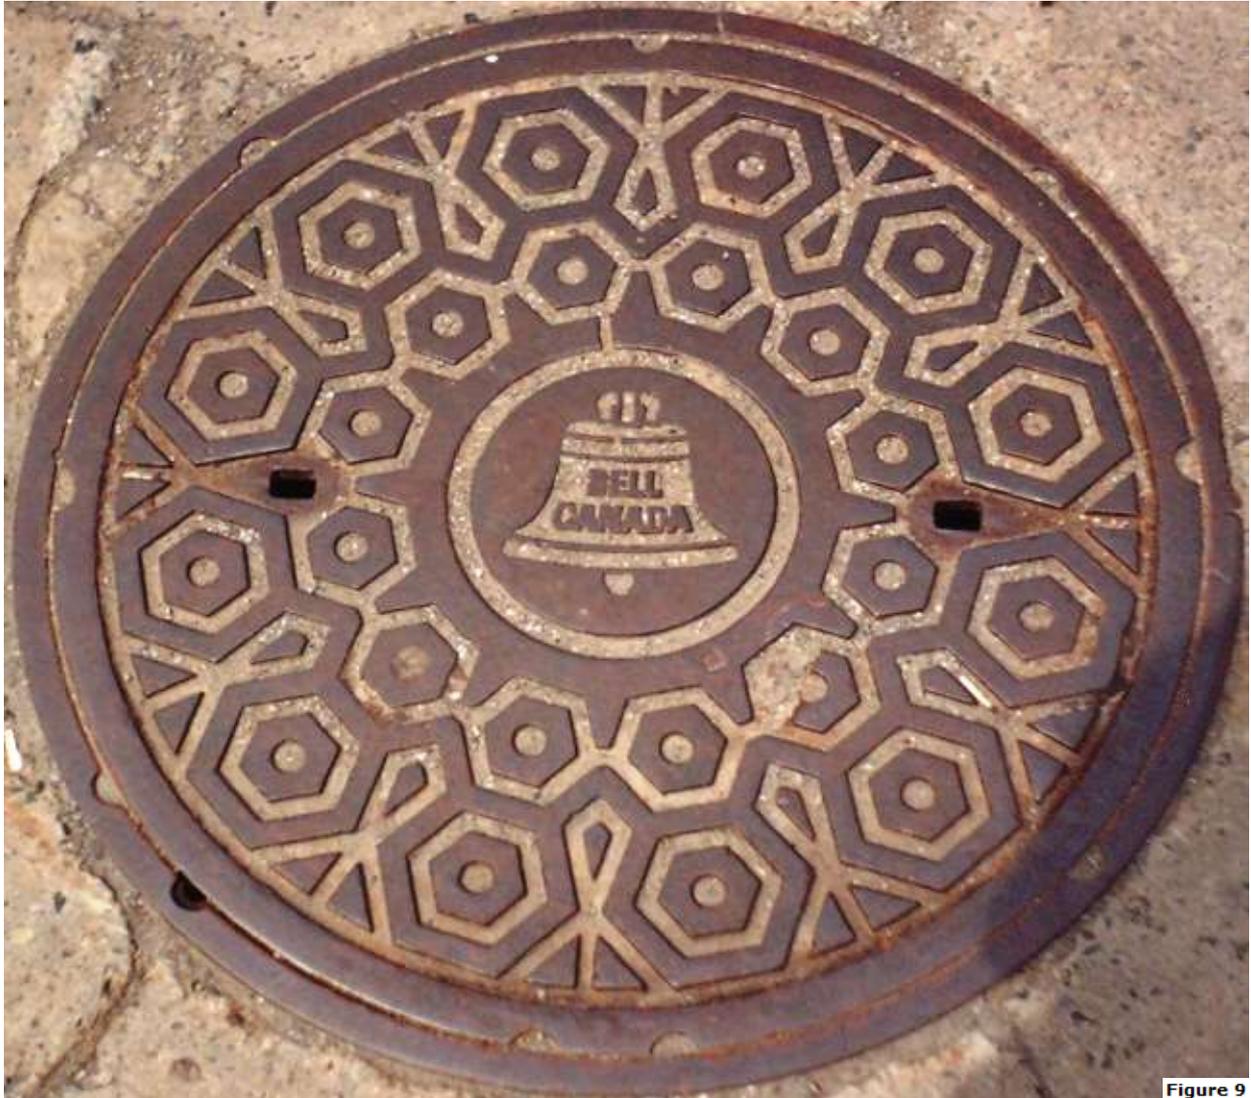
Figure 9

A step backwards in time, design-wise, and at the same time a step forward, since ownership is by Bell Canada. Those readers who pay great attention to detail will have noticed that this cover has two defects which occurred during casting ... the cogwheel is broken near the 12 o'clock position, and the hex-shaped figure near the 4 o'clock position is halved.

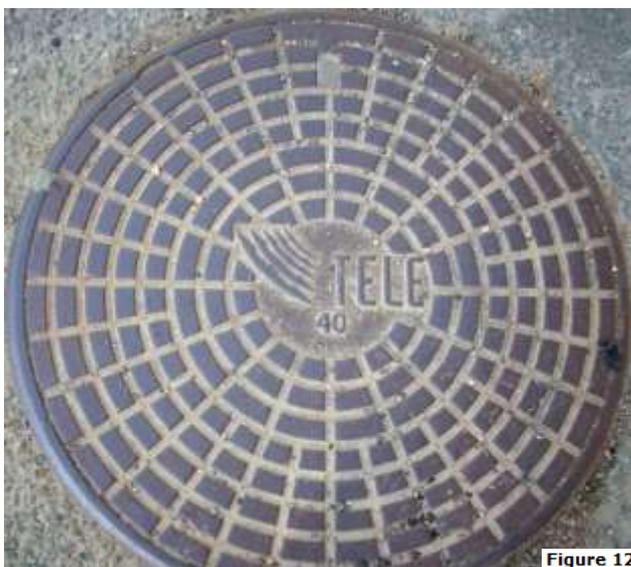
The manhole cover shown here wasn't actually found in Helsinki proper, but rather on the outskirts of the city of Vantaa – near Helsinki. The word "Tele" is a dead giveaway as to ownership, but I haven't been able to figure out what the 5 symbols to the left of the word are supposed to represent ... they *could* be stylized telephone handsets. "40" again represents a traffic load factor of 40 metric tons.

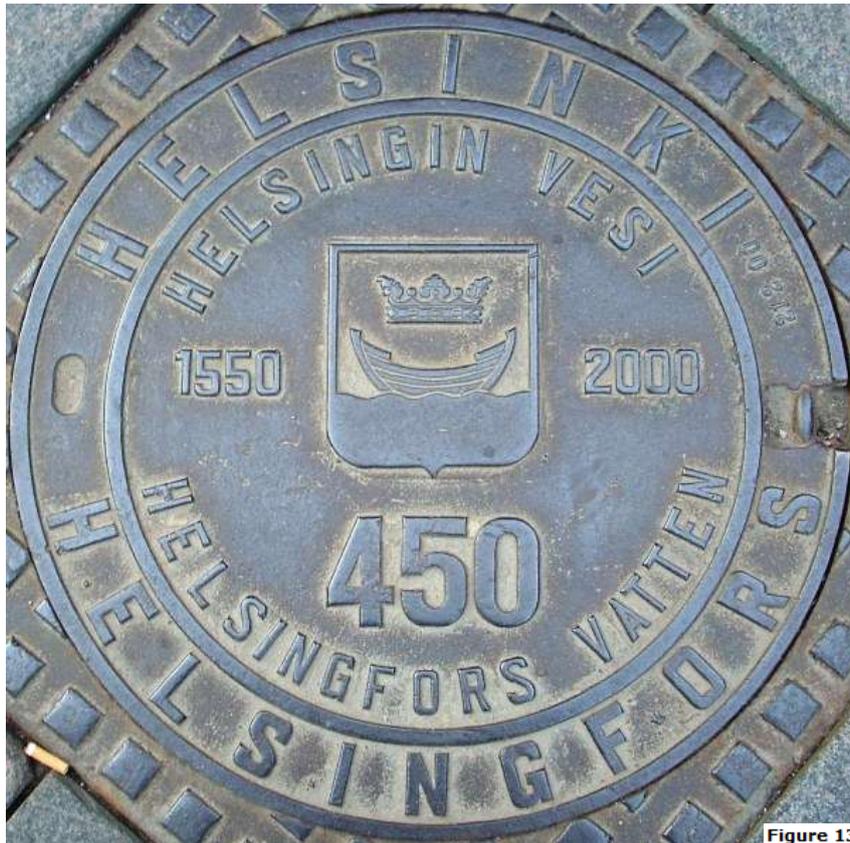
Figure 13

Although definitely **not** a *telephone* manhole cover, I found this one to be so very unusual that it well deserved to be photographed and presented here. This cover was cast in commemoration of 450 years of public water works in Helsinki (the text on the cover is in Finnish and Danish). Commemorative coins, medals and stamps are nothing new to me, but a manhole cover? I guess this is the sort of thing folks come up with in a country where it's pitch black for many a month, and in which alcohol is a rather common solace ....

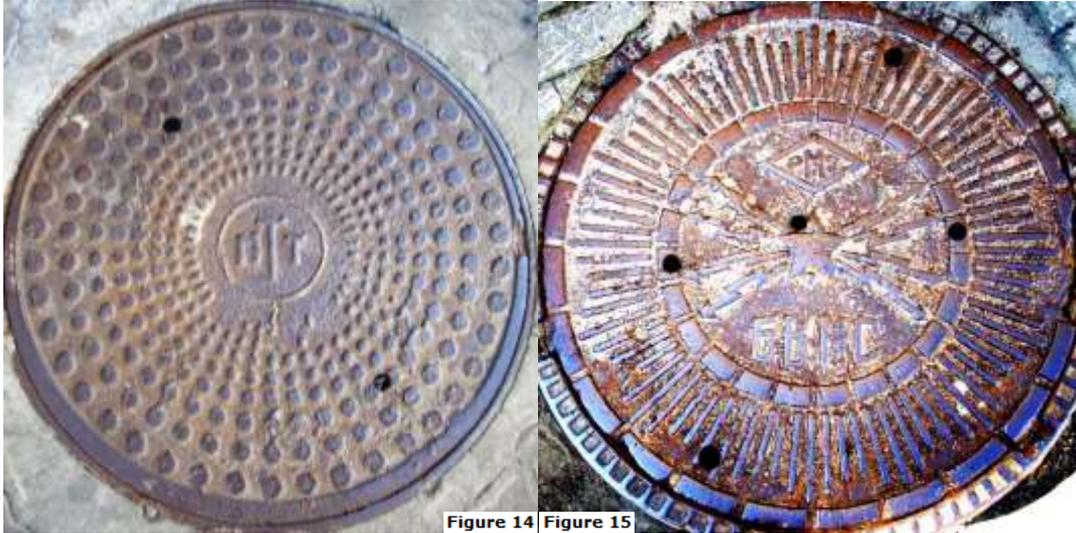
Even though the lettering is Cyrillic on the left-hand cover, it's easy to guess that the abbreviation equals "PTT." This particular one is a well-worn example of the type I saw most often while walking through the old city center of Tallinn. On the other hand, the design on the manhole cover on the right *could* either symbolize electrical power or telegraphy – six lightning bolts radiating from a nice, five-pointed communist star.

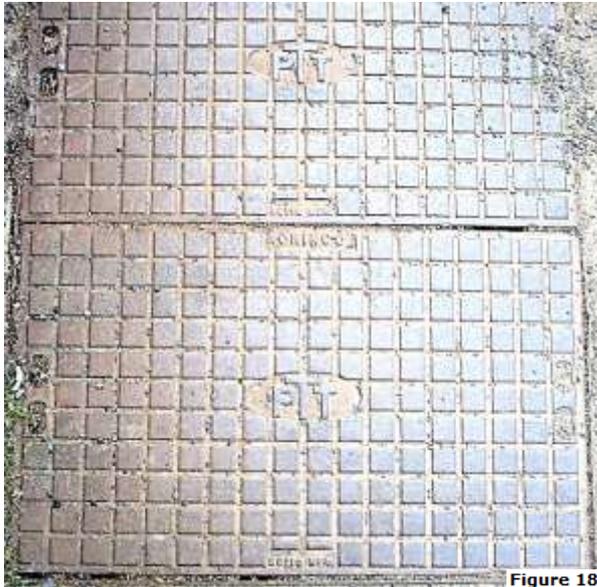
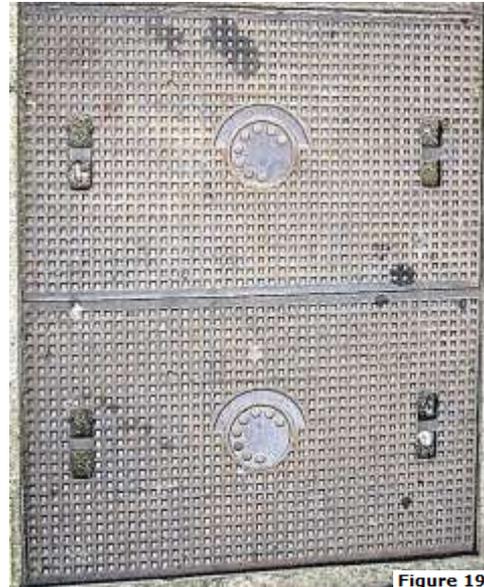
The unobtrusive PTT logo on the covers shown to the left is of a similar type as on the subscriber distribution box shown in the lower photograph on page 108, but it isn't an exact copy, so it's safe to write that even something as simple as this logo evolved over time. This style of manhole cover was the least common type I saw in Châtelleraut. I doubt that anyone, anywhere, who is familiar with good old dial telephones, could possibly misinterpret the pictogram on the manhole covers shown on the right ....

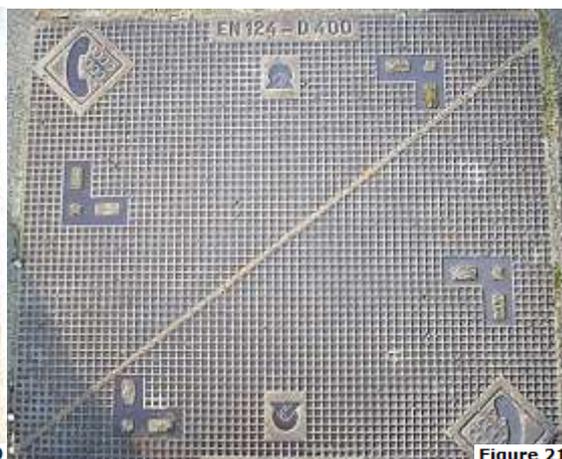
Figure 21

When *dial* telephones are a thing of the past, the old pictogram could prove to be misleading or even illegible, so what better thing could be done than to use a pictogram showing a handset and keypad? The lettering at the top of the cover spells out the manufacturer's name, while the lettering at the bottom states that this manhole cover meets the specifications set forth in European Norm 124 B125.

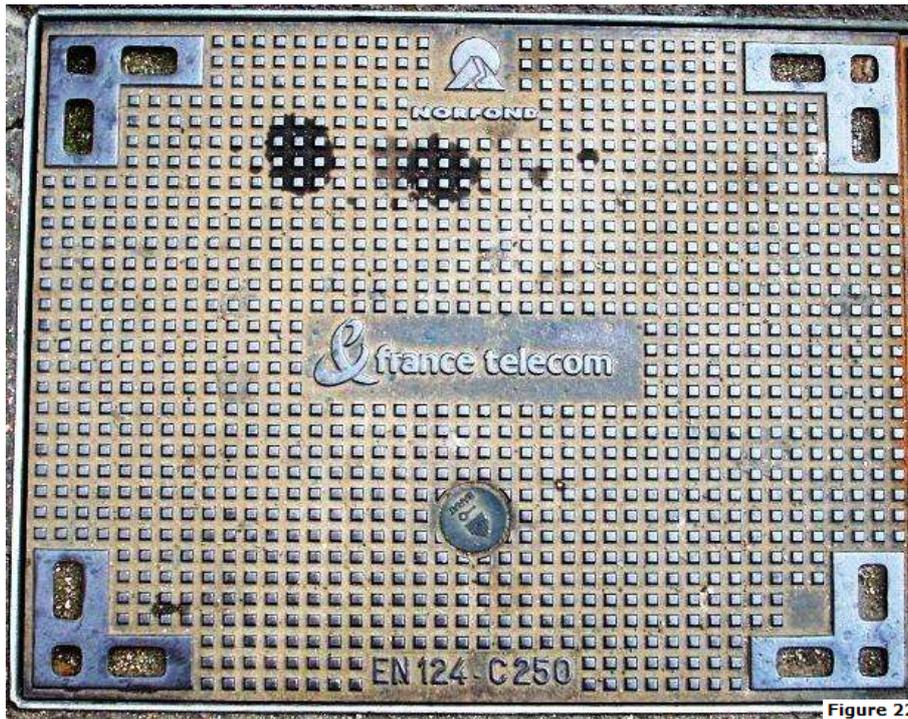
Figure 22

The telephone manhole cover shown above is the most modern design which I came across while wandering around in Châtelleraut. No need to guess whom it belongs to ....

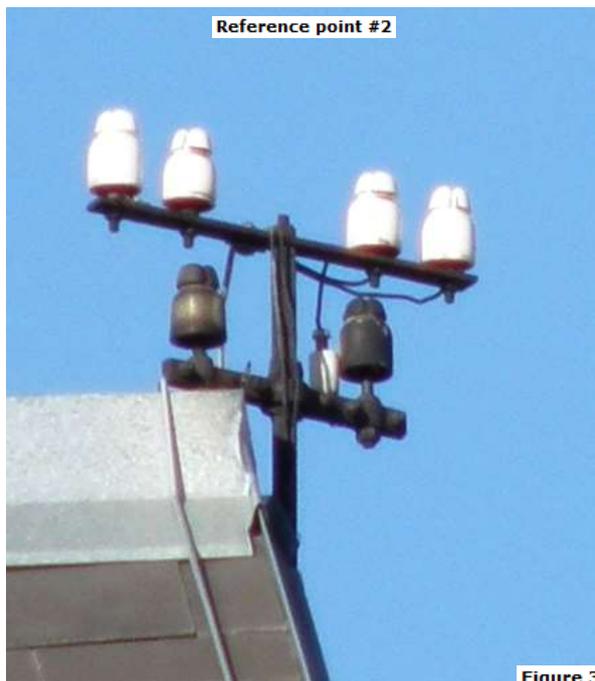
Figure 3

The address Diefenbachgasse 19 is a public school, which still exists. The photograph shows the open wire mast which is still attached to the left-hand end of the roof gable. The mast is constructed "upside down" when compared with the scan shown below. The upper crossarm of the mast still carries remnants of the lead-in wiring, so it's safe to say that the two telephone numbers listed above were terminated there.

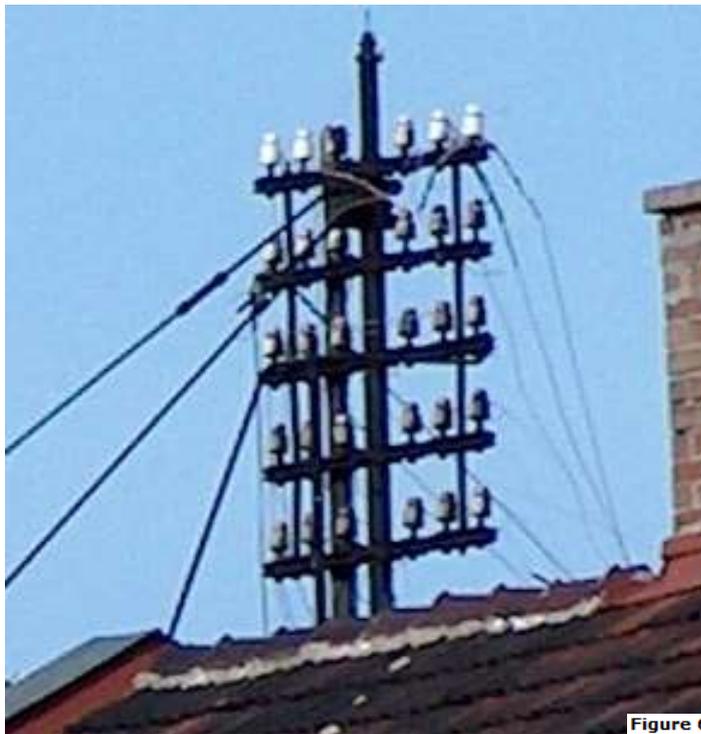
Figure 6

which were intended for short term service, but a few of them are still the original bronze wires ... this distribution mast actually stands atop the building at Stiebergasse 6, around the corner from Diefenbachgasse.

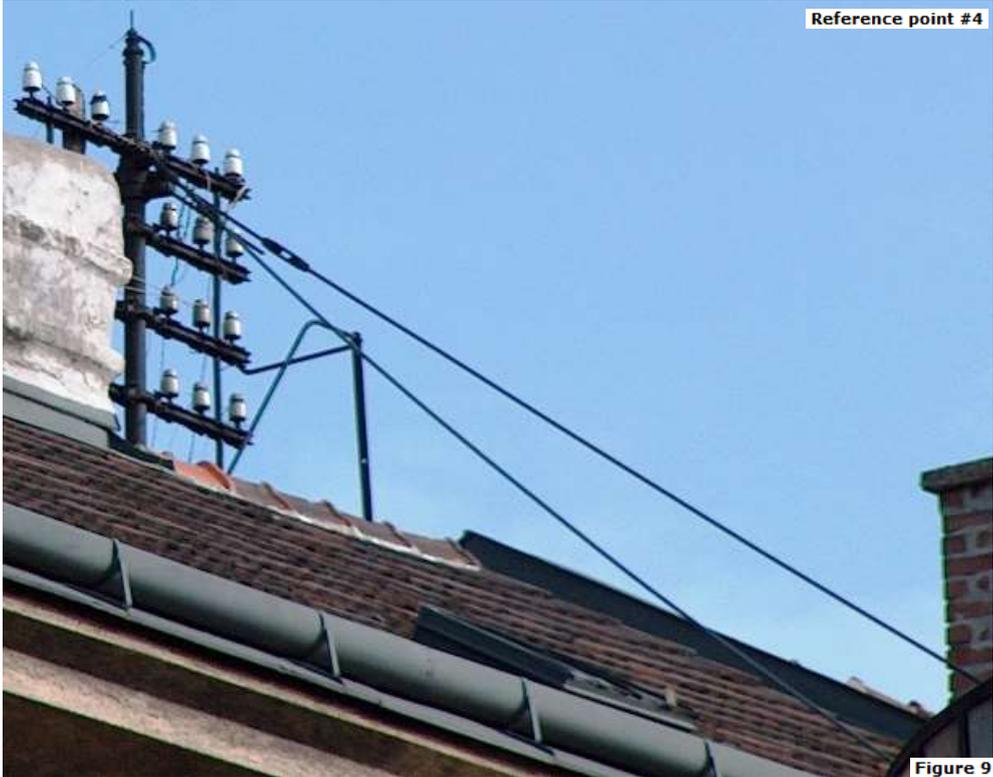
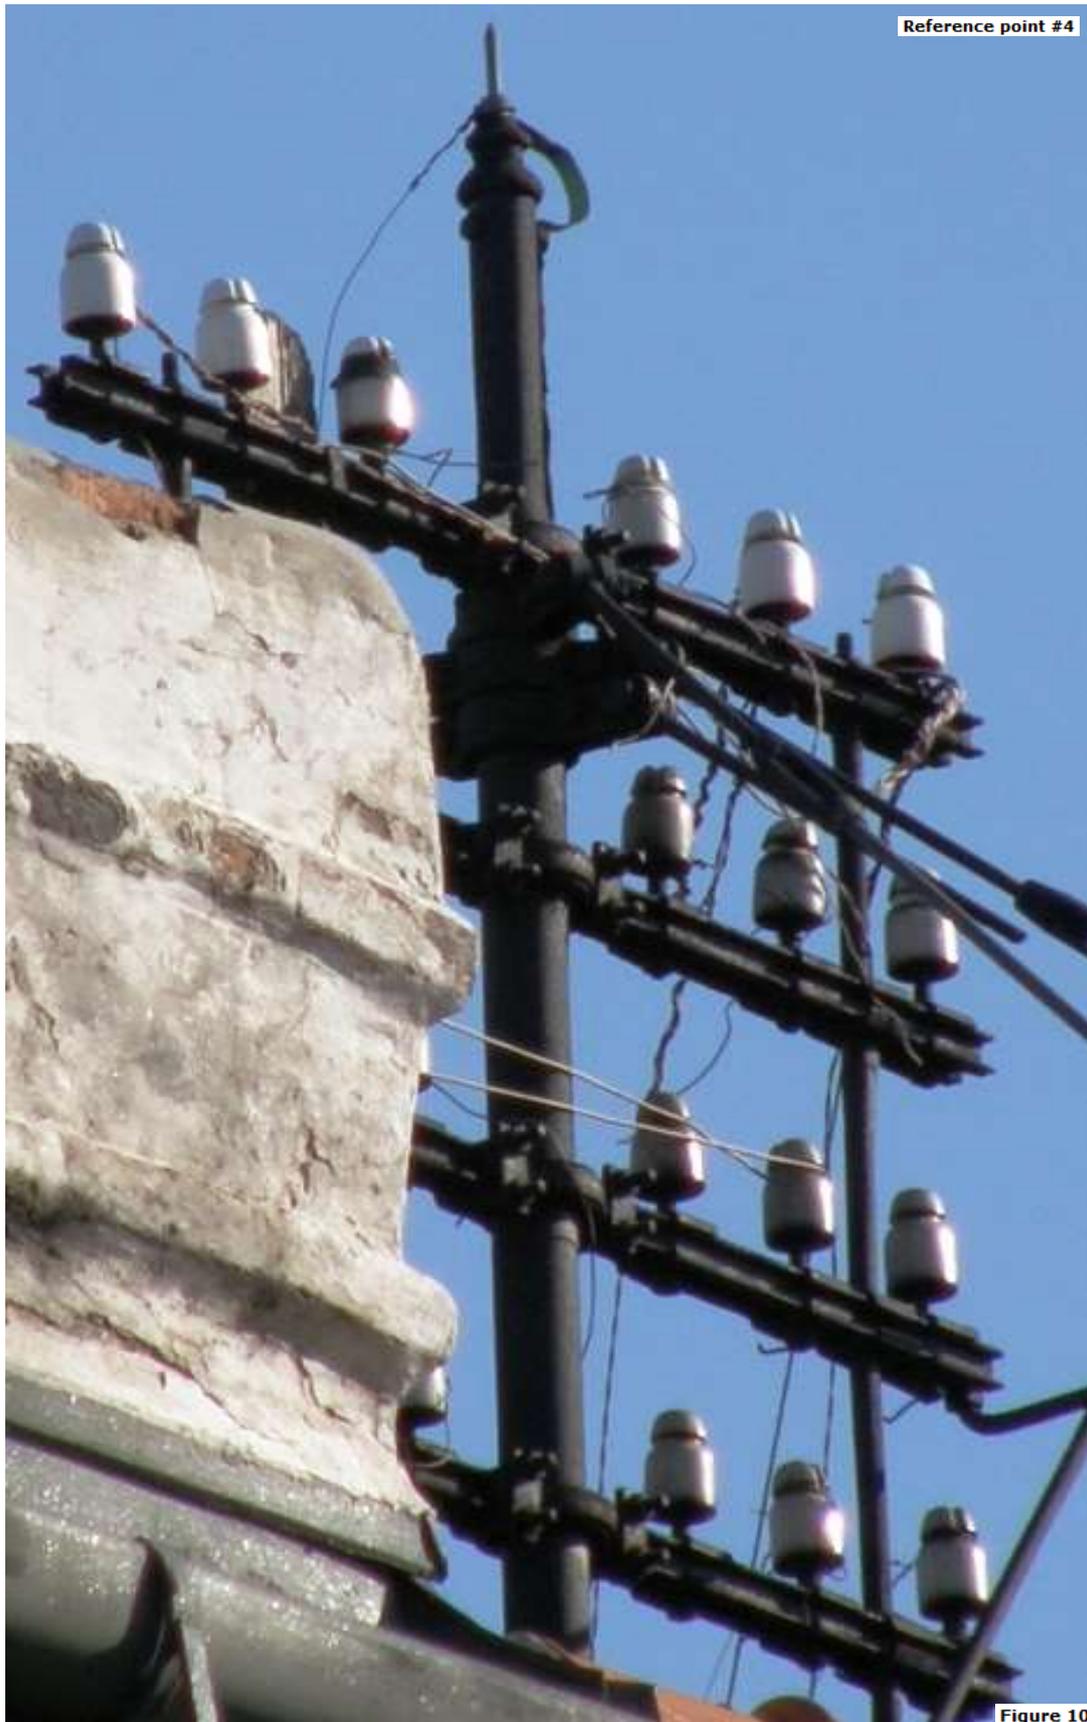
The scans depict some standard practice drawings from 1915, showing the construction of the mast and also some of the details, such as the lightning rod tip – the mast shown on the previous page, below and on the next page is of the same design.

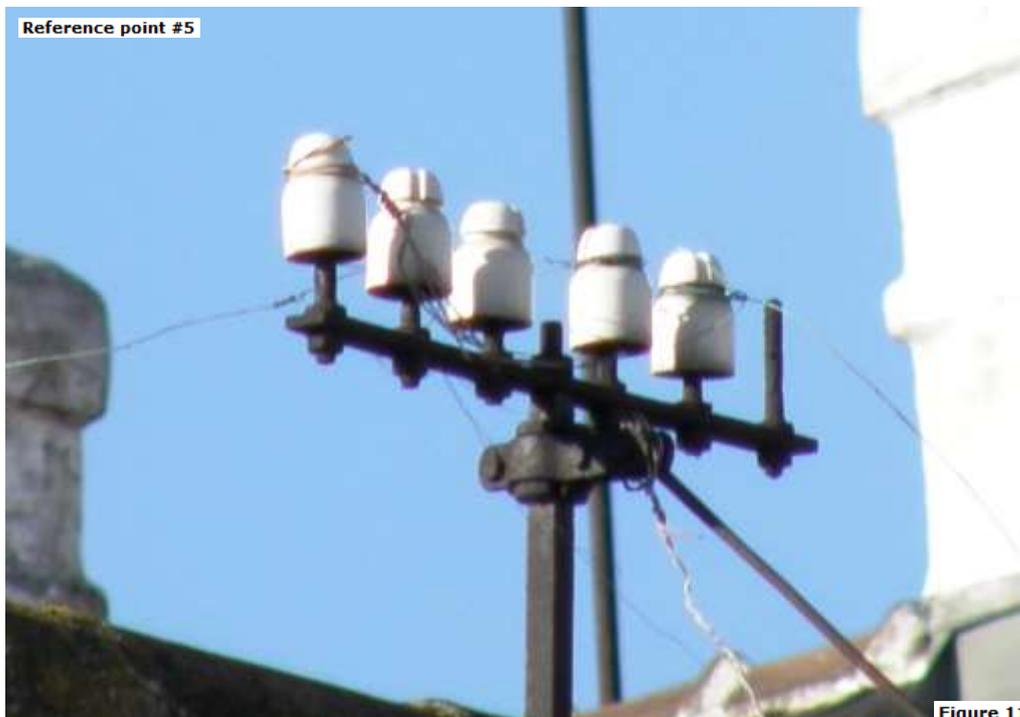
Figure 11

Readers should take note of the fact that the telephone numbers -6-13, -7-13, -8-13 & -9-13 share one pair of wires; thus, reference point number 5 is served by 3 pairs. As may be seen below, the mast supported 6 wires and is guyed to relieve strain in the direction of the distribution mast at reference point number 4.

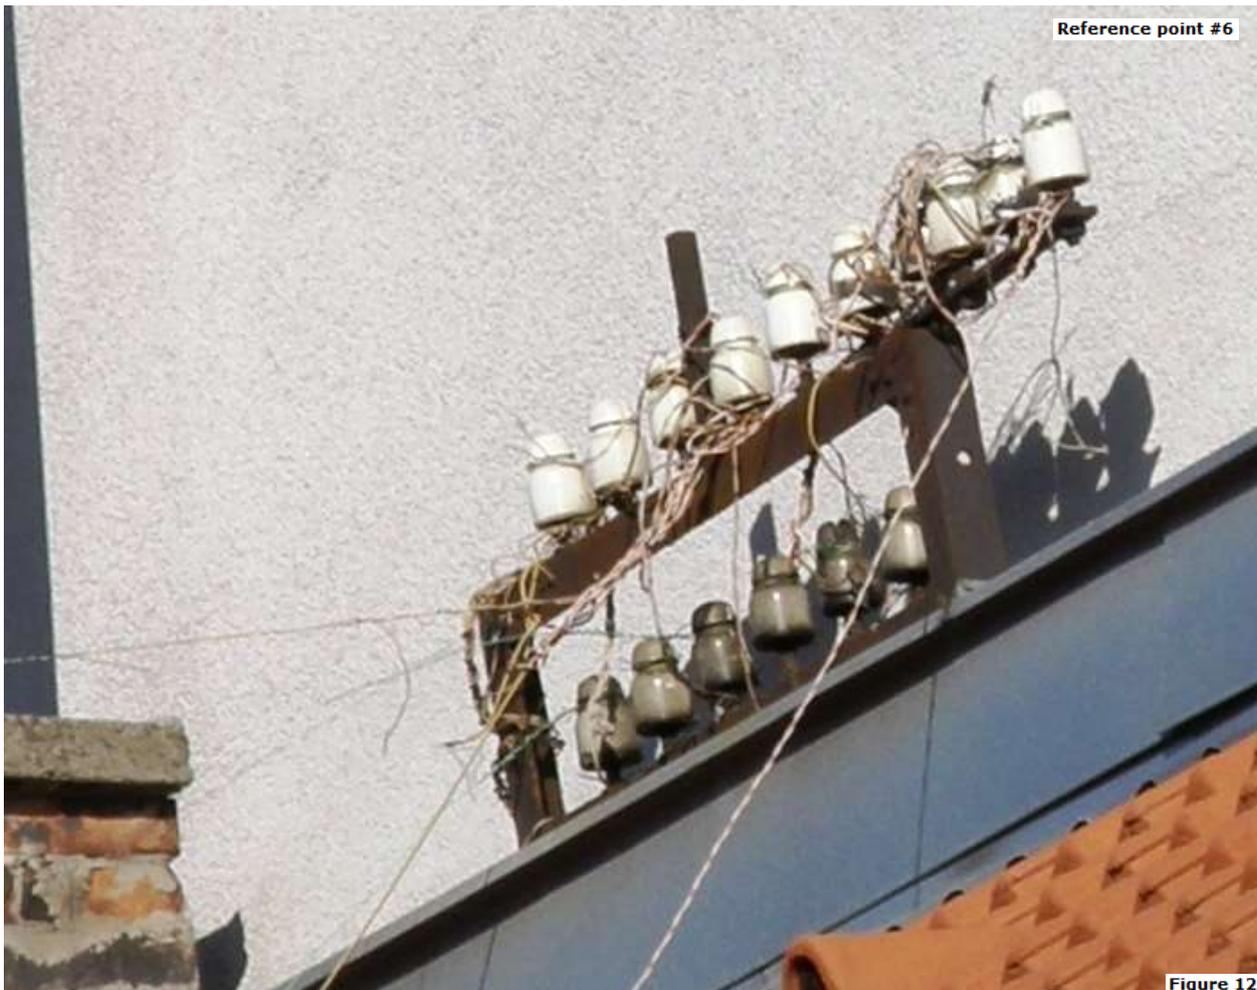
Figure 12

The bracket shown above supported the 6 pairs from the crossarms (3 and 4 from the top) of the mast at reference point number 4, further on down the line to the buildings which used to stand on the plots of land at Diefenbachgasse 1, 3, 5 & 7 (these were torn down at some later date and replaced by a single modern building complex).

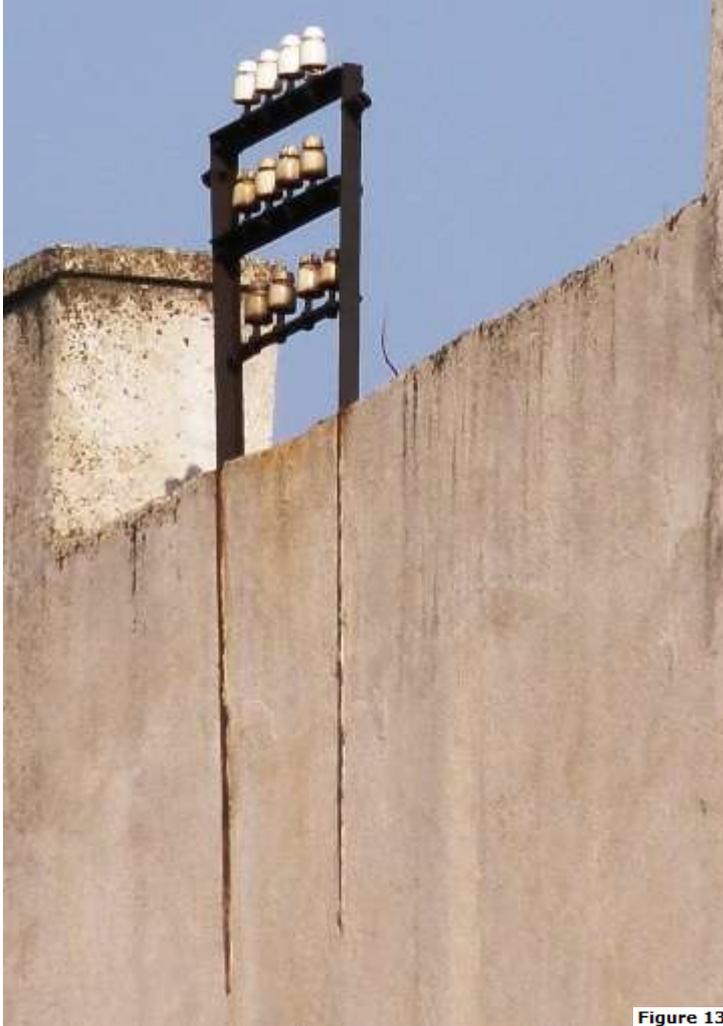
Figure 13

This "A" frame was situated at the top of the back wall of a building near the subway station in downtown Meidling, and is roughly 30 feet up in the air.

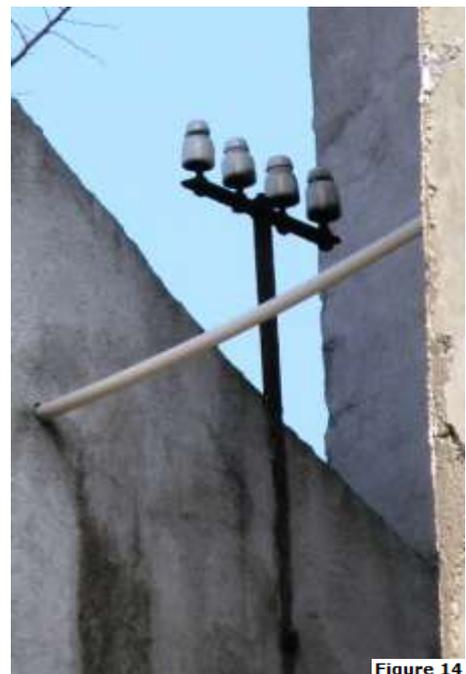
Figure 14

The two pair mast to the right is attached to the same building as the A-frame above, just around the corner (so to speak).

This mast is especially unusual in that, at some later date, after the wires had been taken down, a building was erected right in front of it – the vertical, white stucco seen on the extreme right of the picture is a corner of the back wall of the new building.

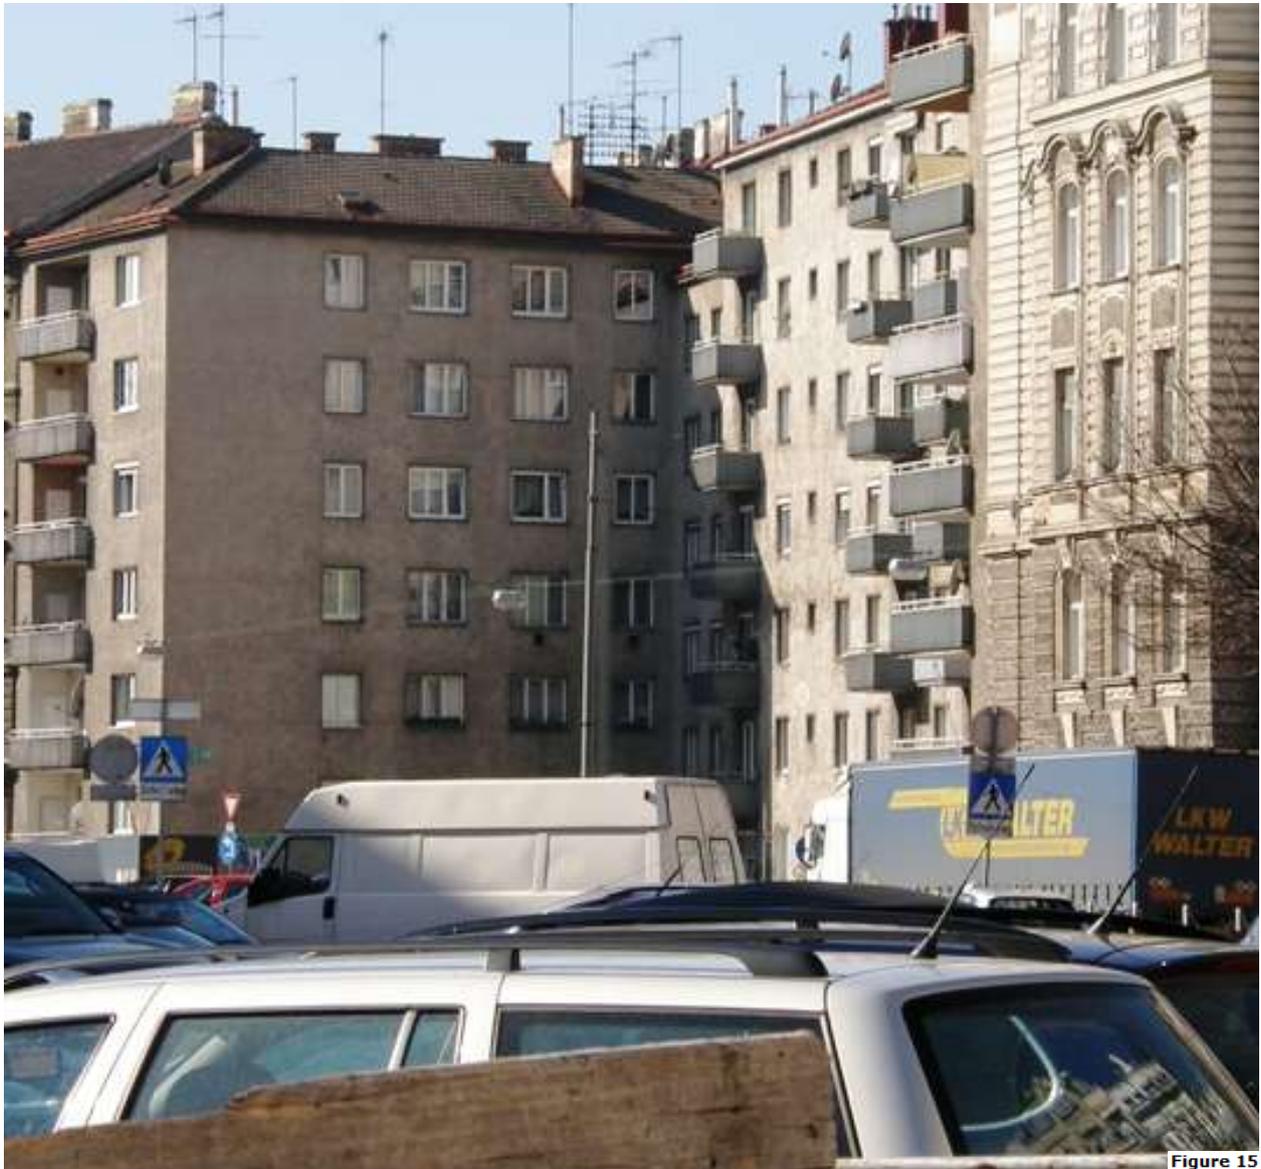
Figure 15

This photograph was shot in Vienna's 5<sup>th</sup> district, very near the local flea market which is held every Saturday (excepting on public & religious holidays). I have looked at the buildings shown very, very many times without noticing anything unusual or exceptional – at least until *after* I shot this picture ... I took it because I thought that I saw an unusual antenna farm on the rooftop of the building facing towards the camera.

Well, I was very surprised by what I had actually discovered ... in reality, the antenna farm is a large, open wire rooftop frame to which a number of TV antennas and antenna masts have been bolted over time; these obscured the lines of the frame.

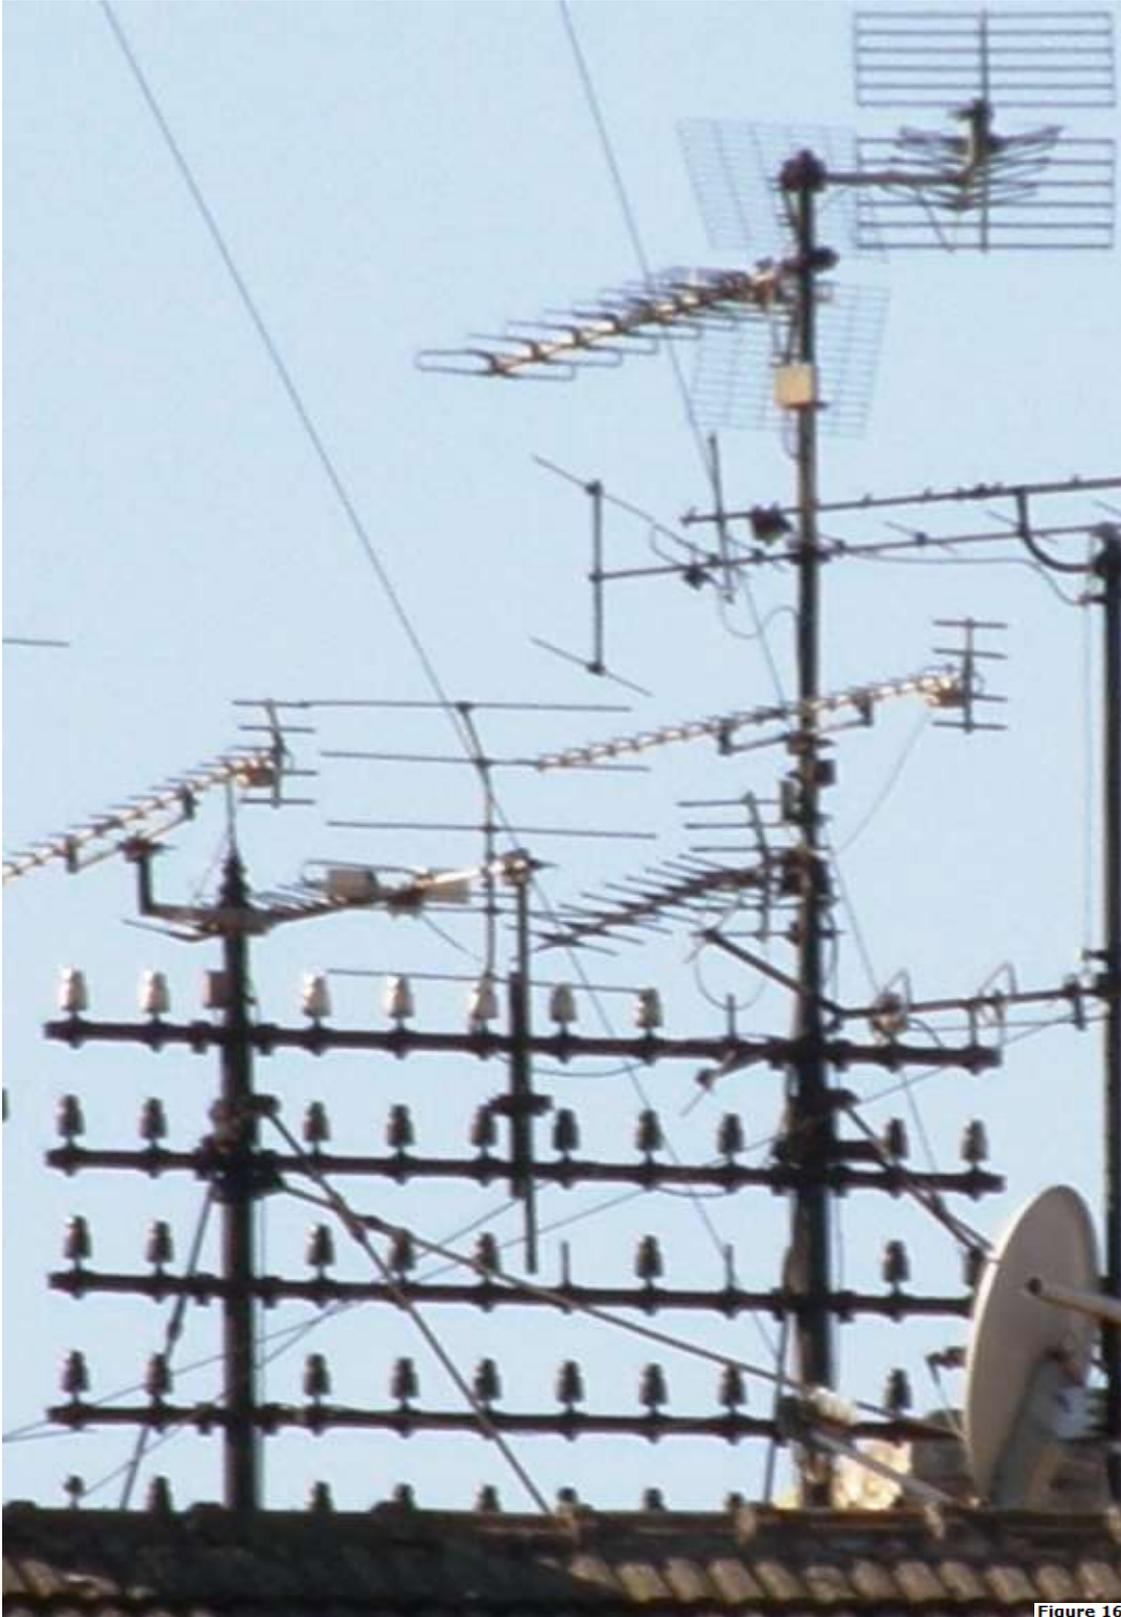
Figure 16

This heavily guyed rooftop frame was equipped with 50 porcelain insulators (of which 46 still exist), serving 25 subscriber pairs ... each individual pair *could* have been a party-line, in which case up to 100 subscribers may have been served from this frame of insulators at one time.

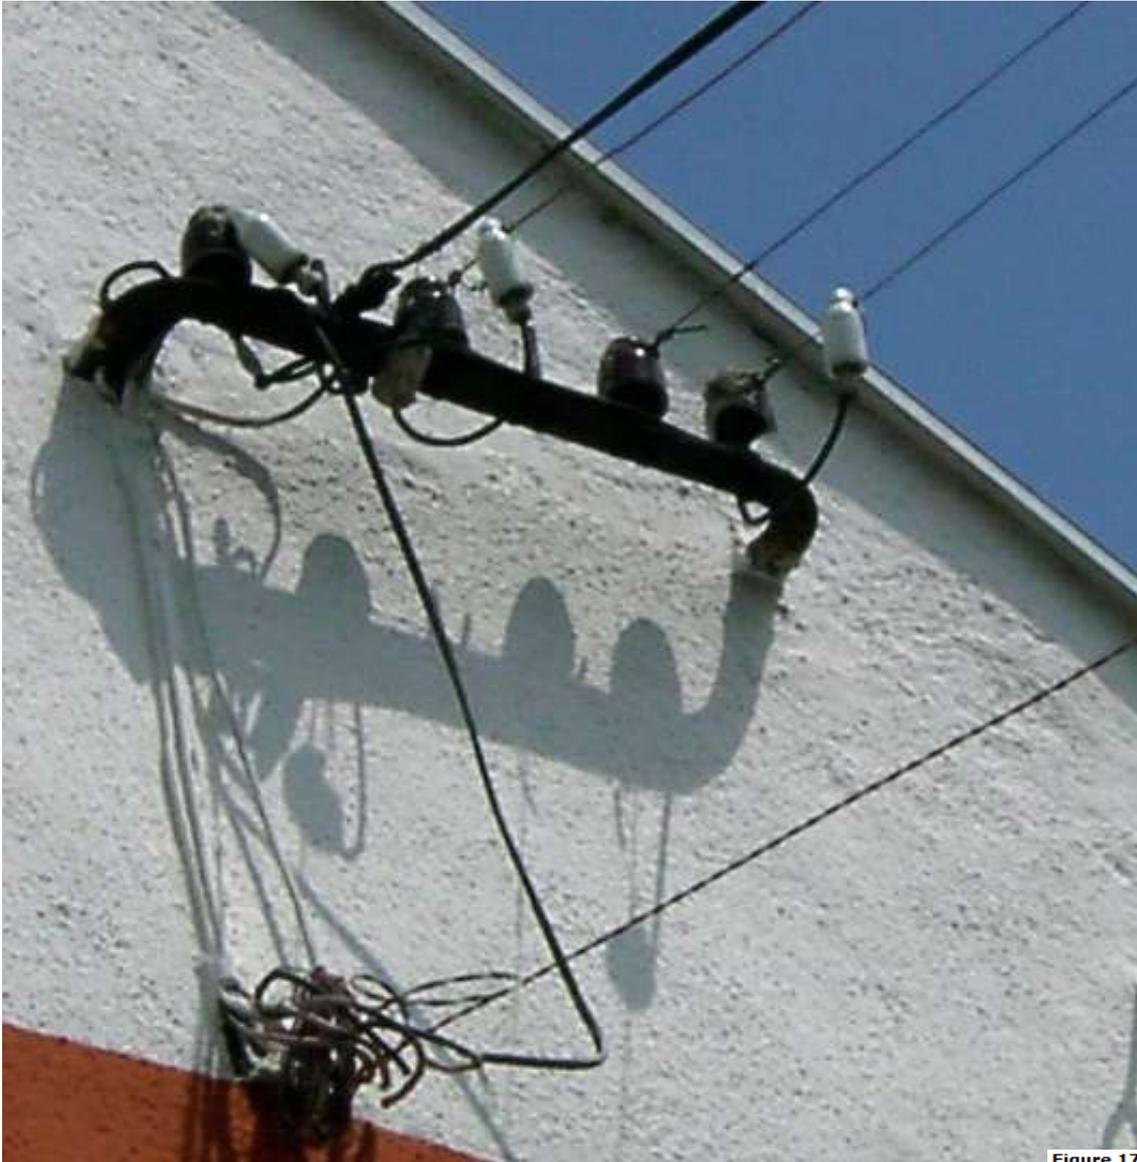
Figure 17

This bracket, and the wall, deserve closer examination for a number of reasons. First of all, the aerial feeder cable previously mentioned is wrapped around the bracket a few times in order to take up the strain. Secondly, three of the original wires are dead-ended on insulators on the bracket and, thirdly, at least two of the wires are still attached to the lead-sheathed entrance "cables" by the original method (which will be explained in detail in a moment's time). The entrance cables run down the wall, below the left-hand corner of the bracket and disappear through a small hole – they're painted white and thus rather difficult to see.

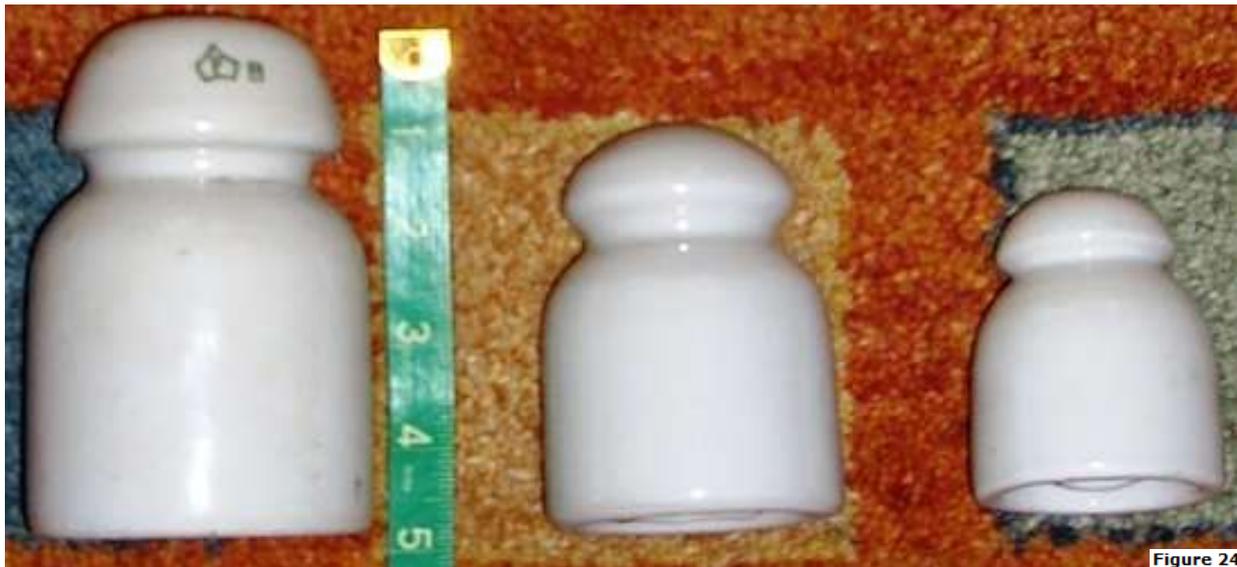
Figure 24

Open wire telephone insulators as used in Austria; the three shown here are, from left to right, sizes "B," "C" and "D." Longer spans of thicker wires exerted quite a strain on the insulator, requiring the size "B," while shorter and lighter spans made do with the two smaller sizes. A size "A" insulator (used for national and international toll lines) existed as well – but, sadly, I don't have one.

As to the physical construction of the insulators, it's to be noted that the various Austrian PTT entities felt that porcelain was a better insulator than glass. The insulators all have a very deep, double petticoat and are glazed inside and out – with the exception of the bottom lip of the outer petticoat and the inside of the thread with which the insulators are screwed onto their pins or pegs.

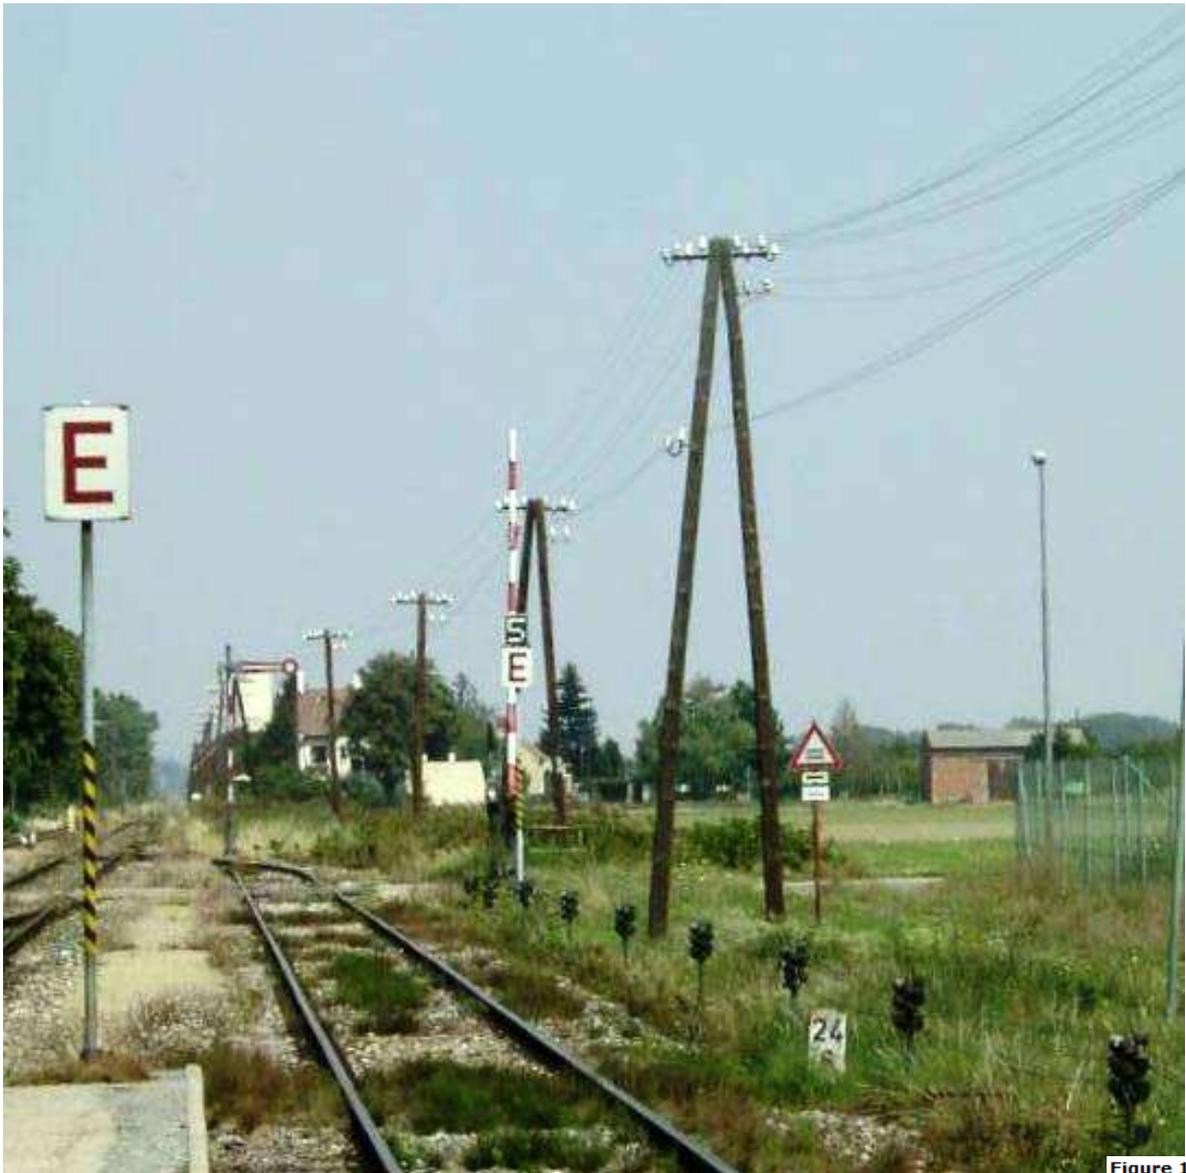
Figure 1

This photograph shows a few of the typical features of such open wire runs ... among which are that wire sag is of no special concern anymore, the poles immediately adjacent to road crossings are not only doubled up for additional strength, but are also somewhat taller than the rest (minimum clearance is roughly 4.50 meters) and that, as far as the wire supports are concerned, anything handy is used. To wit: the double pole in the foreground has a large "J"-style insulator mount on the *left* one of the two poles, while all the other poles have a small, separate, two pin arm on the *right* side.

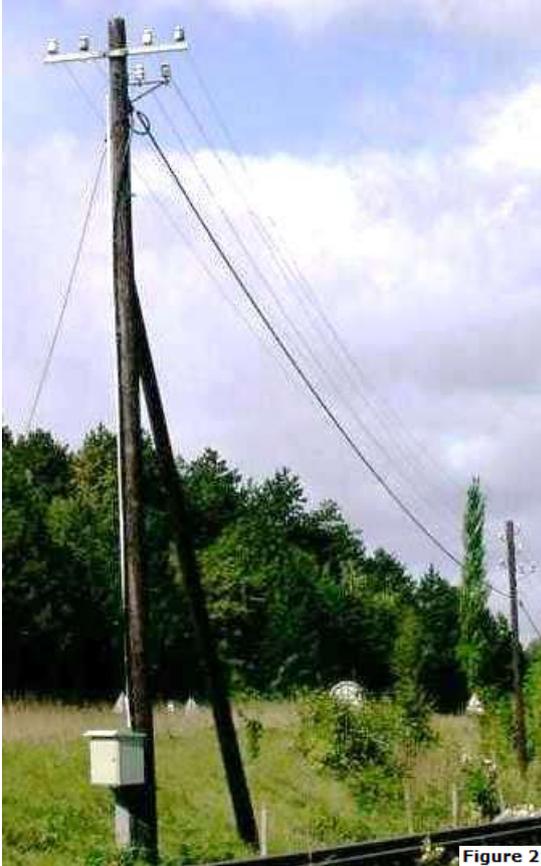
Figure 2

Another typical feature is that, while the old, open wire lines are kept up, additional pairs are added in the form of "figure 8" aerial cables of spiral-four quad construction (in fact, the same type of cables as used by Telecom Austria).

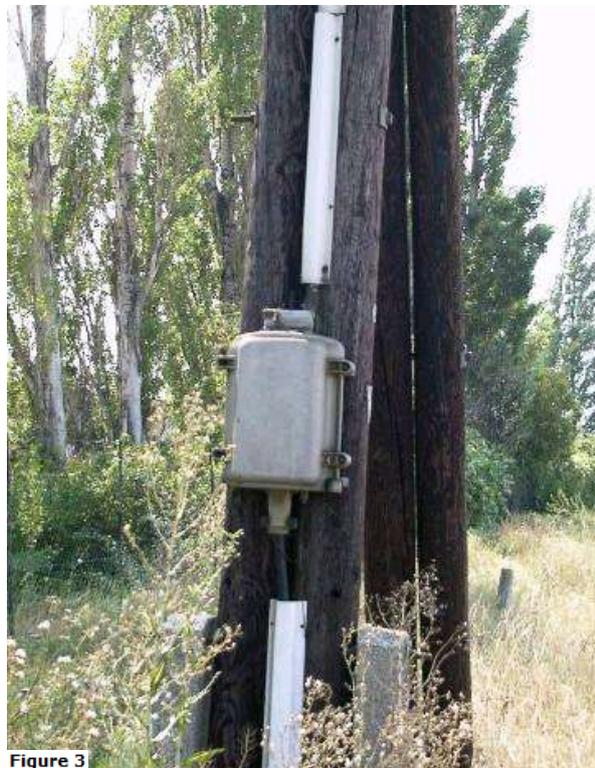
Figure 3

The protector box shown to the right is obviously of an older style than the one above.

A major difference between the two types is the method by which the door is attached and locked in place ... while the newer type has a normal, hinged door which is secured with a tumbler lock, the older style has a cover which is held in place by four triangle-headed, metric thread bolts. The reason why a triangular head was used instead of a square or hexagonal head is because the latter types could be grasped and turned with the aid of a pair of pliers, while it's nearly impossible to get a good grip on a triangular head.
