## A Collection of Telephone Tales

written by Herbert Schwarz of Vienna, Austria, European Union

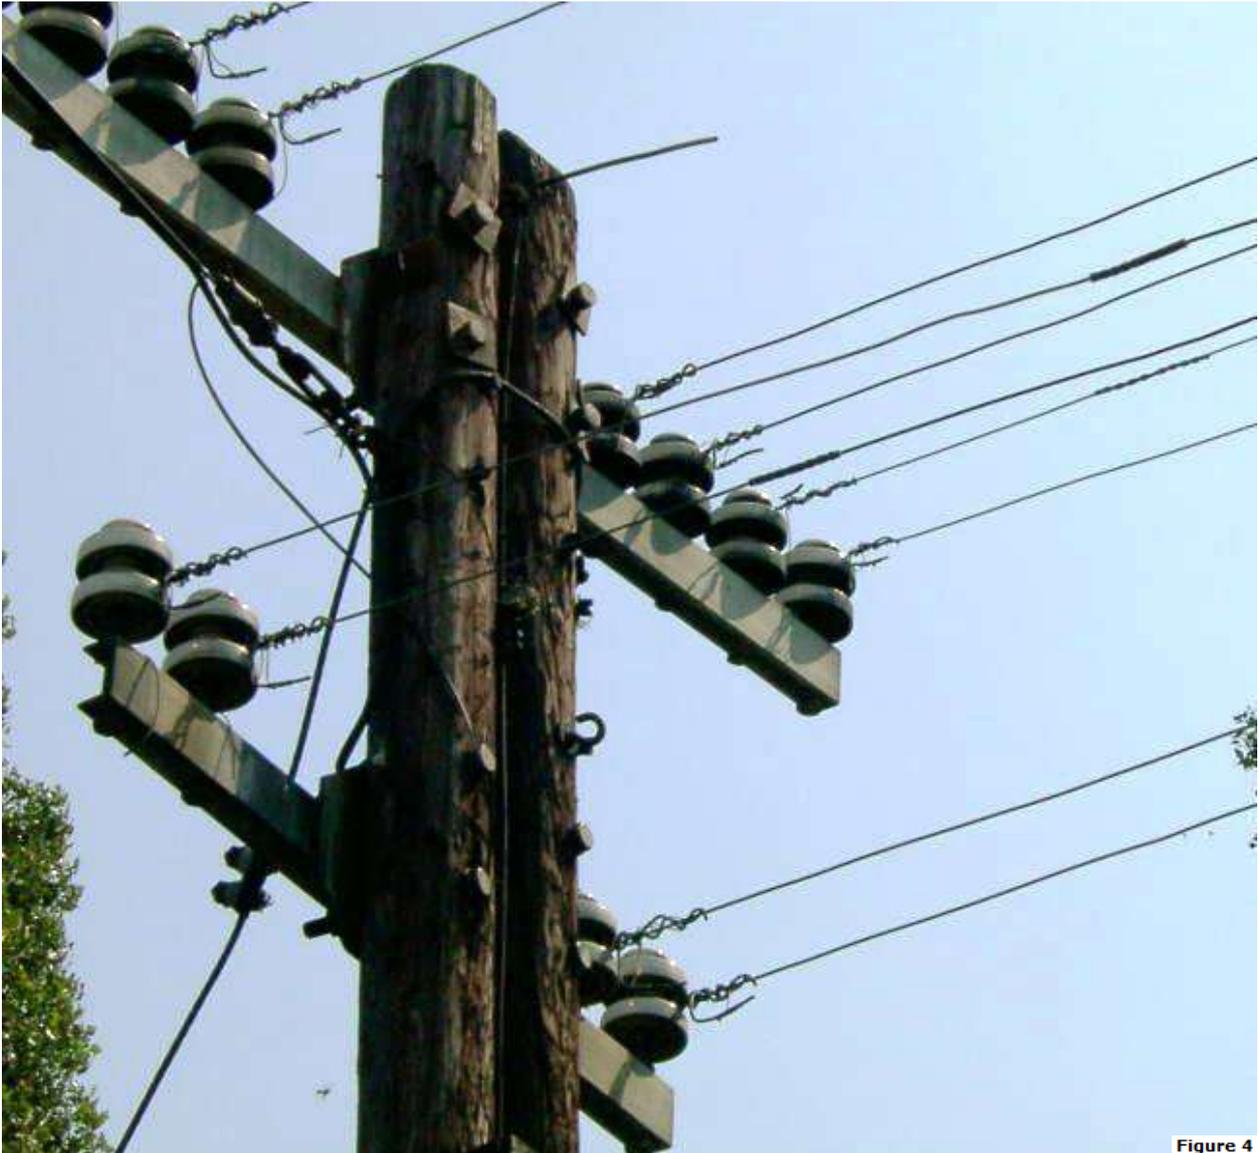
Figure 4

The photograph above shows several typical features of railway open wire lines as well as a few *atypical* features ... starting at the top: what appears to be an orphaned wire, jutting out from between the two poles, is actually a bent lightning rod of 6 millimeter iron wire. The poles don't have gains cut into them for the crossarms; these are attached using special backing plates and with the aid of four large sized carriage bolts.

After being dead-ended, the wires are bent downwards, back parallel to the line wire and the remainder cut off, leaving a short pigtail to which the feeder wires from the protector unit are soldered – however, in this specific case, the line wires are directly soldered to the wires of a "figure 8" cable which leaves the poles almost parallel to the left-hand side of the upper crossarm.

The line wires apparently don't put much of a strain on the double pole, since the guy wire is hanging down rather slack.

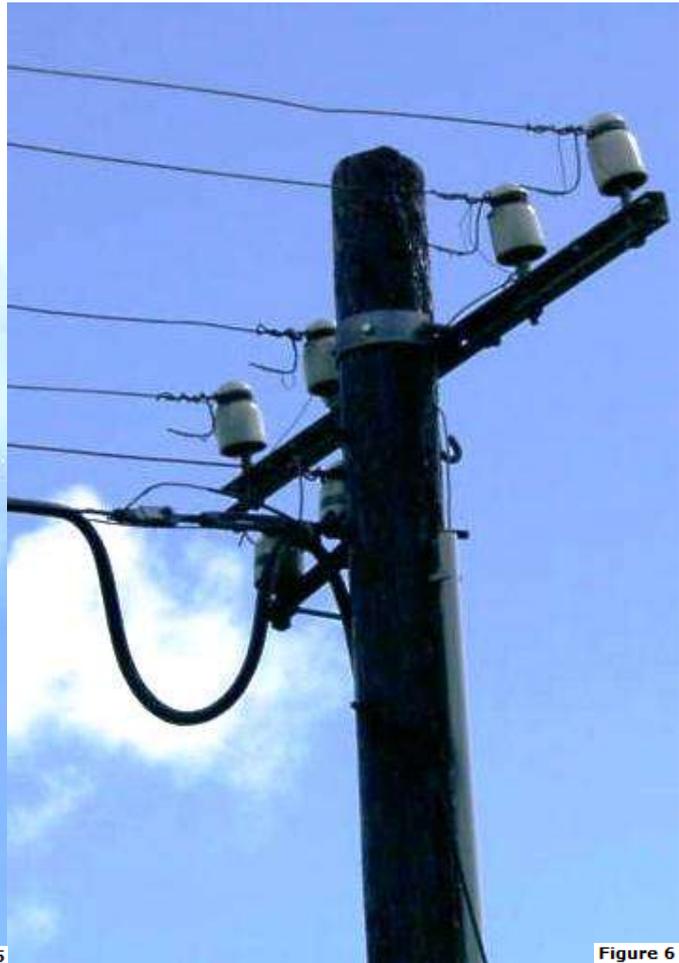
Figure 6

Two views of another dead-end pole which carries open wires and a cable. Judging by the manner in which the crossarm is twisted, the wires must impose a considerable load – which makes one wonder why the various guy wires are all slack. It may also be of interest to note that the crossarm is attached to the pole with a saddle clamp instead of with backing plates and carriage bolts.

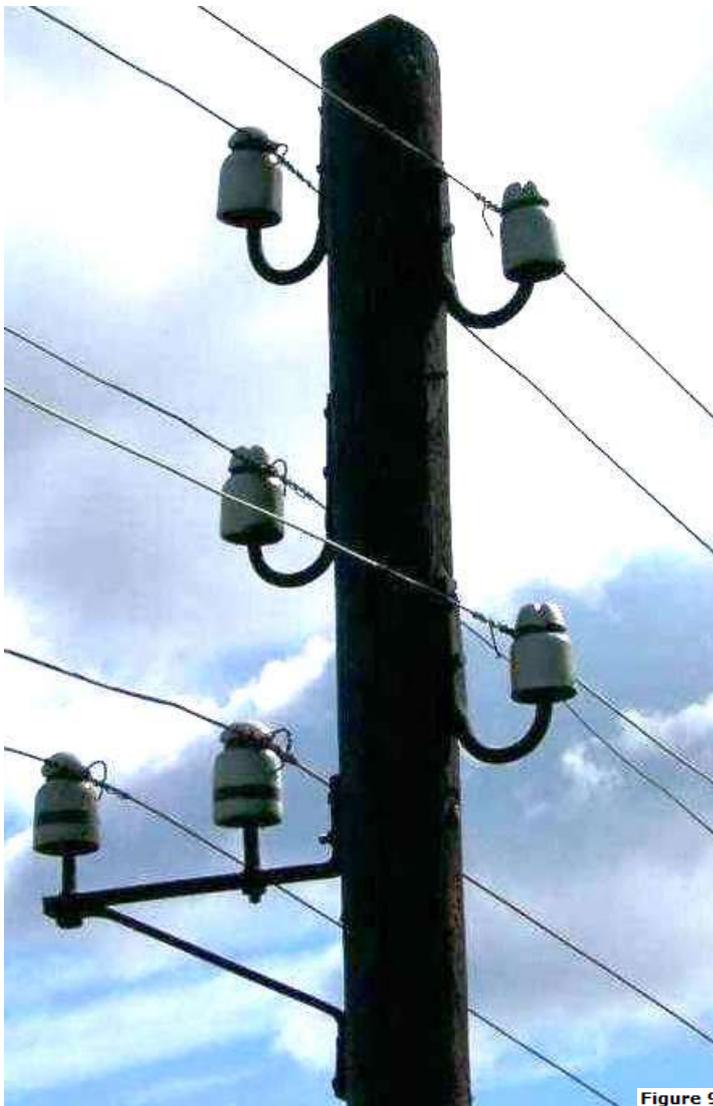
The photograph to the left shows an interesting mix of insulators. The one in the topmost position on the left is a standard size "B" insulator as already used in the Austro-Hungarian Empire, while the next three, with a wire groove on top of the head, are of a type which the German Reichspost and Reichsbahn favored.

The two insulators on the bracket at the bottom left of the pole are typical for the size "B" insulators used by the German Reichsbahn. These insulators have a dark green band near the base ... this signified that the relevant wires were used for communications purposes and not for block signals.

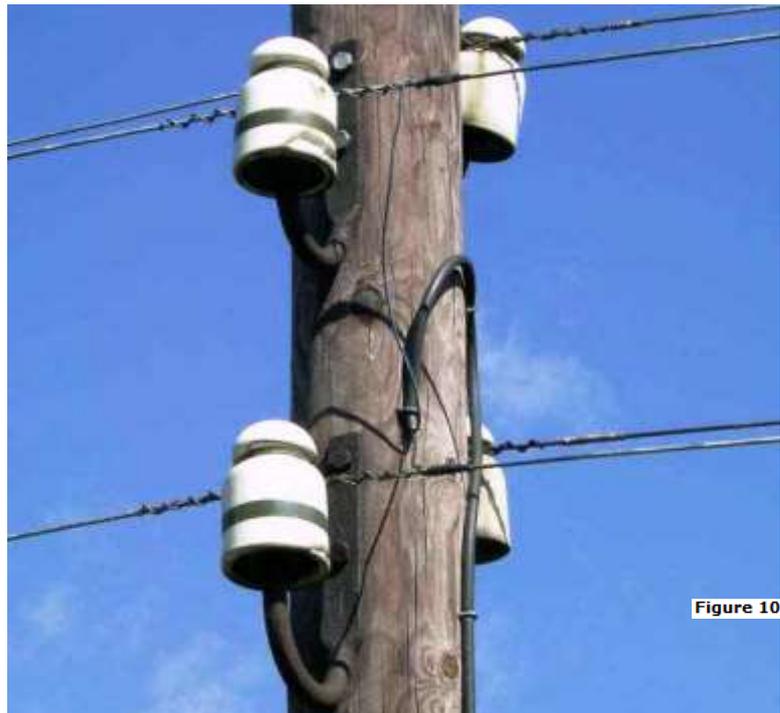
Figure 10

These two wires are stranded and are of 18 AWG size. They're connected to the open wires by being stripped for a good two inches, the bare portion being tightly wrapped around the line wire and then soldered with rosin-core solder.

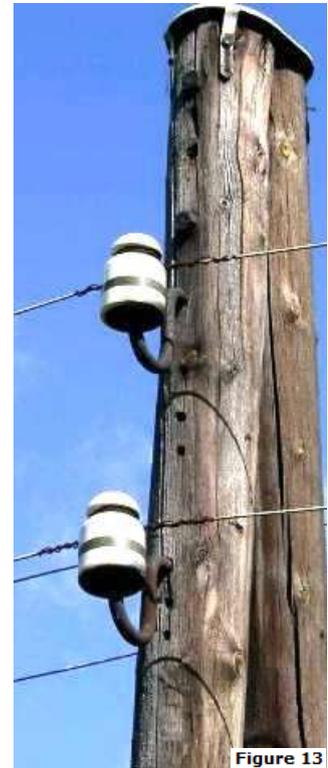
The insulators shown in the photograph on the previous page are attached to the pole by using small "J"-style, forged iron brackets, such as those shown on page 143. There was, however, a second approved method for attaching individual insulators to a pole, as shown in the photograph to the right ... in this instance, the brackets are u-shaped, with a horizontal tail which carries a thread cut for being screwed into holes drilled into the pole.

Such brackets were less expensive to manufacture and also required less work to be installed, since it was only necessary to drill one hole per bracket, instead of two.

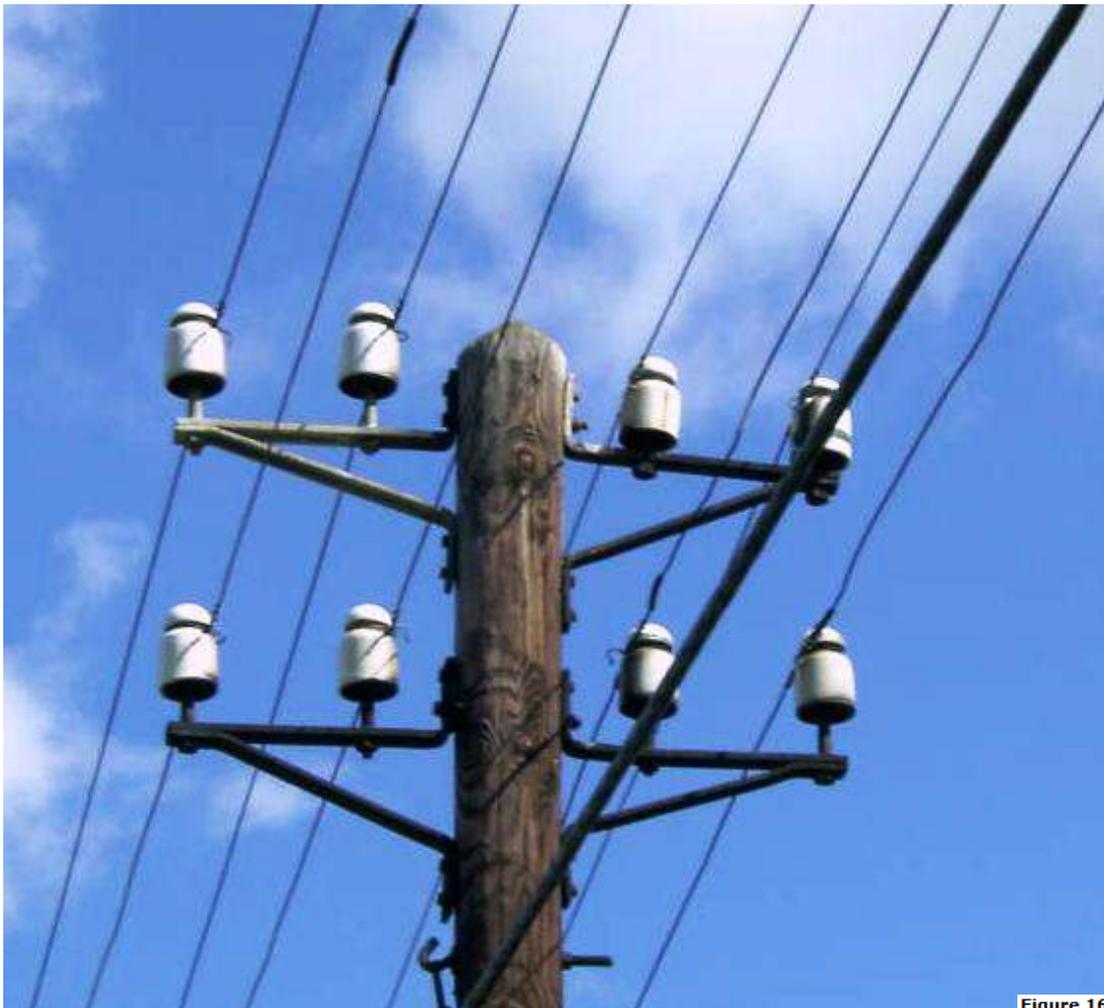
Figure 16

The photograph on the previous page shows a pole which is equipped with 4 two-pin brackets or arms – these don't count as normal crossarms. Two of the wires were spliced at some time, using pressed sleeves.

Another thing to be noted is that the wires are tied to the insulators on the side facing *towards* the pole; this was standard practice along straight wire runs, so that if the tie wire were to break, the line wire would come to rest on the bracket or crossarm, instead of falling off of the same (in the case of the outermost pins) and thus sagging very far down and possibly causing a short to ground.

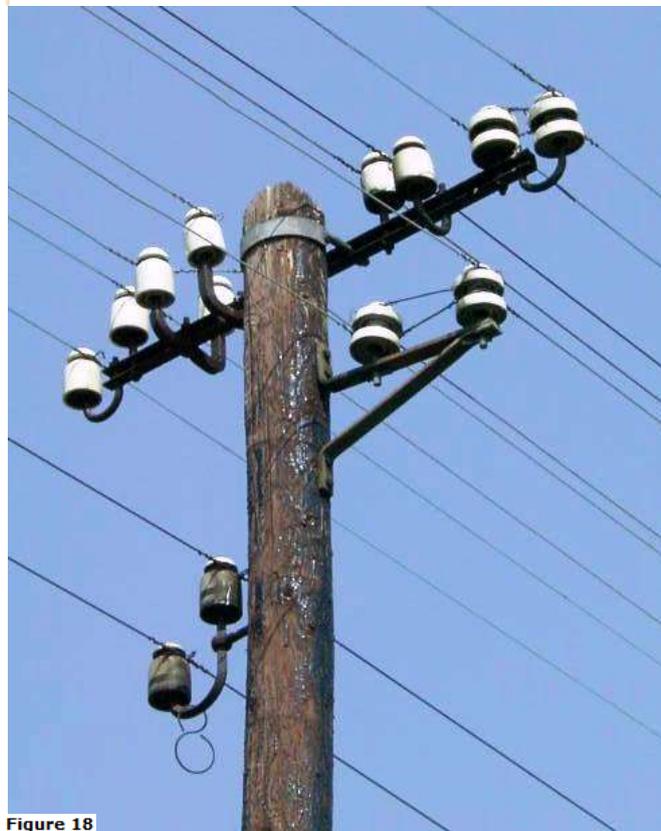
Figure 18

The pole also offers the very best in pair transpositions; there is a standard crossover, using four size "B" insulators, on the left side of the crossarm, while a transposition using two type "Bd" insulators is to be found at the end of the right-hand side of the crossarm.

A variation of a transposition with two type "Bd" insulators may be seen on the two pin bracket below the crossarm.

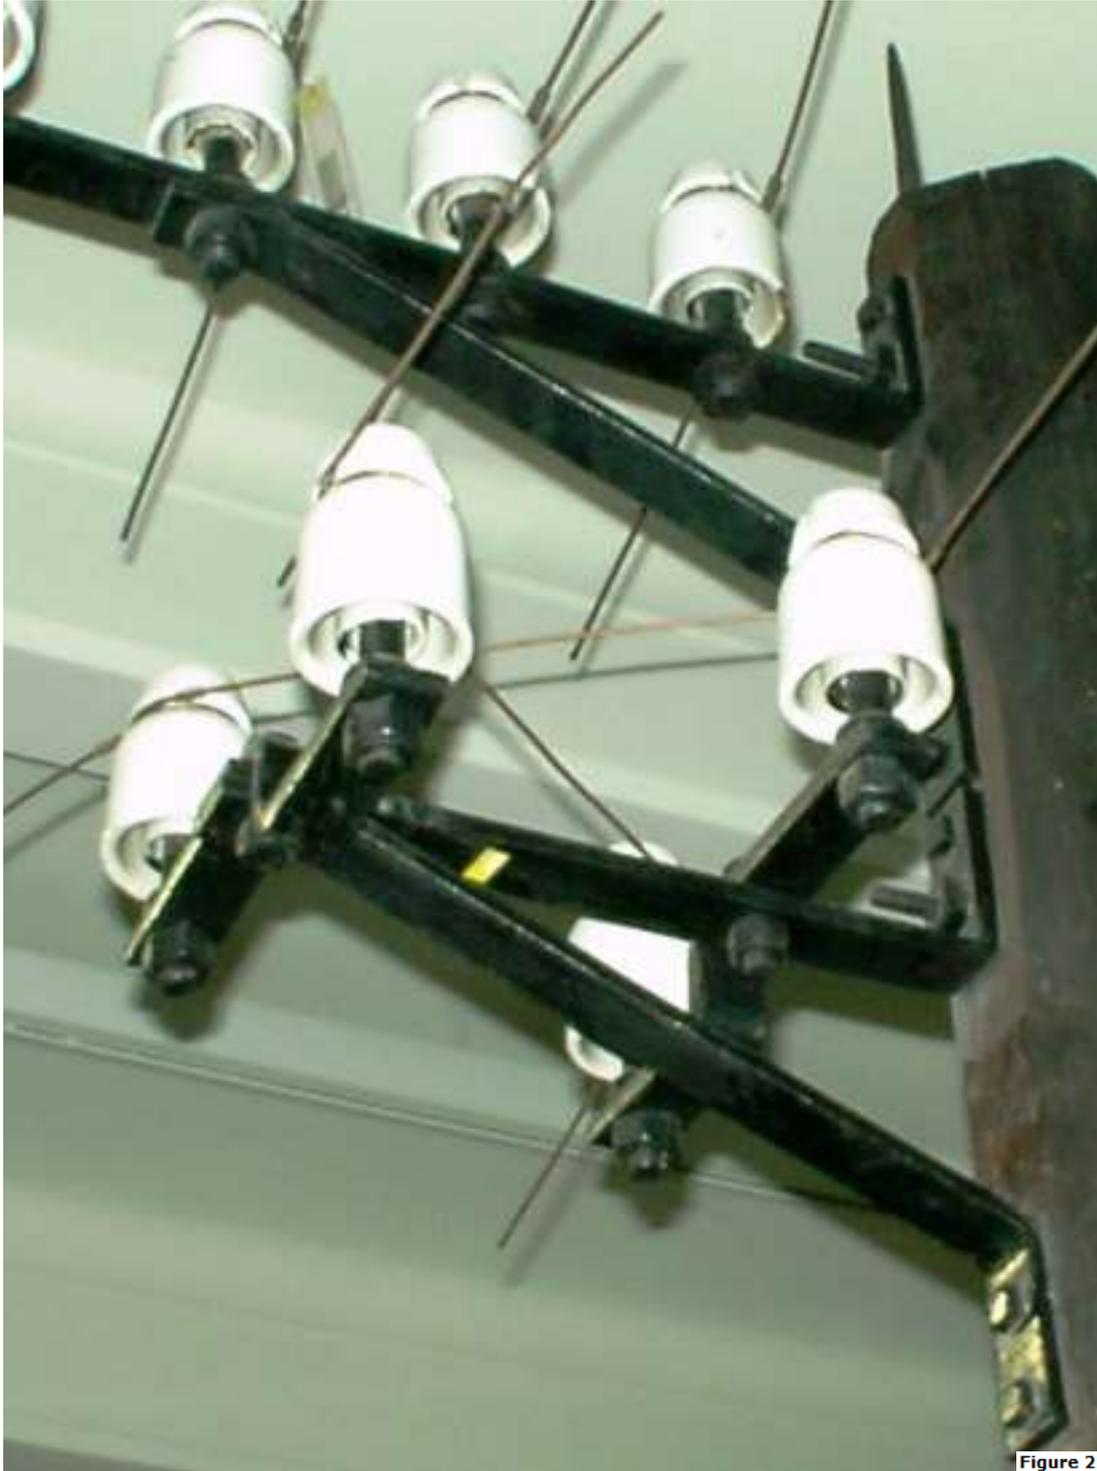
Figure 21

I took the photograph above while visiting the Technical Museum in Vienna in August, 2003. The demonstration mast shown is part of the display concerning itself with wire-line communications. The above is actually an enlargement of a portion of the original photograph; one can see how zed brackets and standard insulators were used to transpose a pair of wires.

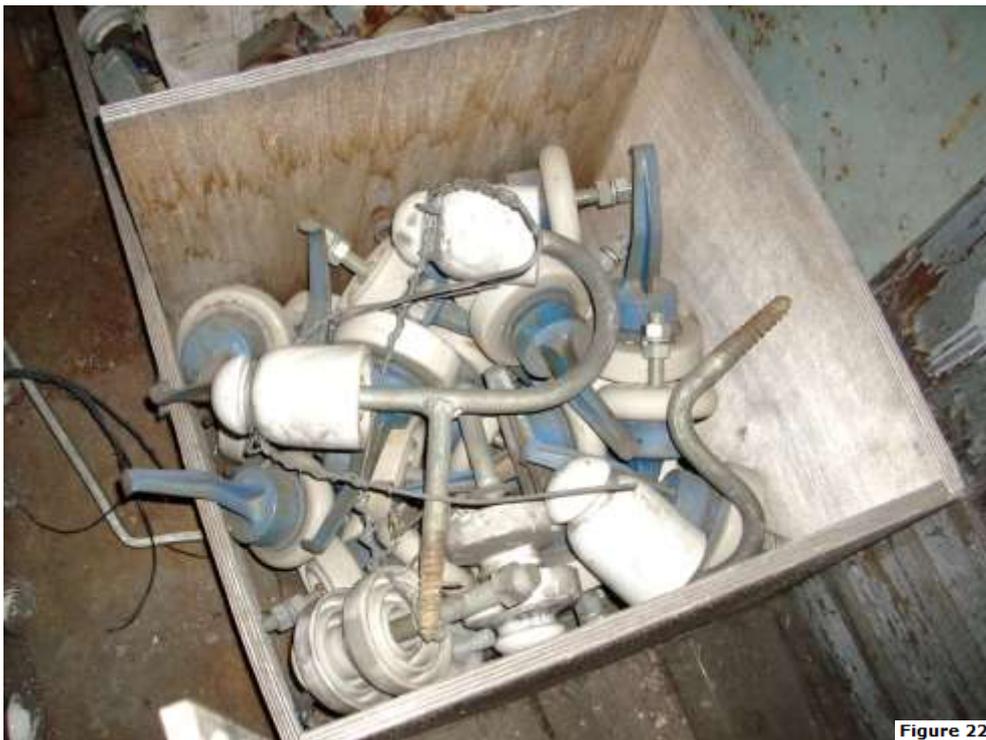
Figure 22

The wooden box pictured above truly is a mixed kettle of fish; the bottom layer consists of A.C. power insulators, while the top layers shows three different styles of insulator pins and brackets for phone and track block signal lines.

The most prominent piece is a large "J"-style bracket with two pins, carrying two standard size "B" insulators; lying in the lower left-hand corner of the box is a type "Bd" insulator with a pin which was attached to a crossarm with a nut and washer. In the lower right-hand corner, there is a u-shaped bracket, complete with a size "B" insulator.

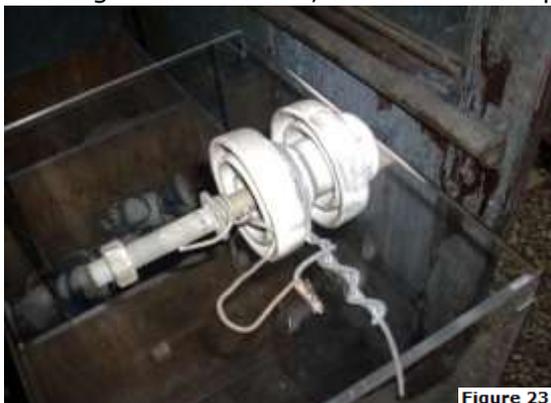
Figure 23

The type "Bd" insulator shown to the left is one which found its way into my collection with the blessings of the museum curator.

While it's possible to see how the lead-in wire is attached to the open wire pigtail, the first photograph on the next page shows the same in much better detail.

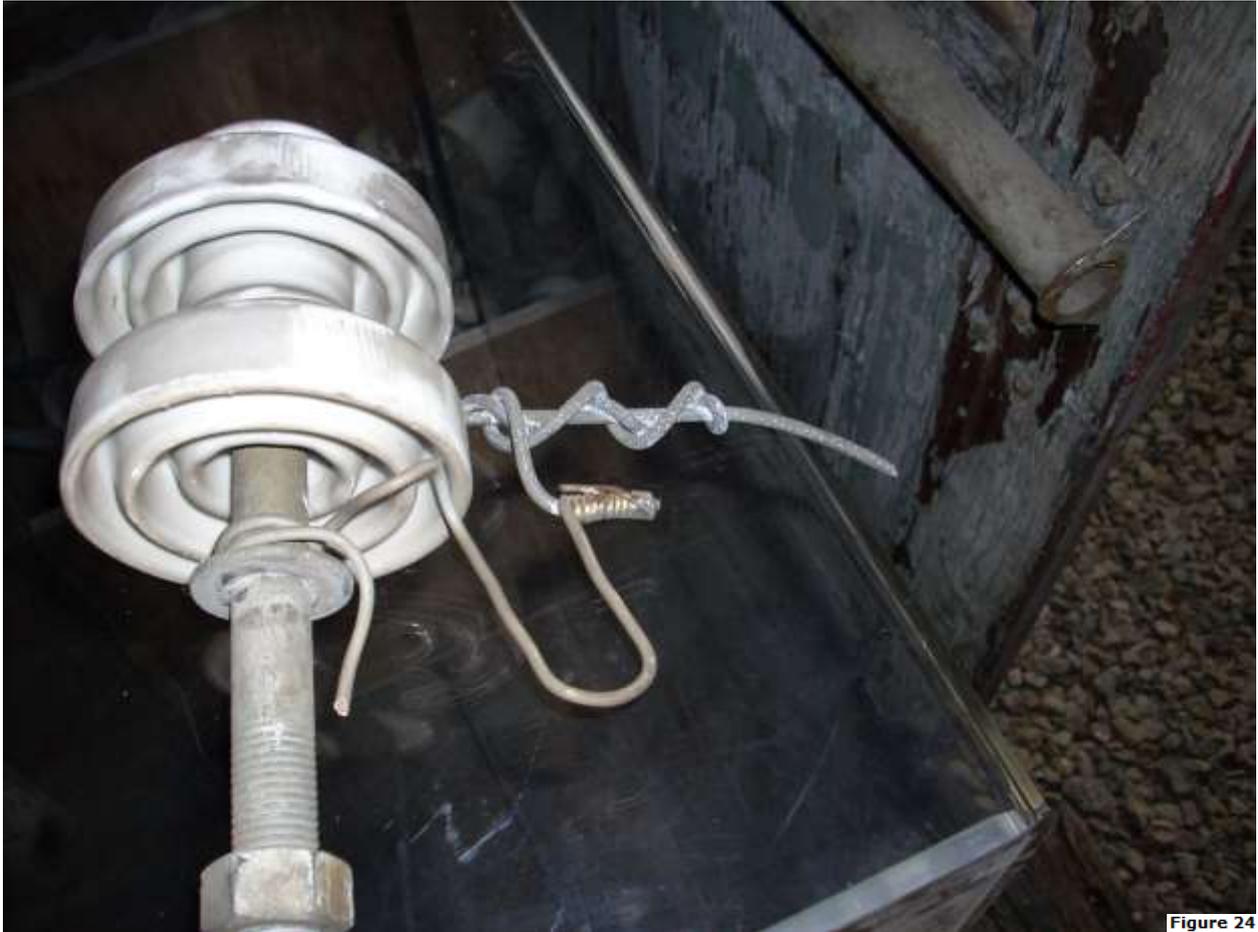
Figure 24

As may be seen, the type "Bd" insulator has three petticoats instead of just two, as the normal sizes "A" thru "D" have. The reason for having three petticoats is increased insulation resistance, which is of great importance because type "Bd" insulators were commonly used in transposing high-grade, open-wire phantom lines.

As can be seen, the galvanized iron wire is 4 millimeters (roughly 14 AWG) in diameter, and the feeder is an insulated, solid copper wire of 18 AWG size. It's tightly wrapped around the dead-end pigtail and well soldered.

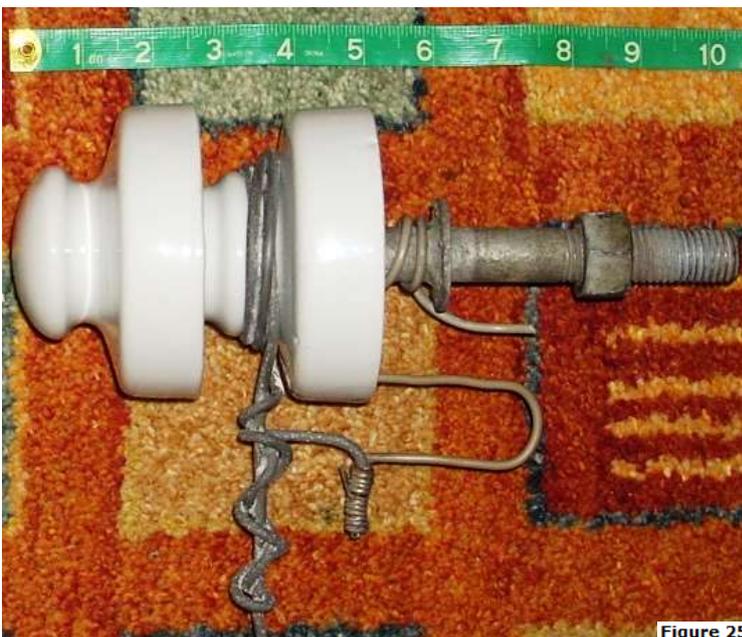
Figure 25

This photograph shows the same "Bd" insulator, after having received a thorough washing at home.

Once again, the measuring tape is in inches and, as readers can see, the type "Bd" insulator is 5" tall – just the same as the standard size "B" insulator.

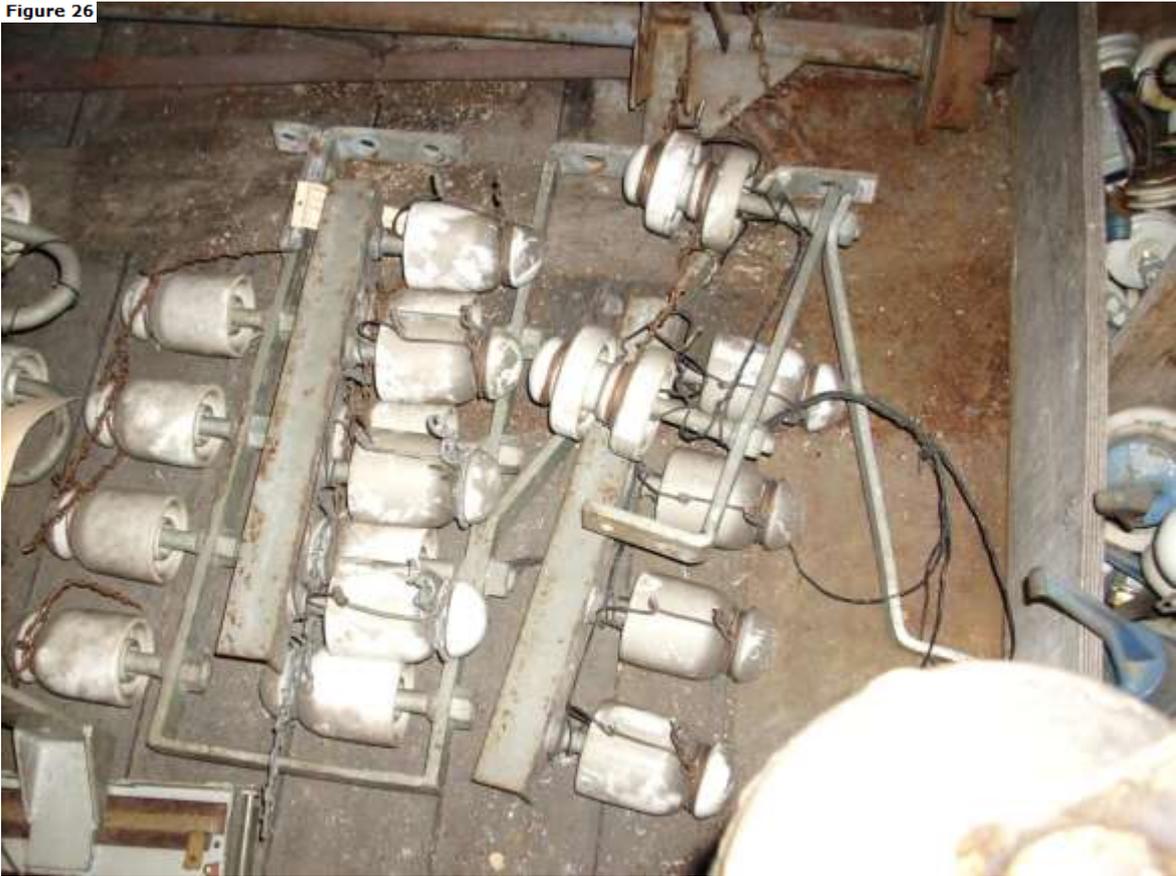
Figure 26

A nice bunch of size "B" and type "Bd" insulators on a variety of brackets and crossarms. As can be seen, a few of the insulators terminated hard-drawn copper wire, but most were used with galvanized iron wire.

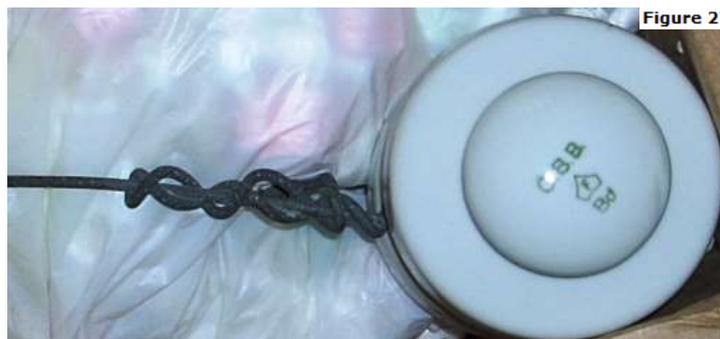
Figure 27

The lower snapshot on the previous page was taken in order to illustrate that insulators which are the property of the Austrian Federal Railways carry the ownership mark "ÖBB" ("Österreichische Bundesbahnen" in German).

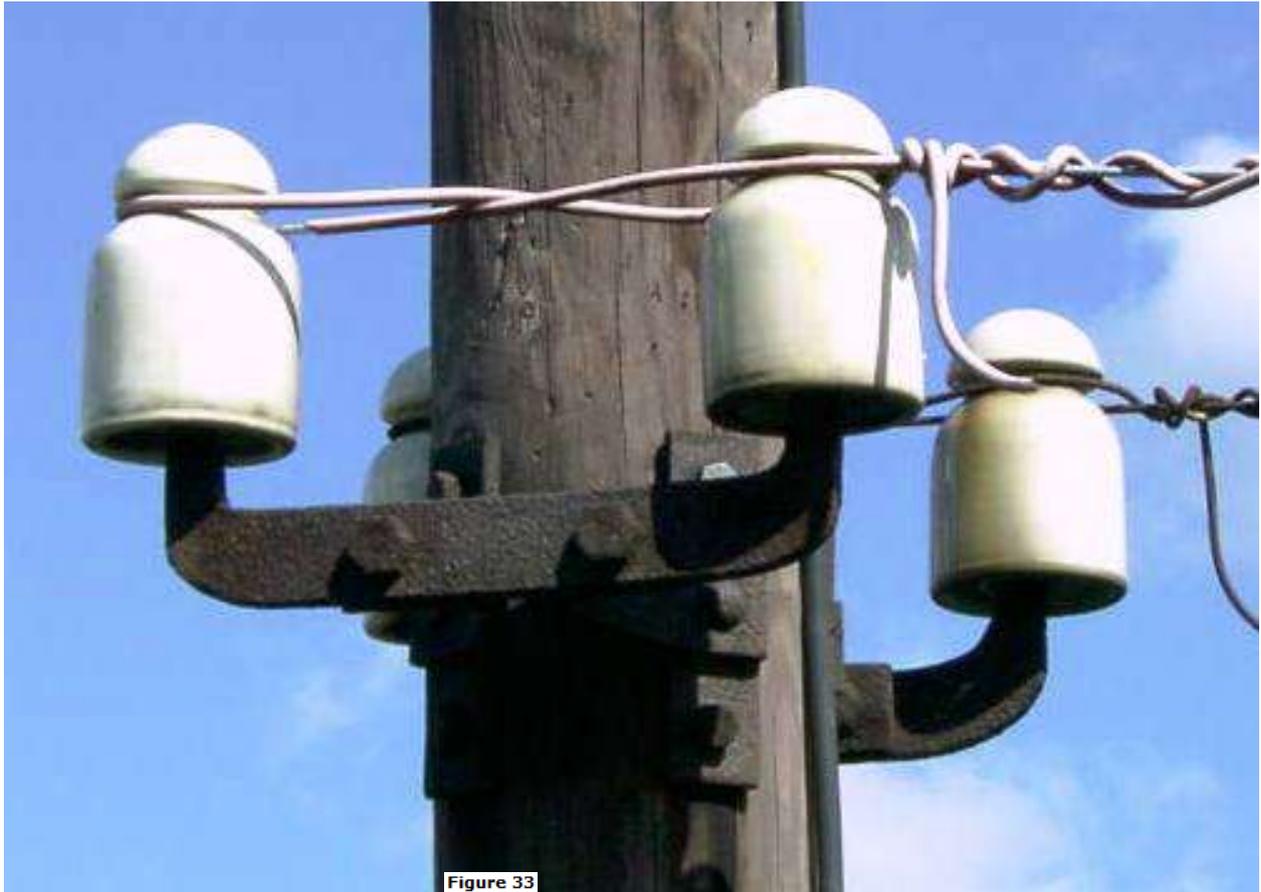
Figure 33

The photograph above would be a lot easier to interpret if it weren't for all the trees in the background ... this double pole with side brace is very interesting because it's a demarcation point; the wires coming in from the right are dead-ended in the upper grooves of the type "Bd" insulators, while those continuing on towards the left are dead-ended in the lower ones.

The line wires are soldered to solid 18 AWG wires which are, in turn, connected to the wires of an aerial feeder cable by way of a standard Telecom Austria style pole junction box. The "figure 8" cable leads off to a switch-room located in a small railway station building. There, the wires from the cable are terminated on a switching panel which allows each East-West (or North-South?) open wire pair to be switched straight through or to be split for testing purposes ... while it was possible for me to look through the window in the door belonging to the switch-room, no lights were burning inside, and the sunlight shining through the window was too weak to light the room up sufficiently so that it would've been possible to take a picture of the switching panel.

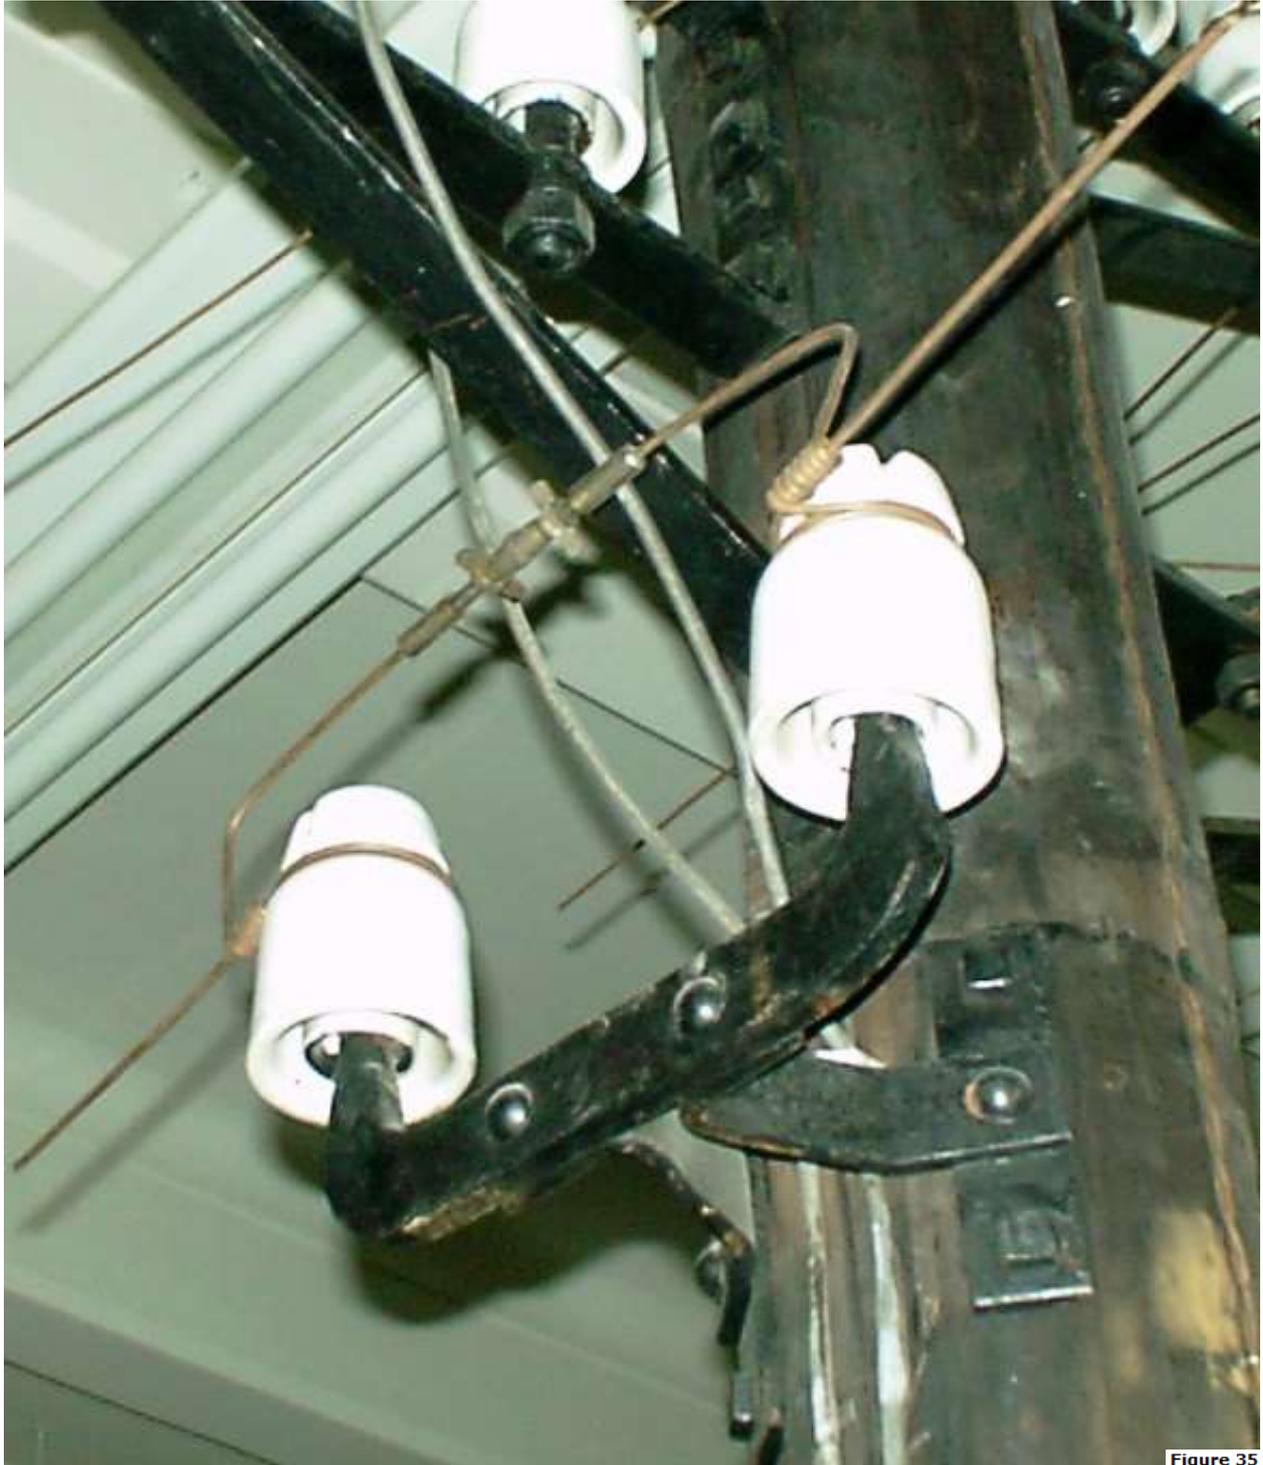
Figure 35

The photograph above is another one I shot while visiting the Technical Museum in Vienna .... The demonstration mast shown is part of the display concerning itself with wire-line communications. The above is another enlargement of a portion of the original photograph.

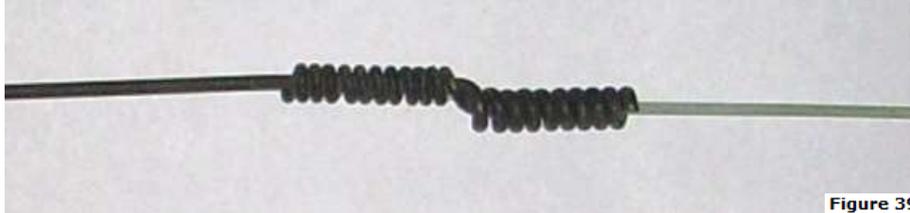
Figure 39

The next step towards a simple and efficient splice was the style commonly known as the "Western Union" splice – the line wires are bent to a 90° angle as before, but the pigtails are left long enough to be able to wrap each one around the straight portion of the opposite line wire in at least 6 tight wraps. If such a splice is left as it is, without being soldered, it's only capable of withstanding roughly 55 percent of the strain which the uncut wire will withstand; soldered, such splices can stand circa 95 percent of the strain.

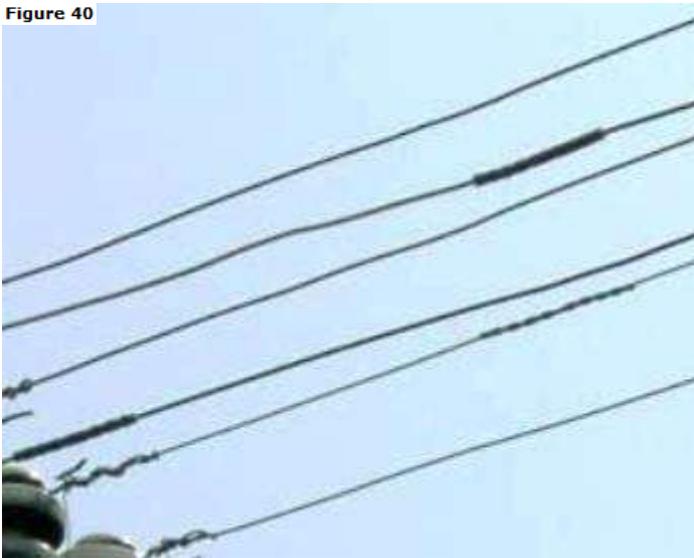
Figure 40

The photograph to the left is an enlarged excerpt from the picture on page 147. The line wires show two different types of splices.

The two fat splices are made with sleeves which are crimped to the line wires, in a manner similar to the U.S. patented "NiCoPress" system, while the slimmer splice was made with a twisted splicing sleeve.

Here is where possible dissimilar metal corrosion comes into play: while the crimped sleeves are commonly of metals similar to that of the line wires, the sleeves for

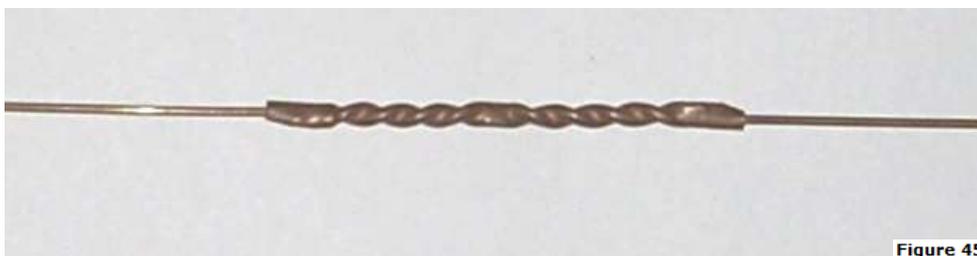
Figure 45

There are two different circumstances under which line wires could require splicing: 1) if line wires break due to excess strain (snow, sleet, ice formation, high winds), or 2) if the wire remaining on a spool is too short for the span concerned. In the latter case, splicing is performed on the ground ... and such splices can cause problems when the wires are pulled over the crossarms, simply because the flat ends could get caught. To prevent this from happening, the ends of the splice are cut off at an angle, as can be seen above.

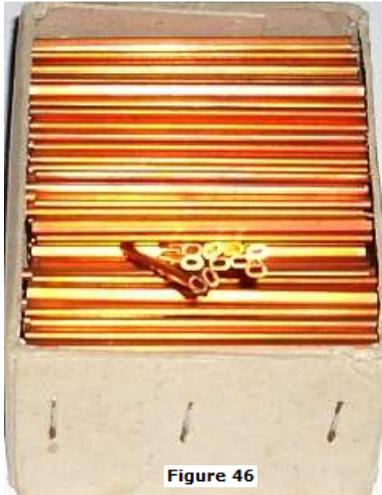
Figure 46

Alas, the box of copper splicing sleeves shown on the left *isn't* from Austria – they're code number 016253 sleeves, jointing, No. 13 from England. I bought them just so that I'd have some (from anywhere) in my collection. The seller even had two of the proper GPO marked tools for twisting exactly this size sleeve – and naturally I bought the tools as well ....

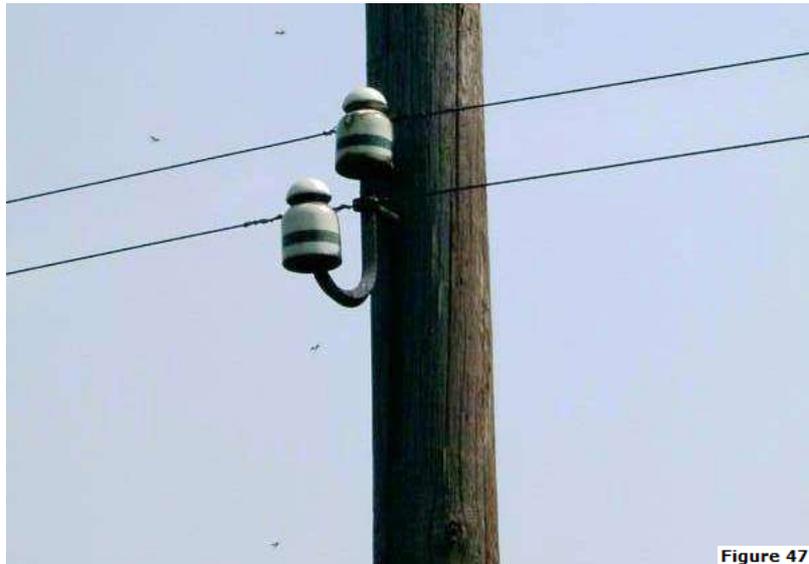
Figure 47

I simply couldn't resist including this photograph, even though there are no splices to be seen.

What may be seen, however, is a small sortie of wasps homing in on the creosoted pole ... wasps in Finland and Austria apparently share a penchant for telephone poles.

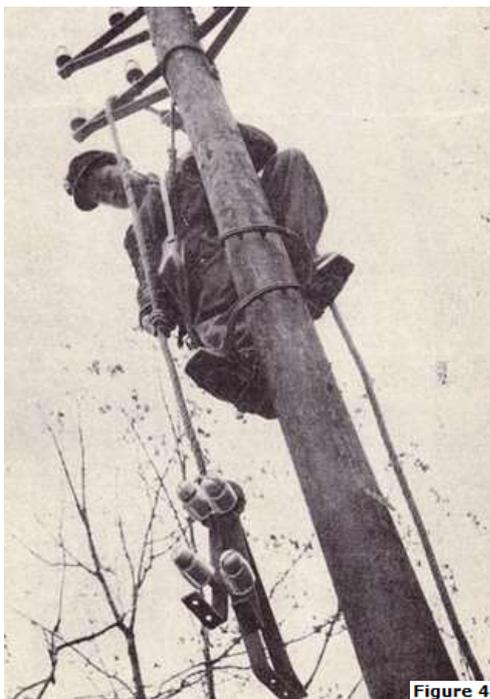
Figure 48

One very last thing – how did craftsmen climb telephone poles in Austria?

The scan to the left pretty much tells the tale; the climbers are more or less semi-circular affairs with several strong spikes along the inner curve. The curved arms are riveted to steel shoe soles, upon which the craftsman stands.

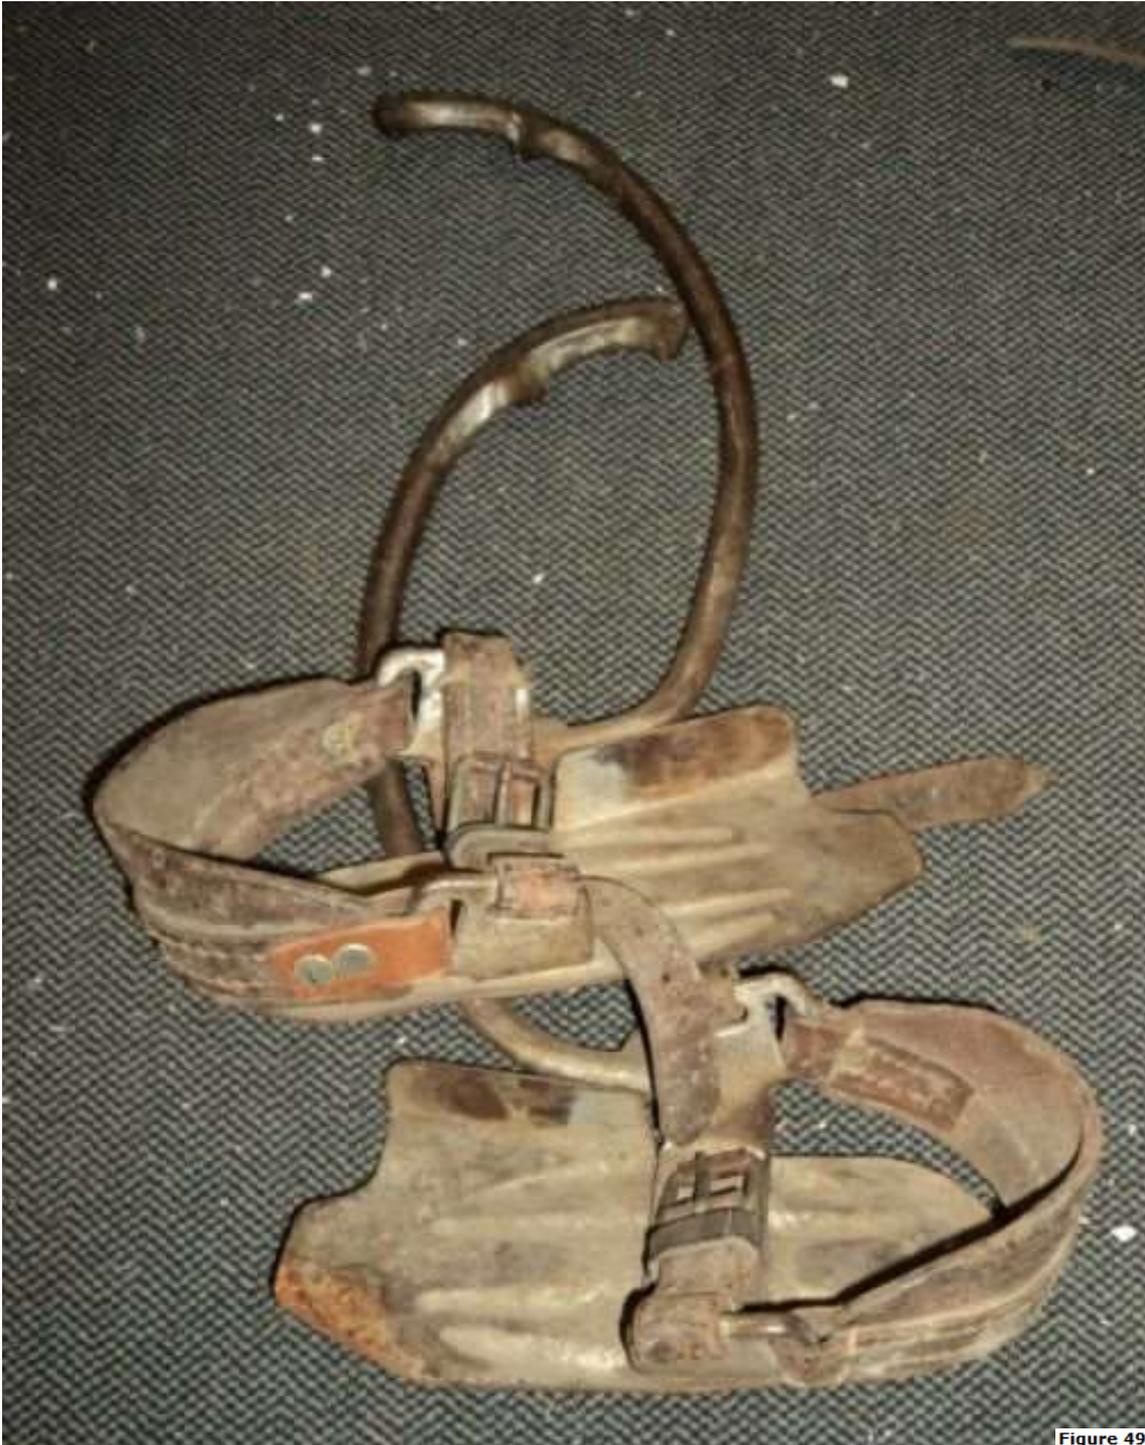
Figure 49

Here we have an old pair of climbers, as they were also used in Austria. Each climber has two leather straps; the one at the rear prevents the wearer from slipping off the steel footplate and is non-adjustable, while the one in the front is adjustable and presses the shoe and foot down onto the footplate.

Such climbers are very cumbersome to walk with while on the ground, and are extremely heavy when compared with the climbers which were formerly used in the USA – the pair shown here weighs in at a little more than four pounds.

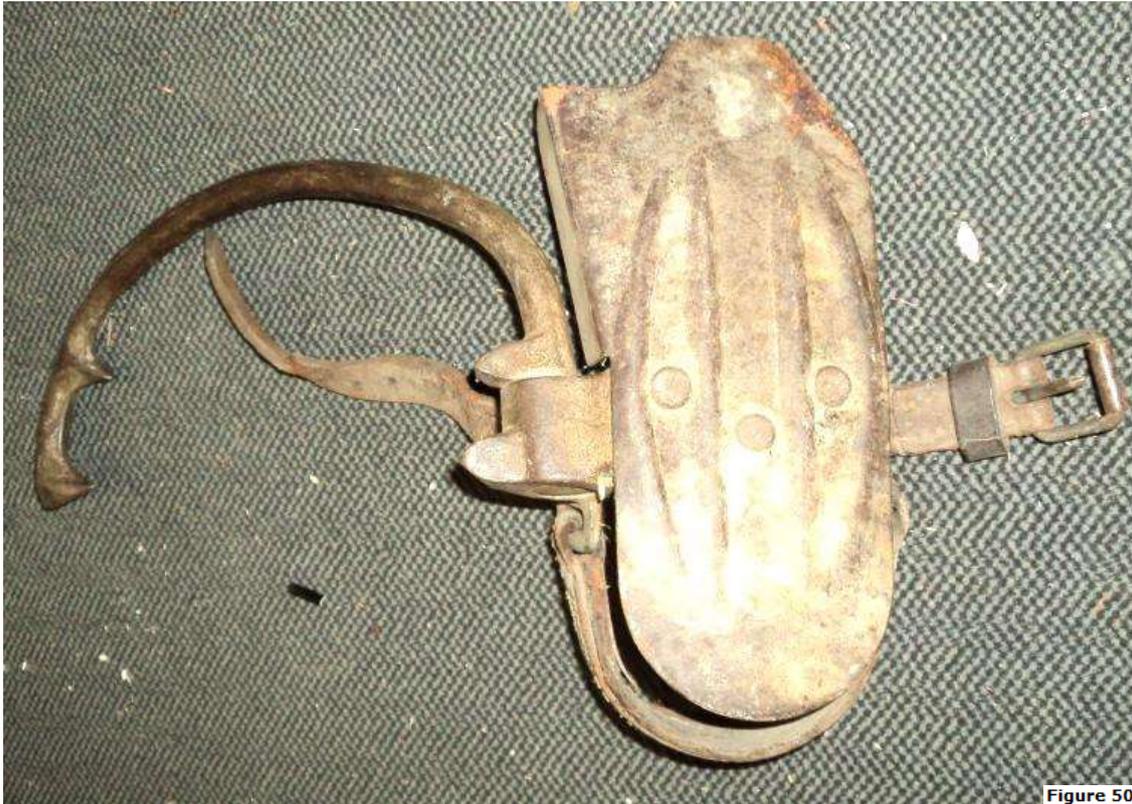
Figure 50

The curved arm on the climber has a certain amount of freedom to rotate in the vertical plane and is attached to the footplate with a strip of drop-forged steel, which has a hole to accommodate the end of the arm. The end of the arm passes through the hole and is secured to the strap by means of a washer and rivet. In turn, the strap is attached to the footplate with three large rivets.

The arm (which is drop-forged) has a total of four large teeth which are an integral part of the arm and which bite into the pole when the wearers' weight is applied to the footplate. One has to be very careful when attempting to climb a pole with such climbers, mainly because the teeth don't bite into the wood very deeply. As I already wrote, it was a hair-raising experience attempting to climb a pole without previous training – and I don't intend to repeat it.

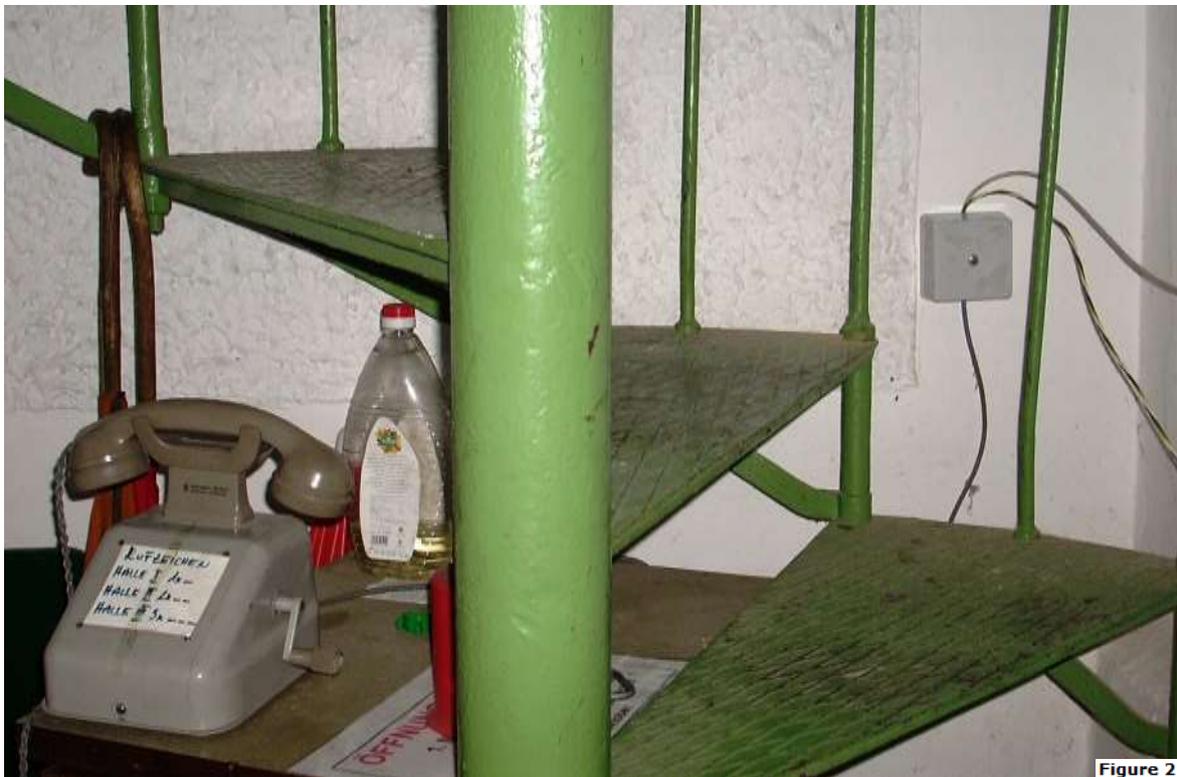
Figure 2

To tell the truth, the snapshot shown above was taken in 2004, *after* I had made the very first minimal improvements to the plant ... the battery/terminal box for the phone has been attached to the wall, and a third OB-33 phone had been installed directly at the ticket counter. This third phone was found to be necessary because the museum is so understaffed that the person doing ticket sales was often also responsible for train dispatching, and running back and forth between the ticketing counter and the phone was simply too time-consuming.
