## A Collection of Telephone Tales

written by Herbert Schwarz of Vienna, Austria, European Union

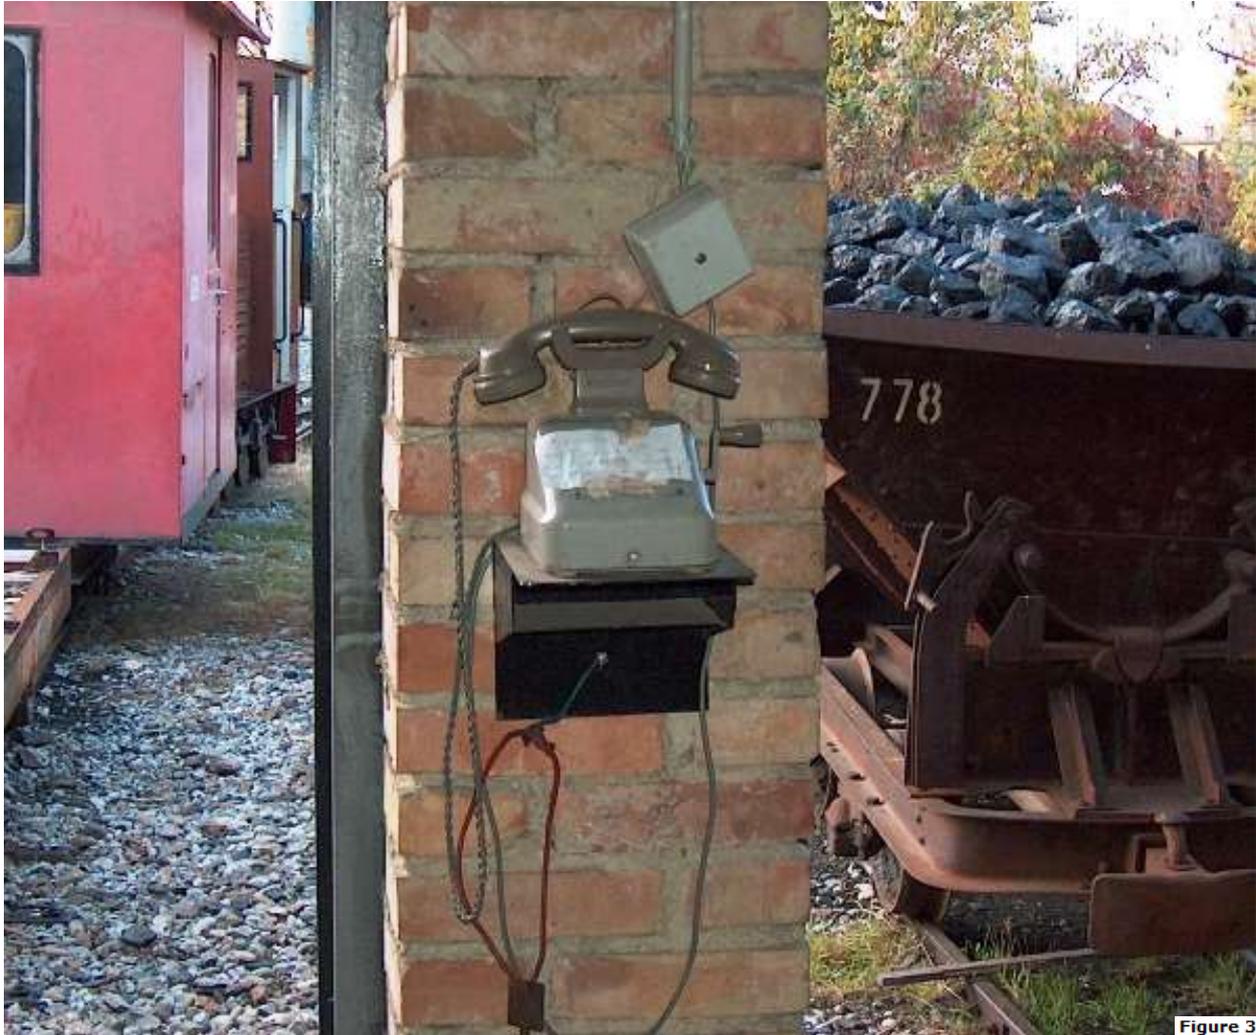
Figure 3

The OB-33 at the other end of the narrow-gauge railway line on the museum grounds ... readers may take note of how "professionally" the battery/terminal box was mounted, and also how the "ringing code" table was attached to the phone.

This phone had a loud-ringing extension bell, mounted under the eaves of the shed – but it certainly didn't ring very loud; come to think of it, the extension bell didn't ring at all, because someone from the museum had backed a truck into the eaves, breaking both gongs off the ringer some time before I started working there.

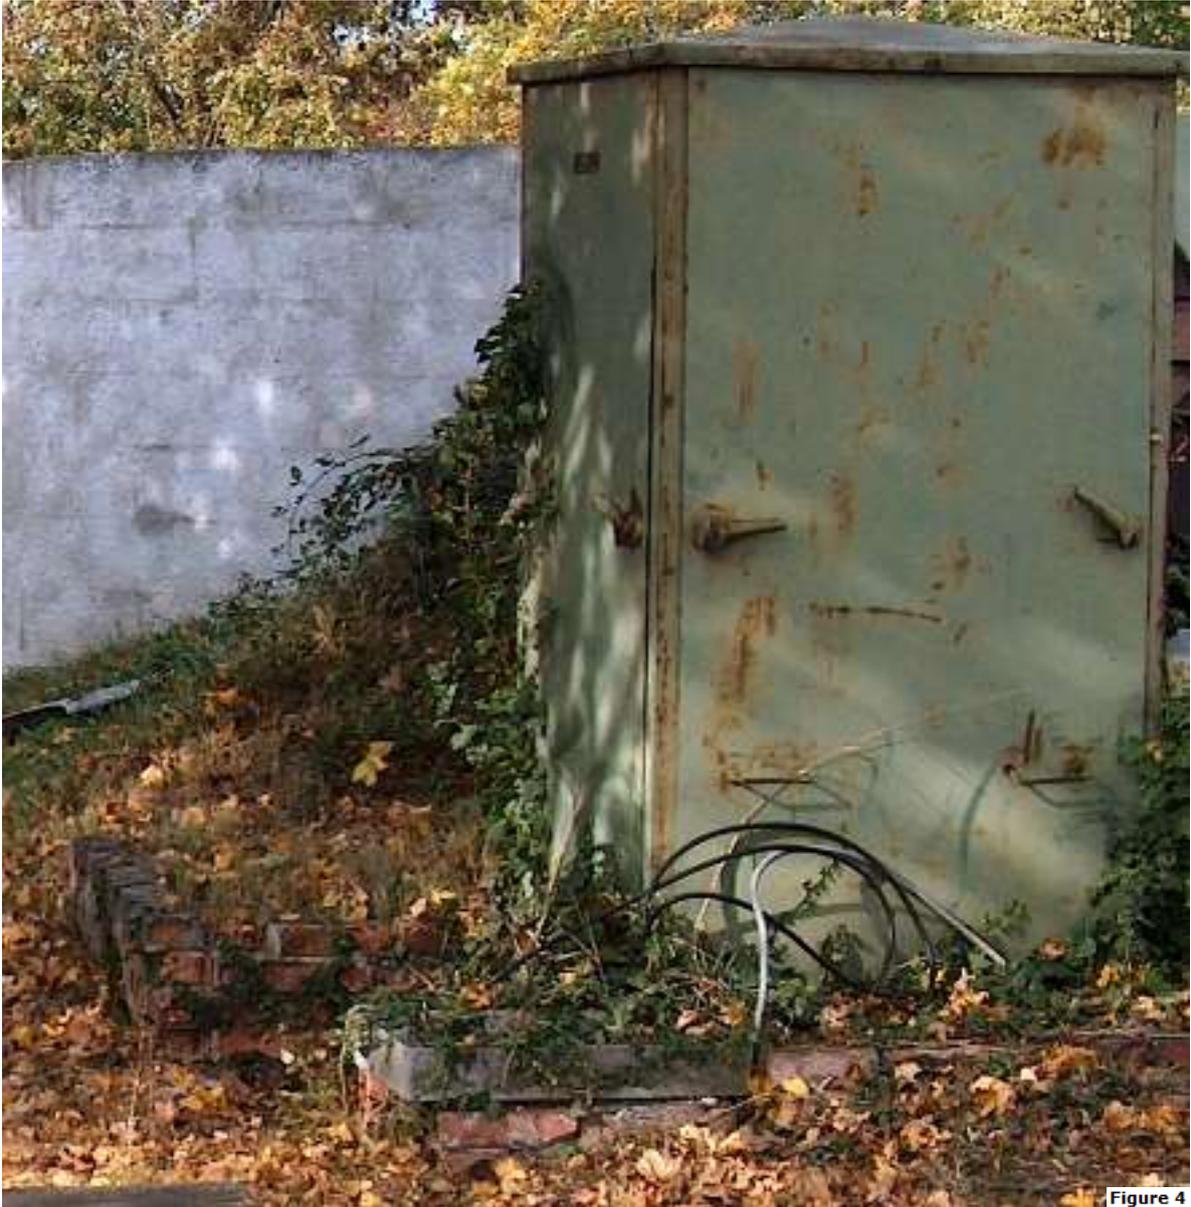
Figure 4

One can't see it in the photograph, but this is the spot where the two pieces of cable<sup>[1]</sup> that the folks at the museum had buried at some earlier date "met" – one wouldn't dare to call it a splice ... whoever originally installed the two OB-33s had simply hooked up two of the wires between the cables, using a screw-down terminal block more commonly used for electrical power connections. To top it off, the wires had lost some of their insulation and were lying directly on the ground.

[1] Readers can see a total of three cables in the photograph: 2 insulated in black, 1 in slate. The black ones cause all my outside plant headaches.

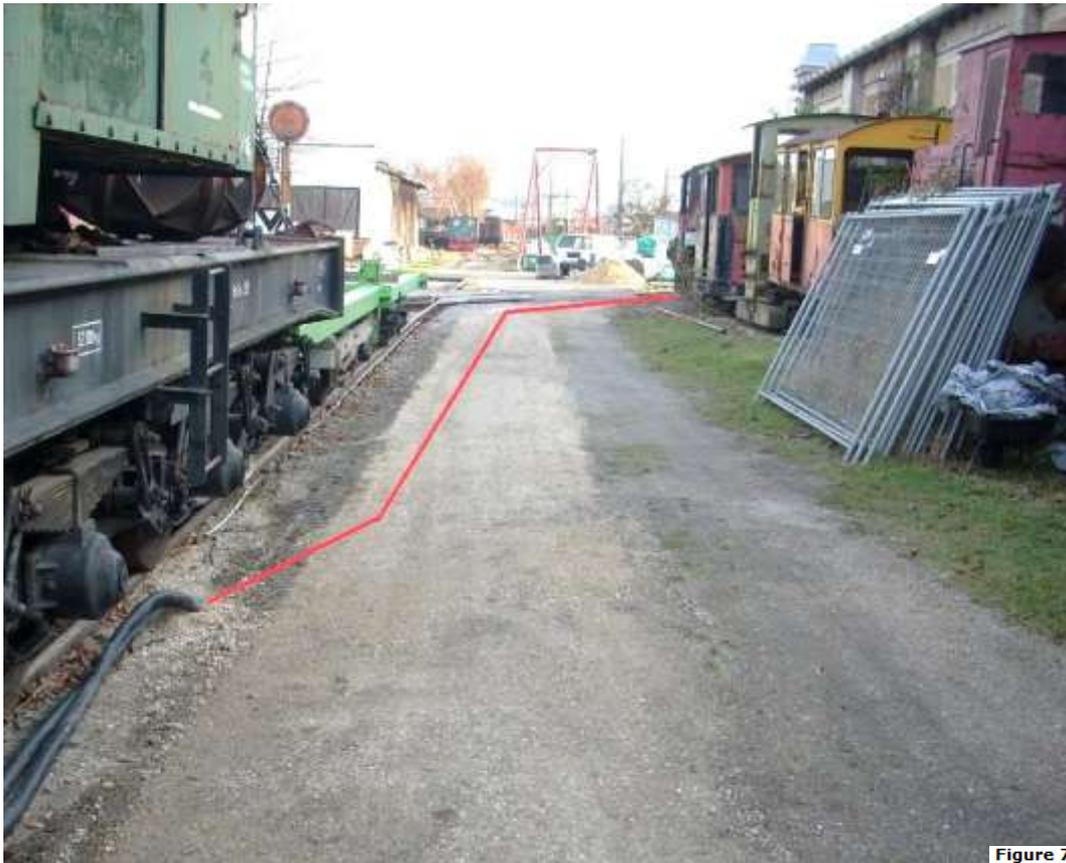
Figure 7

The picture shows the head end of the two flexible conduits the museum folks plowed into the ground ... the ends of the conduits can be seen in the lower, left-hand corner of the photo. These are supposed to be buried in the roadbed and lead to the building on the right.

The red line in the photograph shows the approximate route of the conduits as laid; the big problem with these flexible conduits is that they easily collapse when run over by a heavy truck – even when buried – and the roadbed here is one of two which such trucks use in order to deliver heavy equipment and materials to the museum.

The museum should have known better than to bury flimsy, flexible ducts because the ones they buried about twenty years ago are both crushed and unusable.

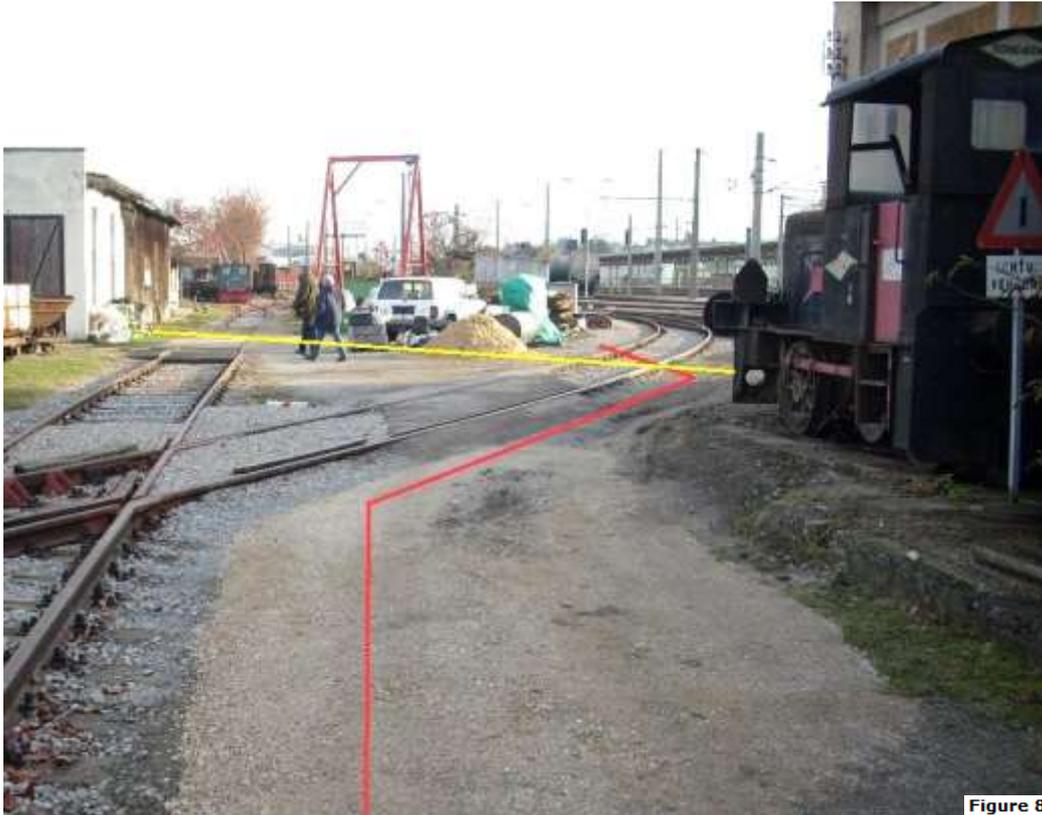
Figure 8

The continuation of the red line shows the nice zigzag they put into both the conduits. They pass beneath one railroad track – this track is a spur line which belongs to a company which distills air into technical gases and medical oxygen, and this one track *must* meet all standards of the Austrian Federal Railways (whereas the bulk of the tracks on the museum grounds don't meet *any* standards). Thus, despite the general screw-up concerning the route the conduits take, it was good that the Federal Railway employees did the work of running them beneath the track.

The yellow line shows the direct route between the workshop building (on the right) and the narrow-gauge engine shed (off on the left). This was the route which the museum *promised* me they'd use to bury two smooth-walled, rigid ducts ... nice, relatively short and straight ducts, into which it would've been easy to pull some cables.

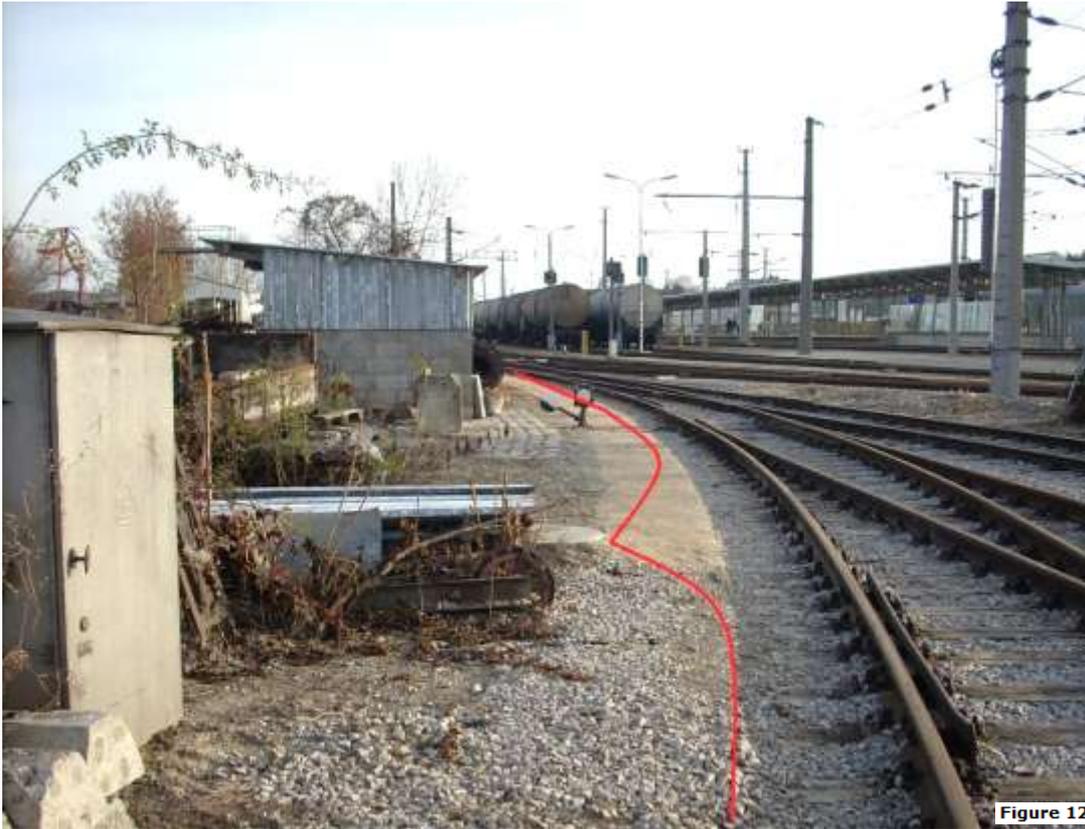
Figure 12

Now we are approaching the one and only cable well allotted to the museum-owned conduits. One of them ends at the well (the one I am *supposed* to be happy about), while the second one runs on through the well and further along the spur track.

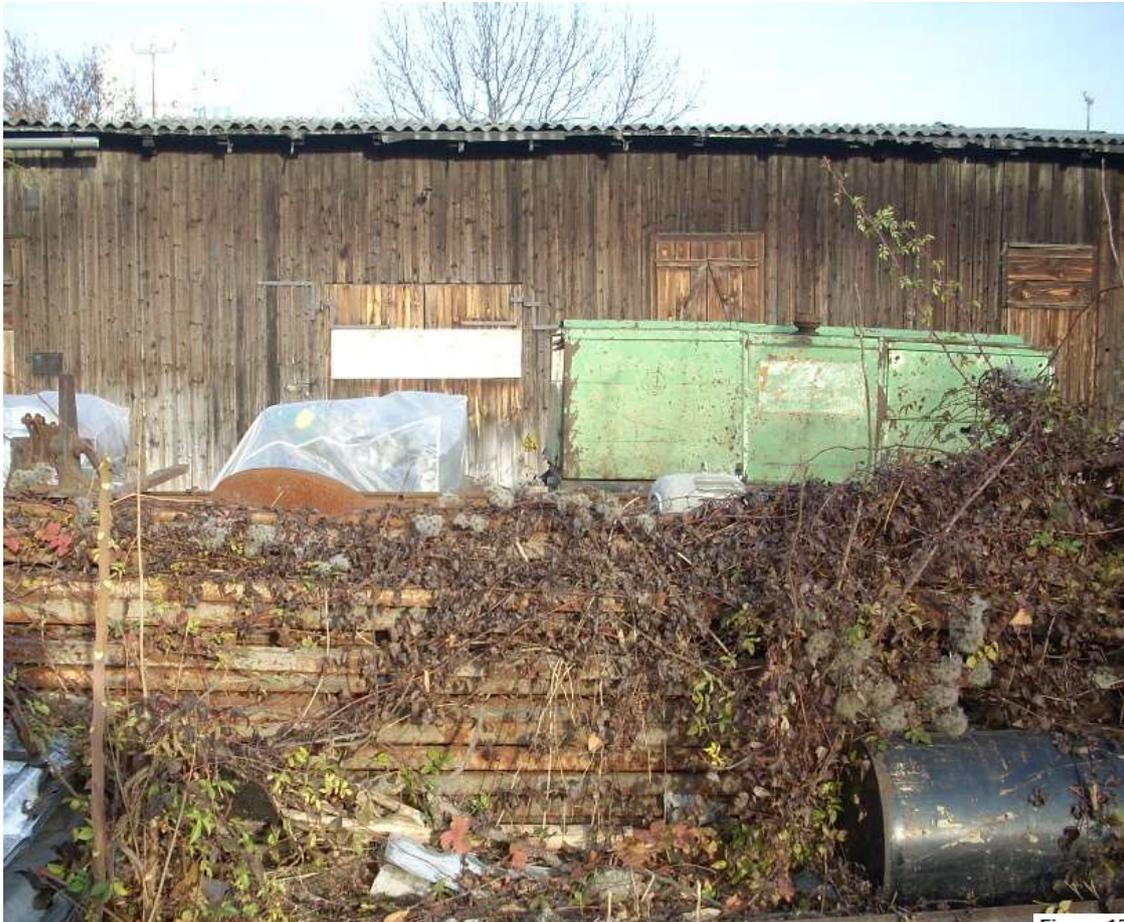
Figure 13

The lower picture on the previous page was shot while I was standing on the cover of the cable well, looking towards the narrow-gauge engine shed. There is very much heavy junk between the well and the shed – all of this stuff must be (re)moved to bury the 50 odd feet of missing duct.

The problem is that the duct (*if and when* the museum gets around to digging a trench and burying it) will wind up being a good ten feet to the right of where it'd actually have been useful. This means that I'll have to rearrange the cabling inside the shed ... luckily, I wasn't rash enough to have cut the buried signal cable inside the shed, leaving only enough to terminate it; instead, I left the original coil of cable as it was, and this is long enough that it would've been possible to pull it into the duct originally planned.

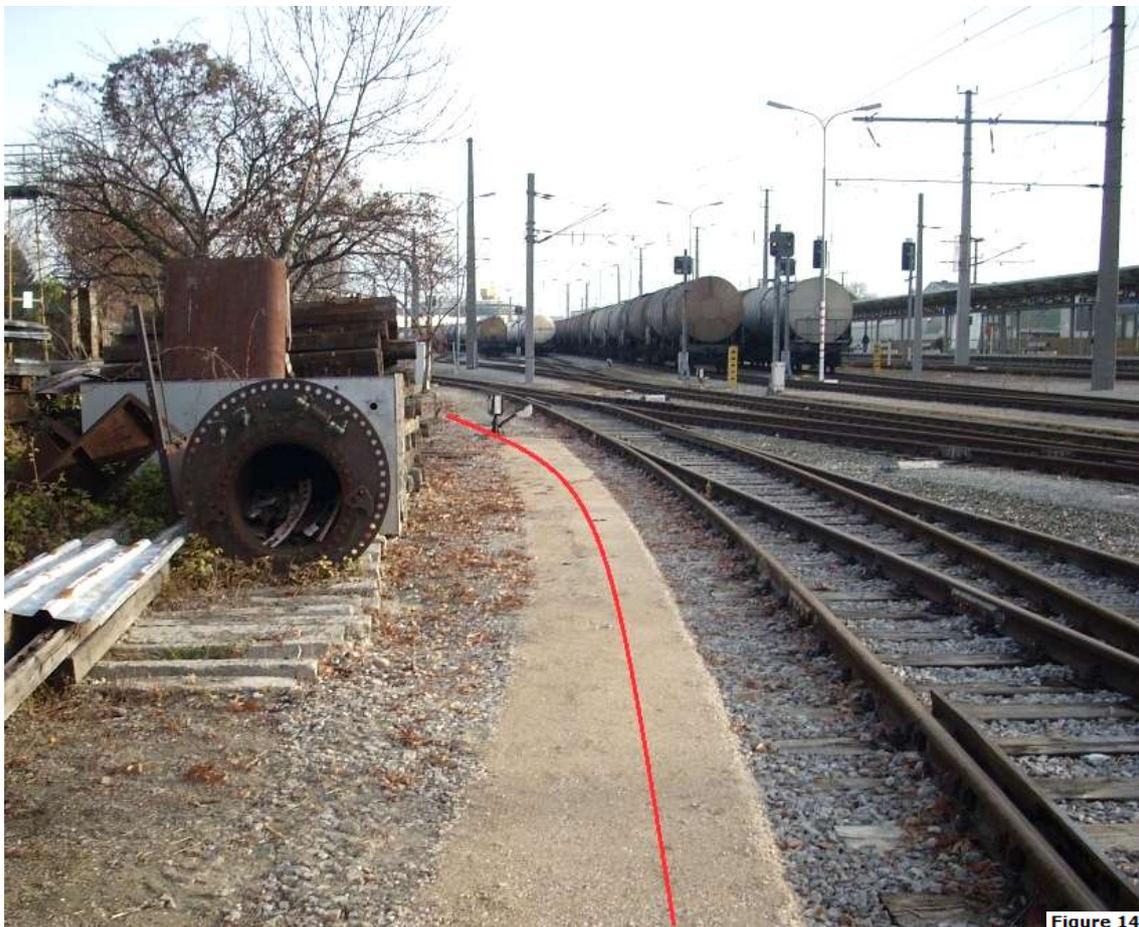
Figure 14

This photograph shows the route of the second conduit after leaving the cable-well ... it runs a good sixty to seventy feet, only to peter out in the middle of nowhere. By the time the museum folks come up with a sensible use for this conduit, it will have disintegrated due to old age.

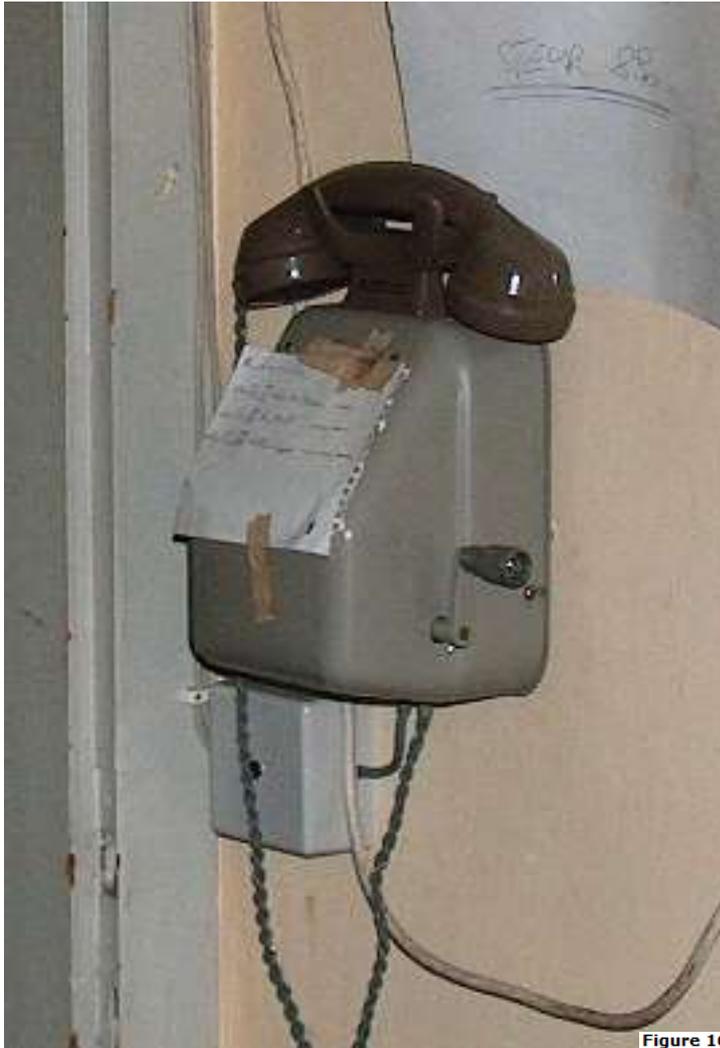
Wonder of wonders, the museum actually managed to come up with the OB-33 wall phone shown here – NOS, at that.

The wall-mounted and desk versions are the same electrically; however, the original design didn’t foresee a wall-mounted version. Instead, it was common to mount a desk set on a small iron table which was attached to the wall, exactly as was done with the phone on page 173.

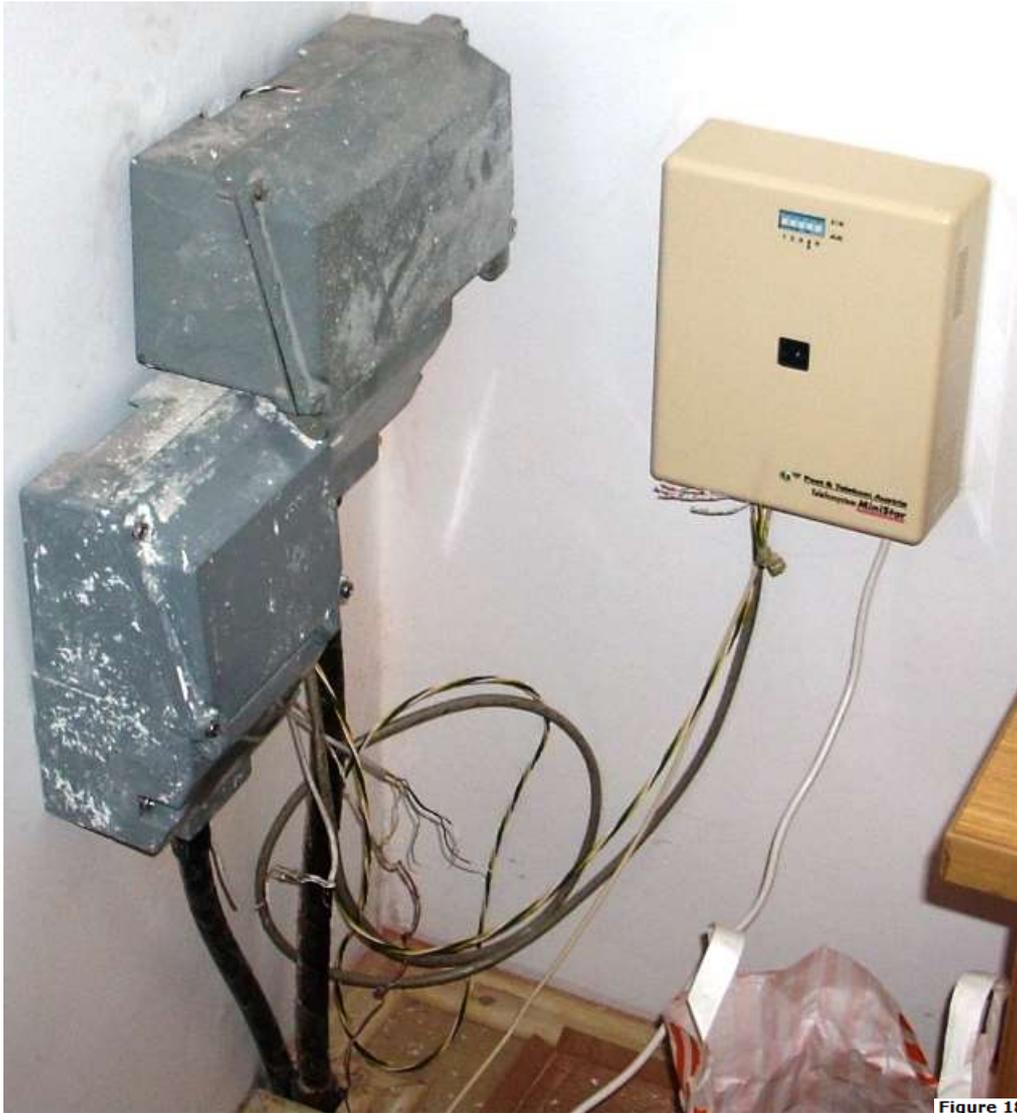
Figure 18

The photograph above shows the digital PBX, as *originally* installed in the workshop office. The two slate-colored boxes on the left are terminals for 20 and 50 pair cables which are railroad property ... there are also two small cable terminals in the main display hall, as shown on the right, and I had hoped that a few pairs from one terminal at one end of the museum grounds might have remained patched through to one of the terminals at the other end, but when the Austrian Federal Railways pulled up stakes, they disconnected everything.

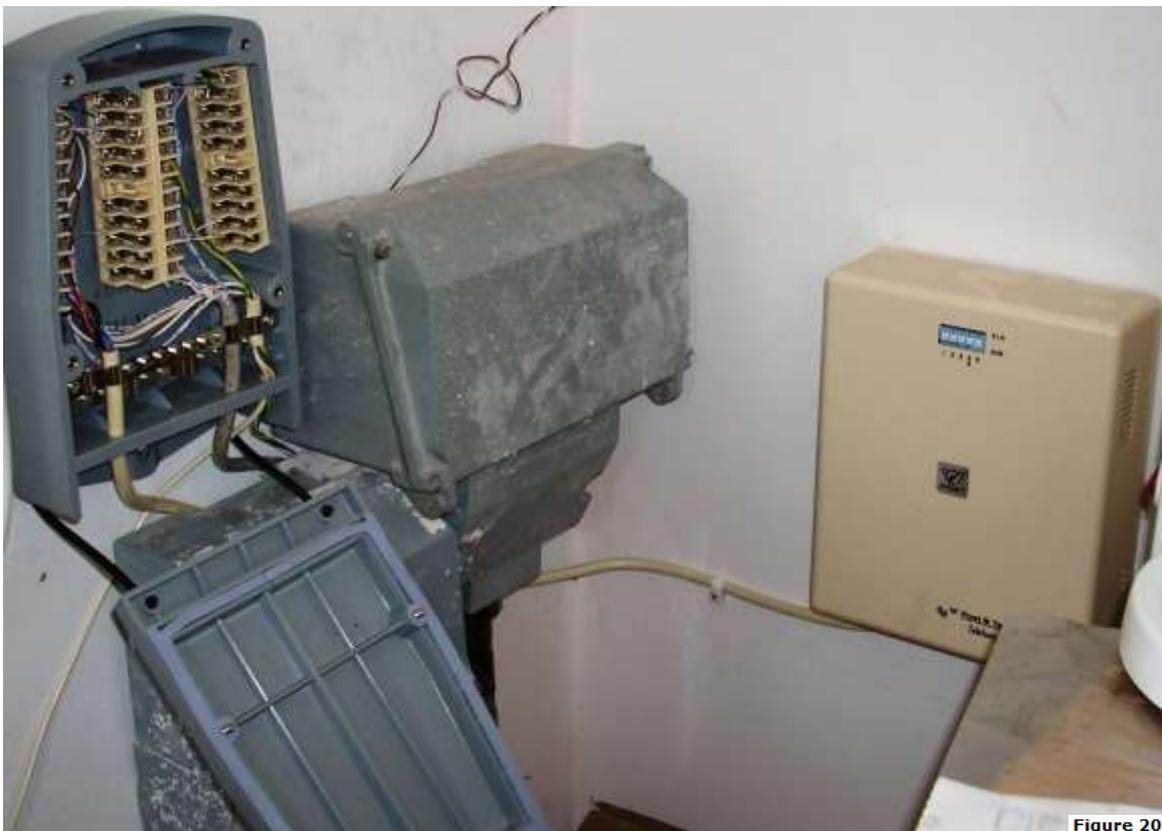
Figure 20

The photograph shows the next upgrade to the telephone plant – I had bought a few NOS pole cable terminals at a flea market in Lower Austria (the exact same units as previously used by the Austrian PTT) and thus had some more stuff to play with. This was certainly tidier than just running the wires and cables into the PBX ... as was originally done.

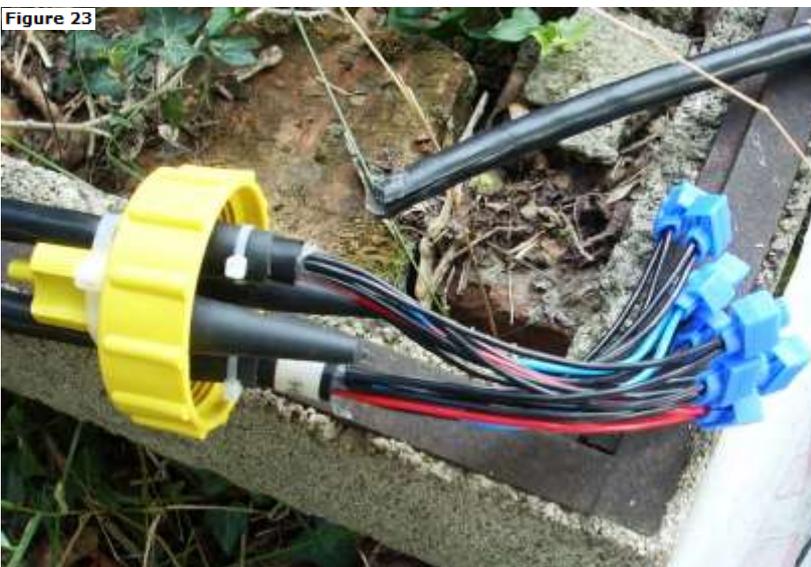
Figure 23

I actually *did* discover something useful – a waterproof, re-openable splice case intended for A.C. power wiring.

The blue splices on the wires are actually “tap” style IDC units intended for automotive wiring, but they were the best bet for a quick repair, since the wires in the two cables are of a similar gauge as your average car wiring.

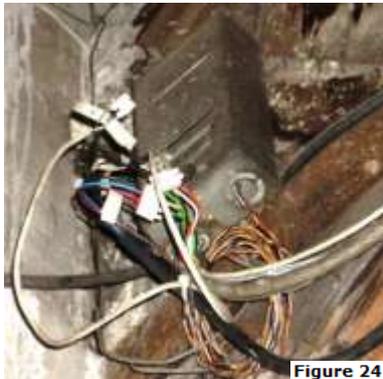
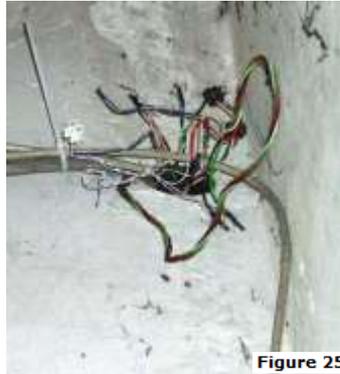
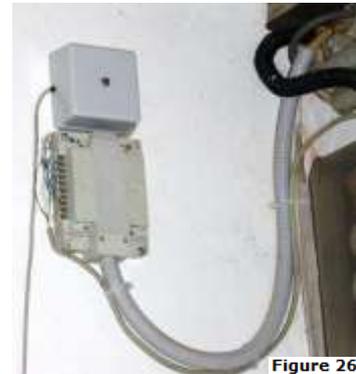
This cable was chopped off at the terminal box and, ah, “spliced” to the signal cable (using those ubiquitous A.C. power screw-down terminals) and the wires at the distant end of the cable were then soldered to a newly-installed piece of used phone cable, which is terminated in the buffet, behind the green-painted, spiral stairway seen in the photograph on the second page of this tale. The three photographs below illustrate the situation at the present time.

The largest obstacle in this phase of “construction” was that the “figure 8” cable only contained two type III spiral-four quads – four pairs – but the signal cable has ten wires in sum... so, the original segment of microphone cable was left in place and used to extend the last two wires belonging to the signal cable. At this time, the magneto phone line had four phones connected, and the internal digital PBX was in operation with three extensions and no outside line.

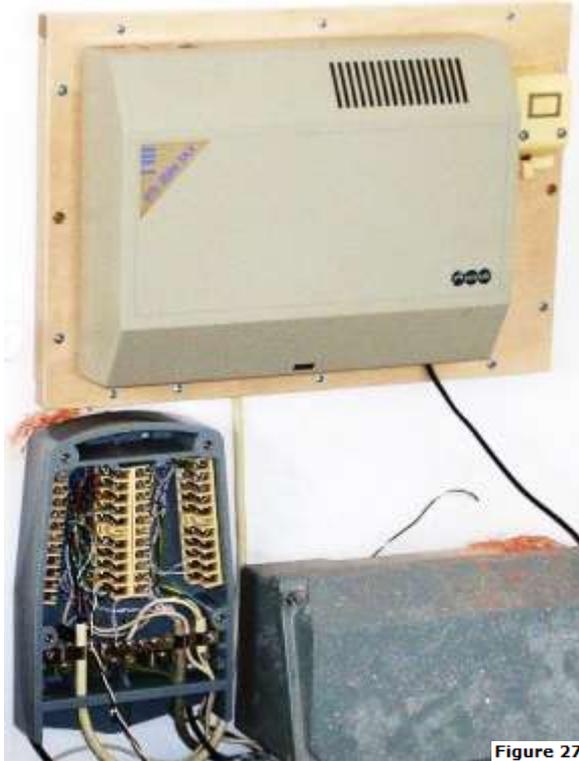
Figure 27

One problem this PBX posed was of a mechanical nature – it was intended to be mounted upon a plastic frame (because the wiring was supposed to enter the unit from the back), but this frame was missing ... which is why I mounted it on a homebrew wooden backboard (a minor technical inconvenience was that the Austrian digital PBX had single-digit extension numbers from one to five, while this one uses numbers 31 thru 36 for the extensions).

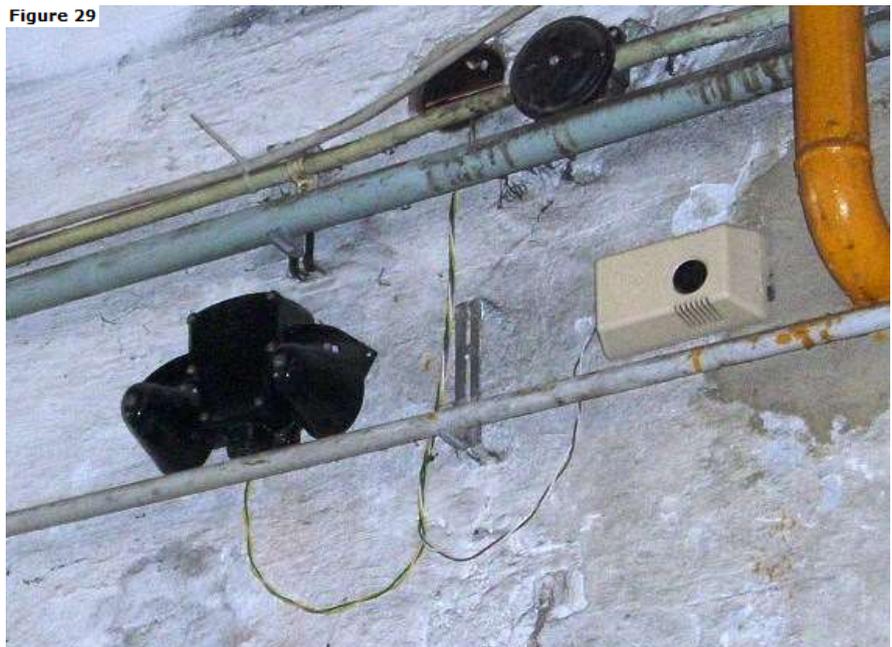
Figure 29

Since the OB-33 in the changing room in the workshop building might not be heard ringing if no one is in there, I added an extension ringer on the rear wall of the shop building; the beige box to the right is an auxiliary electronic ringer for the internal PBX extension, which is also located in the changing room.

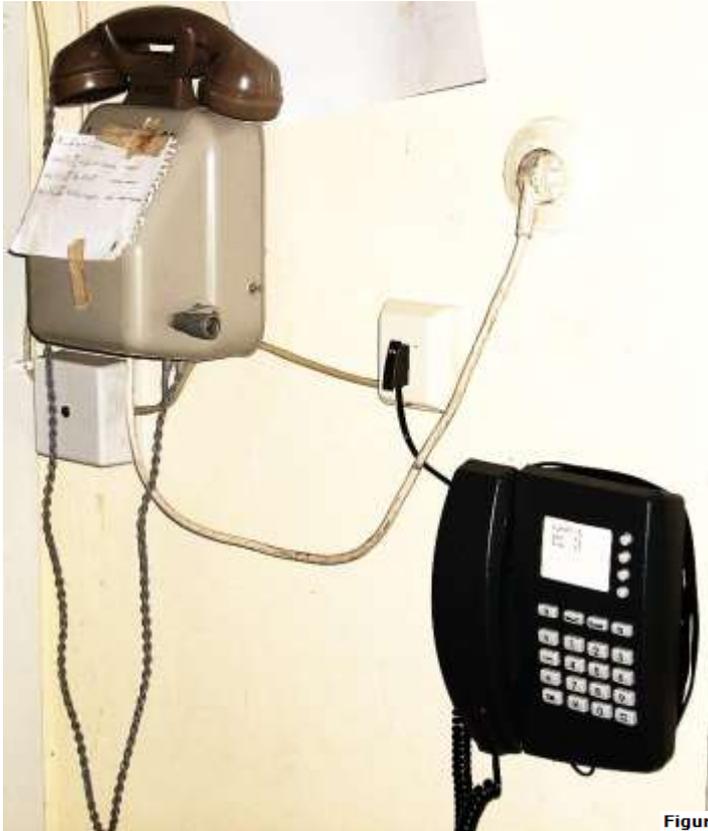
Figure 30

The internal PBX extension phone in the changing room in the workshop building.

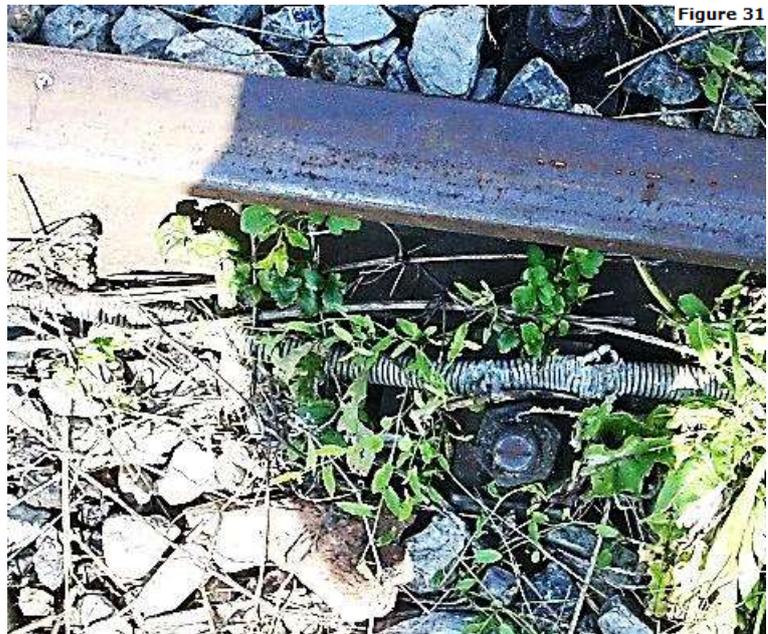
Figure 31

The photograph to the right shows a short segment of the phone cable I laid in along one of the standard-gauge tracks between the workshop building and the narrow-gauge engine shed. The cable was pulled into flexible conduit for a little bit of added protection ... trust the folks at the museum to drop something very heavy onto the cable and partially crush it in the process.

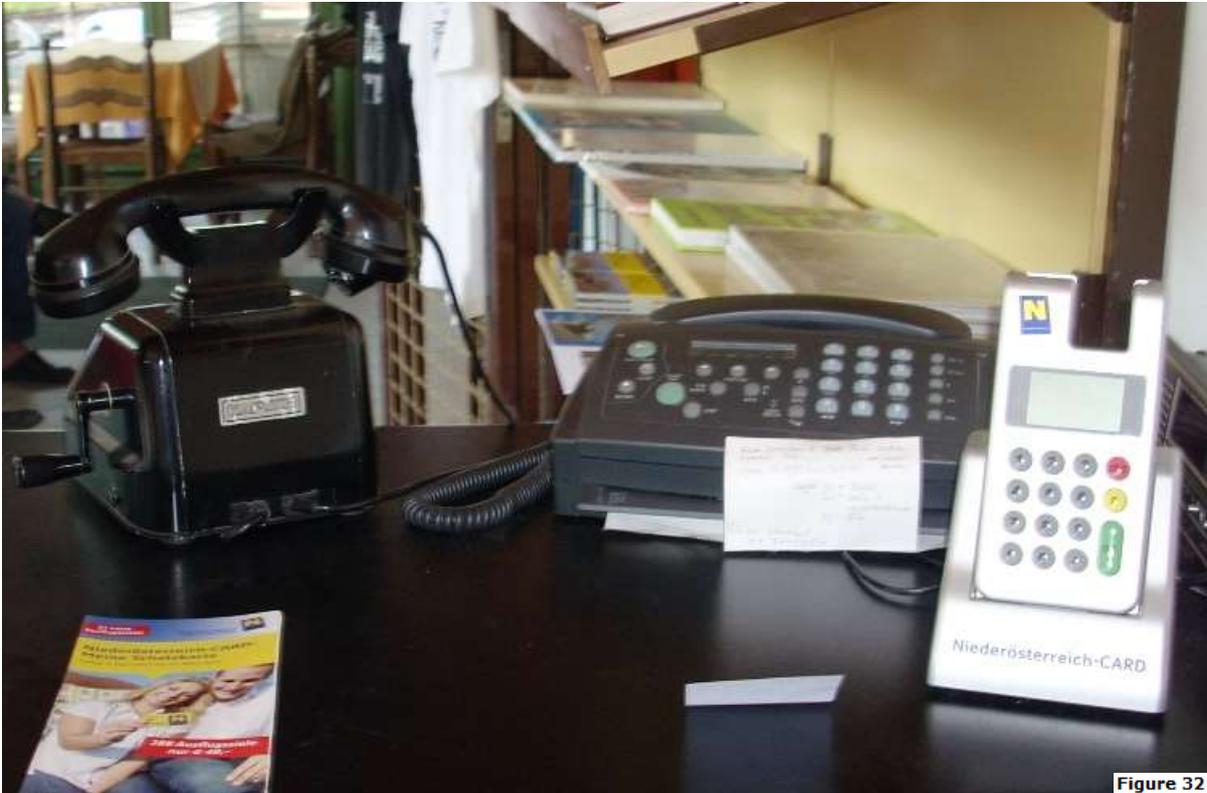
Figure 32

The situation as it now exists at the ticketing counter at the head end of the railroad museum is shown above ... from left to right, we have the extension OB-33 phone for train dispatching, a combined FAX/telephone unit which the museum curator dug up somewhere and connected to the internal PBX and, last but not least, the card reader in its cradle.

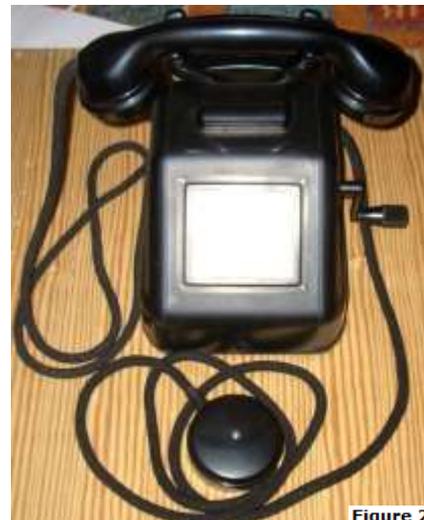
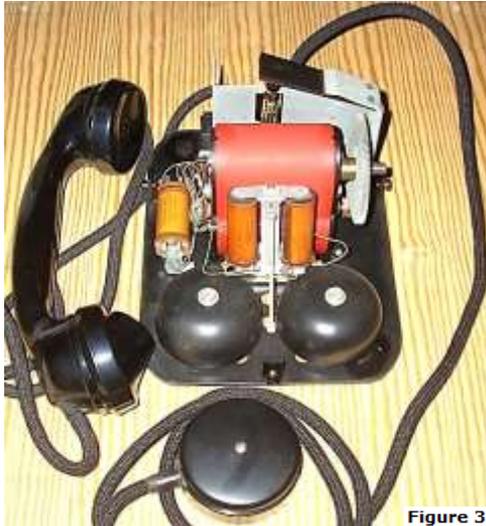
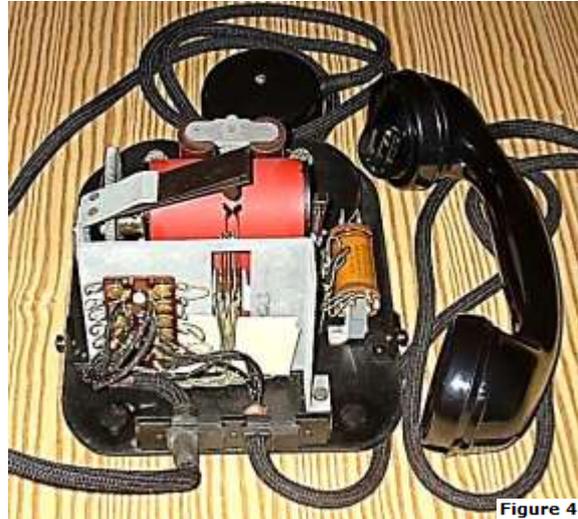
The photographs above give an overview of the internal arrangement of the OB-33. There are a few unusual features to take note of: the gongs of the ringer are painted flat black, instead of being nickel-plated to prevent rusting (this was an economical factor, since painting is much faster and less expensive than electroplating), and the large gear of the magneto is die cast of a zinc alloy instead of being cut from a solid disk of brass (another economic measure, since brass is much more expensive than the zinc alloy). Aside from this, the switch-hook actuator is rather novel – a wide, flat piece of blued spring steel with a small, wedge-shaped Bakelite plunger attached. The handset was of a new design which found its way into public telephone service via the Siemens & Halske model 1936 & 1938 dial telephones.

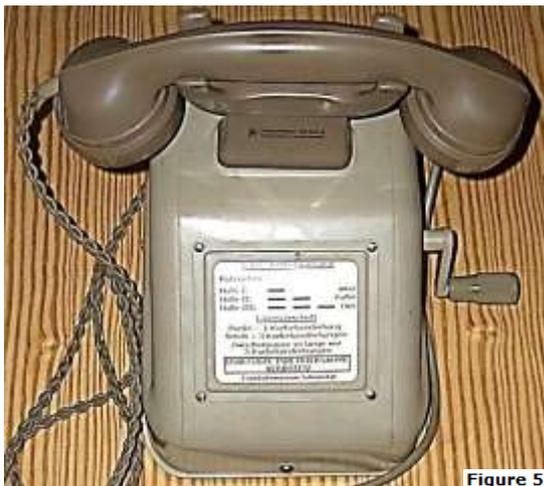
Figure 5

This OB-33 was manufactured by the company Friedrich Reiner of Munich, Germany, in 1985 and is former property of the Austrian Federal Railways.

When comparing the old Siemens OB-33 with this one, the only design changes noticeable from the outside are the different color scheme, and that the handset mouthpiece is flat instead of having the small half-funnel of the original ... the physical dimensions are exactly the same.

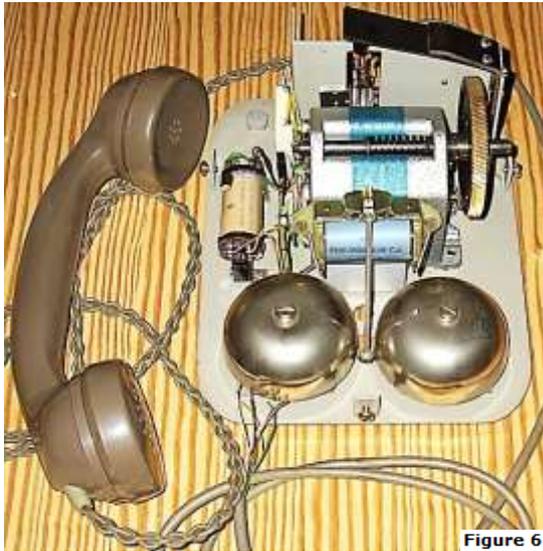
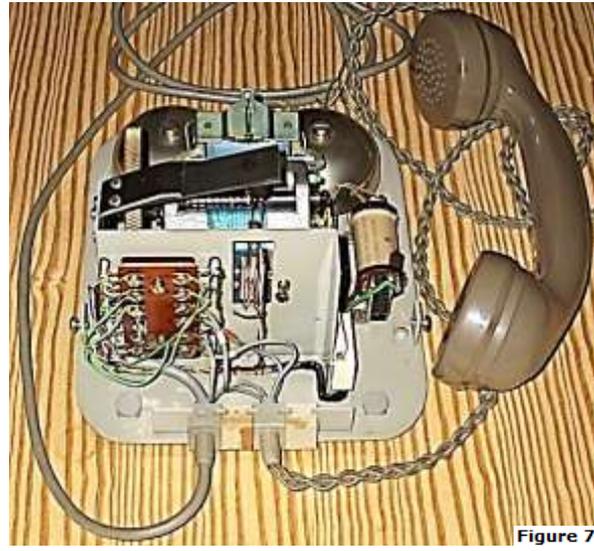
As may be seen, some things never change ... the induction coil is located in the exact same spot as in the original, the vertical iron plate which carries the switchhook and the terminal strip is of the same dimensions and is located in the same spot as in the original and even the two gongs are of the same size. When one takes into account that the two OB-33s shown in this tale were manufactured over 40 years apart, it's safe to say that this is certainly one of the longest-living, *unmodified* designs in telephone history.

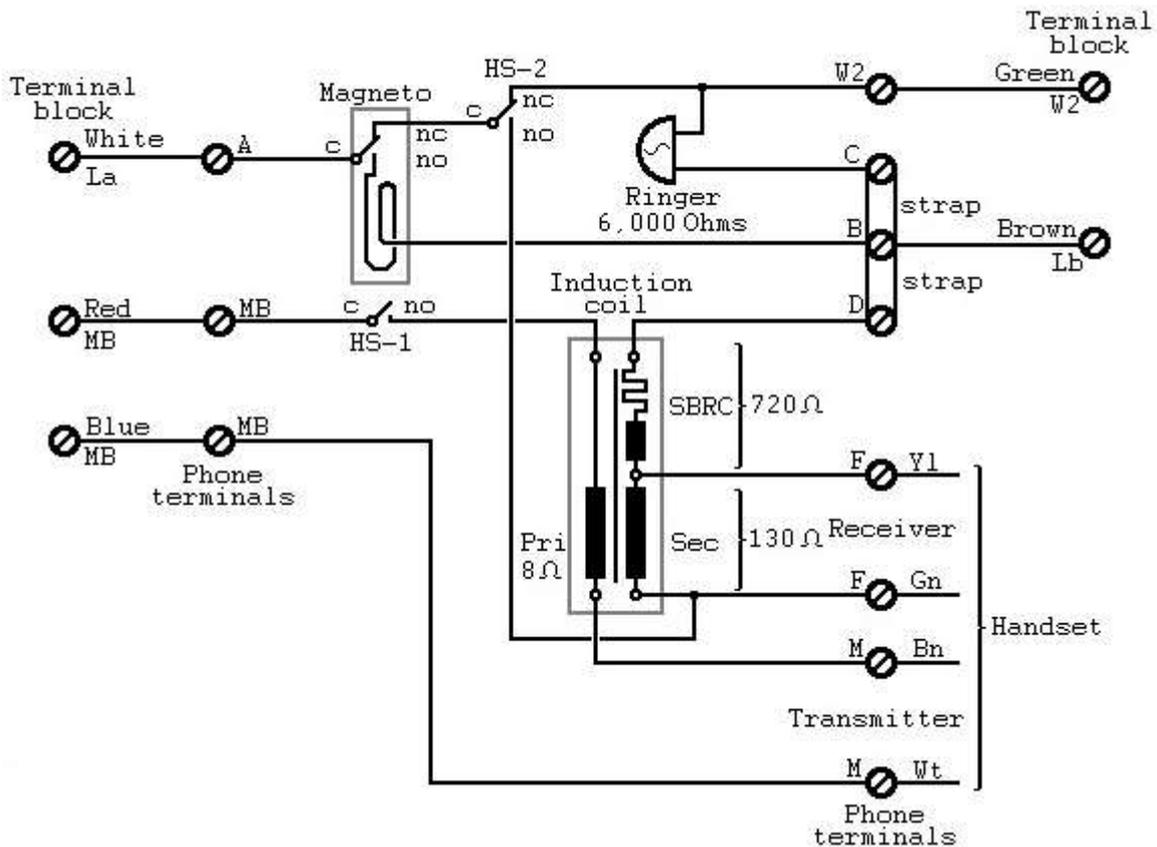
Figure 8  
OB-33 "Siemens & Halske"

If the internal ringer is to ring on incoming *and* outgoing calls, then terminal "La" is to be strapped to terminal "W2" on the terminal block. If the ringer is to ring on incoming calls only, then the connections are left as shown. If the phone shouldn't ring at all, then the strap between terminals "B" and "C" inside the phone is to be dropped. An auxiliary ringer may be connected between terminals "W2" and "Lb" on the terminal block.

The induction coil of the OB-33 shown here, as well as the ones on the next two pages, are designed as anti-sidetone coils; the portion designated as "SBRC" consist of one coil winding and a pure, non-inductive, resistance (a so-called "bifilar" coil); the abbreviation stands for "sidetone **b**alancing **r**esistor/**c**oil."

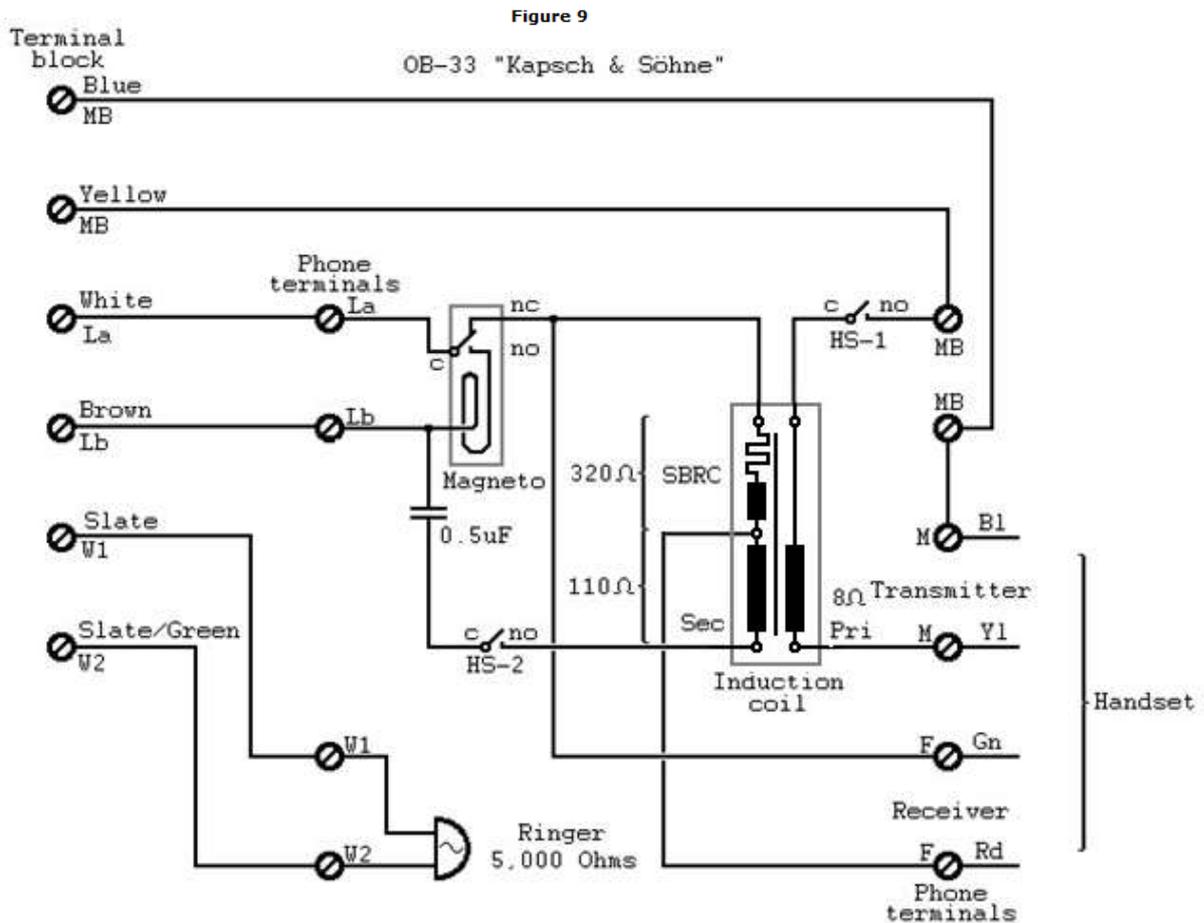
If the internal ringer is to ring on incoming and outgoing calls, then terminal "La" is to be strapped to terminal "W1" and terminal "Lb" to terminal "W2" on the terminal block. If the ringer is to ring on incoming calls only, then terminal "W1" is to be strapped to terminal "F/Gn" inside the phone and terminal "Lb" to terminal "W2" on the terminal block. If the phone shouldn't ring at all, then the straps between terminals "La" and "W1" and between terminals "Lb" and "W2" on the terminal block are dropped. An auxiliary ringer may be connected between terminals "W1" and "W2" on the terminal block.

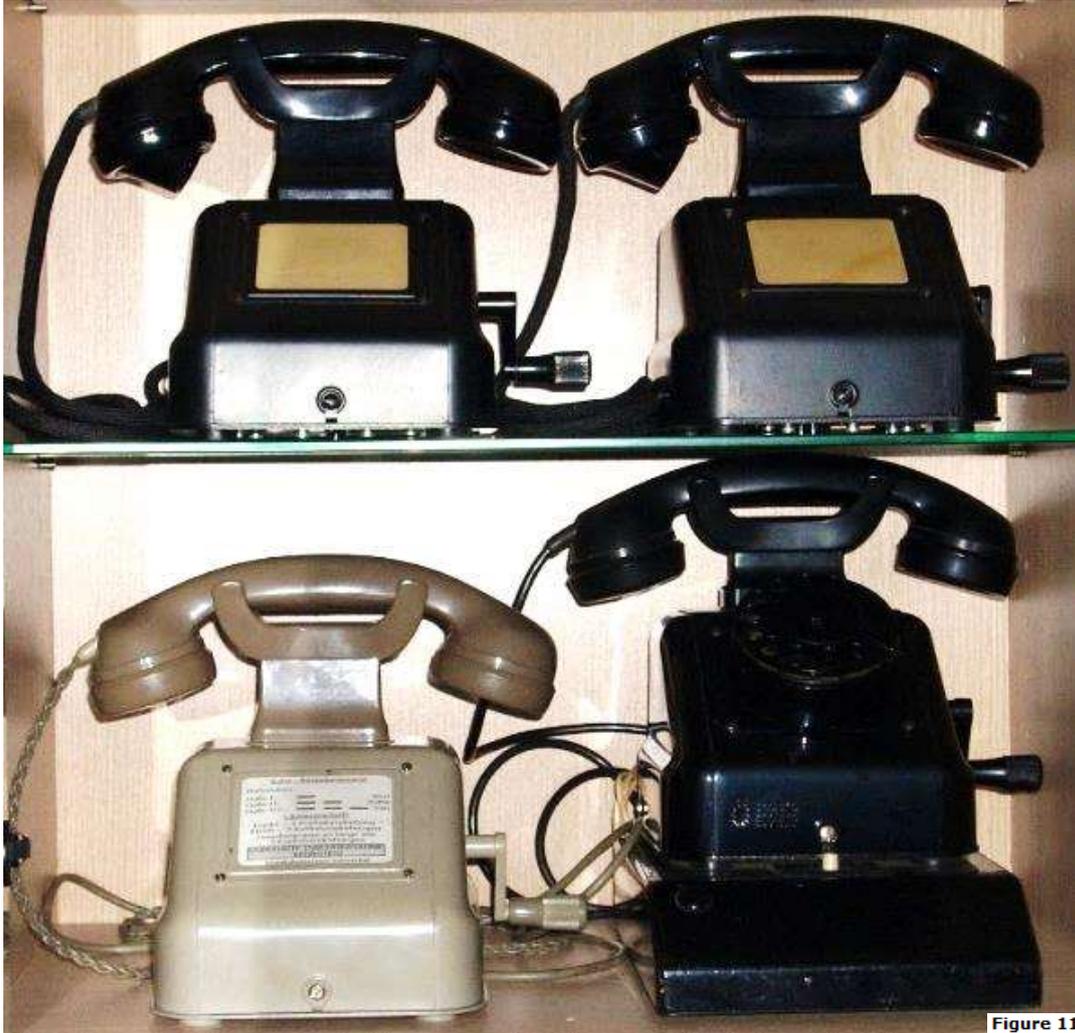
Figure 11

The photograph above shows the nicer OB-33 magneto desk telephones I have on display in my living room.

The one in the lower right-hand corner is a special one with an adjunct and dial (which is difficult to see) – this type was used in conjunction with a special circuit in the PBX to allow connection of a magneto line to the (then) dial PBX of the Austrian Federal Railways. Depressing the white pushbutton on the adjunct with the handset off-hook connected the magneto line to the PBX – the dial sent ground pulses over tip and ring. If the pushbutton wasn't depressed, then the phone functioned as a normal magneto set, without connection to the PBX.
