## A Collection of Telephone Tales

written by Herbert Schwarz of Vienna, Austria, European Union

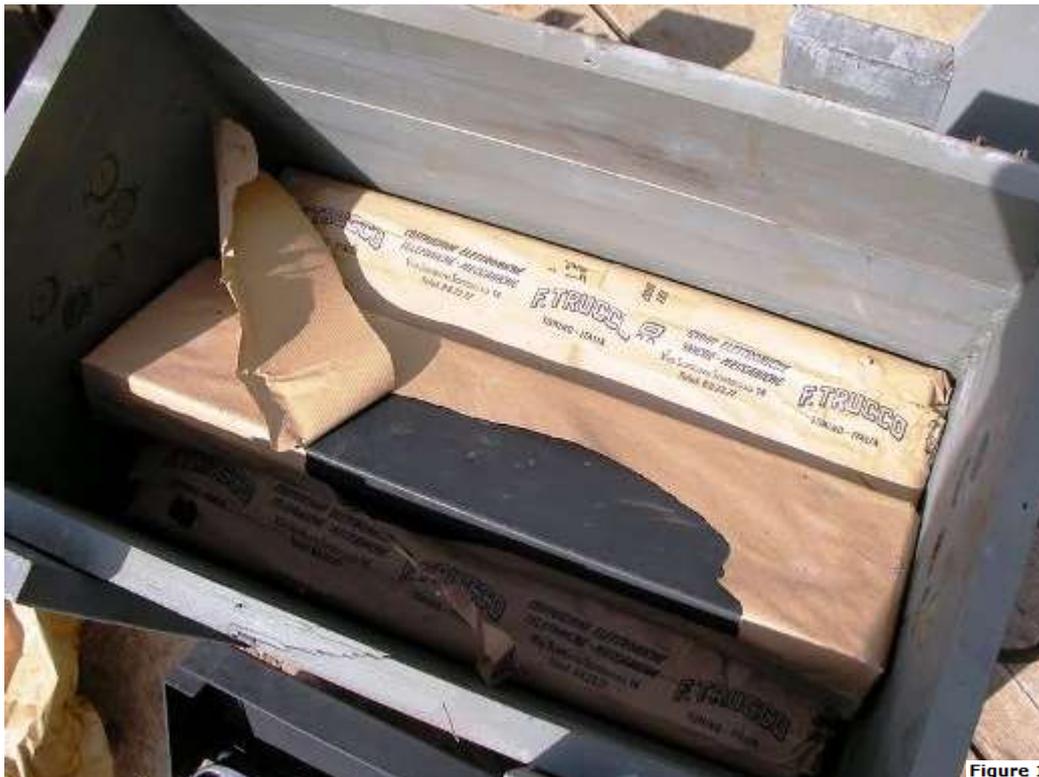
Figure 1

The interior bottom of the wooden case of accessories; inside, one can see four original weatherproof terminal boxes for connecting ten pairs of field wire (each) to rubberized switchboard interconnect cables. So far, so good ....

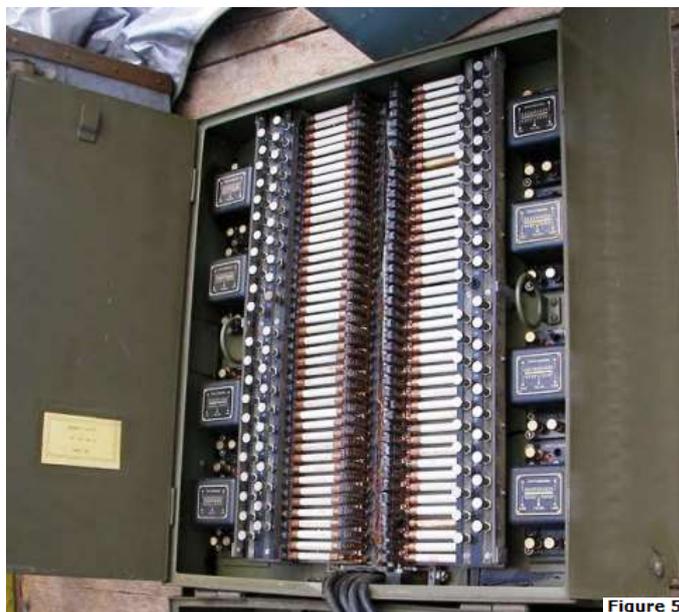
Figure 5

Ah – this looks rather interesting, but it's definitely not an original bit of *German* field switchboard equipment ....

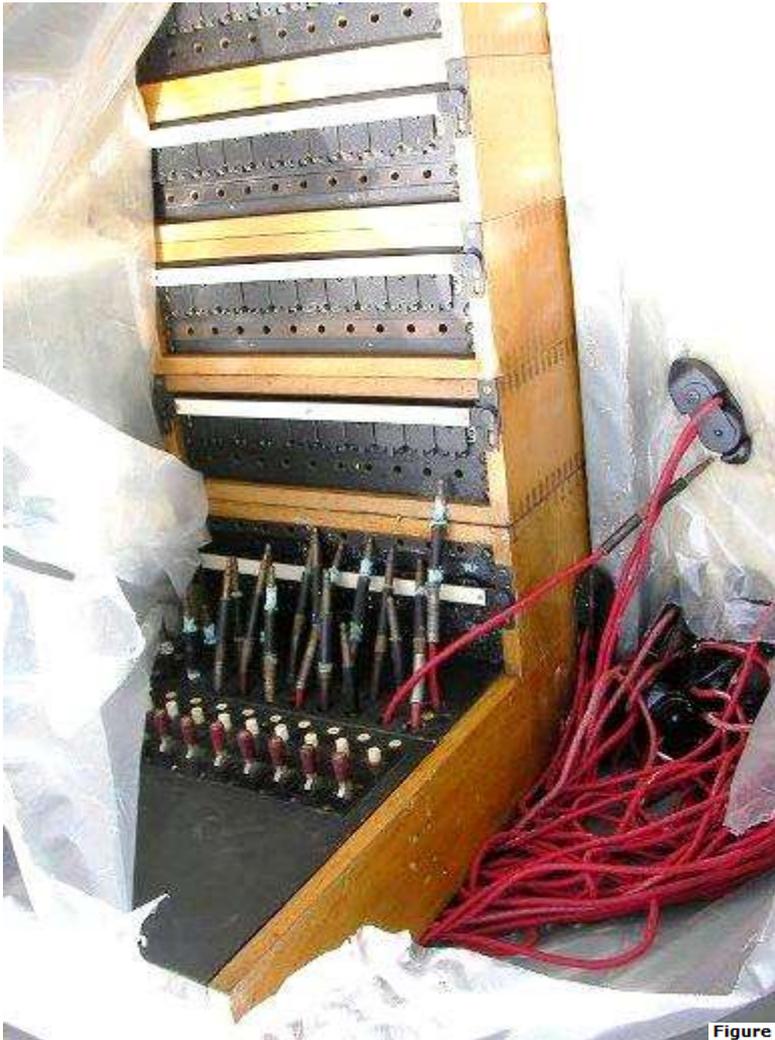
Figure 7

When I saw this photograph, I knew that this *wasn't* the switchboard I wanted to pay for and own ... too much damage from water finding its way into the storage crate at some time in the past.

At least eight of the 20 plugs on the cord board have such severe corrosion that they're beyond repair. Besides this, there should actually be 21 cords and plugs. The 21<sup>st</sup> cord, normally installed to the right of the 10 cord pairs, was used in conjunction with a service monitoring position – where someone from the Gestapo or the Secret Field Police could monitor calls.

Aside from this, it appears that the plug sleeves are all black in color, which should not be so. The back row of plugs (for answering calls) *should* have red sleeves, and the missing call monitoring plug would've had a white sleeve.

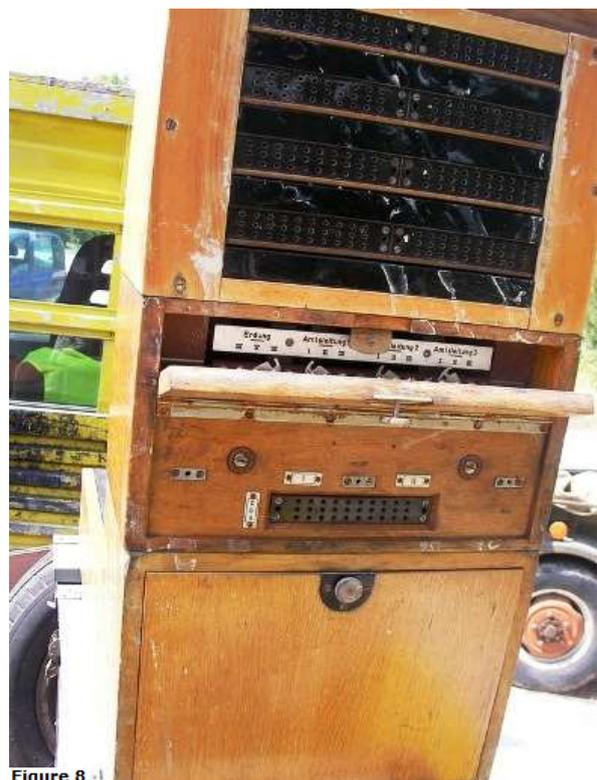
Figure 8

This photograph shows the back side of the second half of the same switchboard suite ... the white splotches and stripes are further water damage, where the water dissolved some of the glue used on the plywood door at the bottom.

Plywood? Didn't I previously write that the only German WWII field switchboard to utilize plywood was the one for 20 lines? Yes, but as it turns out, two components of this half are of Italian design and manufacture – namely the type "B" cord board and the line jack multiple. The components of the first half are all originals, although the wiring was refurbished by the Italians.

Why do I keep on writing that the Italians did this, that or the other thing to this German field switchboard? Simply because it was refurbished, modified and placed into service by the Italian Air Force circa 1963 – it was their “Unita Telefonica A 40 + 3 Linee, tipo Tedesco” (telephone unit for 40 [magneto] + 3 [CB/dial] lines, German type). I refer to this switchboard as being a “bastardized” unit for a good reason: while principally being of WWII German origin, it has some components of post-WWII Italian design integrated into it, and it utilizes a WWII vintage lightning & sneak current protection panel from the U.S. Army Signal Corps.

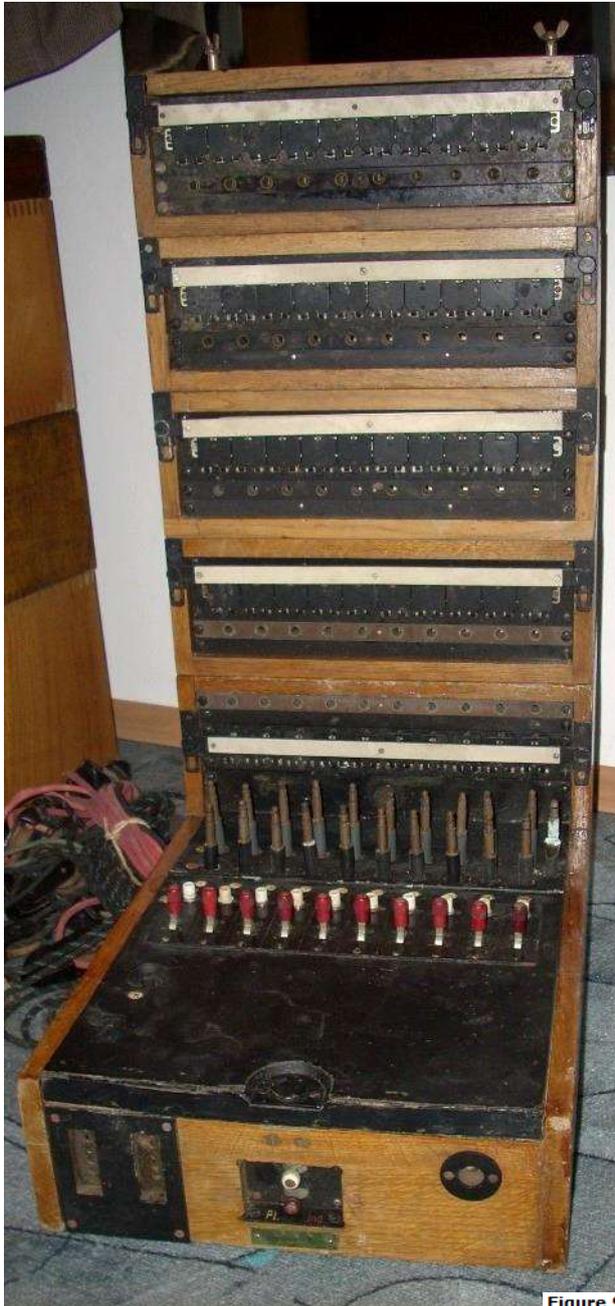
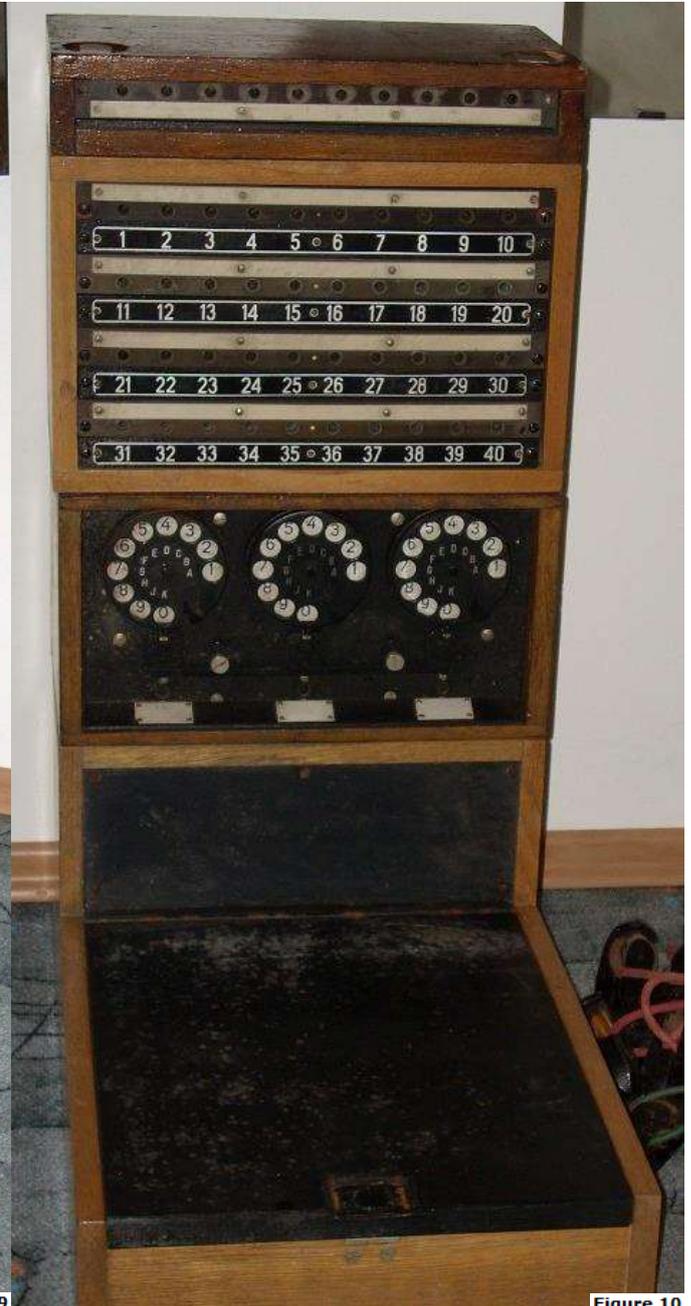
Figure 10

This is the switchboard I bought; as can be seen, it appears as if only one of the plugs is severely corroded ... this cord board actually has all 21 plugs and cords.

Again, I intentionally wrote "... it appears as if ...," because it turned out that the entire back row of plugs had suffered a form of corrosion which made it next to impossible to remove the rear end of the plugs, to which the cord protection springs are attached ... but it was important that I could remove the plugs from their cords so that I could replace the slate-colored (actually severely faded red) sleeves with NOS red sleeves and to polish the plugs up; this caused some headaches, as did the fact that every single jack (even the 30-pin jacks on the rear of the individual units) required cleaning and burnishing. Luckily for me that I had a small stock of original plugs for this switchboard type, as shown below. Further troubles encountered had to do with the fact that the drop circuits for ringing a D.C. night alarm run over the hinges of the armatures of the drops and also via a silver contact pill on each drop ... both contacts required cleaning to allow enough current to flow to actually ring the bell.

For the most part, the replacement plugs I had on hand were equipped with their original Bakelite sleeves; these were replaced with thermoplastic sleeves in the course of restoration. My first choice for replacements were those which were missing their original sleeves anyway, but I only had three or four of these on hand.

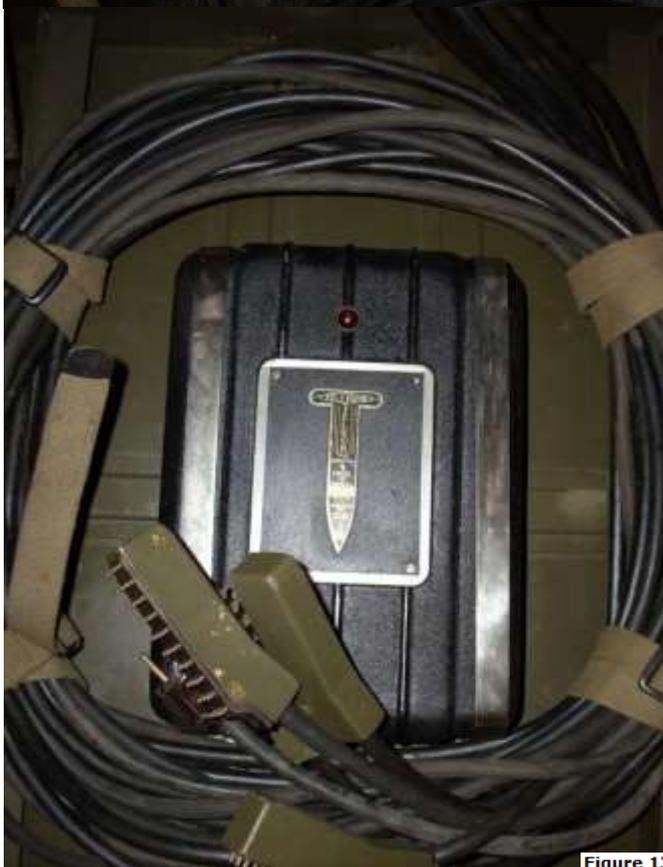
Figure 13

Two detail photographs of the BD-97 panel – as can be seen, the fuses come immediately after the line terminals, with the carbon arrestor blocks cut into the circuit after the fuses on the cable side. The panel even has some nice, big bridle rings for the incoming line wires. If readers take a close look at the photograph shown above, they can see that the first terminal pair on the left really is numbered as pair zero.

I never got around to examining or testing the "Telering" ringing generator inside the panel lid, so I can't say whether it's a static converter or one which uses a vibrator. It's a moot point anyway, since the converter is designed to operate on 120 Volts @ 60 Hz while we have 220 Volts @ 50 Hz in Europe.

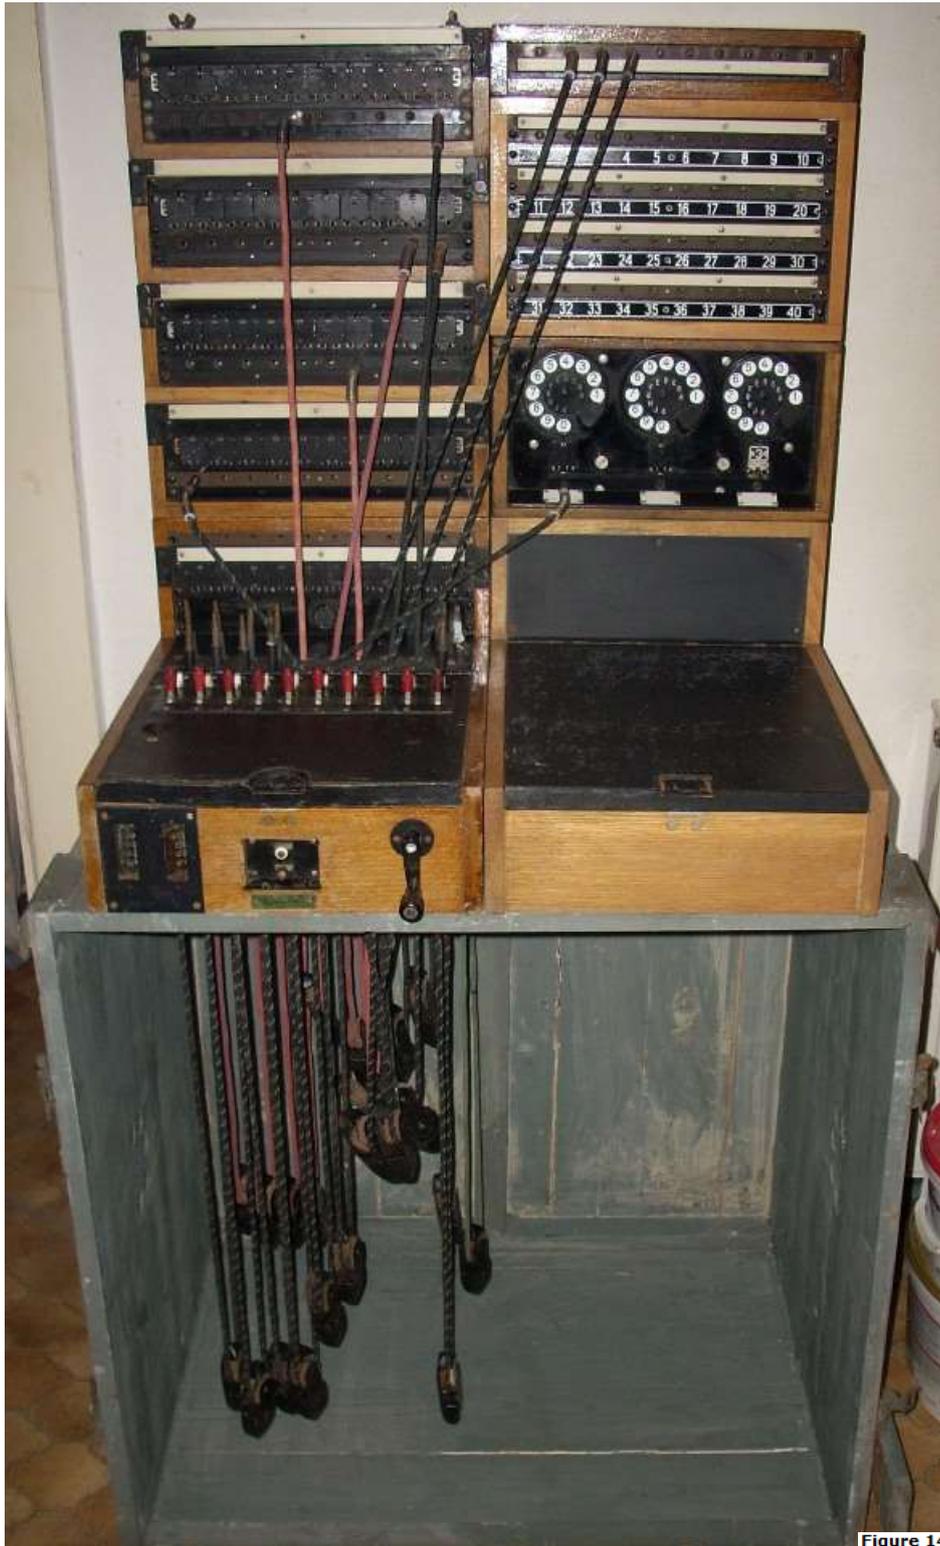
Figure 14

This photograph shows the complete switchboard resting on top of the transportation crate before I began with restoration. As readers can see, there is fine silt on the back wall of the crate – that end was “down” when the crate was packed and in storage. The same silt was inside the back of all the units the switchboard consists of – and in the 510 individual sockets belonging to the 30-pin jacks on the back side of most of the units.

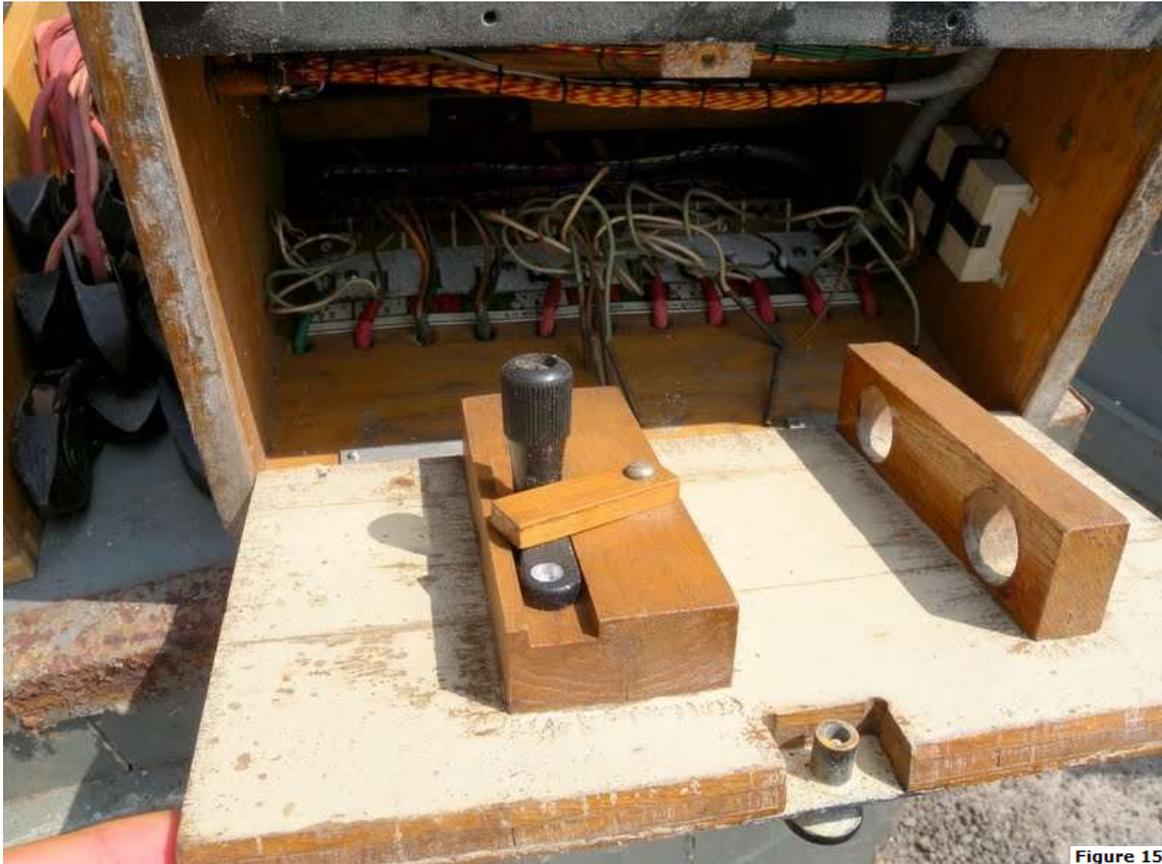
Figure 15

Silt, rust and some damaged plywood on the Italian-made cord board "B" (below); at some time in the past, all three of the switchboard suites were standing in water which was roughly one inch deep inside the transportation crates ....

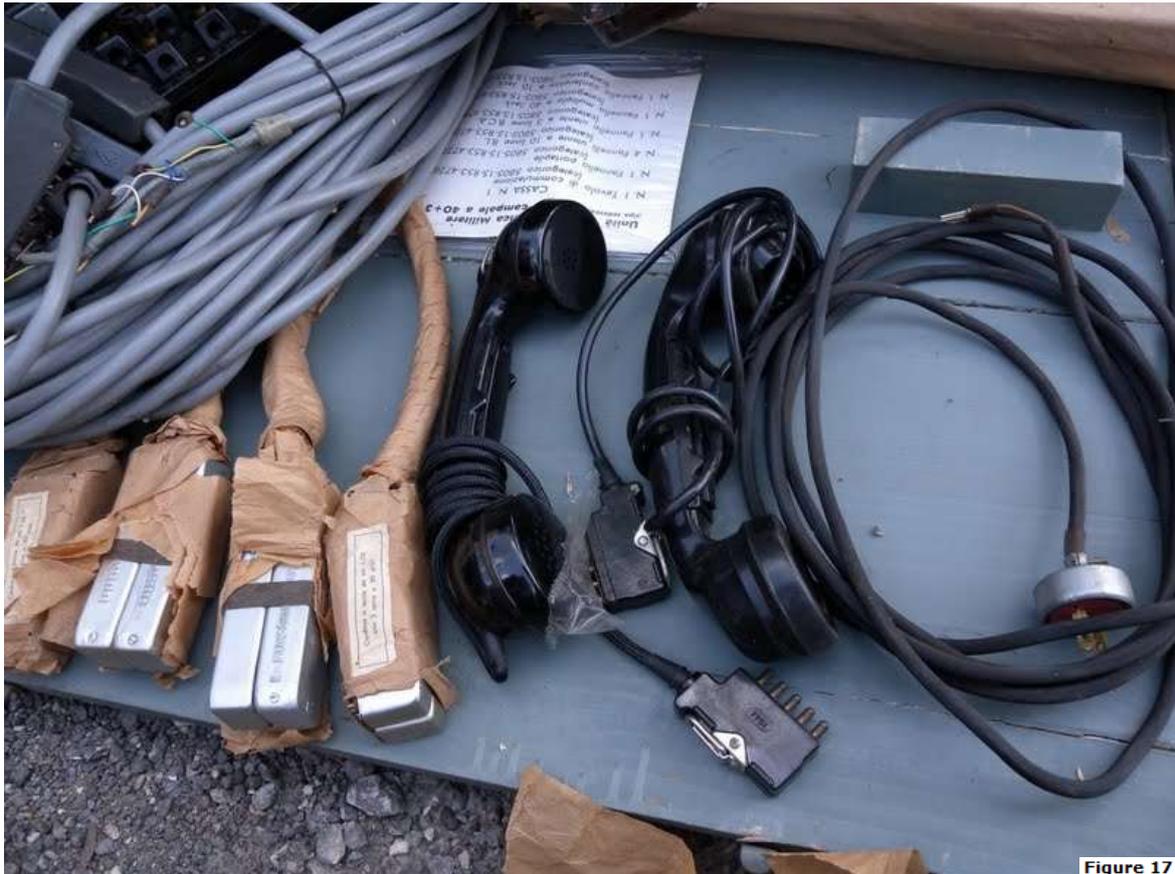
Figure 17

In general, the accessories are in better shape than those which were originally offered by the seller; the left of the two handsets is an original (except for an incorrect mouthpiece). A special chest microphone and headset were often used in lieu of a handset.

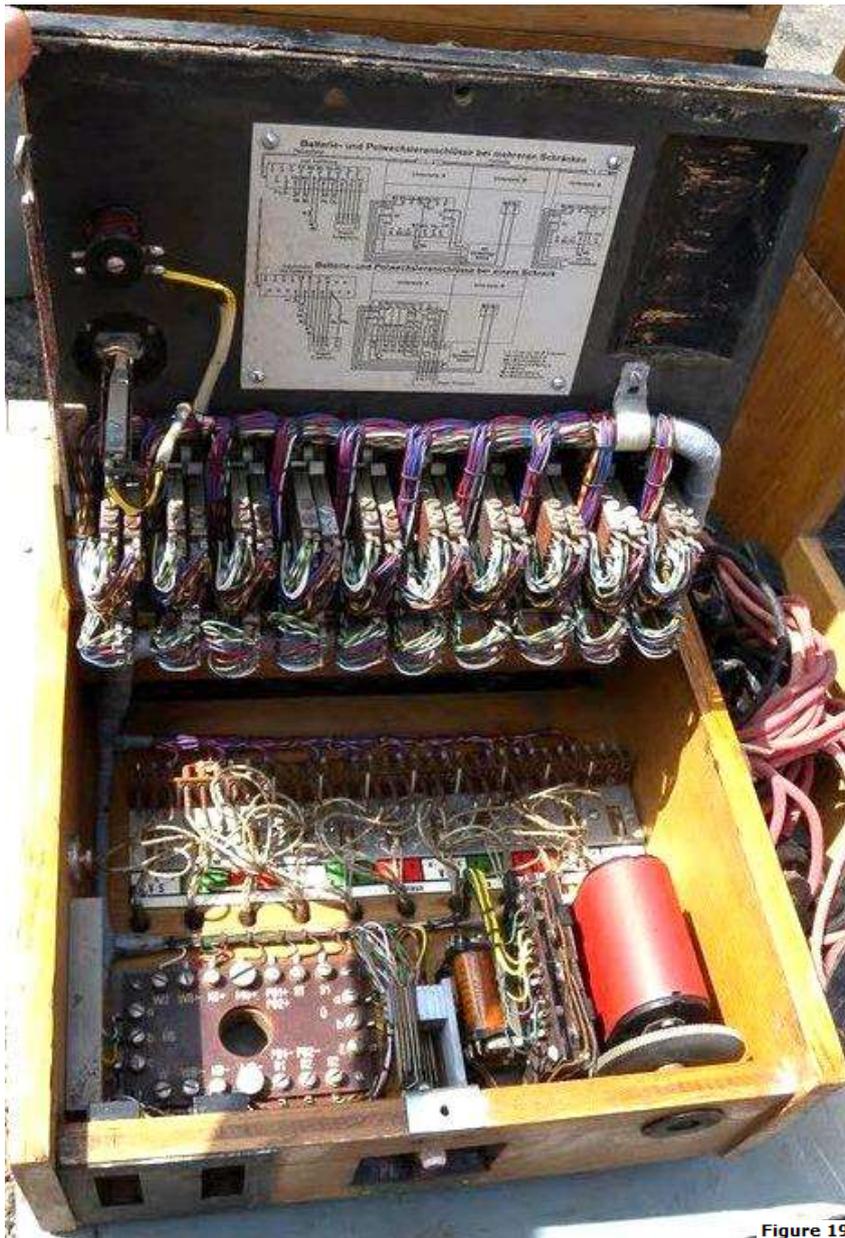
Figure 19

This photograph shows the interior of the type "A" cord board – it was of great importance in finalizing the purchase, because it shows that all of the original components are still inside. The most important bits may be seen on the key shelf – the pushbutton and wire-wound resistor on the far left, above the keys and pushbuttons in this view.

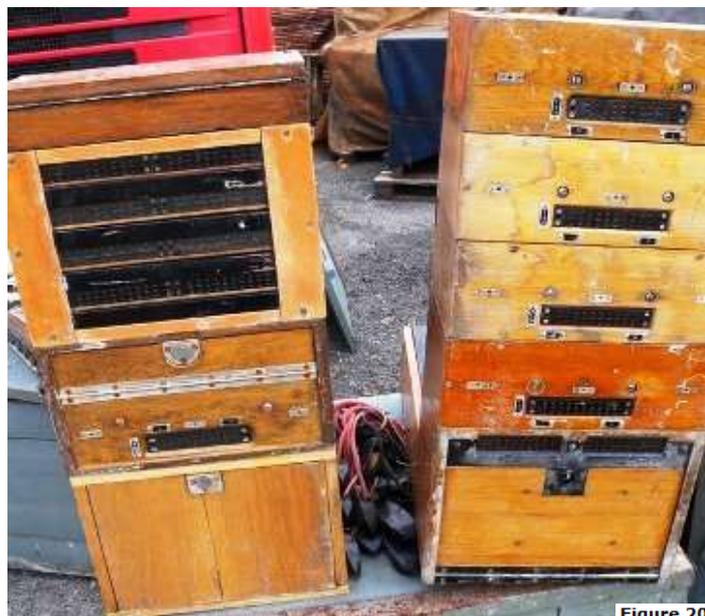
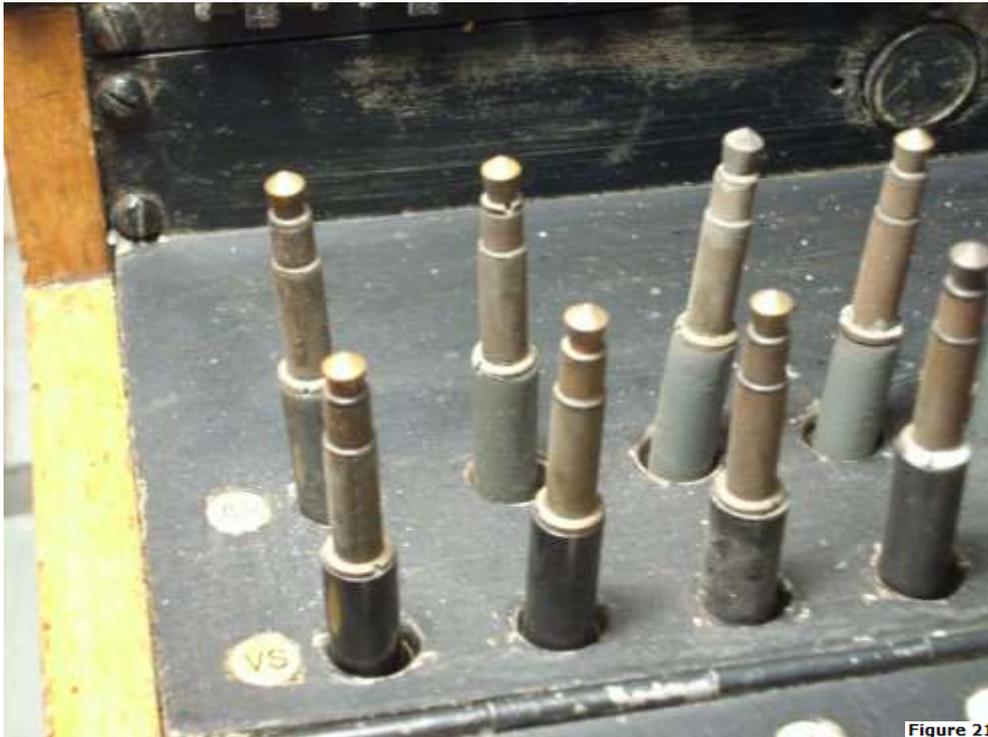
Figure 21

Two general views of the kind of corrosion, dust and dirt I was facing, not to mention that the sleeves on the back row of plugs should be red – not a faded slate color. There is an electromagnetic “star” indicator above the tip of the fourth plug in the back row – this was used to indicate that ringing current from the switchboard was actually flowing into the line being rung. The Kellogg switches with the red handles are combined talk/ring keys, while the white pushbuttons were used to ring back into the calling line.

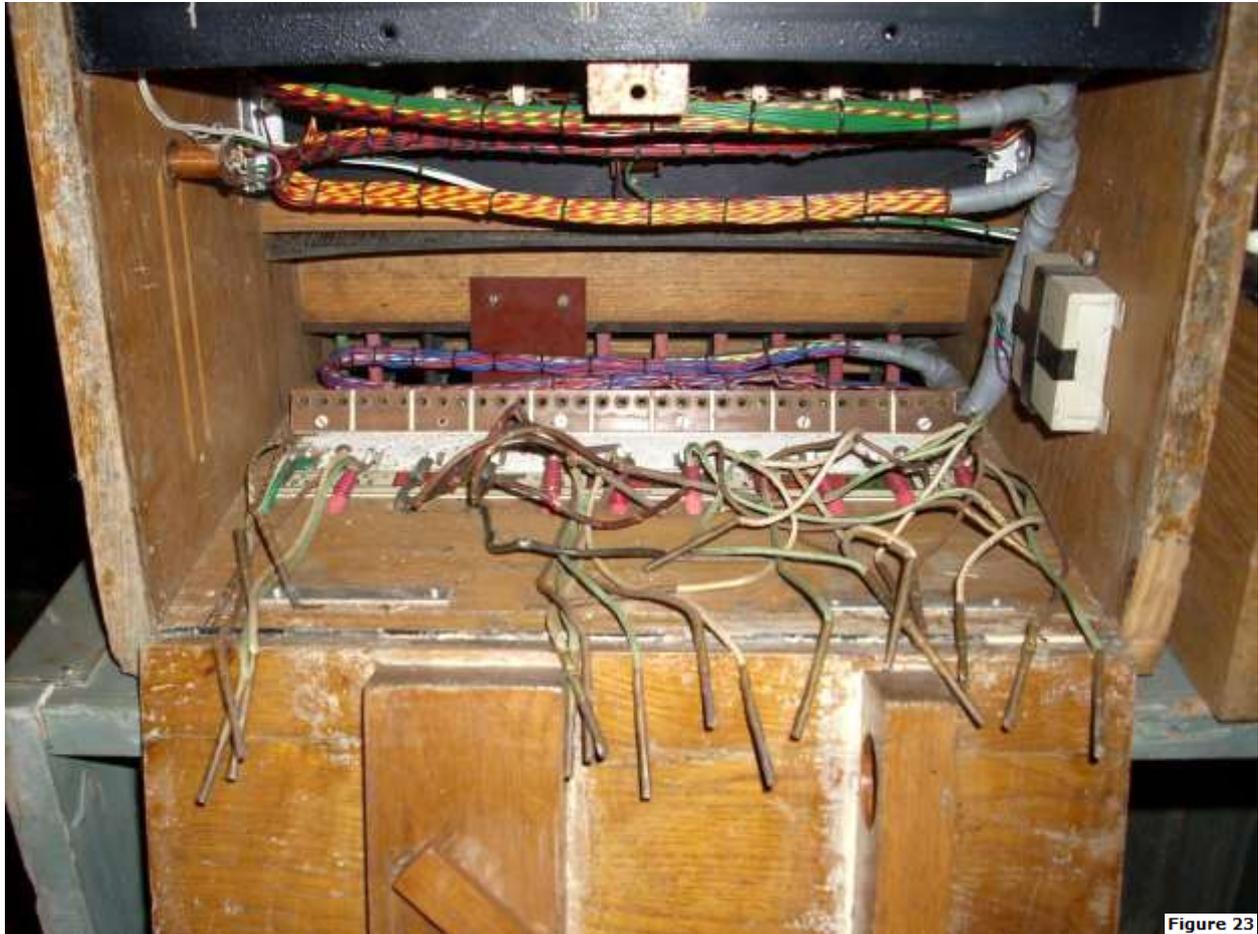
Figure 23

The back side of the type "A" cord board; I was a bit unhappy when I looked into this area, because nine of the ten wire-wound resistors belonging to the original circuitry were missing (to be seen along the left-hand inside wall; I hadn't noticed this in the pictures the seller had provided). These 100 Ohm resistors were intended to limit the inrush current during the "click-busy" test on the multiple jacks. Since the "tip" leads of all 10 cord pairs were originally bussed together via their individual 100 Ohm resistors, the Eyties apparently decided to simply buss them together directly and get away with using a single resistor. This was probably done because such wire-wound resistors were prone to going open, and by eliminating nine of them a major cause of failures was eliminated.

Another thing to be seen, aside from the silt and corrosion, is that some of the cords had wires insulated with PVC instead of silk and cotton... the PVC apparently suffered greatly while the switchboard was in storage, because it's cracked and peeling. Aside from this, the cord tips and their respective sockets required cleaning and burnishing.

BTW – the two pieces of wood attached to the inside of the rear door on the cord board are original. The piece on the left was used to store the magneto crank, but I haven't been able to figure out what the other block of wood was supposed to be for.

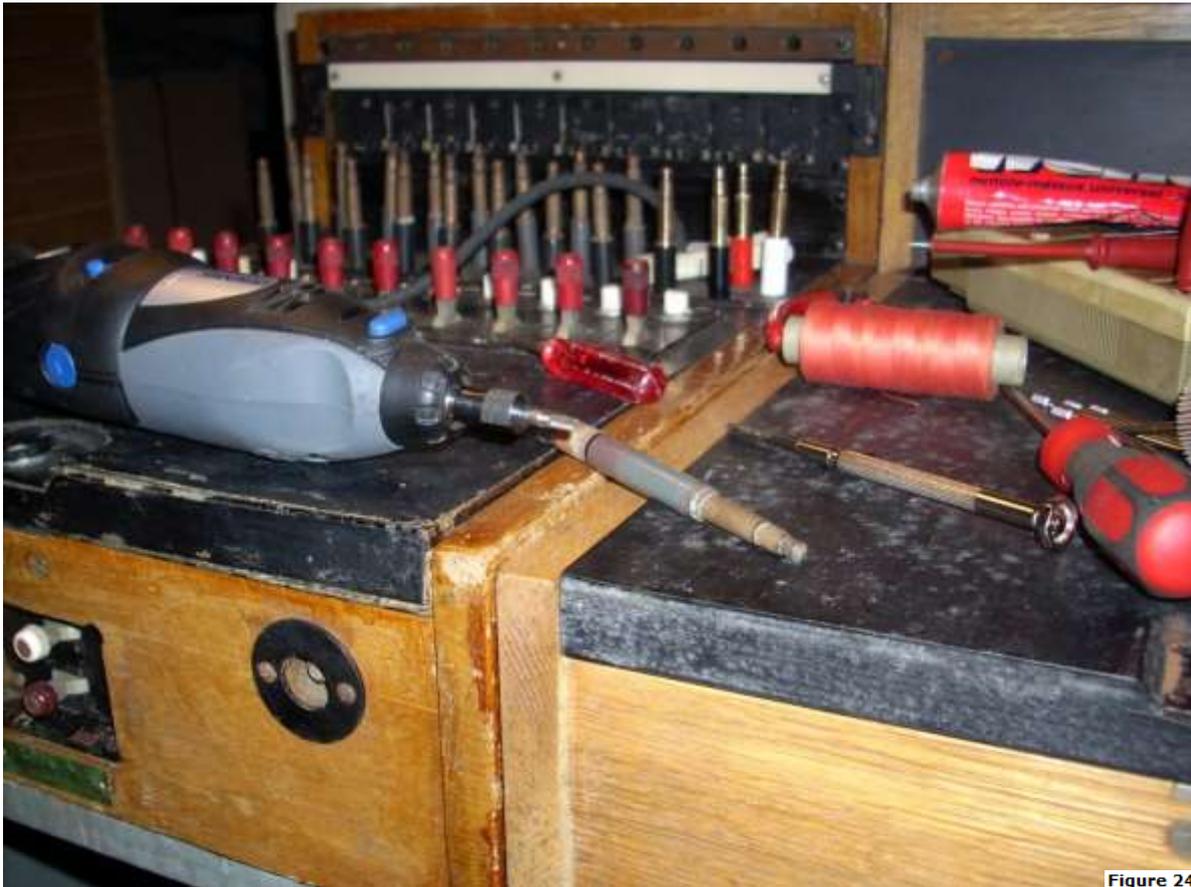
Figure 24

Replacing the ten rear (answering) plugs turned out to be tedious work; the caps at the back end of the plugs (with the cord support springs) were corroded to such an extent that removal would've required brute force which would have damaged the caps. The only workable method was to use an electric hand tool with a grinder bit to carefully cut the sleeves open and then to pry them off the plugs, in order to gain access to the screw terminals inside.

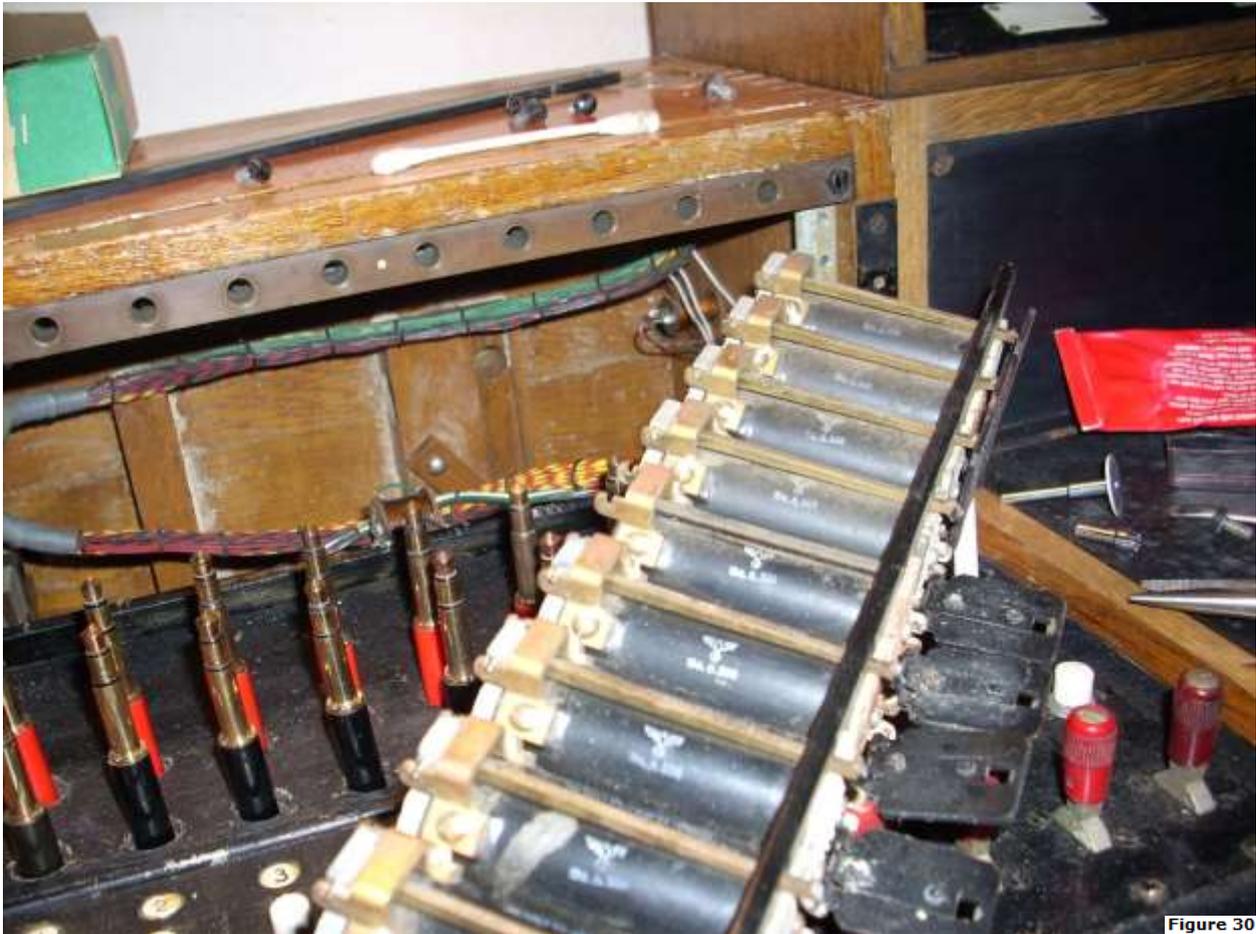
Figure 30

This photograph shows the strip of ring-off drops belonging to the cord board after its removal. I didn't want to have to unsolder and re-solder the wires connected to the electromagnets, so the drops weren't disconnected during cleaning.

If readers take a close look, they will see that the drop armatures rest in two open pivot points on top of the electromagnets – any dust, rust or other corrosion here will prevent the night alarm bell from ringing; each and every such armature had to be removed and burnished.

Readers may also note that there is a rubber stamp on each of the electromagnets ... the stamp consists of a stylized Nazi eagle (complete with swastika) and the lettering "Wa.A. xxx". The first three letters are an abbreviation for the German term "**W**affenabnahmeamt" (literally: weapons certification office – these offices were responsible for determining and guaranteeing that components met all the relevant specifications), while the "xxx" is a placeholder for an arbitrary three digit office identification number.

The ten jacks above the ring-off drops were used in conjunction with the single white-sleeved plug previously mentioned on page 211. These jacks didn't restore their ring-off drops – these had to be manually restored.

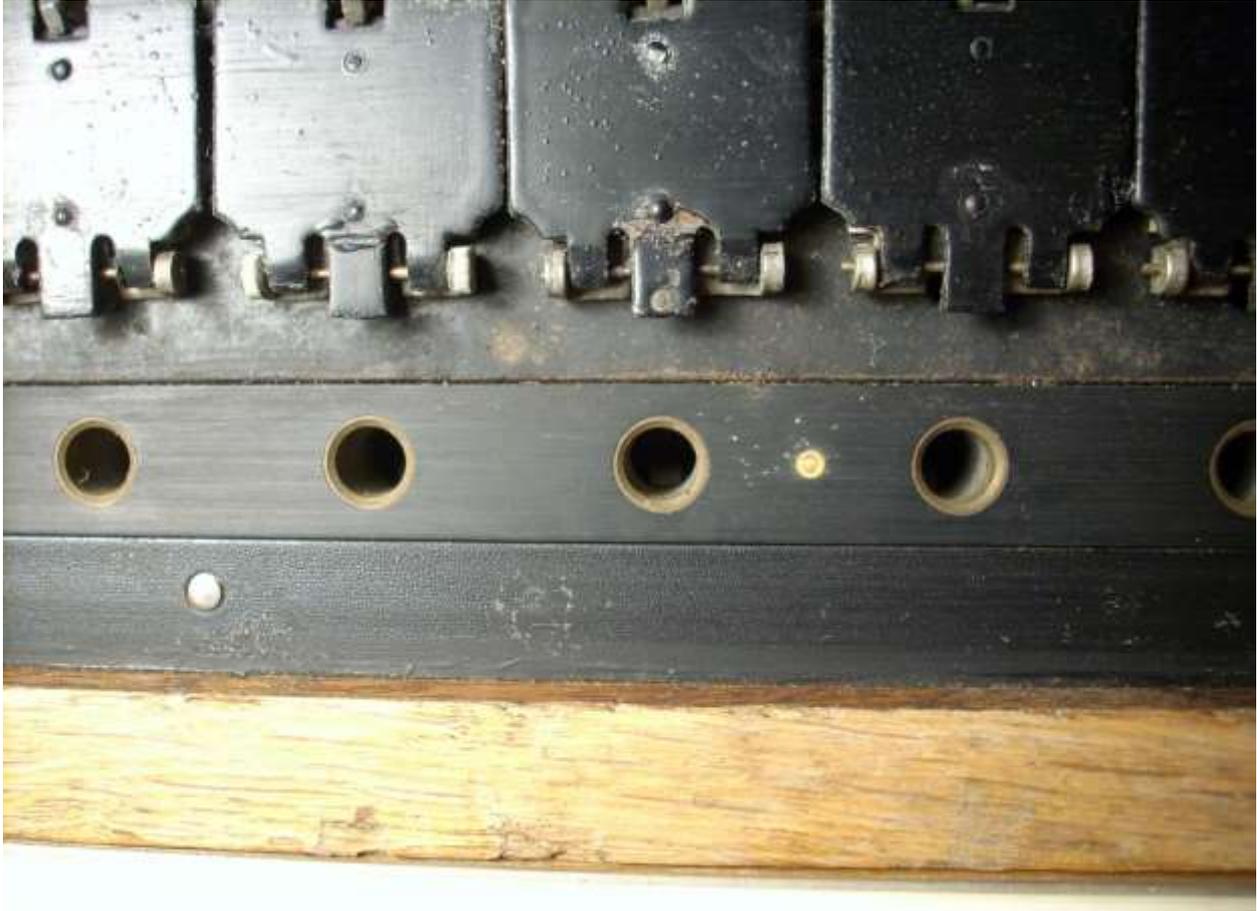
Figure 33

As readers can see, some of the drops themselves are also slightly rusty, and some of the armature hooks slightly bent. I left the drops as found, except those which refused to drop properly – and there were plenty of those. Speaking of the drops: the ones on the line units are of the self-restoring type (i.e. the drop is pushed back up into place by a tongue and roller lever, located above the jack, when a plug is inserted).

Even the jack sleeves were dusty, dirty and corroded on the inside. The question was how to best go about cleaning and burnishing them ... I wound up using a small rotary brush and a lightweight, motorized hand tool; there were "only" 103 jacks, as well as 510 individual contact sockets (for the 30-pin plugs and the sockets for the cord tips) to clean. Each of the latter contacts is slightly smaller than  $1/10^{\text{th}}$  of an inch in diameter (98 mils to be exact, and they're bifurcated as well) so it took quite a while to get them all nice and clean.

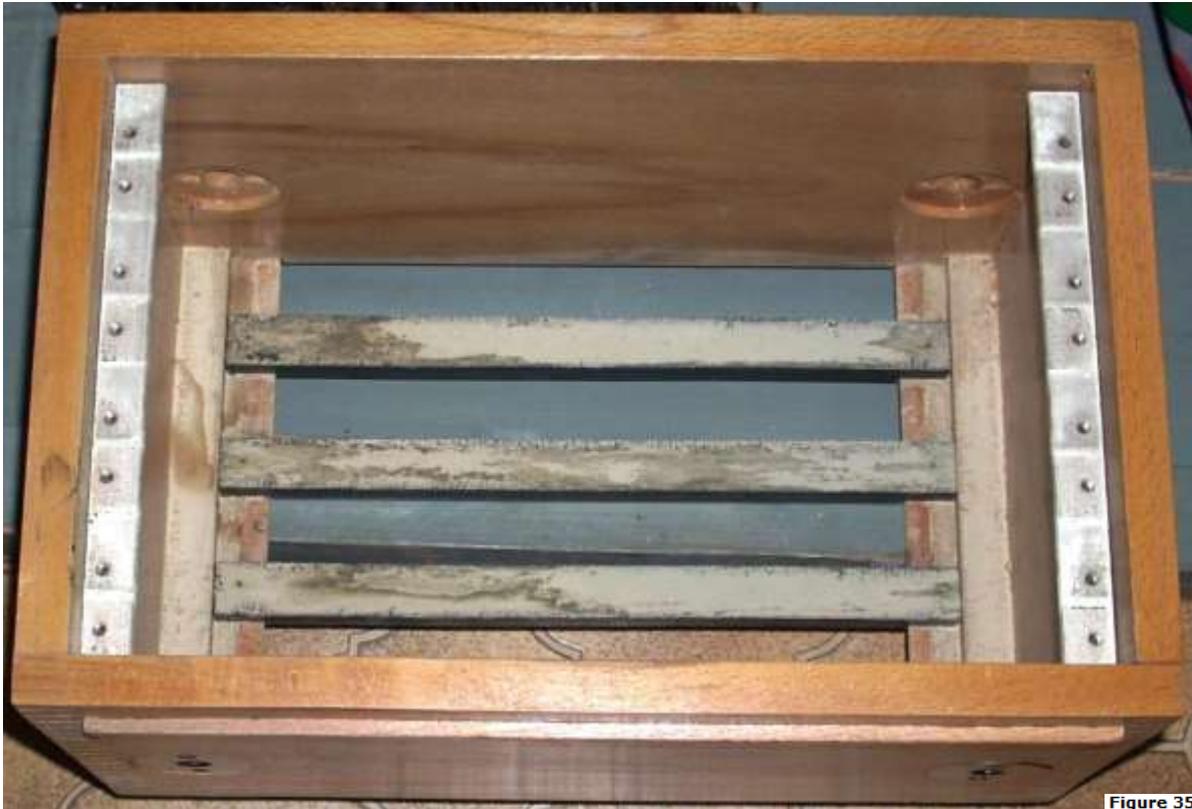
Figure 35

The interior of the box belonging to the line jack multiple, complete with silt. In order to clean this mess up, it was only necessary to remove the threaded metal strips on the sides of the box and apply soap and warm water with the aid of a rough sponge. Washing the soap and gunk out was then simply a matter of rinsing the box inside and out with water from the shower head. The woodwork was then dried with a clean rag, with a bit of further drying with the aid of a heat gun.

After everything was completely dry, the line jack multiple was reassembled and thoroughly tested ... it turned out that a few of the jacks didn't show proper continuity on the sleeve, so the strips were removed again and the two 30-pin jacks of each strip cleaned a second time. That did the trick in most cases, but I also discovered that two of the sleeve wires had broken off at the jacks.

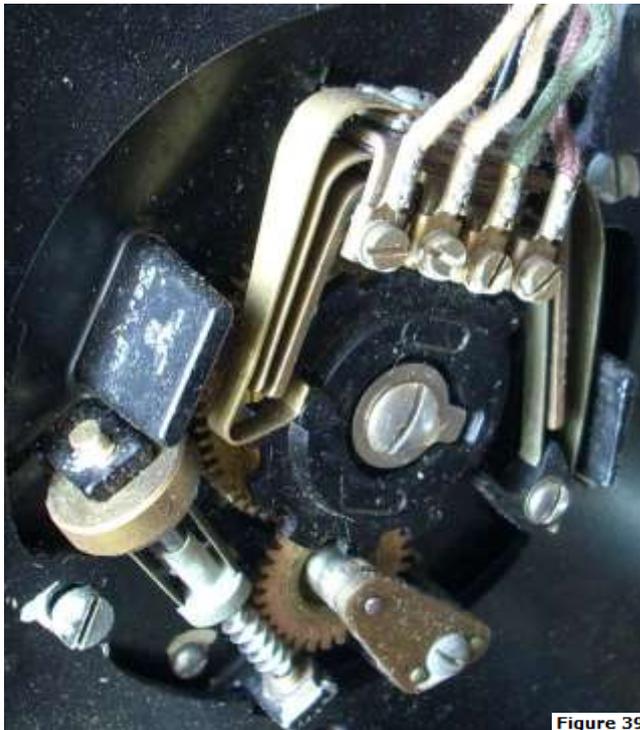
Figure 39

The picture above shows the hallmark on the first two dials, while the snapshot to the left shows the hallmark on the third dial in the defunct unit. Since all three dials carry an acceptance hallmark and are of the BTM style, this specific adapter was obviously intended for use in Belgium only.

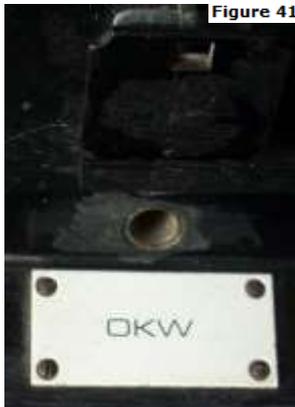
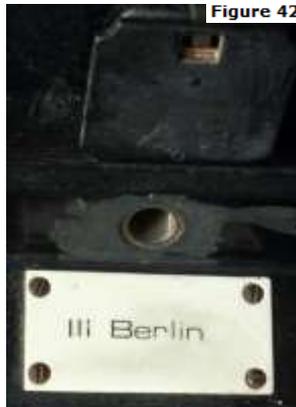
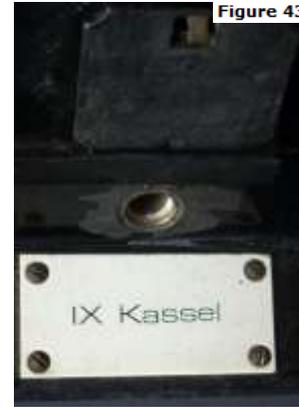
The abbreviation "OKW" stands for the German "Oberkommando der Wehrmacht," which translates to Military High Command; the designation "III Berlin" refers to the high command of the 3<sup>rd</sup> German Army, which had its headquarters in Berlin, and the designation "IX Kassel" refers to the high command of the 9<sup>th</sup> German Army, which had its headquarters in the city of Kassel (all of which are historically correct!)

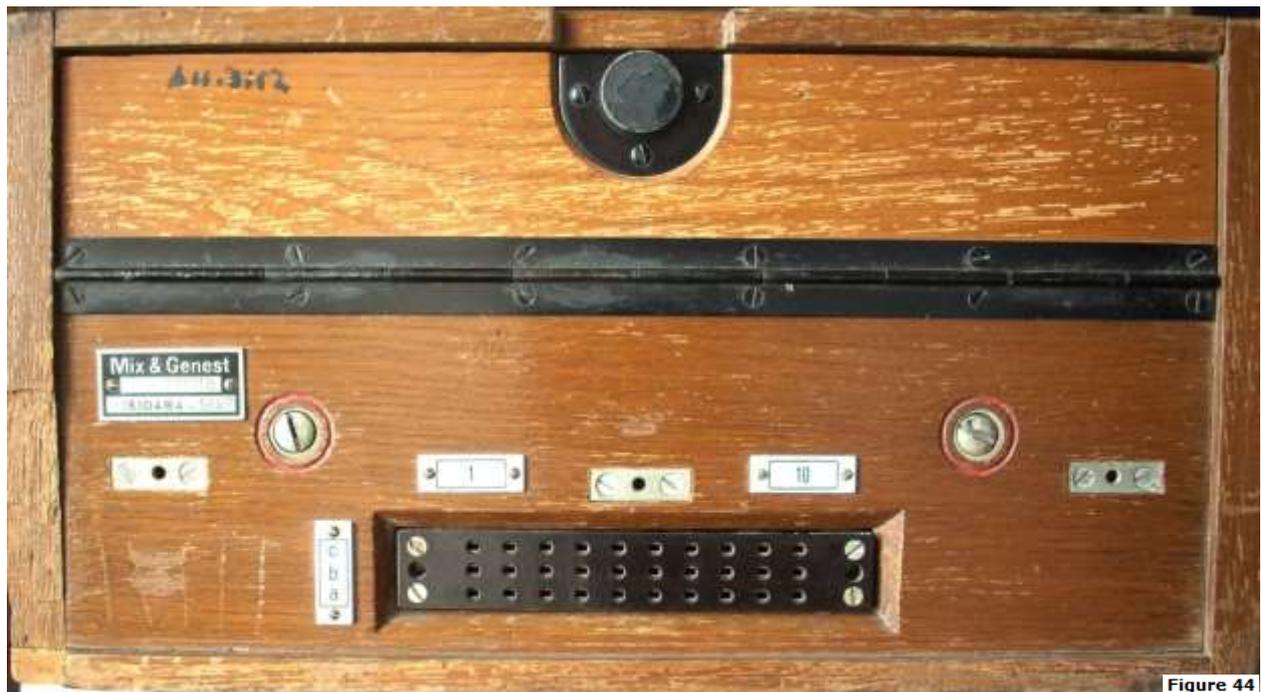
Even up to this point I would've *still* been willing to bet that someone had the line designation tags made up in order to "upgrade" the unit, but then I noticed that the small tags above and to the left of the 30-pin jack on the **rear** of the unit were *also* made of plastic and were factory-printed as well ... although the manufacturer's tag is from the German firm "Mix & Genest" (M&G), the unit *is* of Belgian origin; BTM even manufactured telephones with the M&G logo at one time, so that an M&G tag on a piece of BTM equipment is historically correct. The tag is dated 1942, which matches the year on the frame of the defunct unit, as can be seen in the upper photograph on the previous page. The "B" before the year on the frame indicates the manufacturer as being BTM; an "A" would indicate equipment made by ATEA.

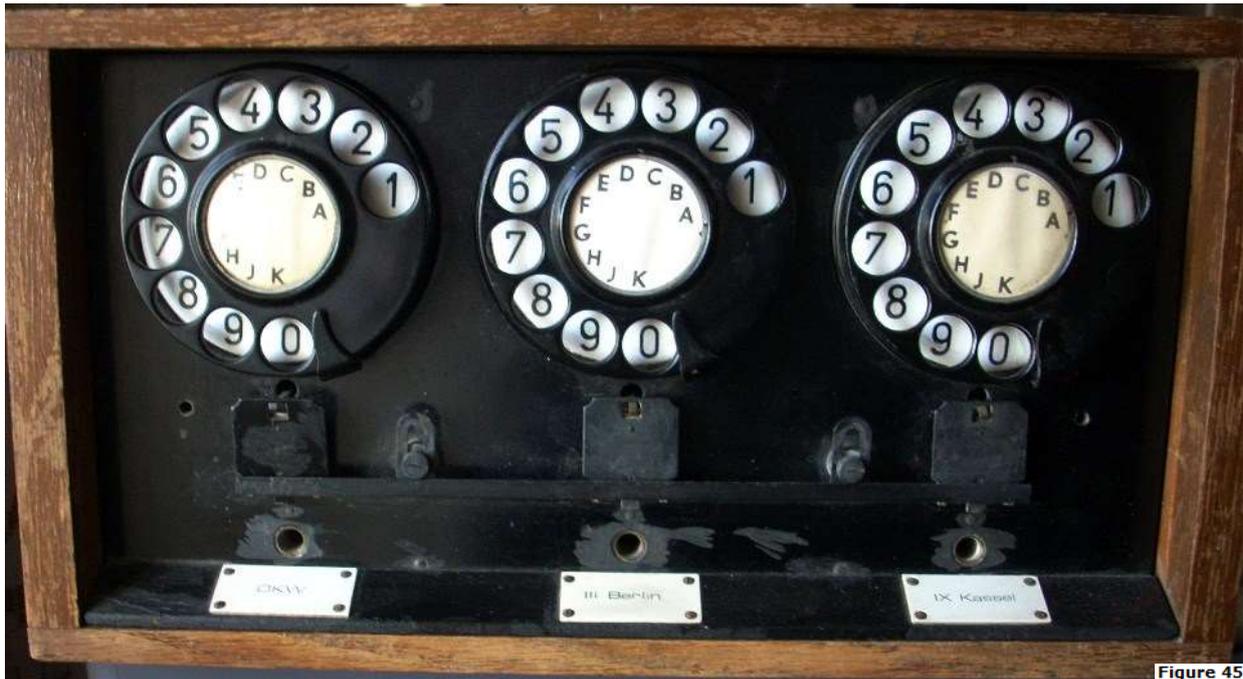
Figure 45

It's interesting to note that the dial inserts carry the letters which were *discontinued* in Berlin as of the April, 1937, issue of the phone book ... despite the fact that this unit wasn't built until sometime in 1942.

The specific unit shown above was apparently used with the field switchboard of some higher echelon military command within Belgium which had direct access lines for dialing into the military telephone networks belonging to the German Military High Command, as well as to the high commands of the German 3<sup>rd</sup> and 9<sup>th</sup> Armies. This unit was an extremely rare find – *nearly* as rare as the interface unit I once bought at a flea market here in Vienna, and which is shown below ....

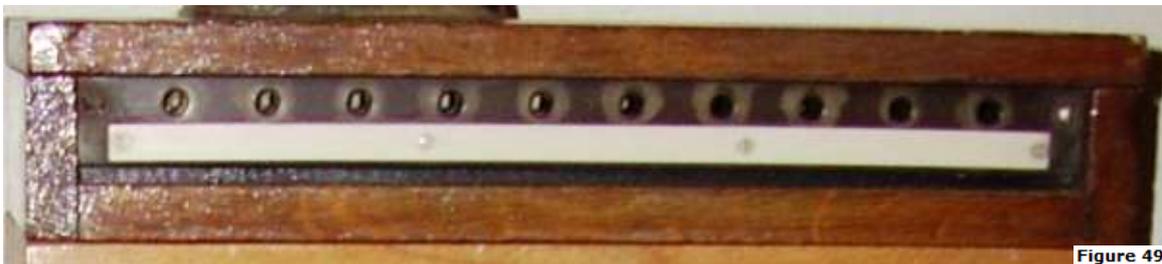
Figure 49

There doesn't appear to be anything special about this unit – it's quite straightforward in its wiring and build. However, this unit was manufactured by the telephone & telegraph firm "VEF" in the city of Riga, in occupied Latvia, in 1943. It would've been very interesting if it had been possible to trace the route this unit had travelled in order to find its way from one of the Baltic States to Italy.
