## A Collection of Telephone Tales

written by Herbert Schwarz of Vienna, Austria, European Union

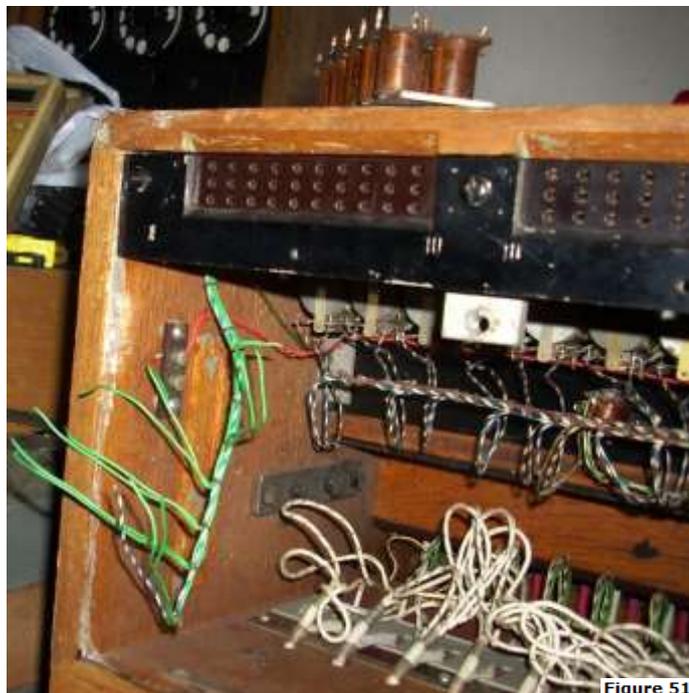
Figure 51

Um, no such luck. Trust folks to really trip me up good. The two 30-socket jacks at the top of the back side of the cord board are used to link up two or more of these cord boards, so that one operator may handle two or three boards from a single position during hours of light traffic. The ones on the Austrian switchboard weren't fully wired up when the board was rewired, and two wires wound up being shifted by one column so that there was no proper interconnection between the boards.

So, I shifted the two wires back to their proper column, closed things up, turned the board around again, hooked everything up, and ... no joy. The click-busy test *still* didn't work. What on earth could be wrong now? As further, tedious troubleshooting revealed, those two wires I'd shifted had originally been soldered in place without any regard for their polarity and were thus *reversed*. After I swapped those two wires back, the click-busy test *finally* worked as advertised.

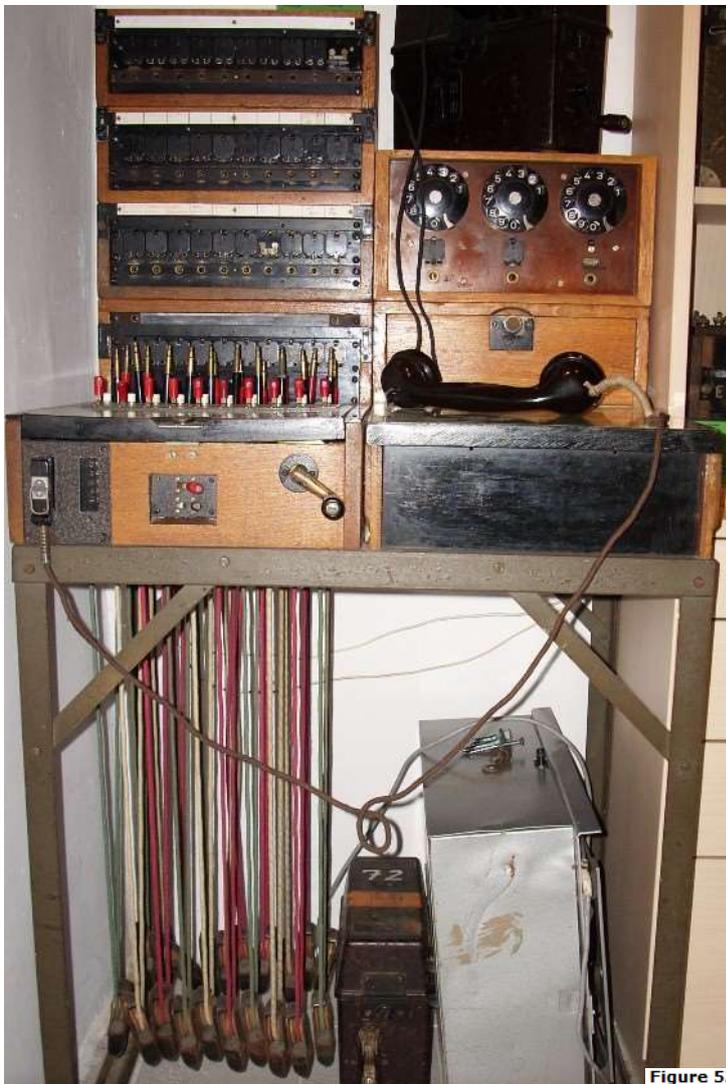
This specific example of a modified switchboard has cord pairs alternating in green, white and red; this was the original cord color scheme as used by the German Wehrmacht in WWII.

The frame this switchboard is standing on is a very good replica of an original, and this suite also has an original type “B” cord board (on the right).

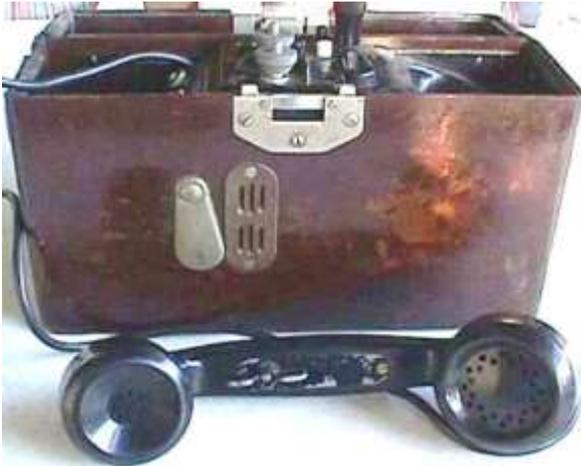
Figure 1

The case shown to the left has a nice, deep luster – which is most unusual – and has the early, nickel-plated fittings.

However, there is something seriously wrong here, namely the handset. The handset shown has a "butterfly" style push-to-talk switch which is typical of the type belonging to the WWII era US Army EE-8 field phone (TS-9-AN) ... and even this handset is messed up in that the mouthpiece doesn't belong to a TS-9-AN handset. This FF-33 is junk.

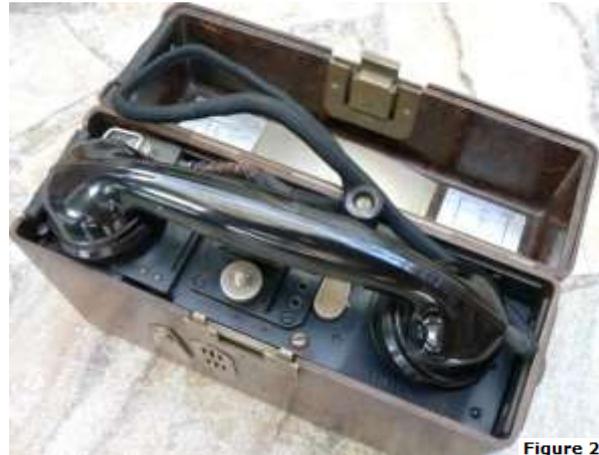
Figure 2

Another FF-33 which has an incorrect handset; in this case, it's a post-WWII German model W48 telephone handset. Aside from this, the handset cord is far, far too short and too thick to be original.

The rest of the FF-33 appears to be complete, but it's very unusual that the two captive screws which hold the telephone unit in the case don't have the obligatory red rings around them – this indicates that the frame of the telephone unit was repainted at some time. Junk.

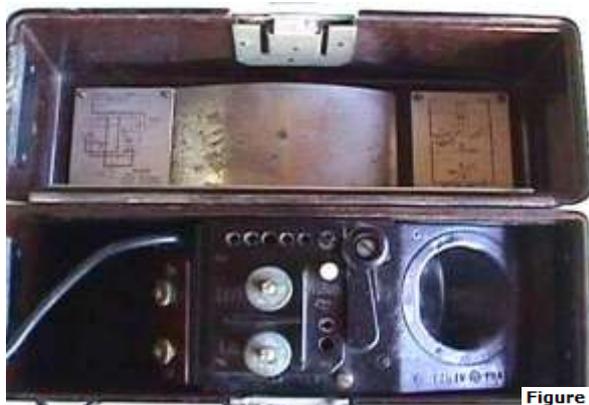
Figure 3

This is another view of the first FF-33 shown on this page ... here, one can see that the handset cord isn't attached to the telephone unit via the standard handset plug, but that the cord disappears inside the phone instead; the wires are probably soldered directly to the sockets inside the phone itself.

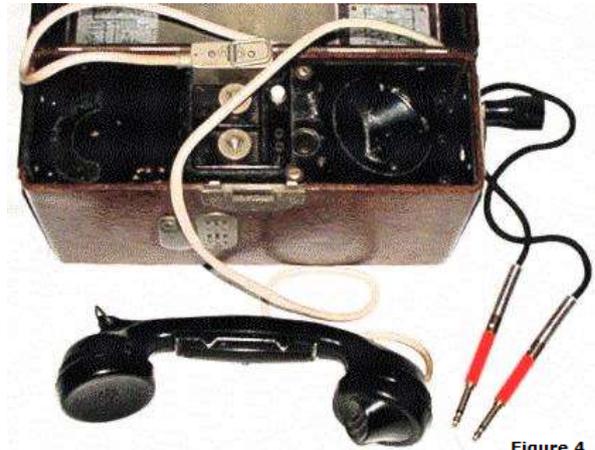
Figure 4

More pure junk – I wouldn't pay more than 10 dollars for an FF-33 like this one. The handset cord is modern *power* cord and what is claimed to be "an original" patching cord (an accessory which is missing 99.99% of the time) is from the German successor to the FF-33, which has *entirely* different patching jacks. The plugs on this patching cord are slightly shorter, and also thinner, than the original plugs, and they're simply too small for the original FF-33 patching jacks (see pages 269 thru 271 for more information on the patching cord and jacks).

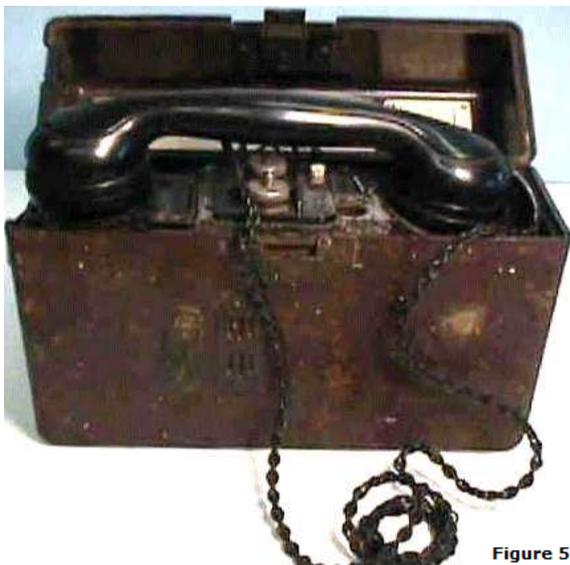
Figure 5

The FF-33 to the left is only scrap – the frame of the telephone unit is corroded, the case is just a bit too beat up to be nice, and worst of all, the handset belongs to a German model W28 desk telephone, but certainly not to an FF-33.

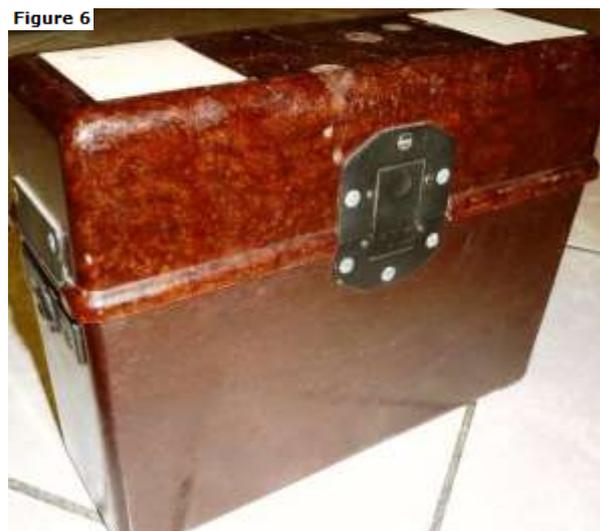
Figure 6

There are at least two things wrong with the FF-33 shown on the left: the mouthpiece of the handset is of an incorrect type, and the handset cord is by no means an original. If I had to make a guess, I'd say that the cord was robbed from a Czech field phone from the 1950s.

More junk, because an original handset cord is hard to come by as a replacement.

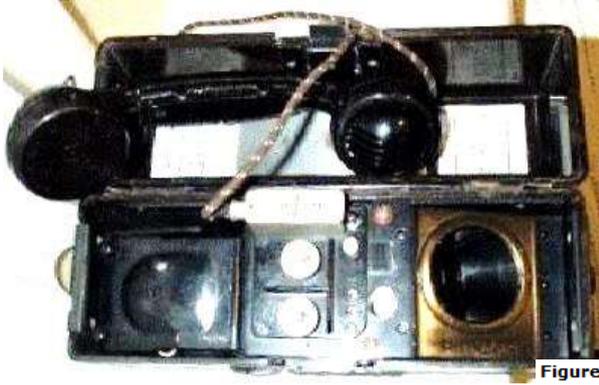
Figure 7

The field phone shown on the right was offered as an "original FF-33." Sorry – the FF-33 was *never* supplied in a leather carrying case, and it never had the coaxial plug seen on the left side of this unit.

What we *actually* have here is a railroad magneto telephone from the mid to late 1940s, with a rubberized handset cord. Although the handset has a PTT switch which looks like an original, there is a subtle difference: the one here is missing the 3 dimples on the frame which the original switch has.

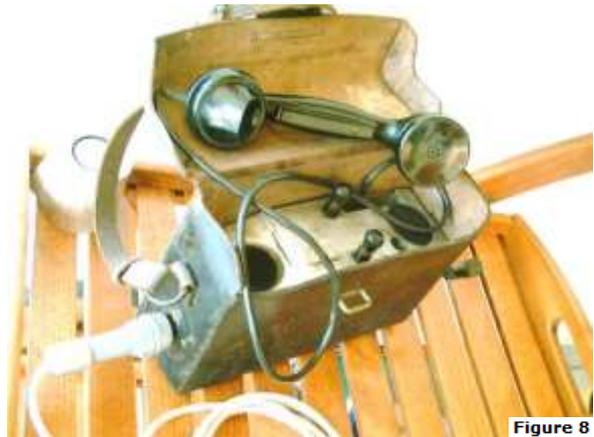
Figure 8

There are several things wrong with this FF-33: 1) the handset belongs to the German successor to the FF-33; 2) the handset cord is correct (but only for the handset shown, and *not* for an original) and 3) the acceptance hallmark, the serial number, the manufacturer's logo and the year of manufacture have been filled-in with white paint, which simply wasn't done.

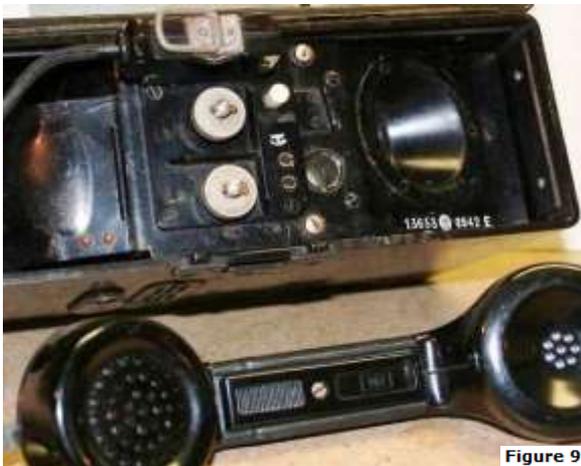
Figure 9

Some fool repainted the frame of the telephone unit on this poor FF-33; flat black and tan/sand were the only colors used. Besides this, the handset cord is a thin, modern cord from the 1960s, and the testing pushbutton (red here) was always white in color on an undisturbed FF-33, although it may have yellowed with age.

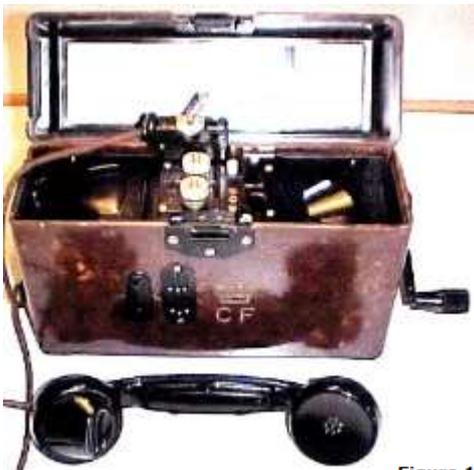
Figure 14

The FF-33 shown on the left, while being in excellent overall condition, *can't* be considered to be an "original" because the front of the case carries some engravings: a crown and the capital letters "CF" – I am no longer certain whether it was the Danes, the Swedes or the Norwegians who refurbished and marked their "left behind" FF-33s in such a manner for use within their own military.

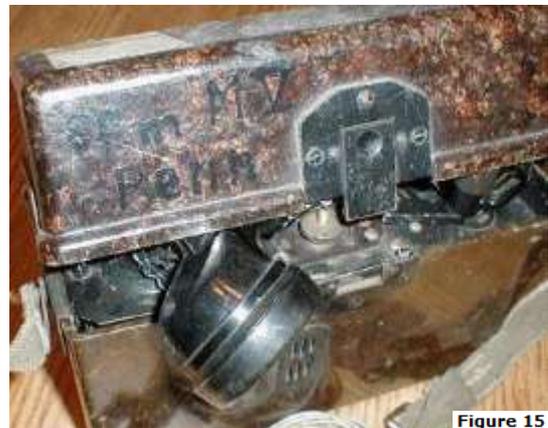
Figure 15

The FF-33 to the right carries the hand-painted legend "Sfm MV Perin" – definitely of civilian origin from some time after the end of WWII.

The only portion of these civilian markings which reminds me of anything at all is the "Sf," which was often the abbreviation for "Streckenfernsprecher", which refers to a telephone used on some sort of "telephone" or "railroad" line.

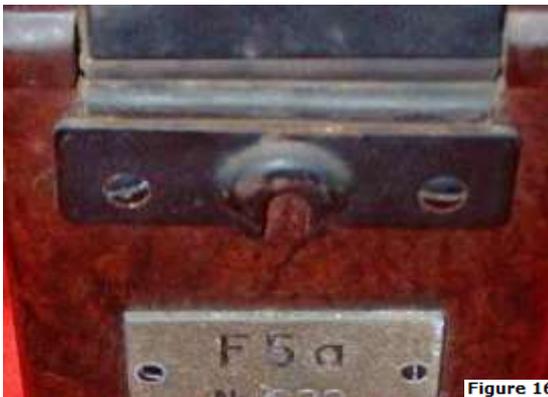
Figure 16

The external, metal placard on this FF-33 reads as "F5a," below which there is a serial number (only partly visible in the photograph). This means that this particular FF-33 was refurbished, possibly with major changes to the circuitry, for use by some civilian entity such as an office of civil defense.

By no means in original condition – junk.

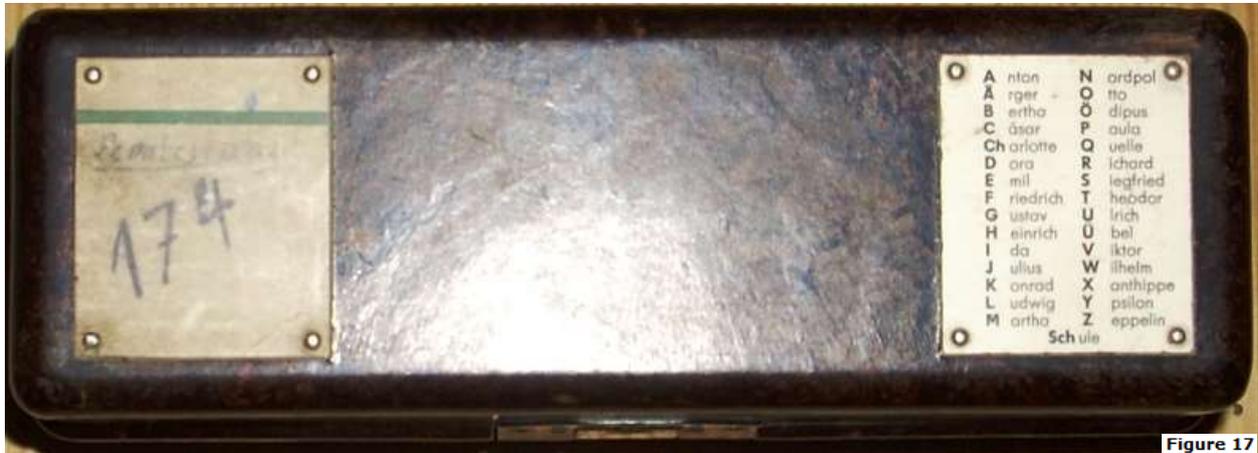
Figure 17

The FF-33 shown above in closed condition is one from my collection. It has some unusual writing on the placard on the left; the code name of the exchange or distant field phone was normally written here. In this case, the text reads as "Fernleitung 174" – long distance (or toll) line 174.

Since this FF-33 doesn't carry any markings showing that it was in use by the Austrian PTT (or any other civilian entity) after WWII, the writing may well date from WWII; it was standard practice within the German Wehrmacht to connect FF-33s to important phone lines when the relevant switchboard was out of commission.

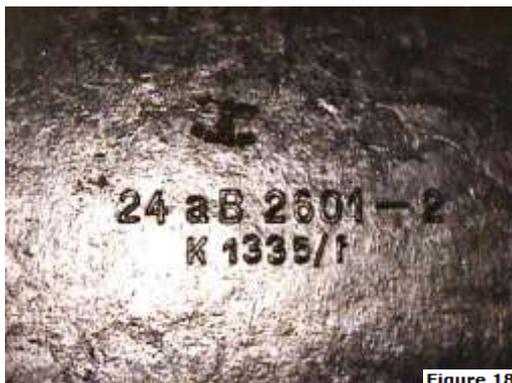
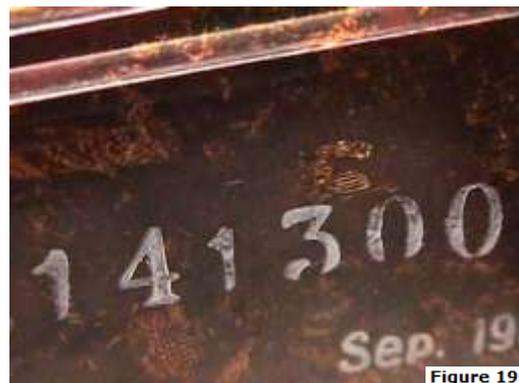
The two photographs above show the inspection hallmark inside the bottom of the case, above the specification drawing numbers, and the same inside the lid (on the right). The FF-33 on the right was used by the Austrian PPT at some time after WWII, and the white stamp markings inside the lid show a portion of the 9-digit PTT part number and a portion of the year and month of refurbishment.

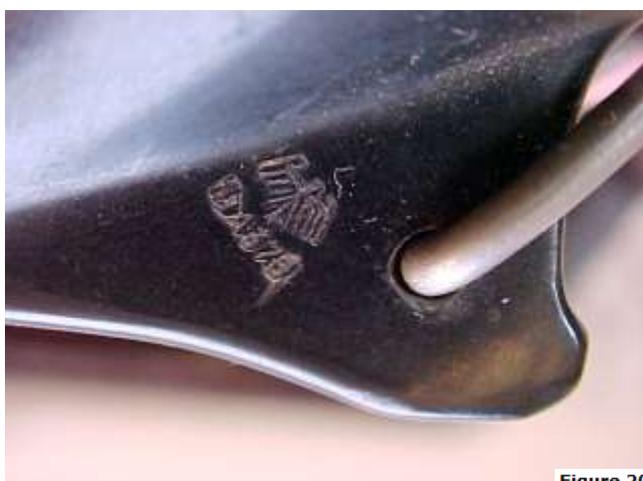
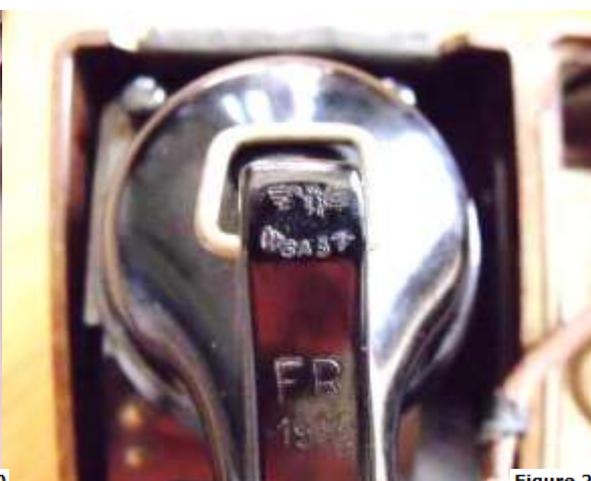
The photograph on the left above shows an example of the older style Wa.A. inspection hallmark on a handset, while the photograph on the right gives an example of the new style Wa.A. hallmark. The former type was used during the German Weimar Republic, while the latter style was used by the Nazis as of circa 1935. As one can see, the handset on the right bears additional markings: "FR" for the German telephone and telegraph firm Friedrich Reiner, and the year of manufacture (1937 in this case).

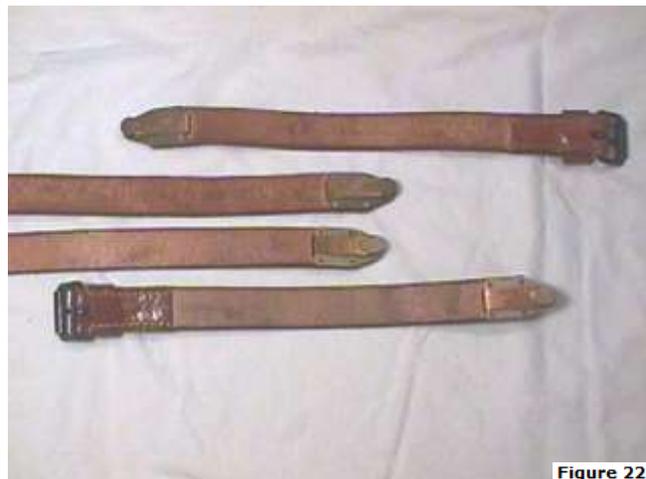
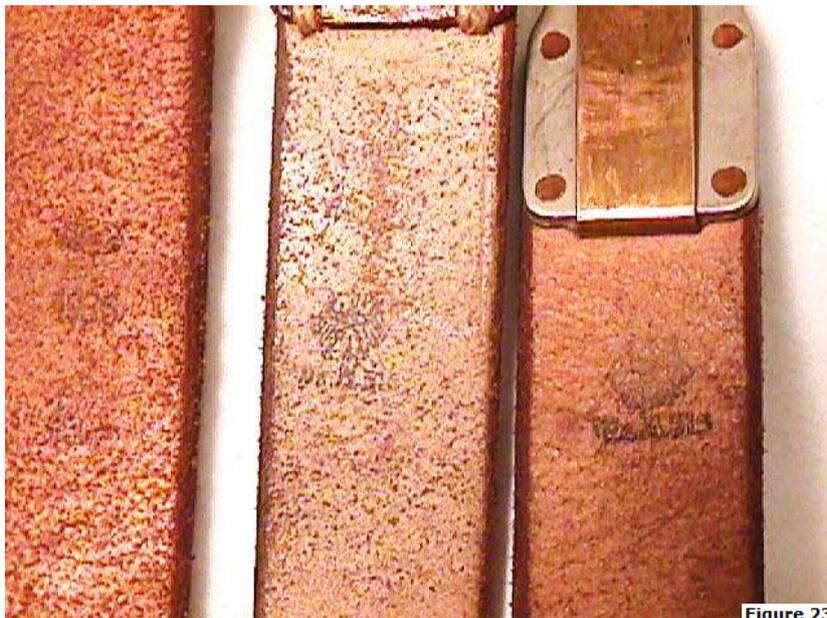
The picture on the left is in a somewhat larger size so that the Wa.A. hallmarks and the year of manufacture can be seen.

Both of the hallmarks are of the older style, since the year of manufacture is circa 1935. The copper-plated steel spring (as seen on the right-hand strap) is intended to force the head of the fitting into the flange on the case.

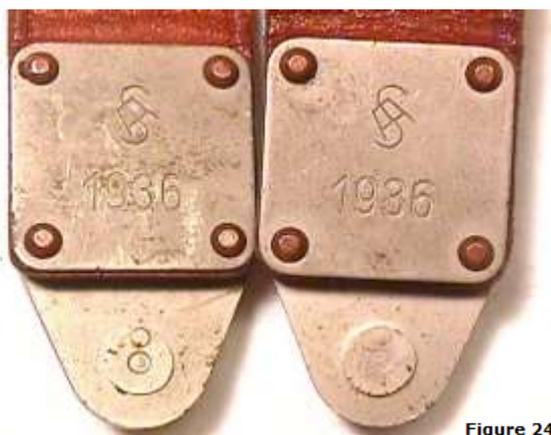
Figure 24

This photograph shows the attachment fittings from the front side. Since this particular strap was manufactured prior to the outbreak of WWII, the fittings are finished in dull nickel-plate.

The logo belongs to the Siemens Apparate und Maschinen GmbH<sup>[1]</sup> (Siemens Apparatus and Machine LLC), a subsidiary of Siemens & Halske which manufactured equipment for the German Wehrmacht.

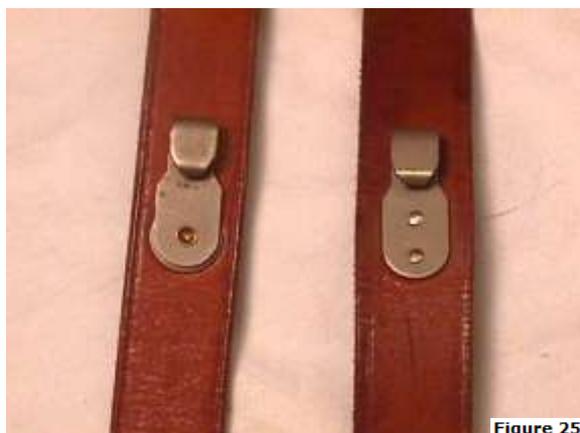
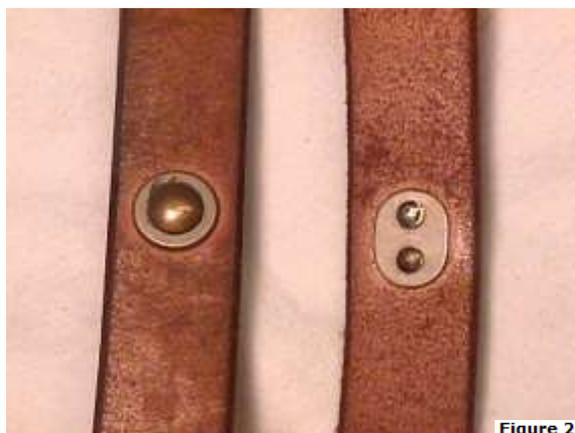
The two photographs above show the handset hook in both variations – with one and two rivets; in both cases, the hook is of the early style, made of spring steel. Changing the method of attaching the hook from two rivets to one had a simple reason: using only one rivet allowed the hook to swivel into any position, so that the handset always hangs straight down, even if the strap were wrapped around a tree trunk, as was often the case. It was standard practice to attach FF-33s to trees at about waist height ... the single rivet was changed back to a double rivet at an unknown time during the war.

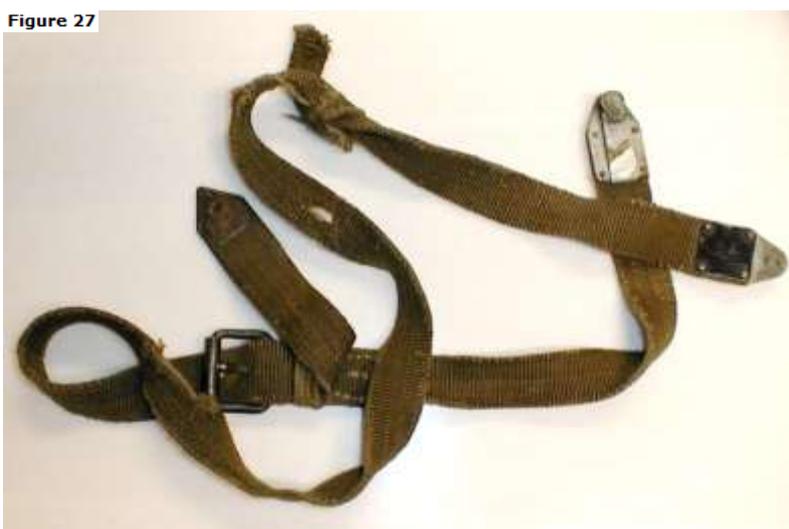
Figure 27

An example of an original, woven carrying strap, although in very poor condition – the strap is torn in one place, and the handset hook is ripped out. This strap has the same type of attachment fitting as the leather straps.

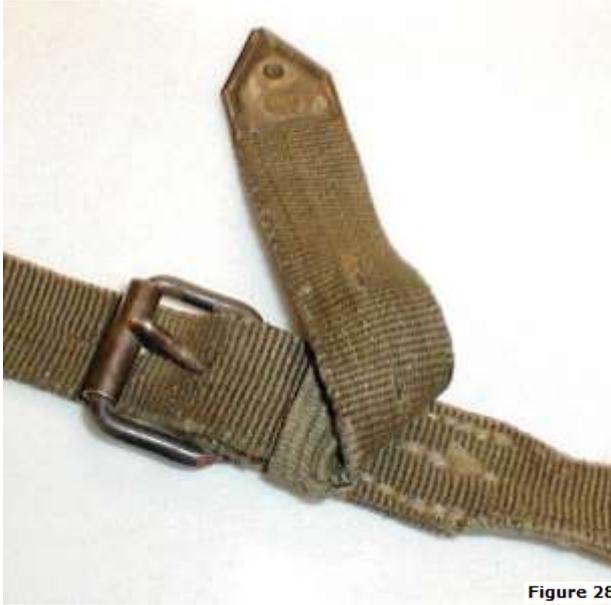
Figure 28

As shown in the photograph on the left, the woven carrying strap doesn't have any reinforcing rings in the holes of the tongue portion, and the end of the tongue portion is steel, pressed onto the strap and held in place with a single rivet. The buckle is of the same style as on the leather carrying straps.

The fittings on the woven carrying straps fulfill the same criteria as those on the leather straps – the manufacturer's logo and the year of manufacture are die-stamped onto the attachment fittings.

In this case, the manufacturer is RB&Co, who was also a manufacturer of FF-33s, and the year of manufacture was 1944.

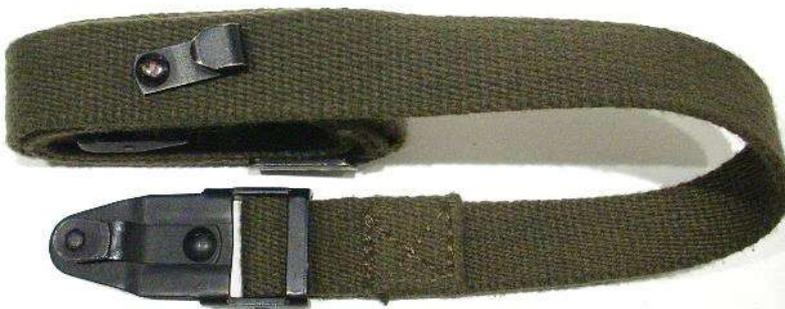
Figure 30

The two leather carrying straps shown here are of post-WWII manufacture, from the early 1950s.

They're made of *black* lacquered leather and have the original type fittings – **but** the fittings of these straps don't carry any logo or year of manufacture, which makes these newly made German military straps easy to recognize.

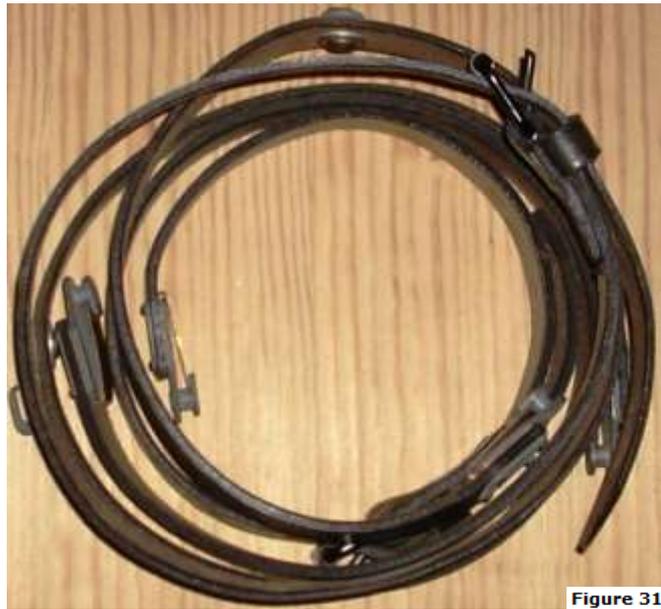
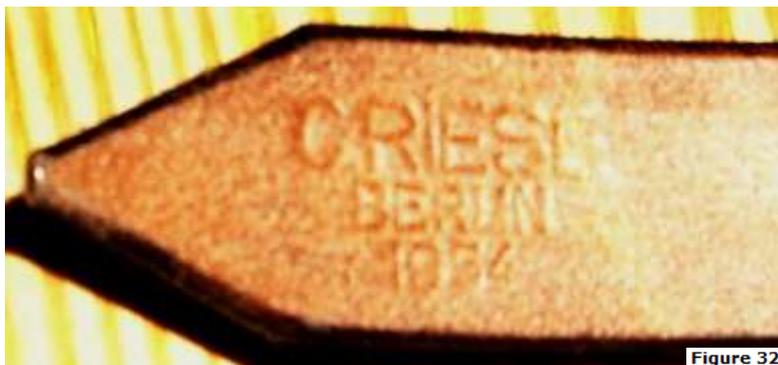
The manufacturer's name, city name and the year of manufacture on the inside of the tongue of one of the German military repro carrying straps – another dead giveaway that this *isn't* an original carrying strap from WWII.

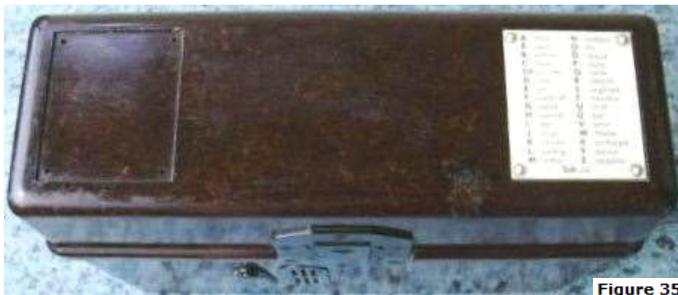
Figure 35

The placard with the German-language phonetic alphabet is far too clean and white to be an original, but the really bad news is that the writing plate on the left side is missing, which also means that the flat brass (or steel) spring inside the lid is also missing.

More bad news: both external placards have been defaced, which means that this particular field phone saw some civilian use after WWII.

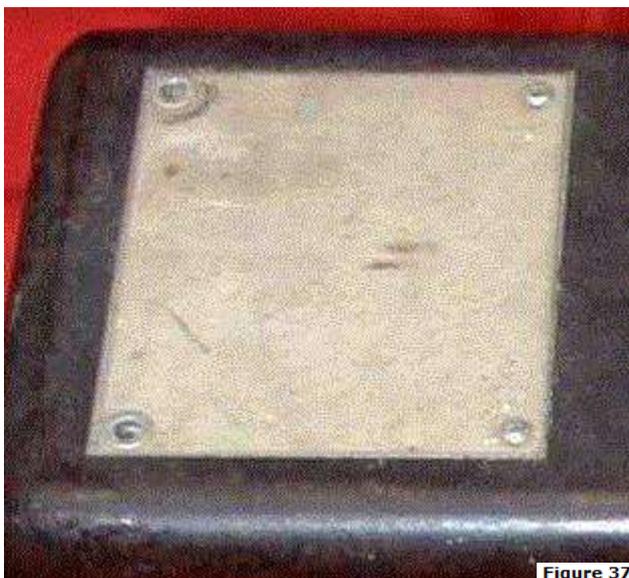
Figure 37

Very bad – not only has the placard been defaced, it was also removed in order to deface it (possible the placard was simply flipped over, since the back side is blank to begin with).

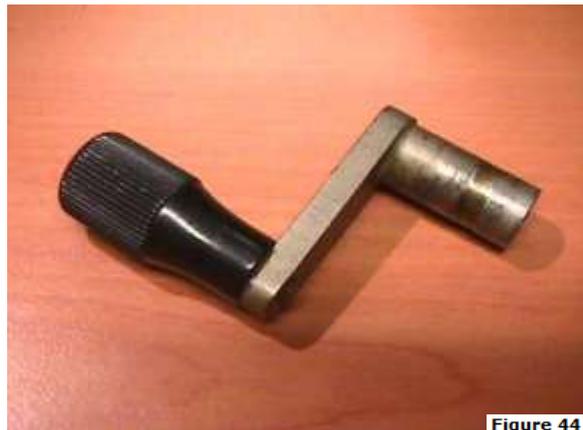
Figure 44

The two photographs above show the oldest of the three types of original magneto crank to be found with an FF-33. As may be seen, this crank carries the manufacturer's initials (F.R. = Friedrich Reiner of Munich, Germany) and the year of manufacture (1937).

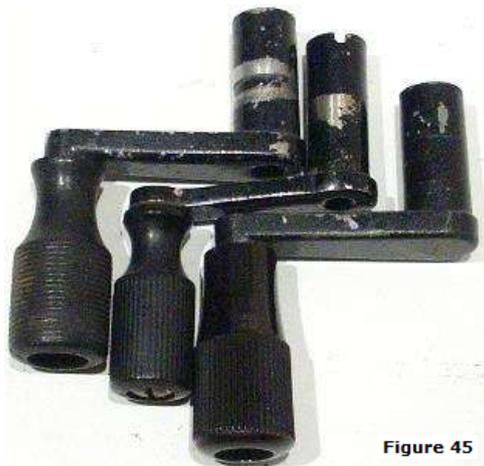
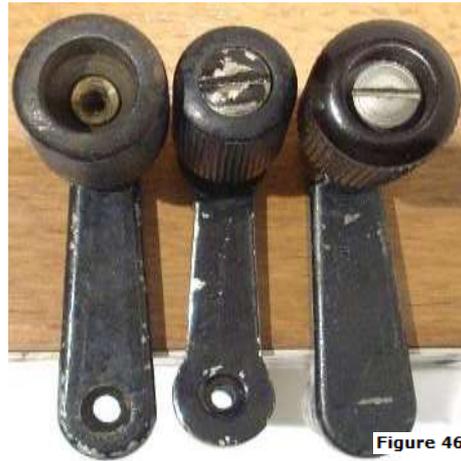
Of the three magneto cranks shown above, only one is an original; it's the one on the right in both pictures. Although the middle one matches the last type of crank manufactured for the FF-33, the one shown **isn't** intended for an FF-33, since it has a through-hole for a screw to fasten the crank to the magneto gear-shaft (the same also holds true for the second crank with a through-hole).

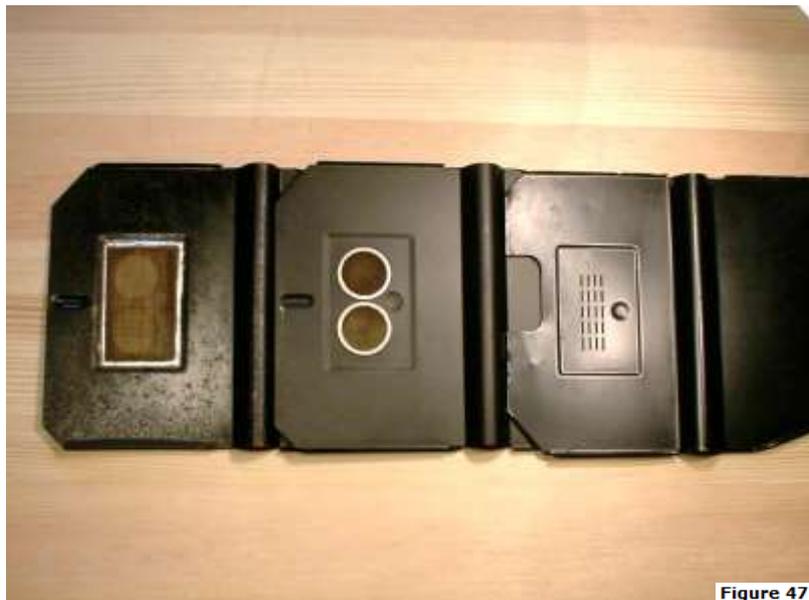
Figure 47

The photograph to the right shows all three types of protective covers which are known to have been used on the telephone unit of the FF-33 field phone.

Soldering the wire mesh to the cover was a time-consuming process and was abandoned after a brief time. The circles of wire mesh used with the second type of cover are not soldered, but rather held in place with pressed metal rings.

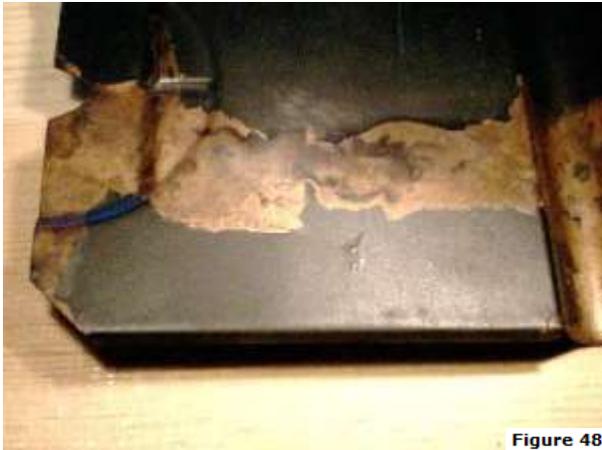
Figure 48

This is a nice example of how the flat black paint can peel off those covers which were copper-plated. The damage shown happens to be on the *outside* of the cover, but any prospective buyer should insist on pictures of both sides of both covers, in order to be certain that they're in good condition. FF-33s are often found with a non-matching pair of protective covers; such mix-ups usually happened at field repair stations.

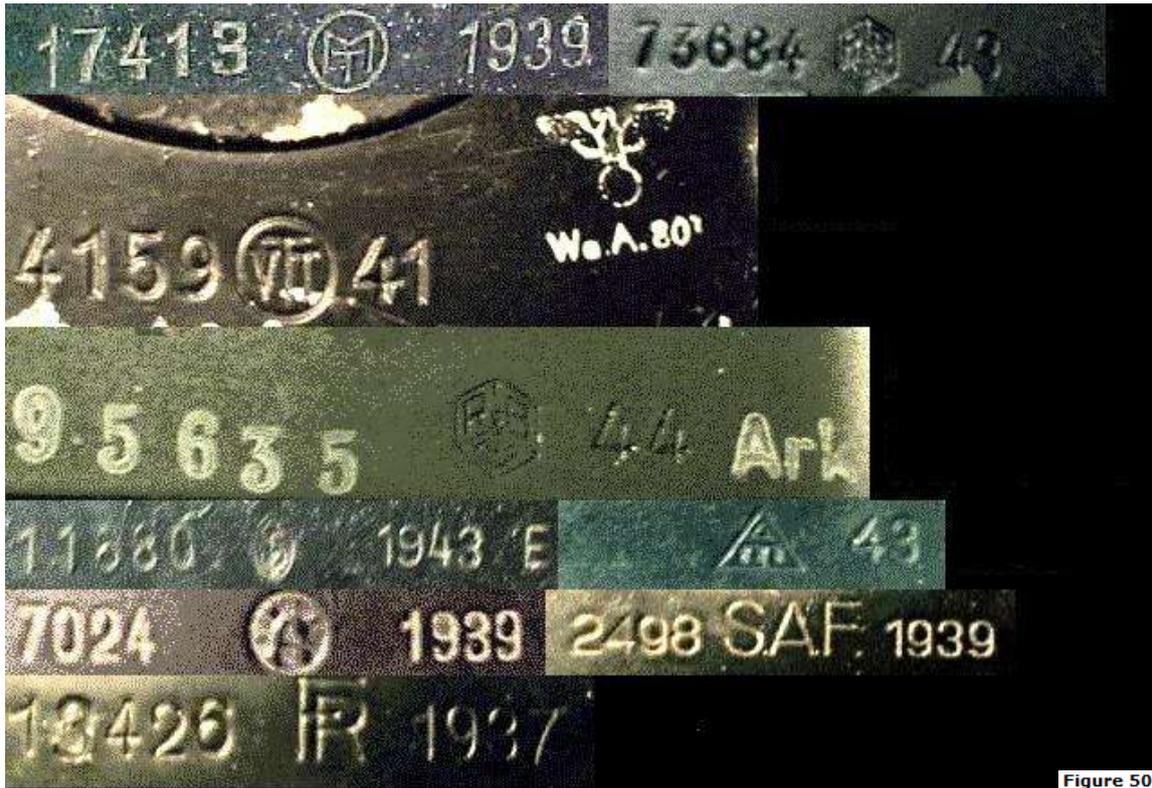
Figure 50

The markings shown above are all from FF-33s in my collection. Some of the markings diverge from the norm for unknown reasons; it's rather unusual that the aluminum frame of the telephone unit itself carries a Wa.A. hallmark – this is usually found elsewhere. It's also highly unusual that a telephone unit carries both a manufacturer's logo *and* the relevant three letter code<sup>[4]</sup>. Some of the manufacturer's logos are still a mystery to me, seeing as how they were most likely smaller factories, but "MT" is Merk Telefonbau, "RB & Co." is R. Bosse & Company, "VTT" is the Vereinigte Telefon- und Telegraphenfabriks AG, Czeija, Nissl & Co. (of Vienna), "SAF" is the Süddeutsche Apparatefabrik, "FR" is Friedrich Reiner of Munich and "FS" is F. Schuchhardt.

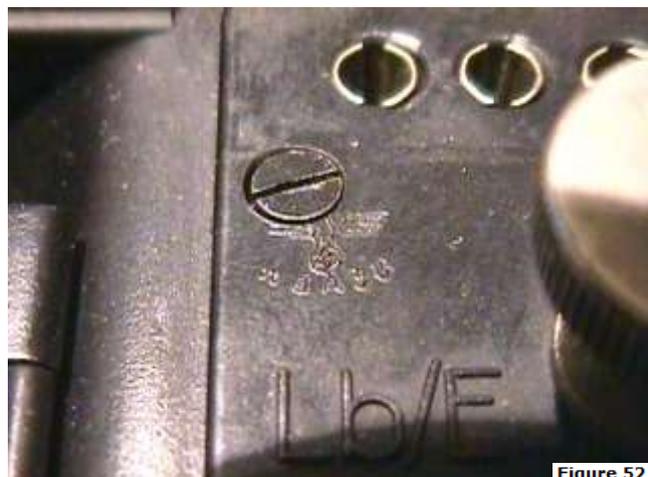
Figure 52

The Wa.A. hallmark wasn't always in the exact same place on the terminal plate, and it isn't always as easy and clear to see as it is in the picture on the right.

This hallmark was sometimes defaced after WWII, and I wouldn't accept any FF-33 as being an original if *anything* is defaced.

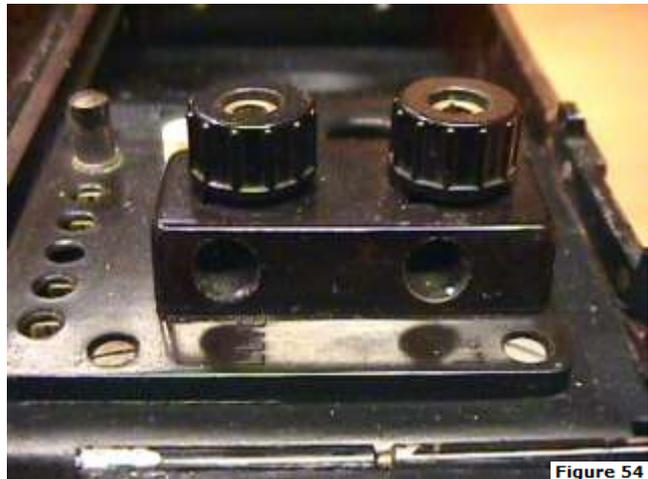
Figure 54

The photograph to the right shows the late-model terminal block used on the FF-33; use of this type of terminal block required a minor redesign of the terminal plate – namely removal of the ridge between the two original brass binding posts.

The type of terminal block shown was in use on other pieces of communications equipment before it found its way to the FF-33.

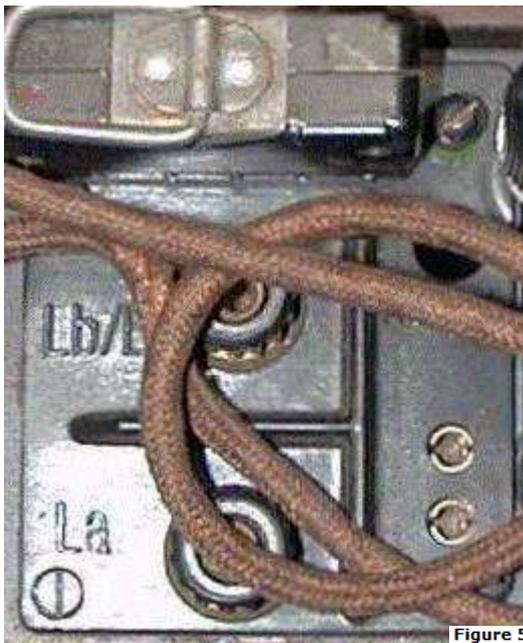
Figure 55

Warning – the binding posts on this terminal plate are by no means originals; they're of a type which was more common from the late 1950s onwards.

If readers take a closer look, they will see that the test pushbutton is completely missing from this FF-33. This field phone can't be considered to be intact and shouldn't be bought or sold as such.

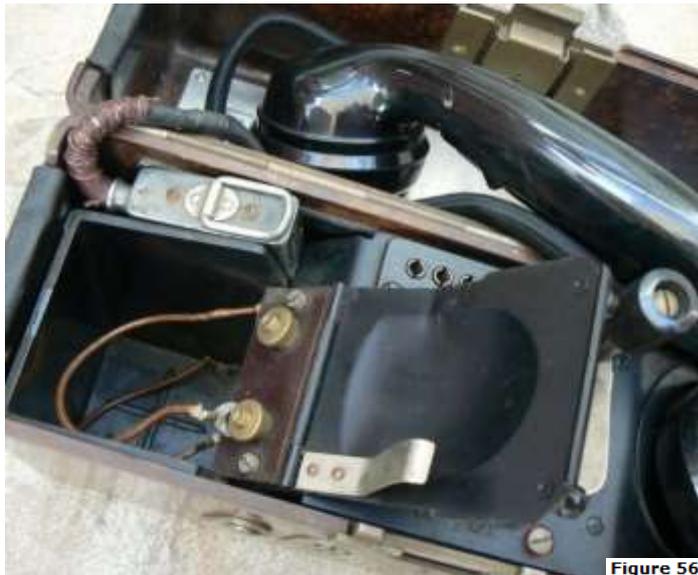
Figure 56

An original cell holder will be of black or brown Bakelite and be held in place by the binding post strip. Cell holders often show vertical stress cracks along the inboard side and are prone to breakage. The binding posts themselves are rather small, and are made of un-plated brass; the *knobs* of the binding posts are usually made of brass, but can also be found made out of a zinc alloy. The binding posts are always mounted on a terminal strip of reddish-brown phenolic paper.

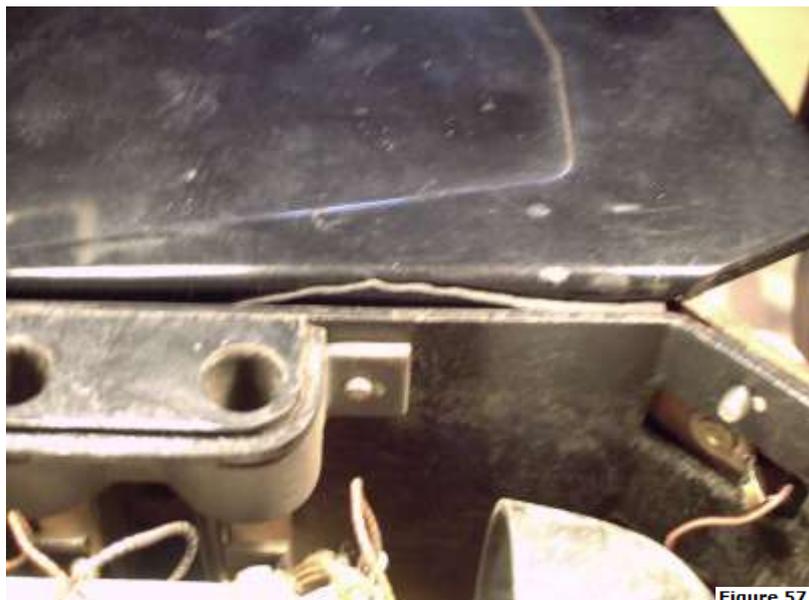
Figure 57

An excellent example of the stress crack typically found on the cell holder.

Since this crack is very common in units which saw service in the field, I *wouldn't* consider this type of damage to be cause to say that the relevant FF-33 was damaged goods.

As a matter of fact, the design of the aluminum frame of the FF-33 practically *invites* this type of damage.

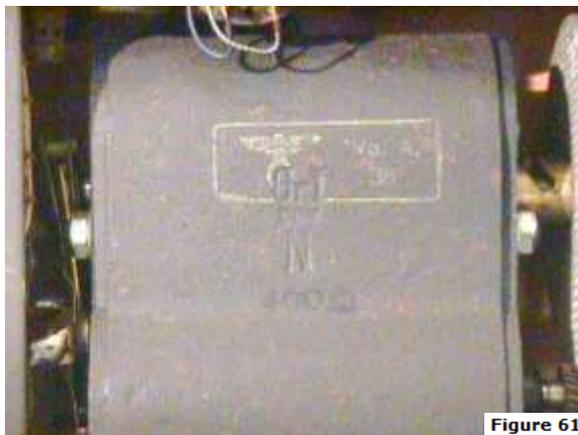
The permanent magnet (made of a cobalt-chrome-steel alloy) was most commonly painted with glossy or flat red paint, although dark slate can also be found. The permanent magnet usually carries the manufacturer's logo (stenciled, printed or as a decal; very rarely the three letter code), a marking "400 Ohm" and a Wa.A. hallmark on the left-hand side (when viewed with the gear on the right).

Magnetos painted in red are by far the most common ones to be found in an FF-33; slate-colored ones are pretty rare. The magnet usually has an "N" embossed to mark the north pole.

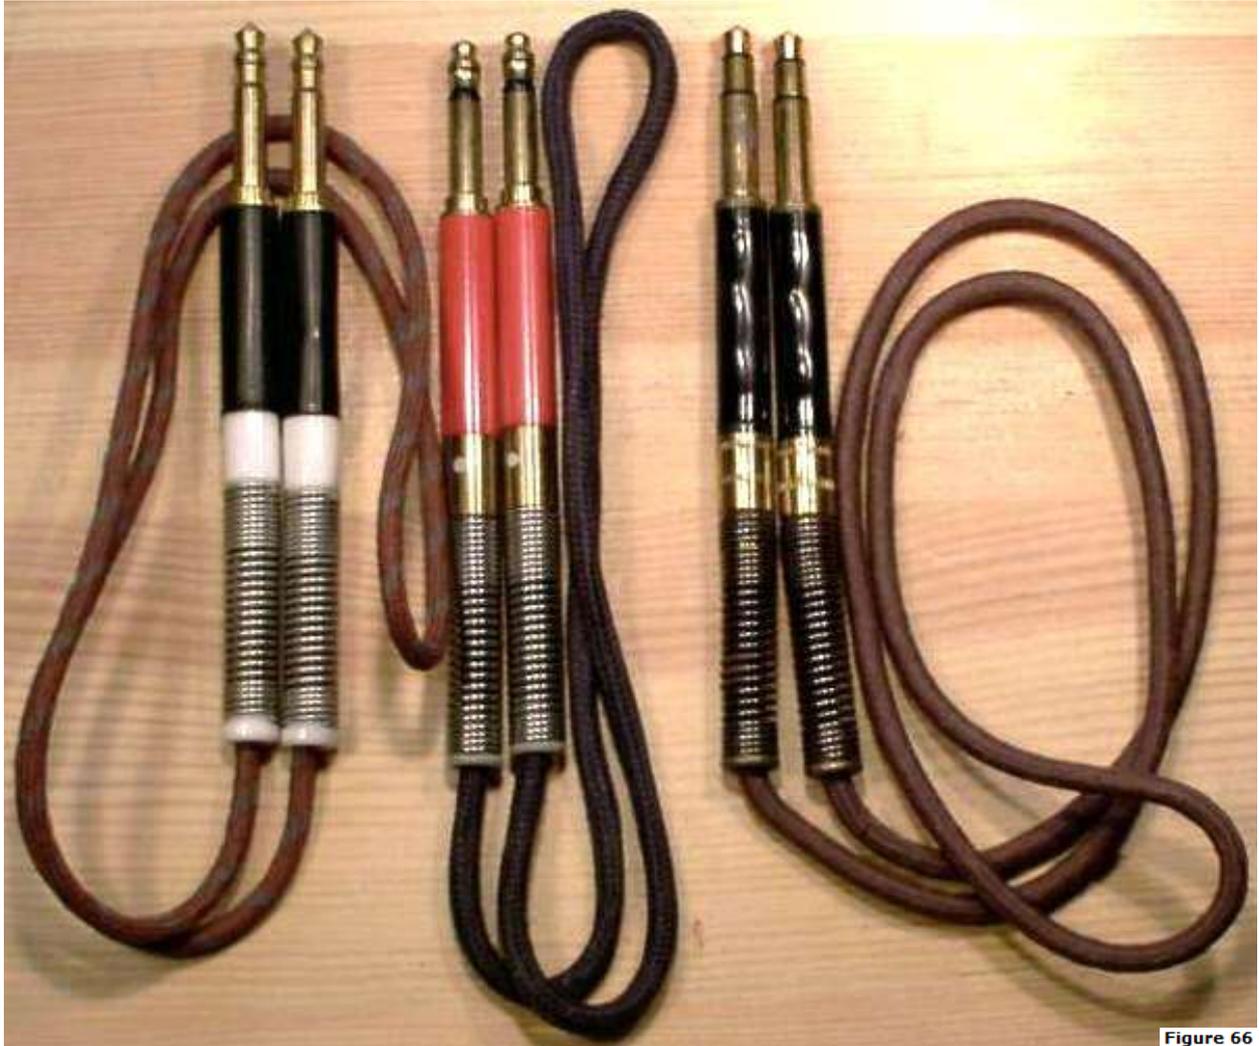
Figure 66

Of the three patch cords shown above, only the one on the right is an original which will fit into the jacks on the FF-33 field phone perfectly.

As can be seen in the lower photograph on the previous page, the most obvious difference between the three patch cords is the construction of the plug itself. Post-WWII plugs have an insulated guard ring between tip and ring, while the original German FF-33 cord has plugs with tip, ring and sleeve without any protective ring. The original plugs are also a tad thicker than those used after WWII – later plugs will *loosely* fit the patching jacks on the FF-33 and will wiggle around in the jacks without making proper contact.

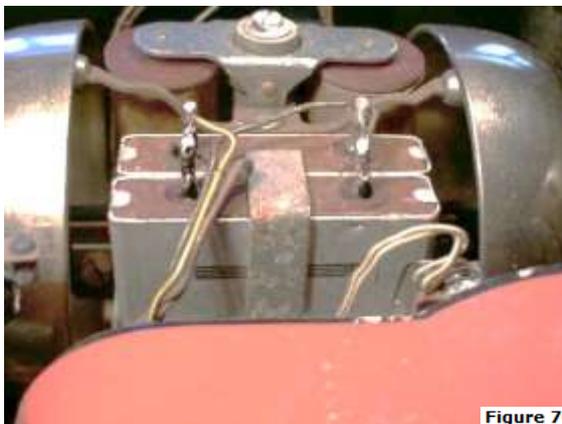
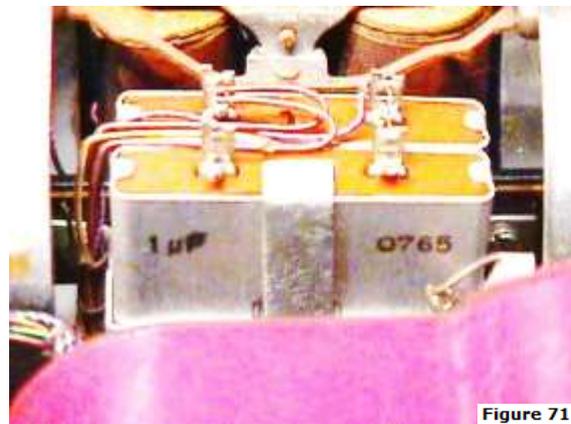
Figure 70

In the left-hand photograph below, it's difficult to decide whether the condensers are originals or not, since a date code isn't visible. What appears to be a portion of the wings of a big Nazi eagle is nothing of the kind – it's part of the manufacturer's logo; anyway, the condensers are originals in this case. The condensers in the photograph below and to the right are obviously from 1965, 20 years after the end of WWII. The FF-33 they belong to was modified in 1965 and used by the Austrian PTT.

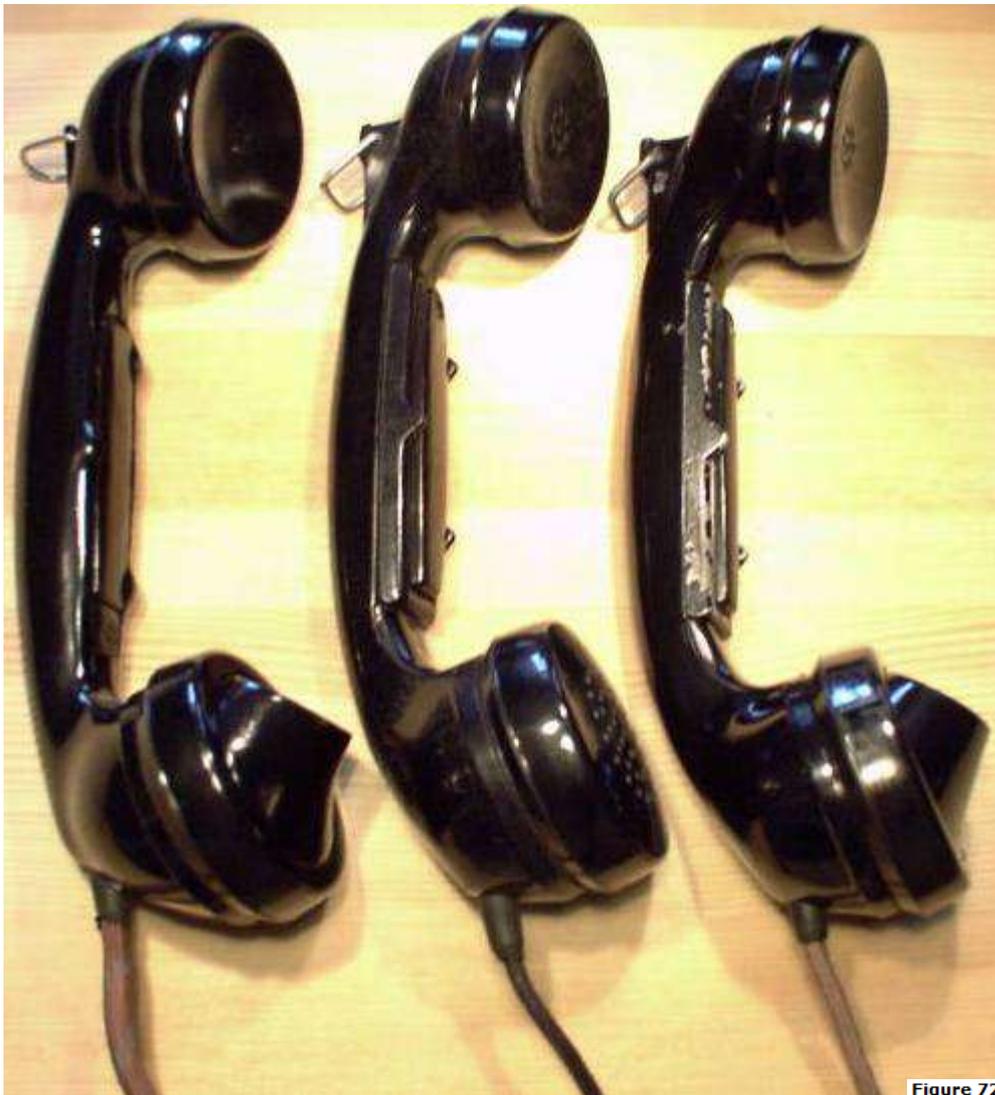
Of the three handsets shown above, only the one on the right is an original field handset 33; the one on the left belongs to a Czechoslovakian field phone from the 1950s and the one in the middle is a reproduction from the late 1960s, as used by the German forces.

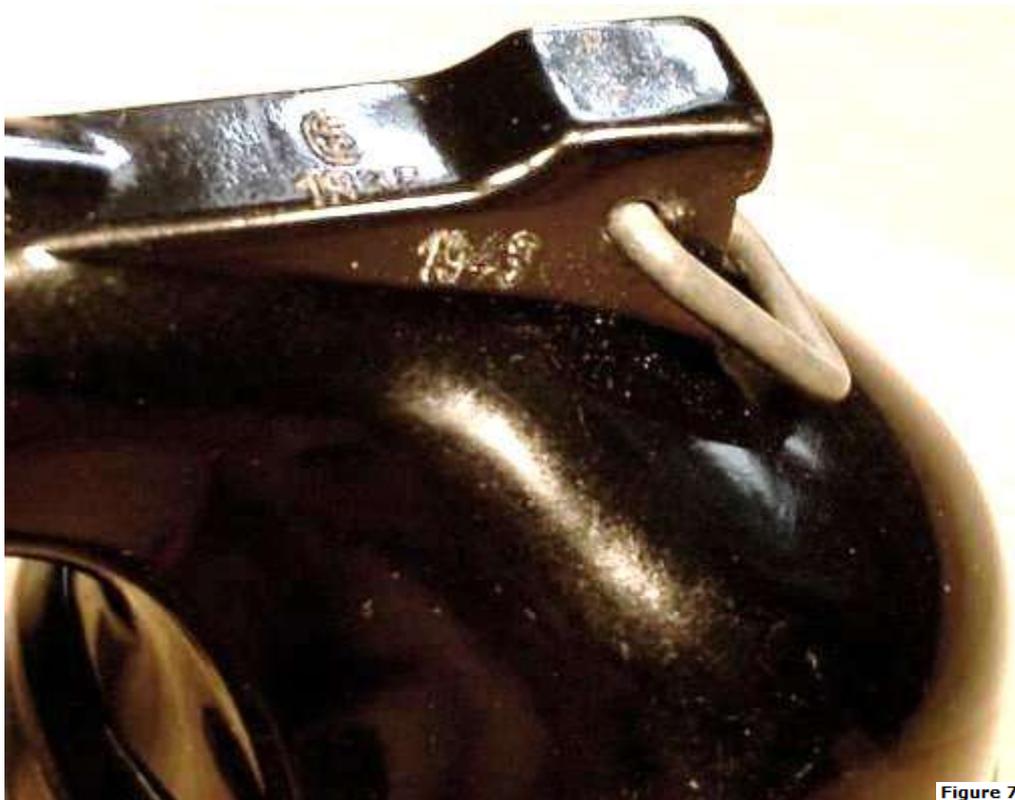
Figure 75

The portion of a field handset 33 shown above carries two different years (1938 and 1943), the manufacturer's logo above the year 1938 and, although very difficult to see, a hallmark on the flat surface of the protrusion.
