## A Collection of Telephone Tales

written by Herbert Schwarz of Vienna, Austria, European Union

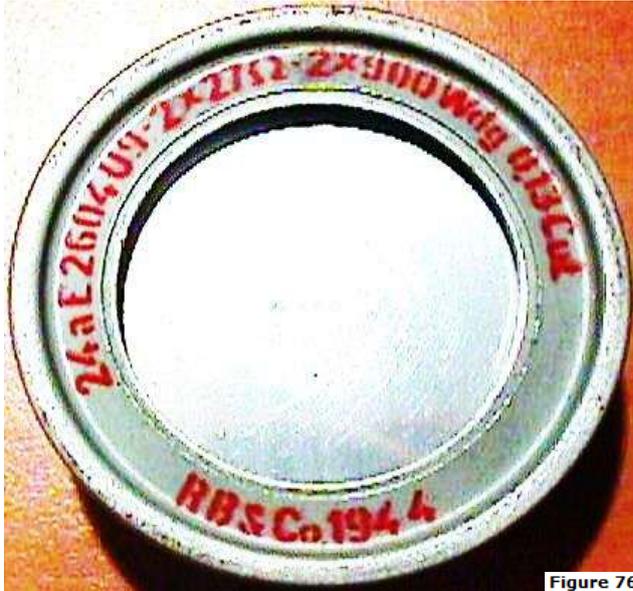
Figure 76

A typical and proper receiver capsule, even though I personally know that the hallmark is missing from this particular unit. The number "24aE2604U9" on the rim is the drawing number which specifies the construction methods and materials. The rest of the info along the upper rim states 2x27 Ohms, 2x900 windings of 0.13 millimeter thick copper wire which was insulated with enamel lacquer ("Kupfer-Lackdraht" in German, abbreviated as "CuL.")

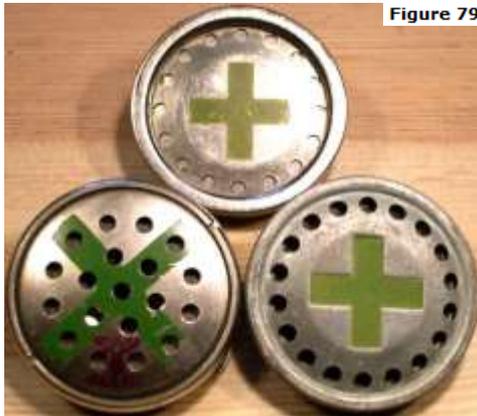
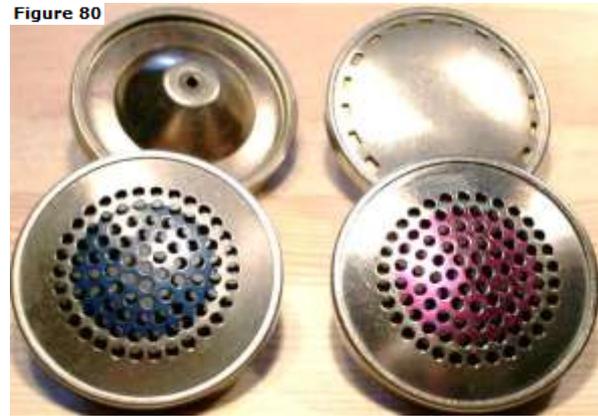
Figure 79

Will the real field handset 33 microphone capsules please stand up? The four on the right are the imposters in this case, having been manufactured between circa 1950 and 1970.

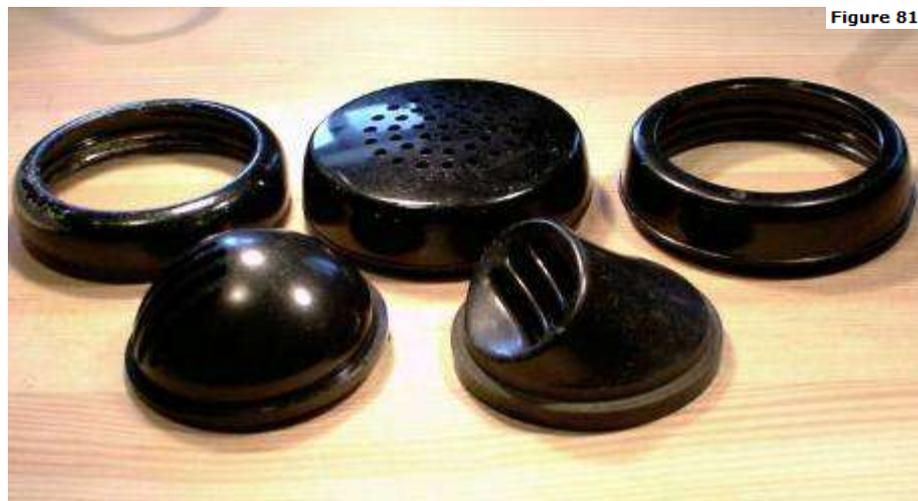
Figure 81

The handset *mouthpiece* consists of two separate parts – a clamping ring and the angled inner part (the two pieces to the right in the photograph below). If the mouthpiece consists of only a single part, or if the inner portion is hemispherical, it's certainly **not** an original.

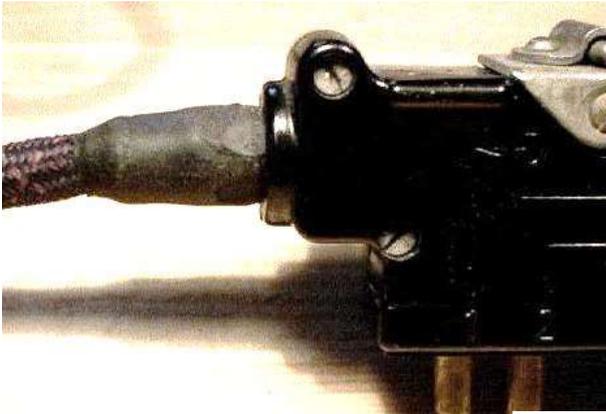
Figure 85

The cord attached to the handset plug shown here isn't an original, not only because it's striped, but also because the strain relief boot was pared down to fit into the plug.

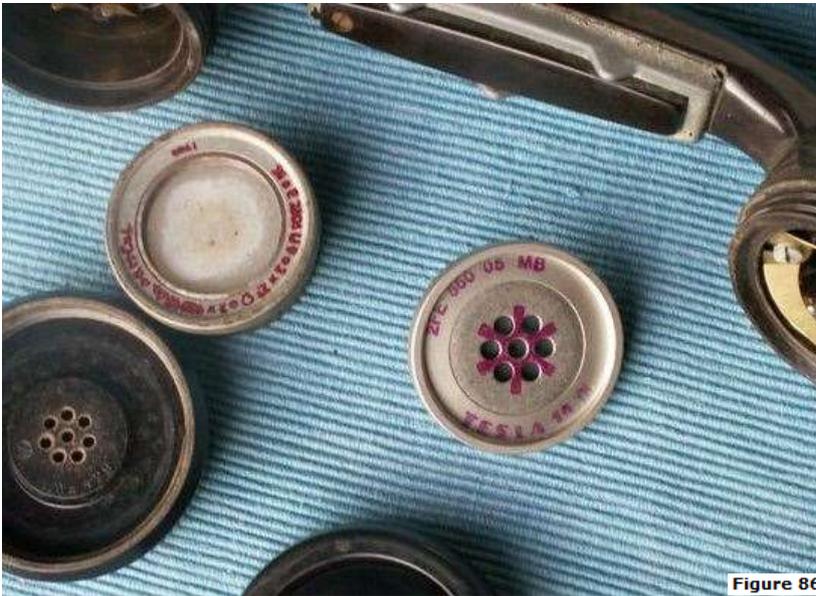
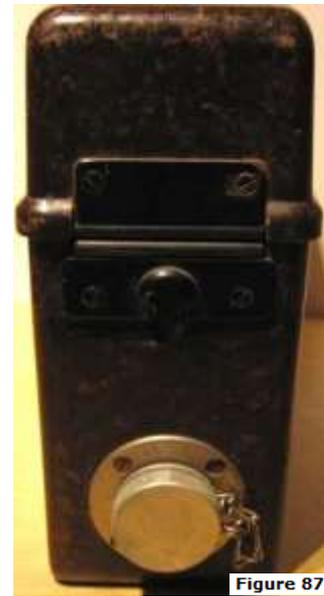
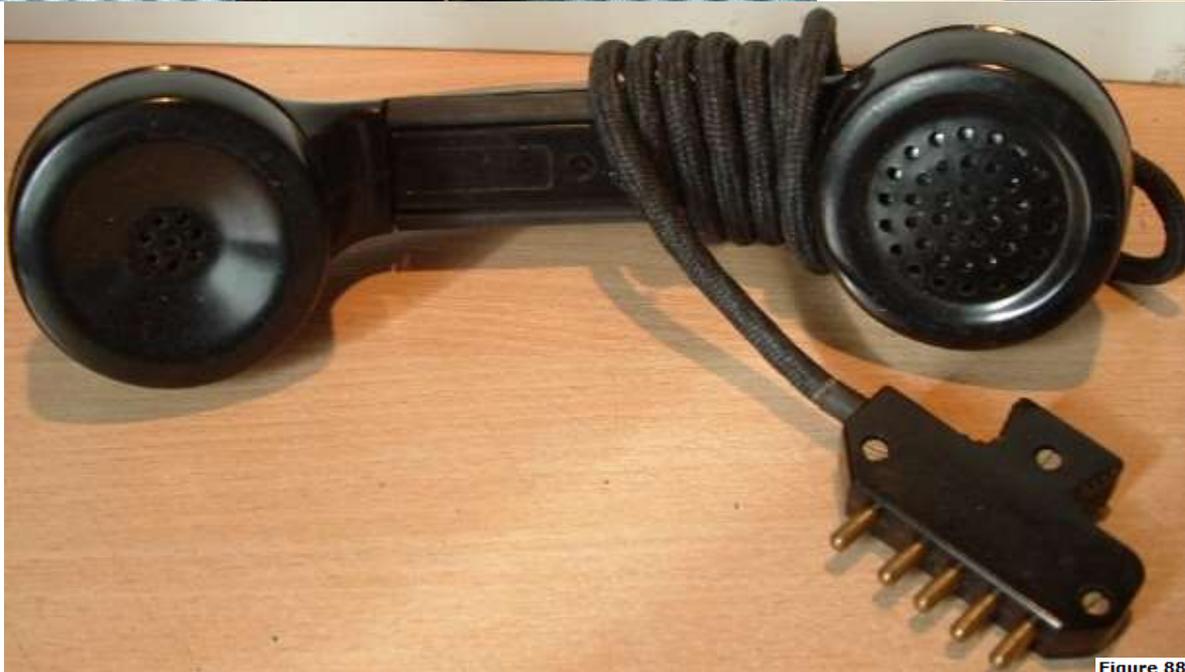
The last three pictures on the previous page are a nice kettle of rotten fish if ever there was one. The handset in the upper left-hand photo belongs to what is, once again, claimed to be a "complete and original" FF-33; the microphone capsule is certainly the wrong type – it was manufactured by the Czechoslovakian firm "Tesla" *after* WWII, and (in the original-sized picture) the year on the receiver capsule can be read as being 1954. So much for being "complete & original." The FF-33 in the upper right-hand photo has been heavily modified for railroad use after WWII, because it has a capped coaxial socket on the side of the case. Stay away from any FF-33 which has such an external jack. The handset in the bottom photograph is often passed off as belonging to the FF-33; in reality, this handset belongs to the OB/ZB-54 model German field phone (the plug won't fit the handset jack on an FF-33 anyway...).

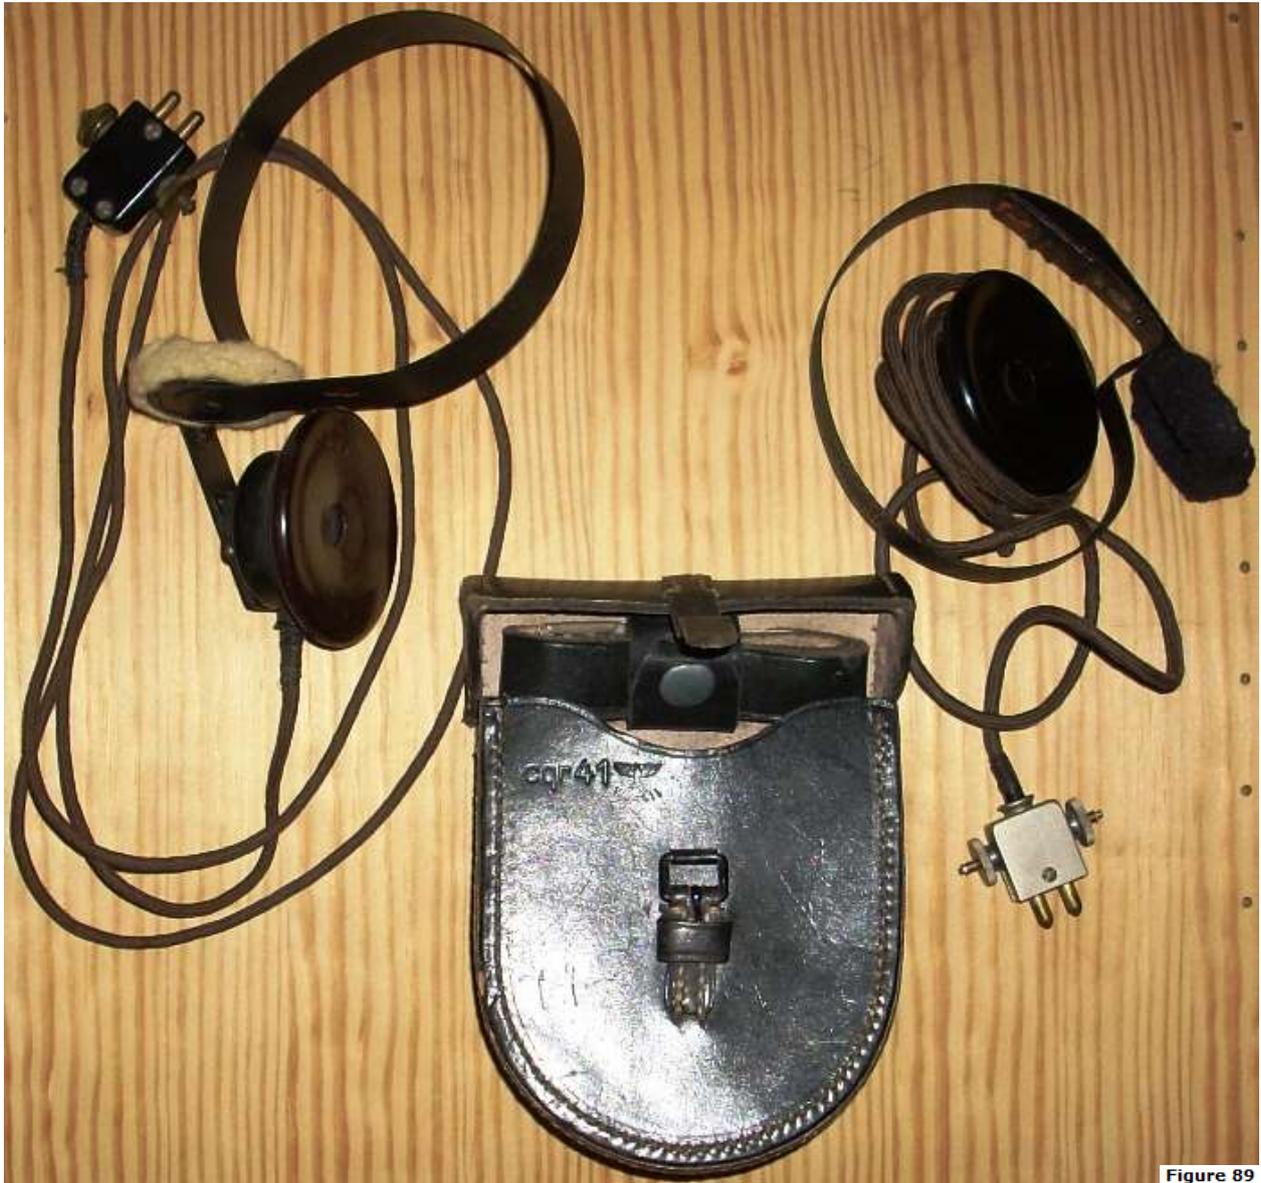
Figure 89

Here we have two original model 33 headphones; the one on the right belongs to the leather case shown in the middle. The leather headband mentioned in the translated German text on the previous page is stored inside the lid of the case and can be seen in the photograph. The headphone on the left is ready for use, while the one on the right is still disassembled for storage.

The leather case doesn't carry a manufacturer's name or logo; in this case, the three letter code "cqr" was used. The case also bears the typical WWII German hallmark and the year of manufacture in the form of the two digits "41."

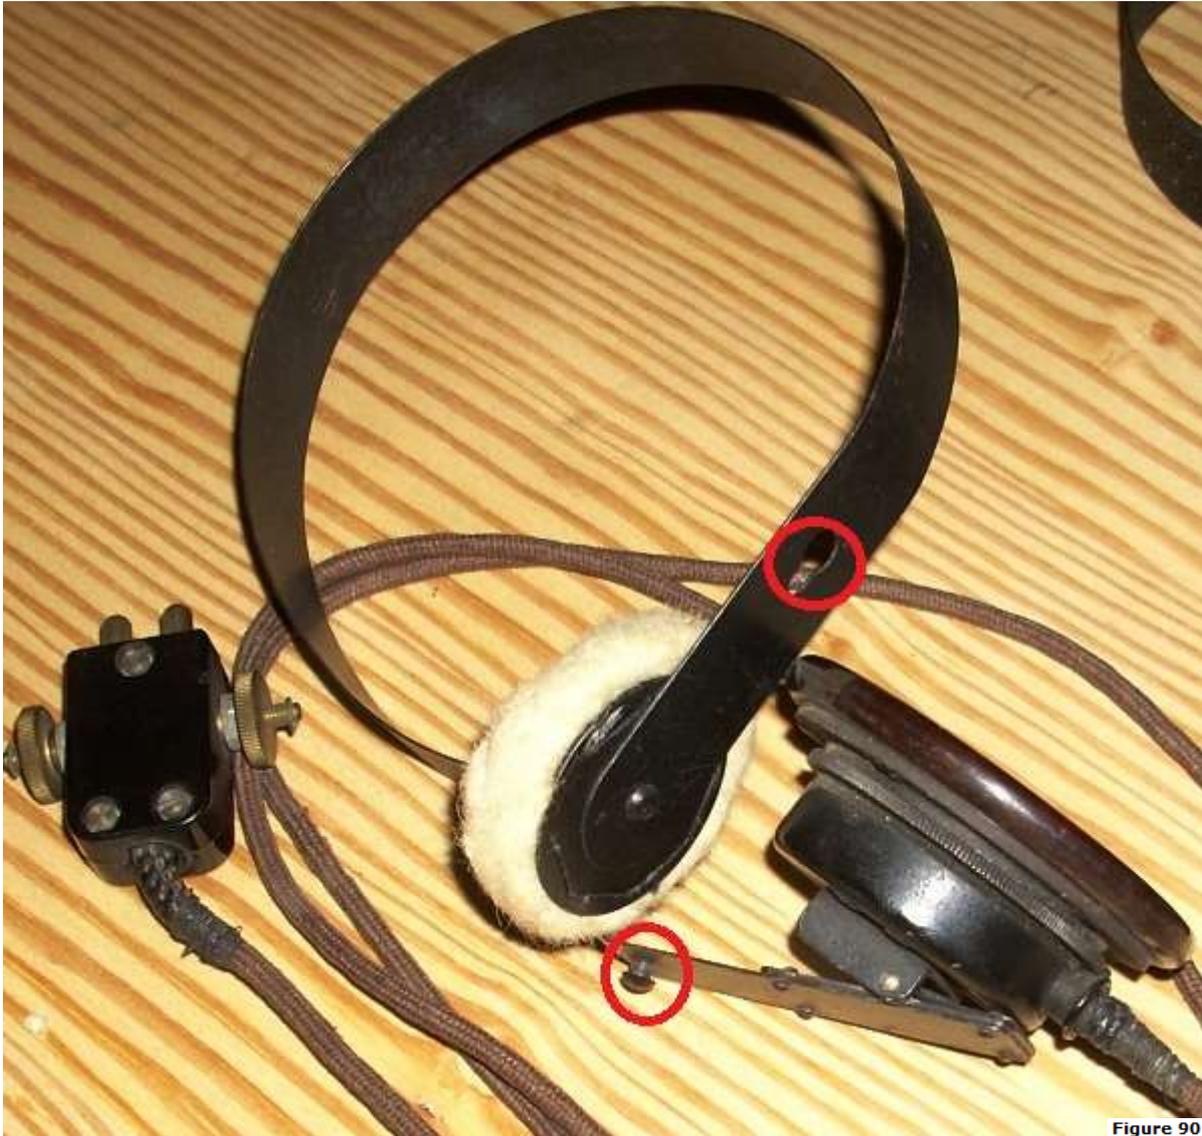
Figure 90

This headphone 33 gives readers a good chance to study some of the finer details; amongst others the late-model, Bakelite plug, where the cord is protected by a thin leather sleeve on both ends (which was sewn onto the outer braid of the cord.) The two binding posts on the sides of the plug are electrically connected to the respective pins; line maintenance personnel took such headphones, connected wires to the binding posts and sought out breaks and other faults. In a pinch, the headphone could be used as a sound-powered *microphone*, allowing two-way communications between troubleshooter and the men at the ends of the line (either field phones or switchboards).

The upper detail encircled in red is a pear-shaped slot, while the lower one is a mushroom-headed rivet. When not in use, the headband was rolled up so that the rivet rested in the smaller end of the pear-shaped slot – this made the headband compact enough to fit into the leather case without problems.

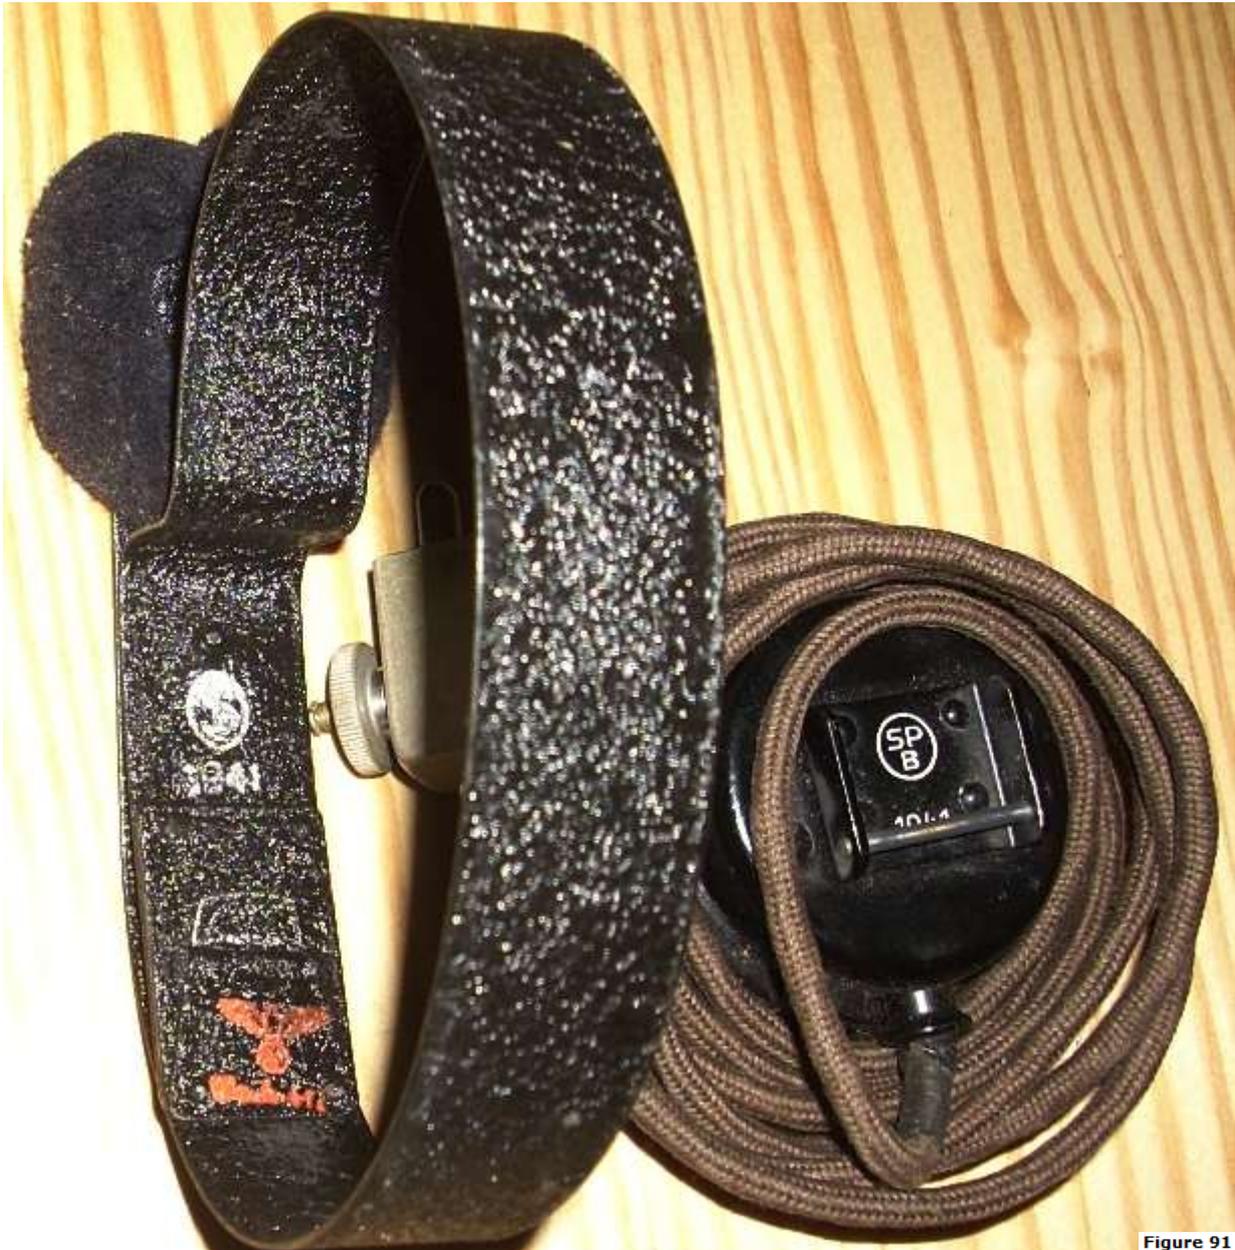
Figure 91

The headphone 33 shown here is the one which belongs to the leather case. On the inside of the spring steel headband (which is rolled up for storage), one can see the following markings in ink: the manufacturer's logo (smeared), the year of manufacture (1941) and a Wa.A. hallmark. The headphone itself also bears the manufacturer's logo and the year of manufacture (the Wa.A. hallmark is on the side of the u-shaped piece of metal which is riveted to the headphone unit and can't be seen here).

The leather case, both headbands, and the headphone were all manufactured in the same year – it's extremely rare to find an intact and complete headphone 33, where the year is identical on all the pieces (the entire unit is also NOS).

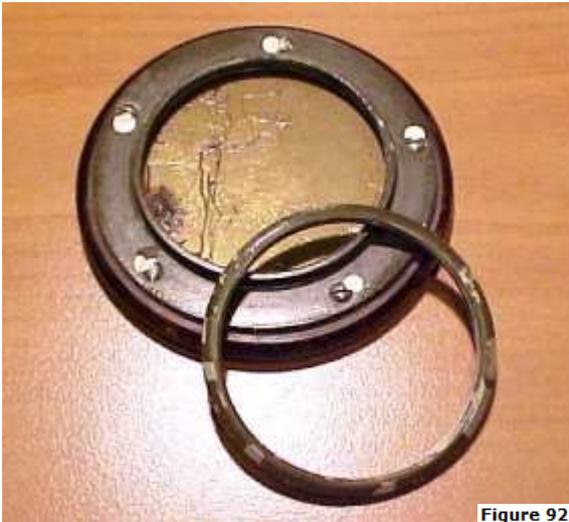
Figure 92

This photograph shows the earpiece and the jamb nut as separate items.

Alas, these two pieces are *not* interchangeable with those found on European crystal radio headsets (such as the Telefunken type "EH333," 2x2000 Ohms, which is still easily found in Europe), so that one needs originals if they should be missing or damaged.

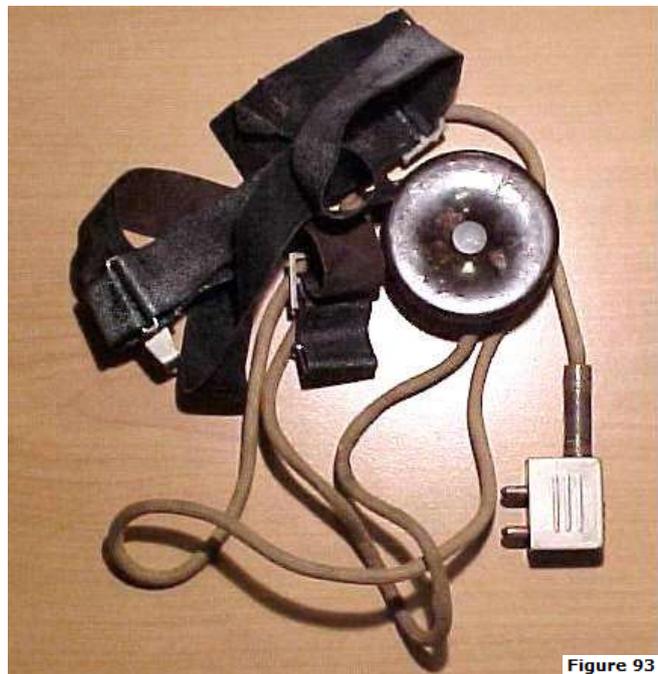
Figure 93

Caveat emptor! The headset shown on the right is often pawned off on the unwary or unsuspecting as an "original" German headphone 33.

It's nothing of the kind - this beast belongs to a *Hungarian* field phone from the 1930s. What makes matters worse is that the plug, although a tight fit, *will* mate with the headphone jack on an FF-33 field phone.

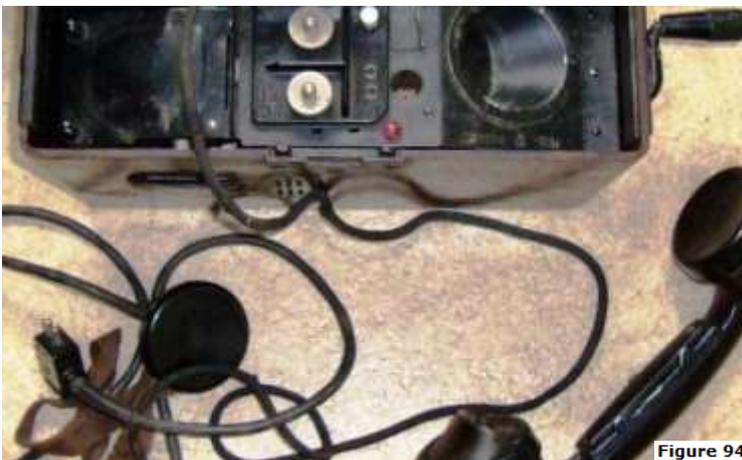
Figure 94

Here we have an FF-33 with an incorrect magneto crank and a late-model Hungarian headphone, which was offered to the unwary as a "complete and original" phone.

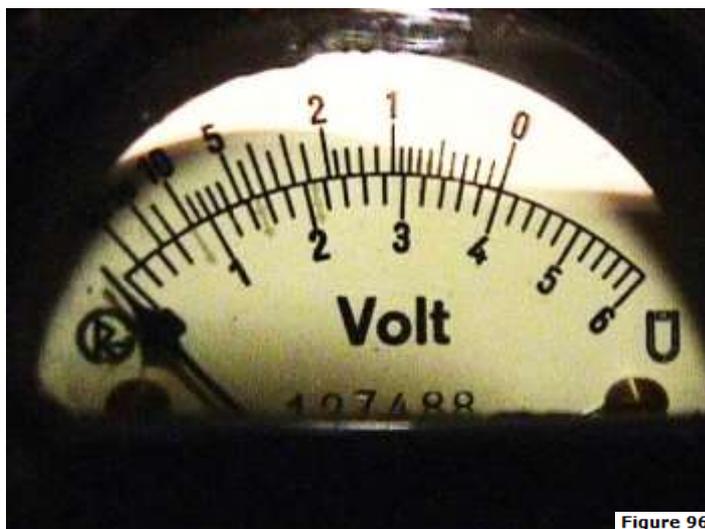
Figure 96

The small, slate-colored arrows at the points 0.8, 1.5 and 2.1 Volts of the Volt/Ohm scale of the Wehrmacht field test instrument mark the lowest voltages allowed for a single cell and batteries made of 2 and 3 cells when tested with a 15 Ohm load.

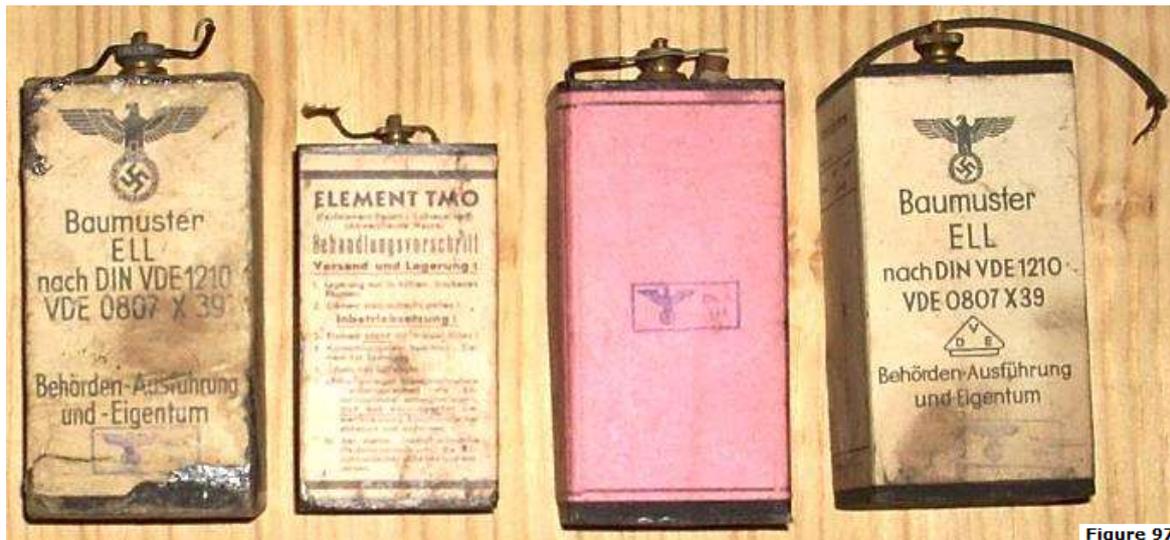
Figure 97

All four of the field elements shown above are originals from my collection. The one designated as an "Element TMO" was manufactured in occupied France – the German text immediately below the designation reads as: "Feldelement-Bauart: Luftsauerstoff, Abweichende Masze<sup>[7]</sup>"; to wit: "field element construction: air-oxygen cell" and "off size," since the element is a bit smaller than normal. The field element with the purplish label is from civilian stock from 1940, which carries a proper but somewhat faded Wa.A. hallmark.

Of the three elements shown at the bottom of the previous page, only the one in the middle is an original. The one to the right is from the early 1960s, while the one on the left is from 1971. Of these two, only the one on the left is useable to *forge* a field element (yes, there *are* people around who do this, because original field elements are very rare), because the external housing was exclusively made of thick, black cardboard – the only exception I have come across to date is the element from France; it appears that a black thermoplastic was used in this specific case.

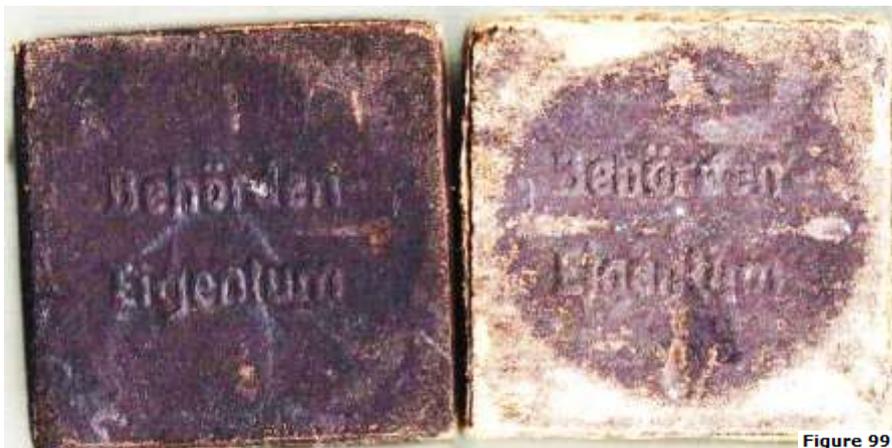
Figure 99

A very distinguishing mark of *original* German field elements, one which no one has yet been able to forge, is shown to the left; the **raised**, embossed German-language legend "Behörden - Eigentum."

Translated, Behörden-Eigentum means as much as "property of the authorities" or simply "government property." The front side of the label of original elements also carries a similar notice: "Behörden-Ausführung und -Eigentum"; literally: "manufactured for, and property of, the government." The reason that the message "government property" was embossed onto the bottom of genuine German field elements was that if some scoundrel were to steal some of these elements and rip the label off, the text would be missing; theft of government property would be impossible to prove without the text embossed on the bottom ... the Germans carried this labeling of government property so far as to even emboss the same text onto pencils, &c. Faked or forged elements are invariably missing this text on the bottom of the housing, because in order to have the text **raised** on the outside, the cell case needs to be *empty* prior to embossing. Of course, it'd be possible to stamp the relevant text into the bottom of forged elements, but in this case the lettering would be *pressed into* the bottom, and *not* be raised.

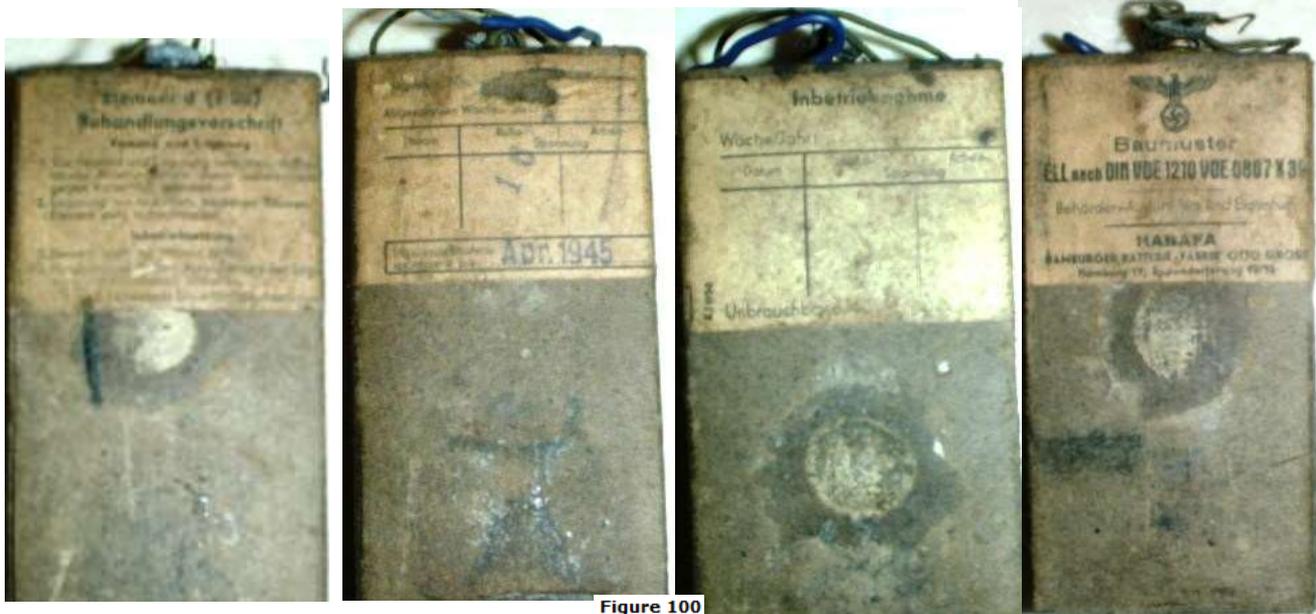
Figure 100

The four shots at the bottom of the previous page show a genuine German field element dated April, 1945. It's interesting to see that even such mundane things as black cardboard and sufficient paper for manufacturing full-sized labels were lacking at that late date.

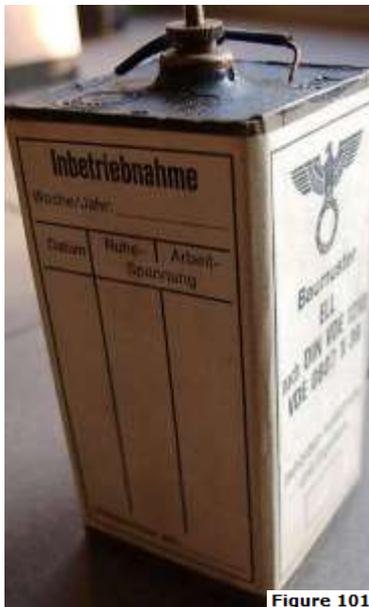
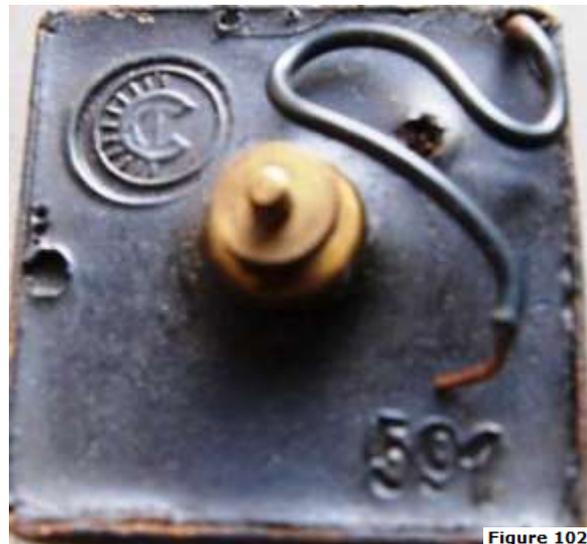
Figure 102

There are two dead giveaways concerning the element shown above: first of all, the label is far, far too clean to be from WWII and secondly, genuine German field elements *never* had a logo imprinted in the pitch layer on the top, and they also didn't have a date code in the pitch (in this case "591" – month 1 of the year 1959). The pitch is far too clean, and it shows more or less severe cracking on old, original field elements.

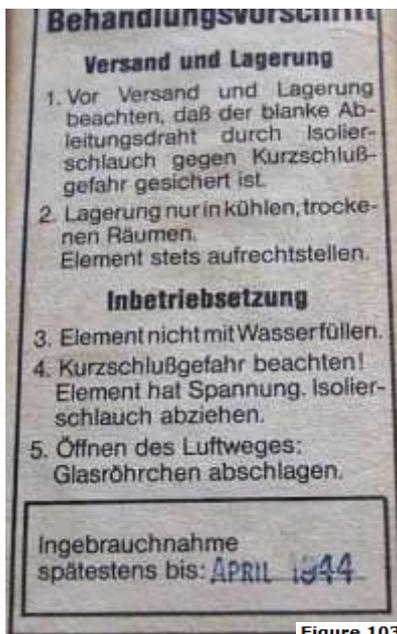
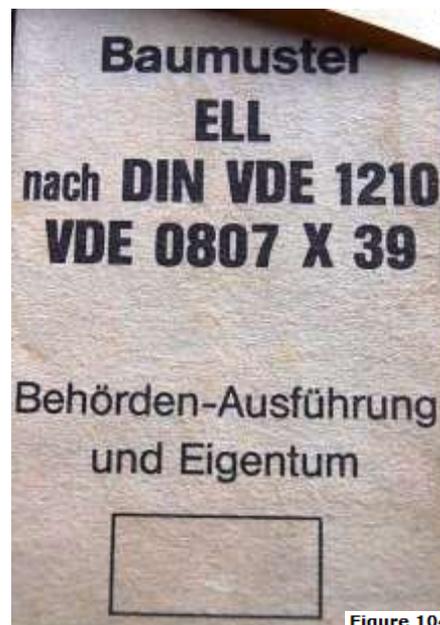
Figure 104

More pictures of the same "original" – date markings were commonly executed in *purple* stamp ink, not blue. Again, the paper is far too unblemished to be original and, in the right-hand picture, the rectangle is *empty*, although this is the space where the Wa.A. hallmark is found on originals.

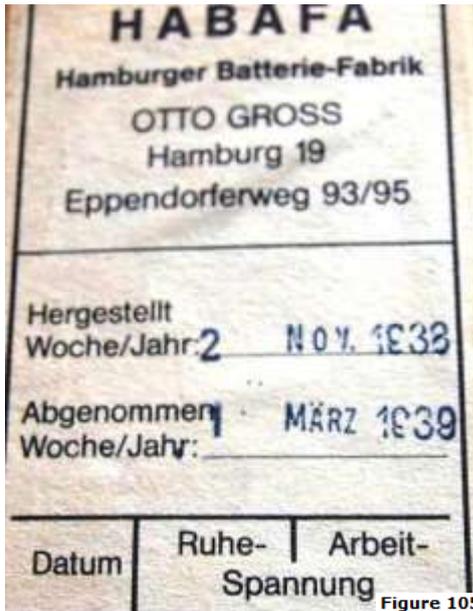
Figure 105

Another odd thing is that almost every single faked German field element I've ever seen claims to be from the firm named in the photo to the left (these are some more pictures of the same forged element as shown on the previous page).

The first date given on the label segment on the left is the date of manufacture (in 1938), while the second date gives the date of acceptance (5 months later, in 1939!) Sorry, it

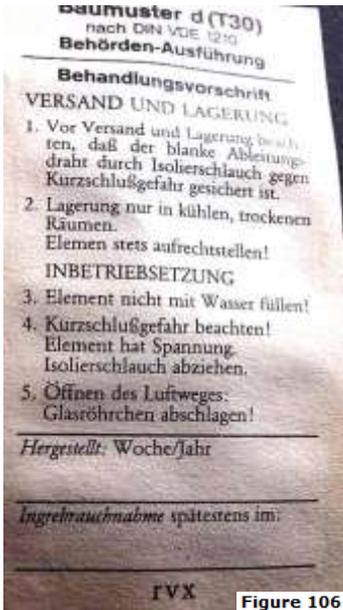
Figure 106

just ain't so ... first of all, the dates were normally given in the form of a number between 01 and 52 for the week of manufacture, followed by a slash and the last two digits of the year (as shown below). The loose label shown to the right supposedly belongs to a packing carton for a German field element – nope, certainly *not*. If one sees such a label being offered along with “an original,” then beware! There are two typos on the label on the right, which is something the highly efficient German military wouldn't have accepted under any circumstances ... no, I am *not* going to reveal what and where the typos are, because that'd be helping the forgers, which I don't intend to do.

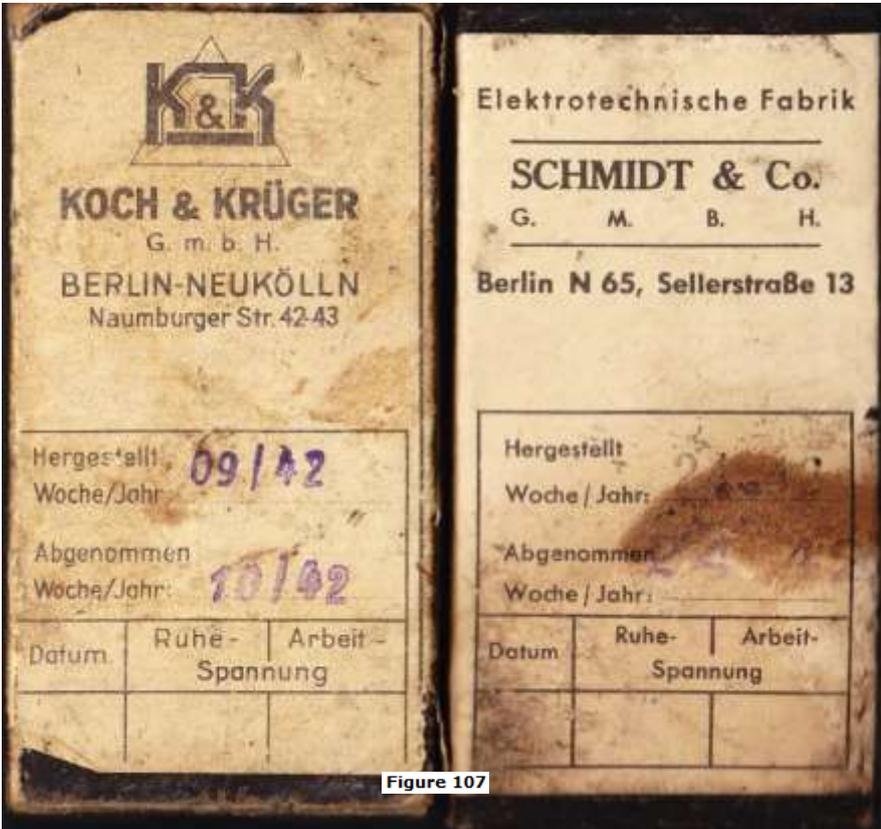
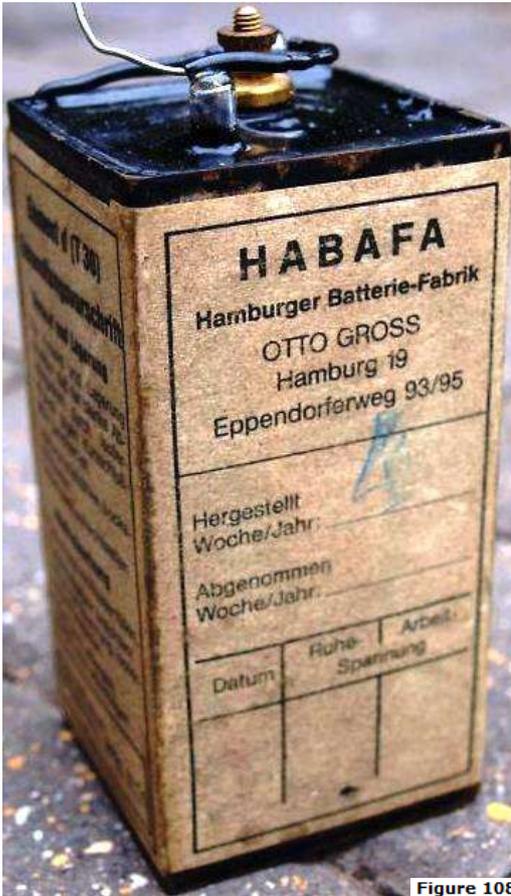
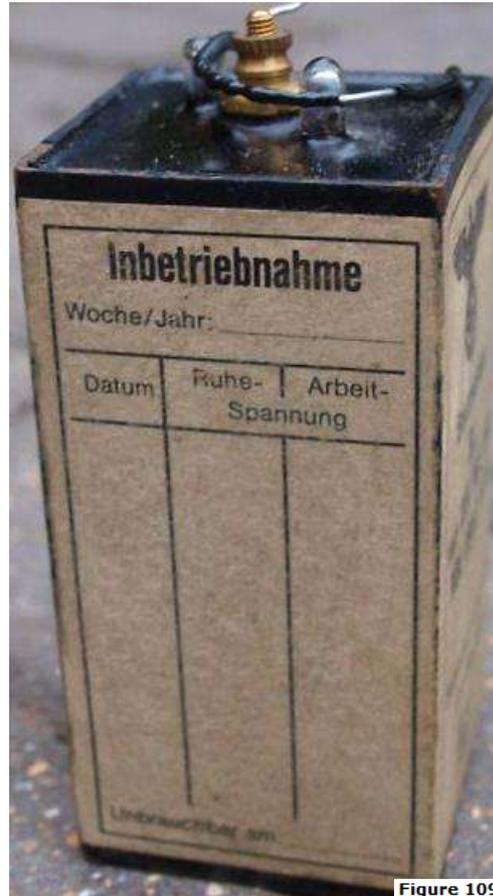
Another forged German WWII field element ... in this case, the label looks to be a bit older, but it's still far too well-preserved to be genuine. A few more tips: here, too, the pitch on the top of the element is far too shiny, and the brass fittings belonging to the positive pole are *far* too clean to be 70+ years old. And, if that weren't enough, the dates of manufacture and of acceptance are *missing*. Aside from this, the two glass tubes on the top of the cell are undamaged, while these would've been broken open on a used, original cell. These glass tubes are intended to let air reach the innards of the cell, so that the oxygen in the air helps depolarize the cell.

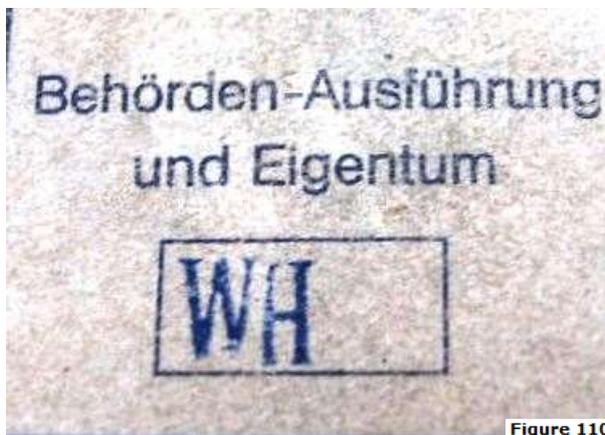
Figure 110

This segment of the label belonging to the element shown above has two major faults: first of all, original labels have a "dash" in front of the German word "Eigentum" (property), and the rectangle which should sport a Wa.A. hallmark – the letters seen here are simply the abbreviation for the German term "Wehrmacht Heer", military forces, army. This was *never* stamped onto any field element because field elements *weren't* produced for the separate branches of the German military establishment.

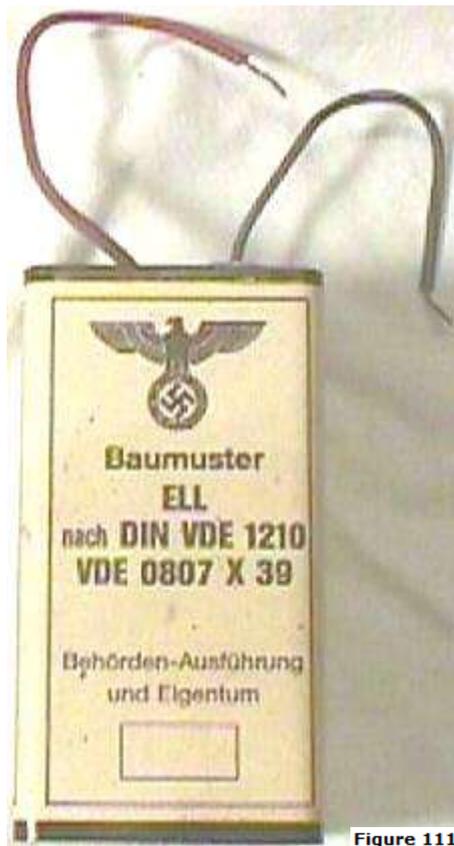
Figure 111

The “original” field element shown above left is an especially *inept* forgery, since original field elements only had *one* wire, and that was insulated in black, not in red or blue. The photo on the right shows the core used for this particular forgery – an element manufactured in former Czechoslovakia!

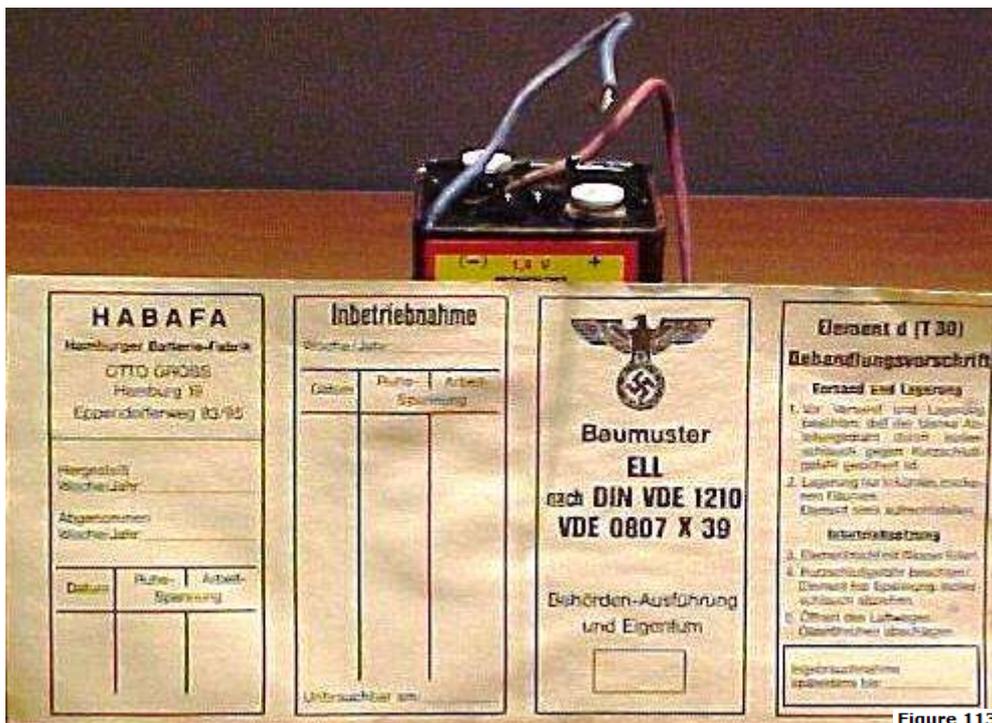
Figure 113

The element from Czechoslovakia (shown in the right-hand and lower pictures on the previous page) is from my collection, as is the forged label (one of four I bought from someone in Montreal, Canada, who claimed that they were "originals"). One dead giveaway for such forged labels is that the lowest bar, or row of feathers, on both wings and the uppermost row on the right-hand wing of the Nazi eagle are slightly thicker and/or darker than the rest. This happens when such labels are printed by any rotary offset method in which the offset printing foil was made with the help of a photocopier. Original labels were printed from frames of individual letters, with the Nazi eagle as a separate item, which were set by hand. Such direct printing is much crisper than that produced by any multistage process ....

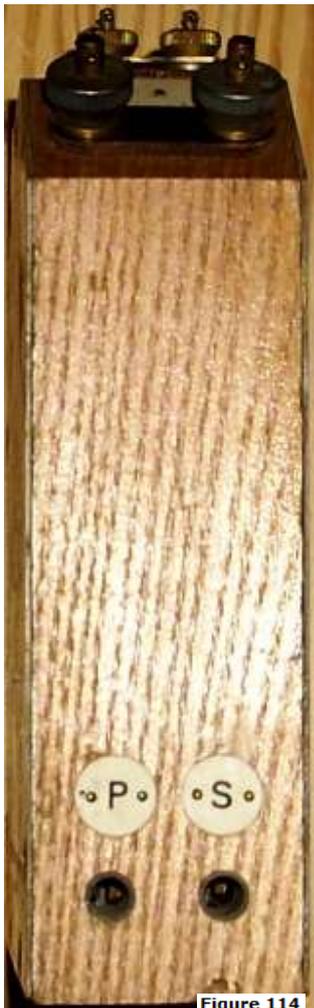
Figure 114

In order to prevent this from happening, the two FF-33 field phones at the command post would be patched together using a special ring-through, talk-through induction coil as shown below.

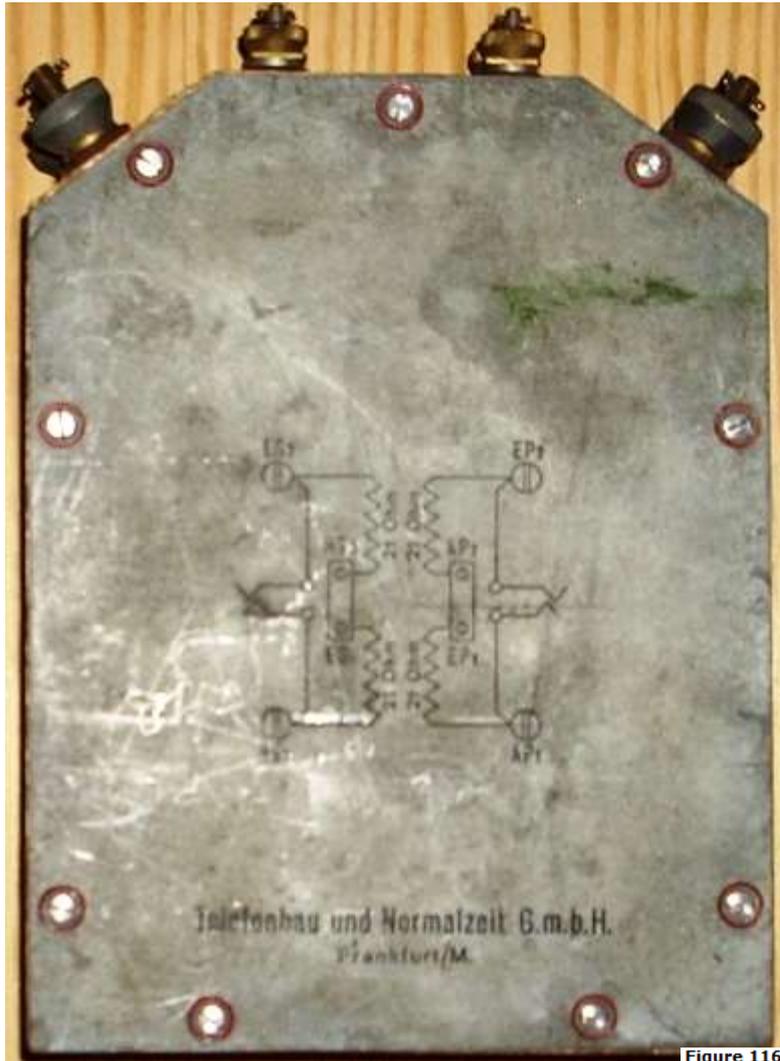
Figure 116

While I did write that "the designation "SB" doesn't *literally* refer to any German WWII switchboard" in connection with the SB-33 accessory, this unit was used to link an FF-33 field phone to a large field switchboard equipped with type "C" cord boards.

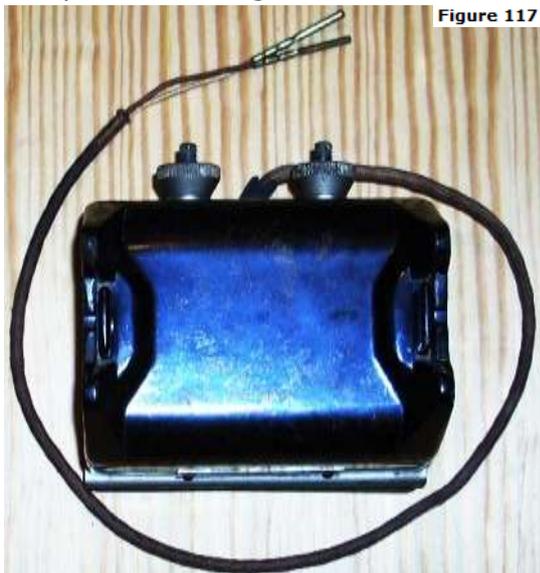
Figure 117

I already mentioned that ... "a type "C" cord board (local battery talking, magneto ringing to call up the operator and common battery signaling to indicate the end of a call) ..." was used by the German military. This is exactly what the SB-33 is all about.

The SB-33 consists of a molded Bakelite cradle for the handset of the FF-33, a simple hook-switch which is *closed* when the handset is on-hook, a blocking condenser of 4 microfarads capacity and a choke with a D.C. resistance of 300 Ohms.

It's obvious that the condenser will prevent the end-of-conversation D.C. signaling current from finding a conductive path through the FF-33, while the choke will provide a good conductive path when the handset is on-hook, without attenuating ringing currents all that much. To tell the truth, I have only seen two photographs of a type "C" cord board, and only a single one of a type "D;" I only happen to know that they existed at all thanks to an ancient Wehrmacht signals training manual which gives schematics for both types, as well as a very brief description of their operation.

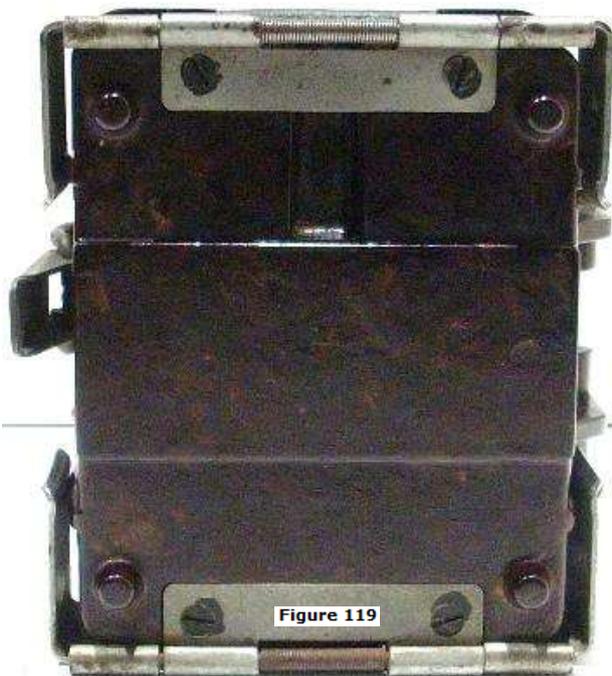
This photograph shows the underside of a field lightning arrester. I chose to show this side by itself, since the closed unit is boring to look at from the top.

There are two spring steel clips folded back onto the housing at the top and bottom. It was normally intended that these clips be folded down and the arrester clipped onto the closed lid of an FF-33; however, this wouldn't be possible if an SB-33 were already clipped to the lid, so there is a notch at the top of the housing which allows for the arrester to be hung up on a nail – indoors or out, since this unit is completely weather-proof.

The housing of the field lightning arrester is made of the same material as the case of the FF-33 field phone and the SB-33 accessory.

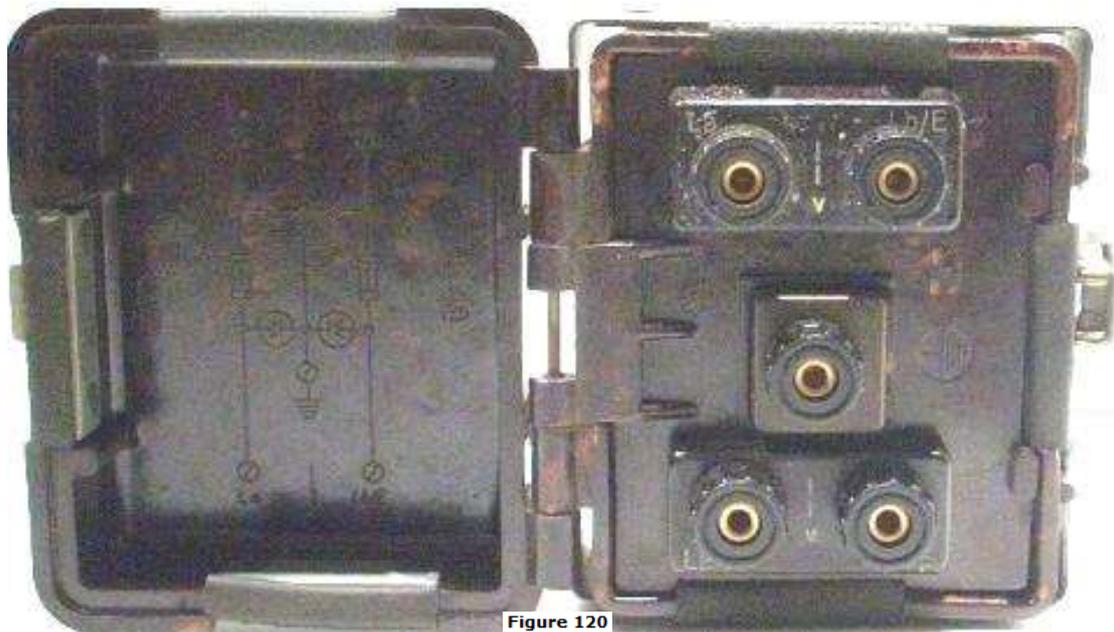
Figure 120

One thing can be said about the German military establishment during the timeframe 1933 through 1945 – they were *very* consequential in everything they did ... such as designating one line terminal on the top and bottom blocks (on the faceplate) as La and the other one as Lb/**E** (!); *not that it'd make very much sense* to run a grounded wire over a lightning arrester made up of a spark gap (500 V), a carbon block arrester (350 V) and a sneak-current fuse (3 A). The *protective* ground wire was connected to the single terminal in the middle of the faceplate. The arrester has a similar setup of rubber lips as the FF-33, except that here we have a total of *three* pairs: one set for the wires entering the unit at the top, another set for the protective ground wire exiting at the right-hand side and a third pair for the wires exiting at the bottom.

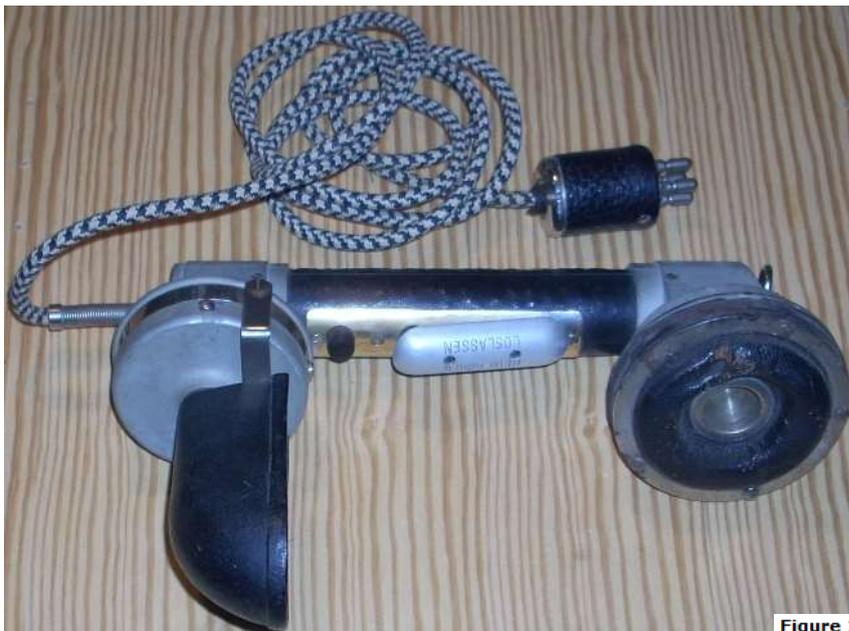
Figure 1

The picture to the left shows a typical Austrian WW I field phone handset, with an integrated push-to-talk switch and a buzzer pushbutton.

This style of handset was plugged into a separate battery box, which only supplied the power for the microphone and the buzzer. Everything else, including the induction coil<sup>[1]</sup>, was integrated into the handset.

[1] The induction coil wasn't a separate unit; instead, it was an integral part of the buzzer. This was done in order to save space and weight.
