## A Collection of Telephone Tales

written by Herbert Schwarz of Vienna, Austria, European Union

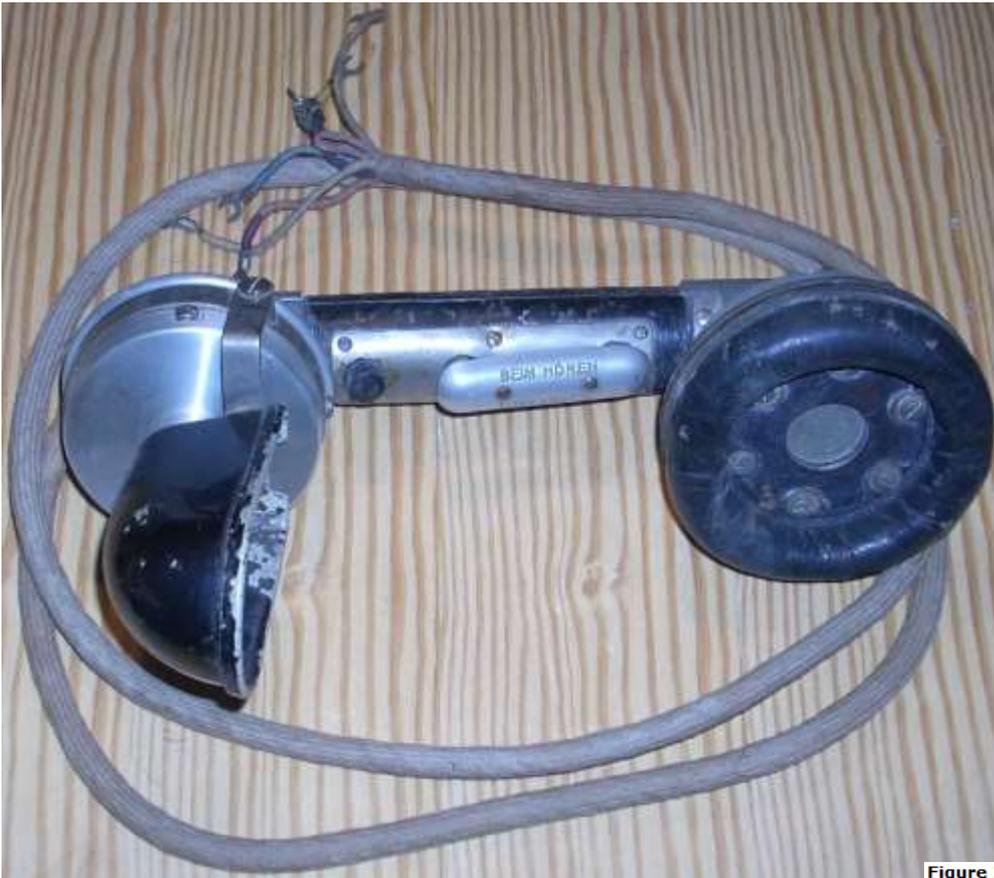
Figure 2

The handset shown here was a component of a different field phone as used by the military forces of the Austro-Hungarian Empire during WW I. While of a similar design as the previous handset, the buzzer/induction coil unit was mounted inside a wooden carrying case which also housed the handset during transportation. The wooden battery box was normally bolted to the back of the carrying case. Design features common to both handsets are the large, foldaway "trough" mouthpiece and the leather-padded earpiece ring, which was commonly filled with horse hair.

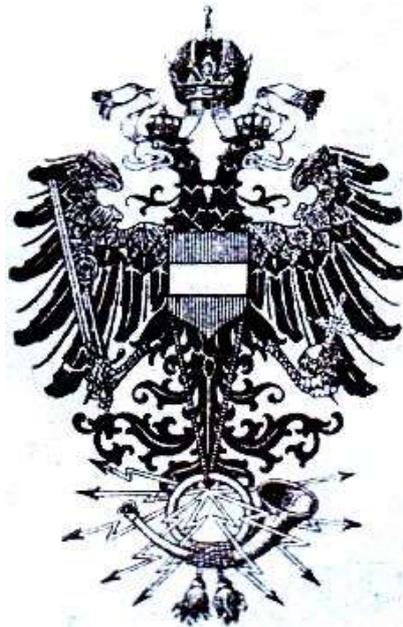
Figure 4

That “the instrument in the picture has the Austrian state insignia” is, alas, patently untrue. The Imperial-Royal Administration of Posts and Telegraphs *never* placed any sort of insignia on any of their phones. The telephone & telegraph administration, being a sub-department of the Imperial-Royal Ministry of Trade, didn't really have its own insignia. *If* any sort of insignia had been used, it would've been the double-headed Imperial eagle of the Austrian half of the realm, complete with a postilion's horn with lightning bolts, as shown at the top of the next page.

Readers should compare the scan above with the logo shown on the phone in figure 10 – does anyone truly see even the slightest family resemblance? The author certainly doesn't.

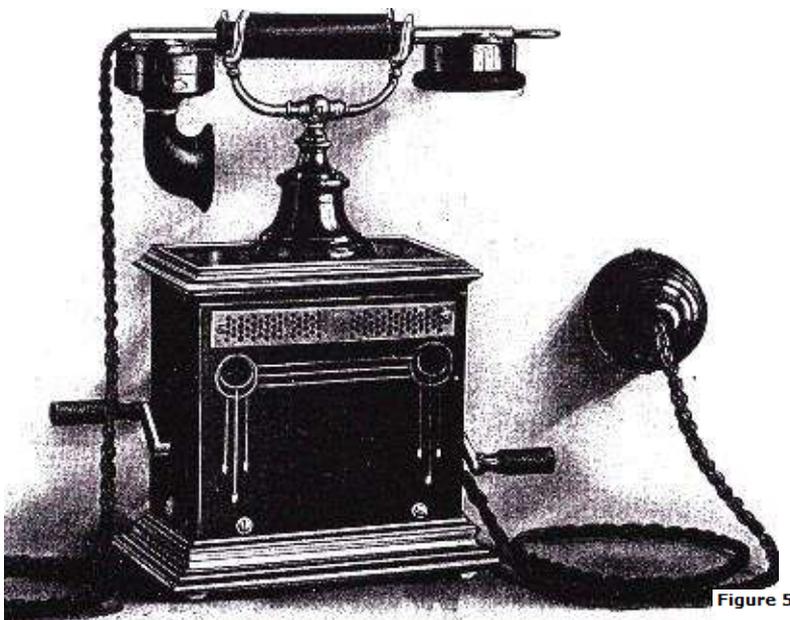
Figure 5

The scan on the left shows the Ericsson AC351w "state type" magneto desk set of 1906 as used by the Imperial-Royal Administration of Posts and Telegraphs.

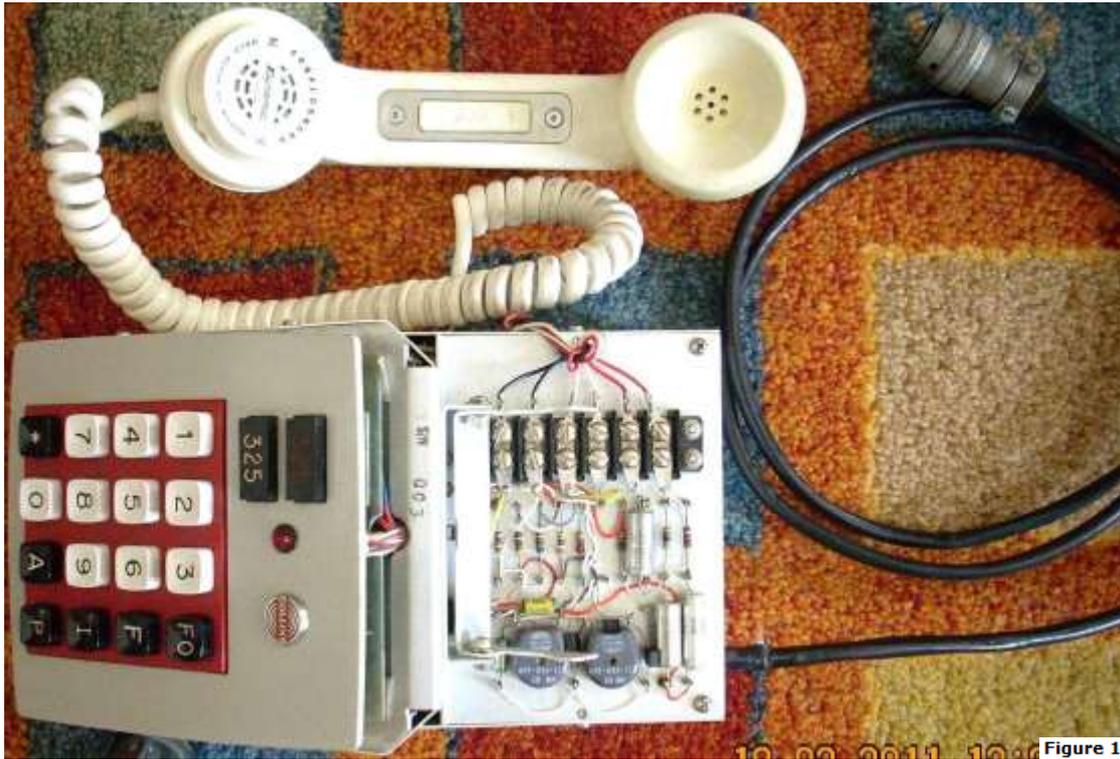
Figure 1

The moment I removed the housing from this phone I saw that this was no ordinary AUTOVON unit, but rather something *quite* different. The discrete R-L-C network the handset is connected to is already something unusual ... just as unusual as the fact that there is no strain relief for the handset cord – it's simply wedged between the thermoplastic housing and the aluminum chassis.

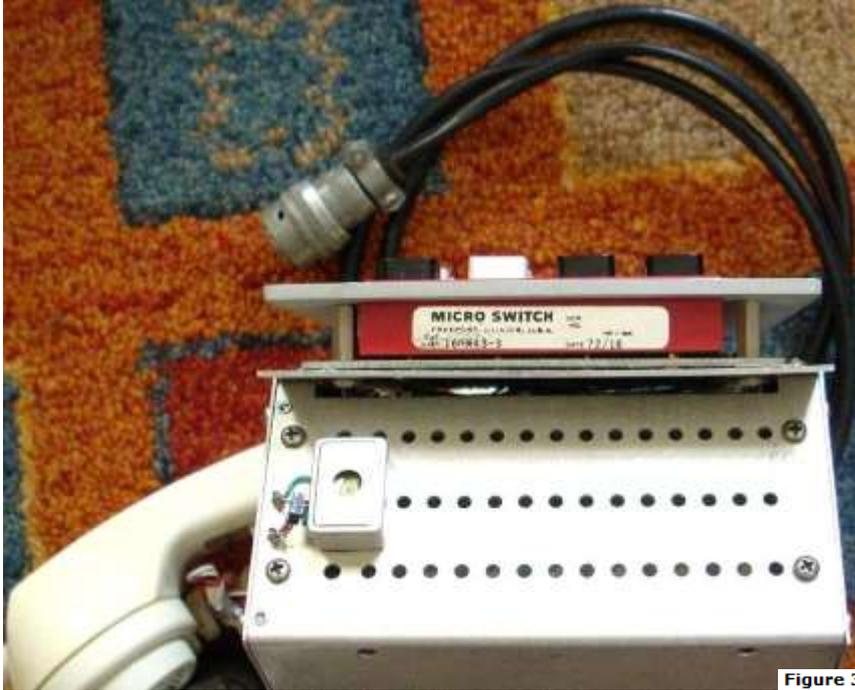
Figure 2

The keypad is a discrete unit, unlike any DTMF pad I've ever seen; it was manufactured in week 16 of 1972.

The phone doesn't have an electro-mechanical ringer; instead, the crystal mike on the left-hand side appears to be used as a kind of loudspeaker to reproduce some sort of electronic ringer tone(s).

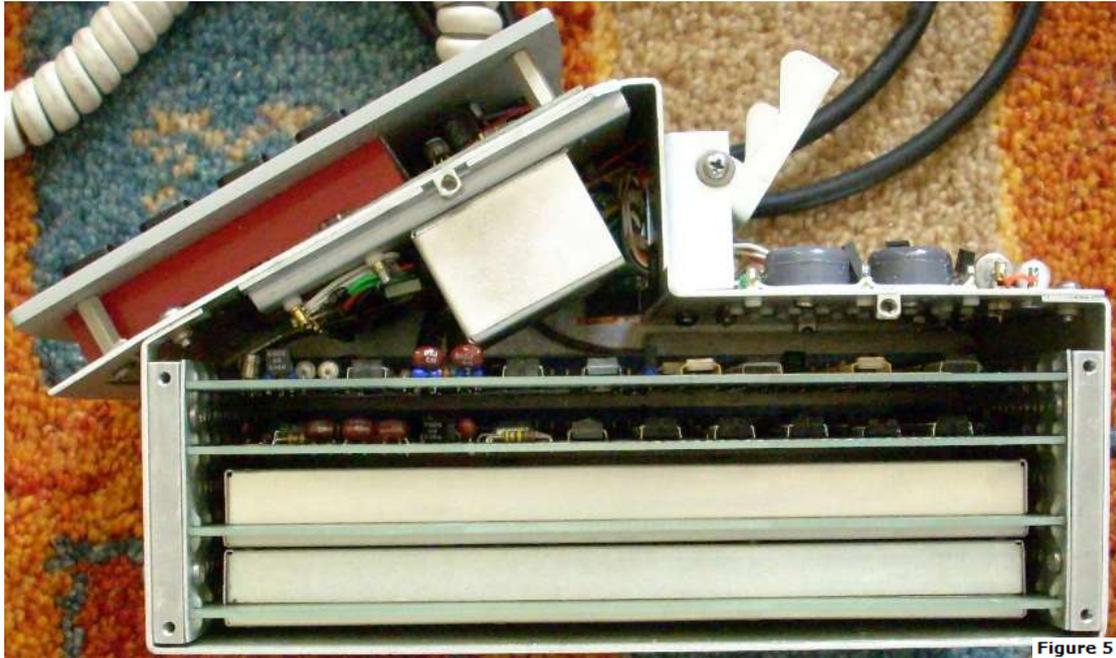
Figure 4

The internal arrangement of the chassis simply screams "high-tech," "military," "bomb-proof," &c. It appears that the upper two PCBs are concerned with low-frequency signal processing, while the other two, with their additional shielding, may have to do with high-frequency signal processing; some sort of analog speech scrambling *may* have been involved as well.

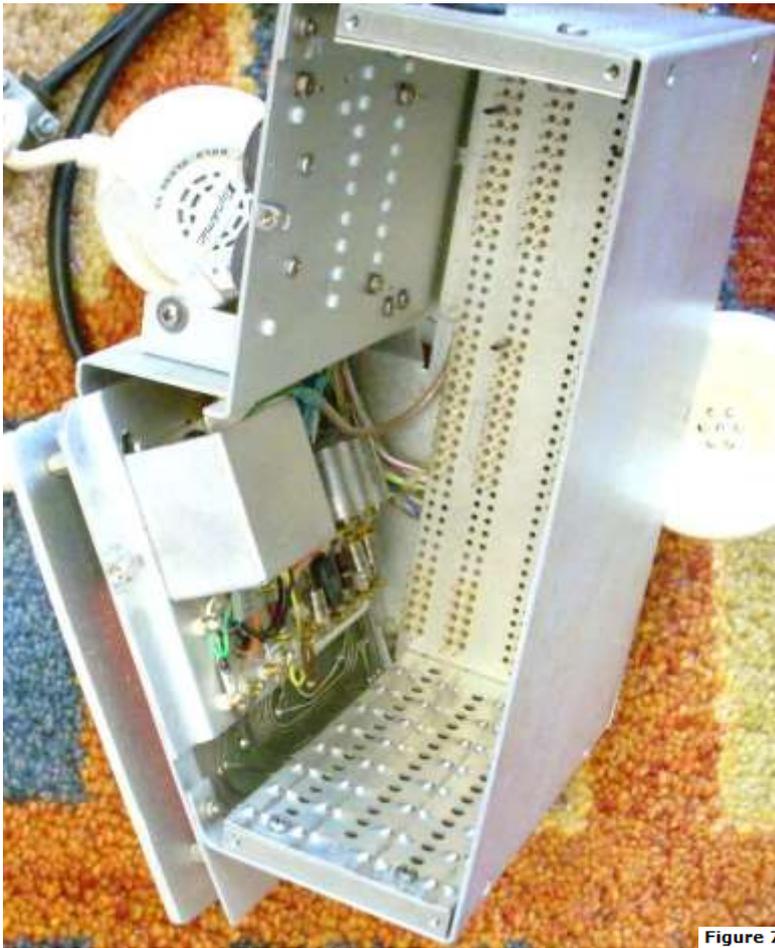
Figure 7

There is some more interesting point-to-point wiring, using individually placed, Teflon insulated stand-offs with gold-plated pins, hidden beneath the keypad.

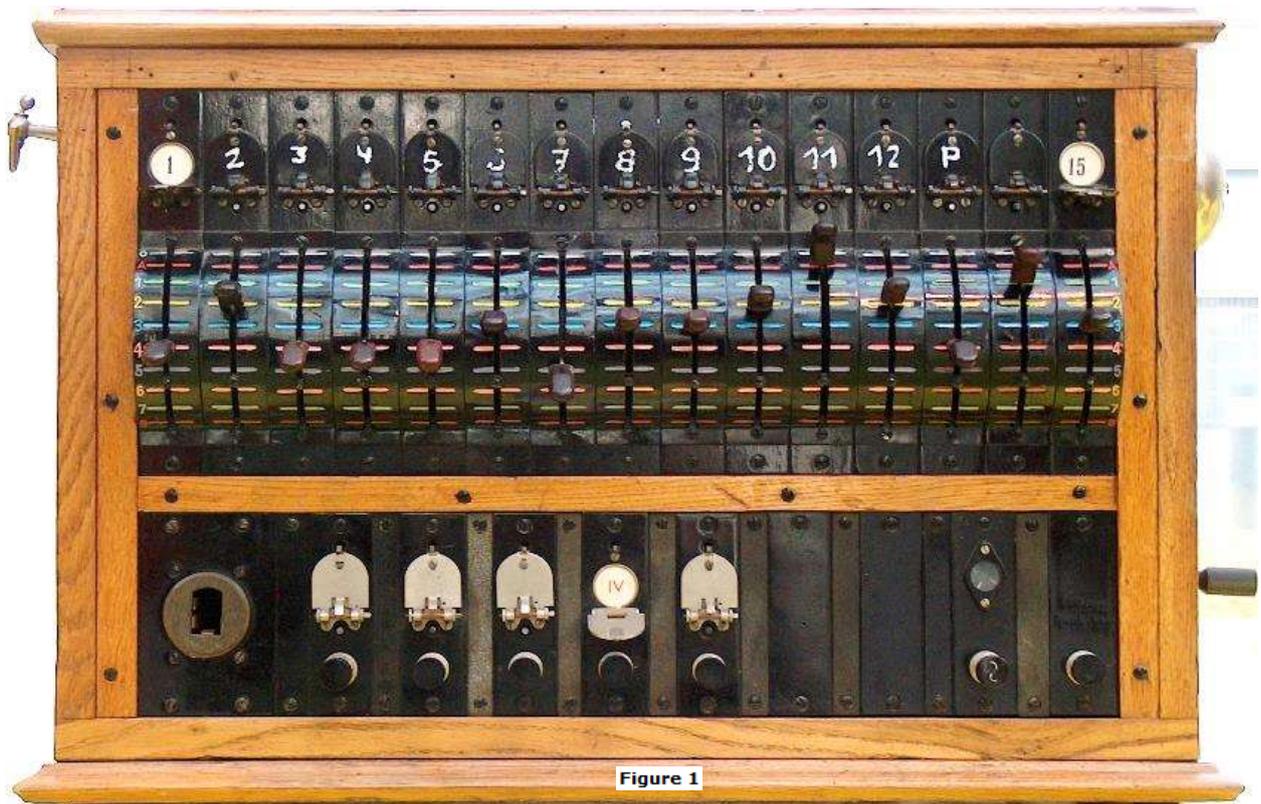
Figure 1

Here we have it: a cordless Austrian switchboard for 15 subscribers, in very good condition. Previous to seeing the one above in the Telecom Austria display, I only knew of the existence of such a switchboard from a description and woodcut in a PTT technical training book from 1953.

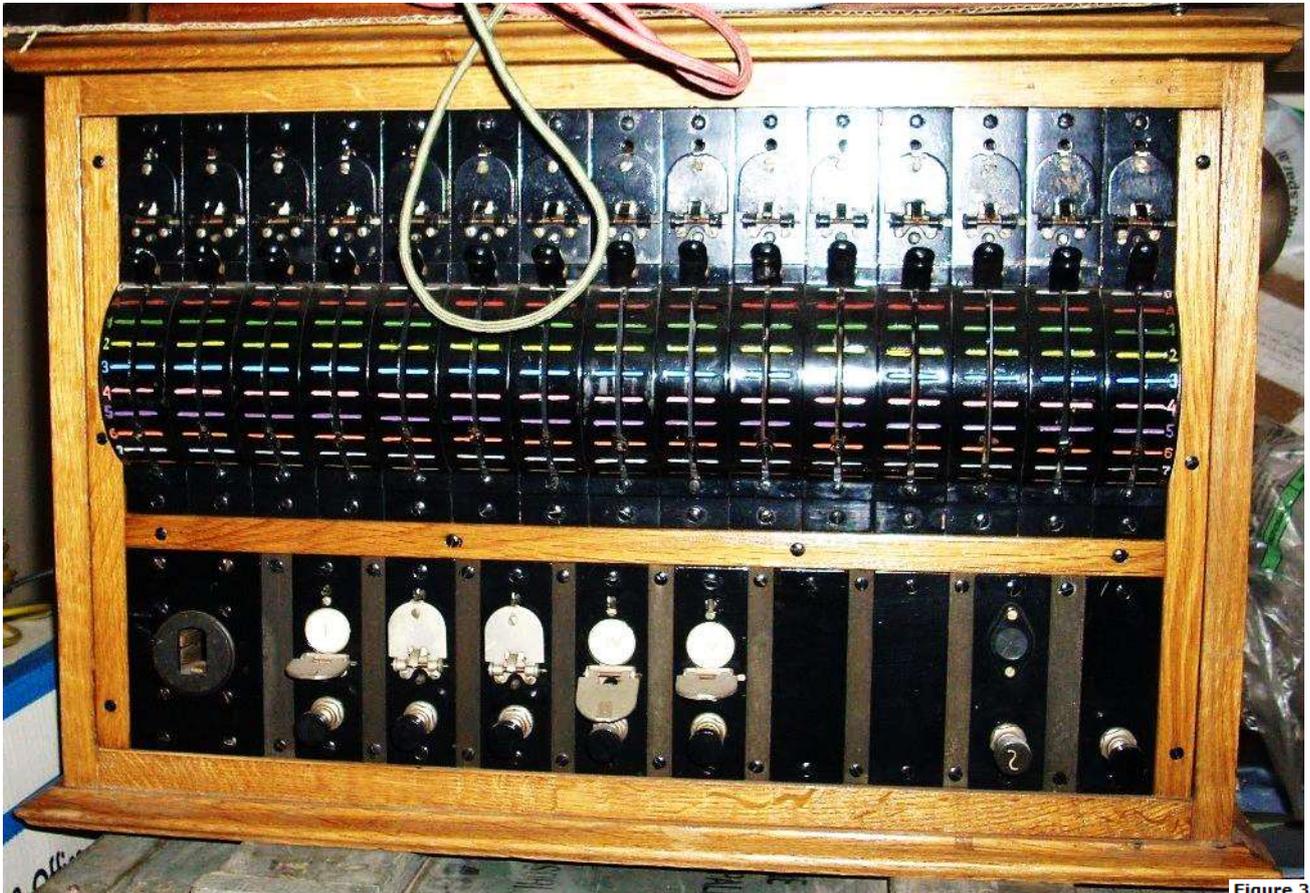
Figure 3

Well, there it is, fresh from being lugged up into my apartment (the cords dangling down from above belong to the second switchboard covered in this tale). The 15 drops painted black, way up on the top of the front panel, signal incoming calls, while the five drops at the bottom are the ring-off drops for the five possible links ... yes, I know that there are nine positions on the individual rotary switches, but the levers are mechanically blocked from being moved beyond position six.

As can be seen, three of the ring-off drops are in the operated position; this is a major fault with this particular switchboard – the armatures are slightly bent out of shape, and the drops are built in a rather complicated manner which means that repair will be a bit difficult. *More work for when I'm truly bored out of my skull ... and I'm not otherwise engaged with oddball projects, such as writing a collection of telephone tales.*

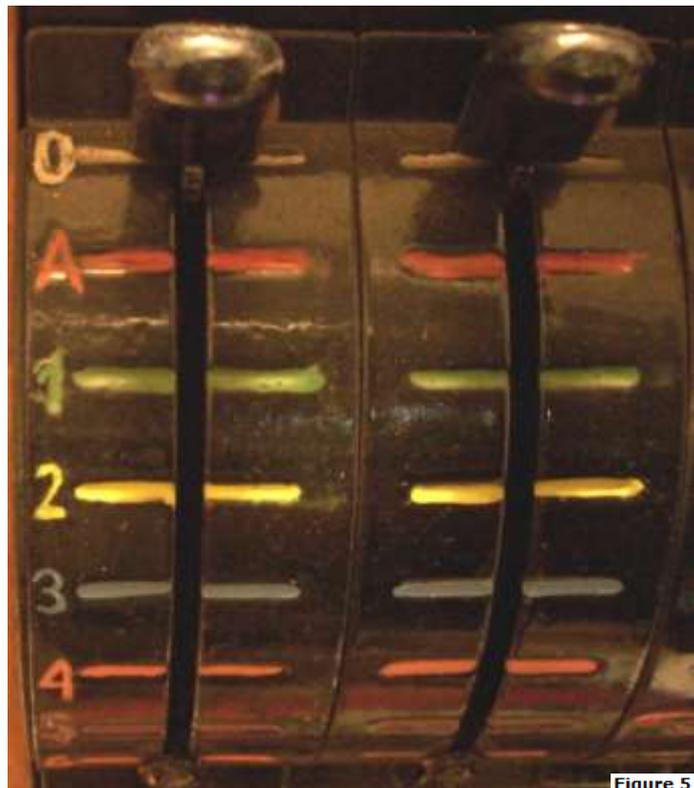
Figure 5

Switch position "A" is used to answer incoming calls; the "A" is the abbreviation for the German word "Abfragen." The individual switching paths are color coded across all 15 switches, so that operation of the board is simplified ... it's quicker and easier to align two of the levers on the color pink than to have to look for the digit four on the relevant switches.

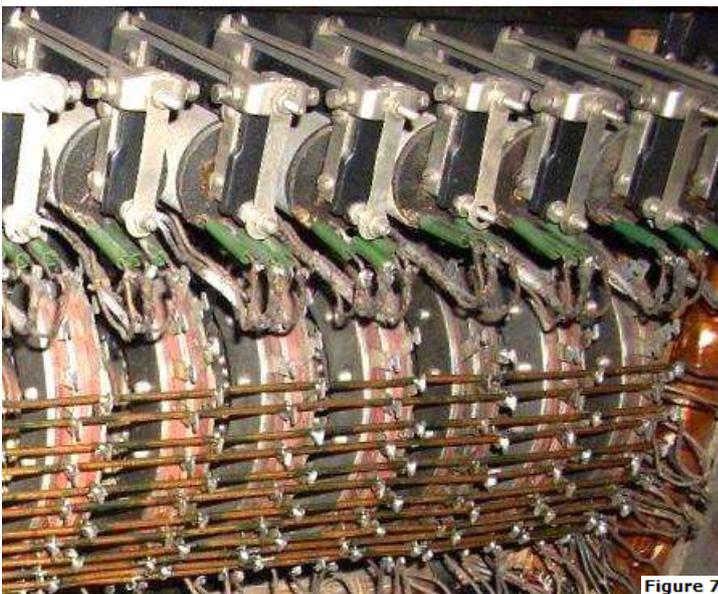
Figure 7

As can be seen in the detail picture to the left, the drop armatures are attached to their frames with two setscrews which have jamb-nuts; the armatures are moved via the flat, vertically mounted springs ... more nuts and jamb-nuts.

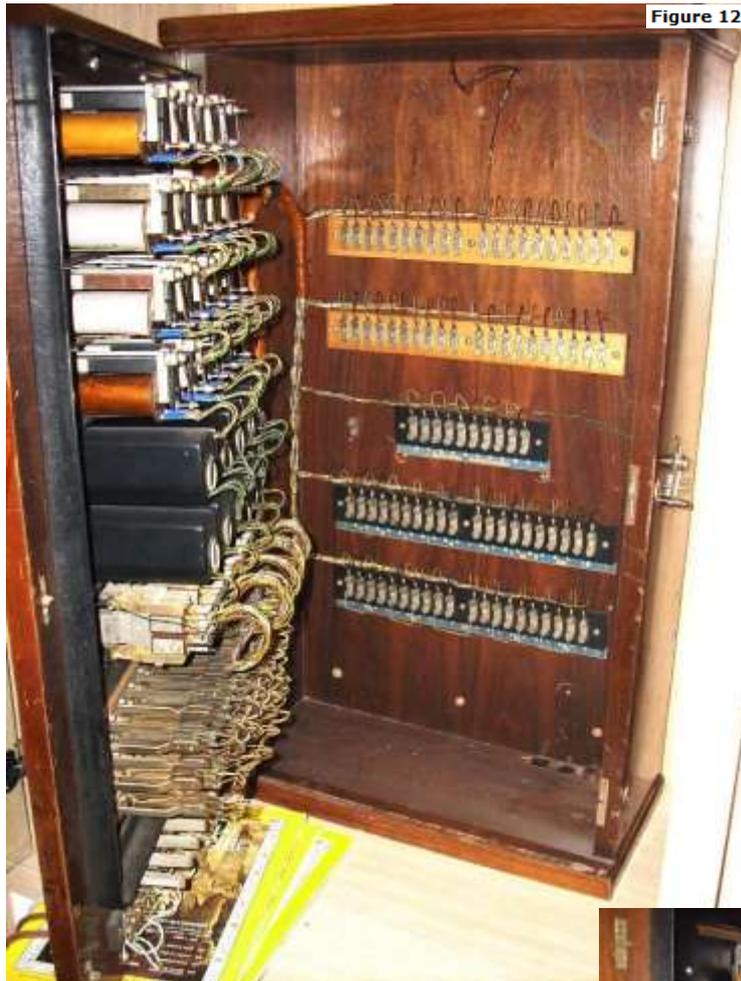
The two terminal strips on the top are for the 20 local lines, while the ebonite terminal strip in the middle is for the five terminal toll lines.

The first of the *long* ebonite terminal strips serves several purposes: 3x4 terminals for the two toll through-lines, 2x2 terminals for the two test cords, one terminal pair for the D.C. night alarm battery and one terminal pair connected to the line terminals of the operator's magneto telephone.

The lowest ebonite terminal strip has 2x2 terminals for the insertion of induction coils in the five terminal toll lines in order to provide isolation between the jacks and the toll lines; these coils were necessary if it was possible that crosses between toll and power lines could occur.

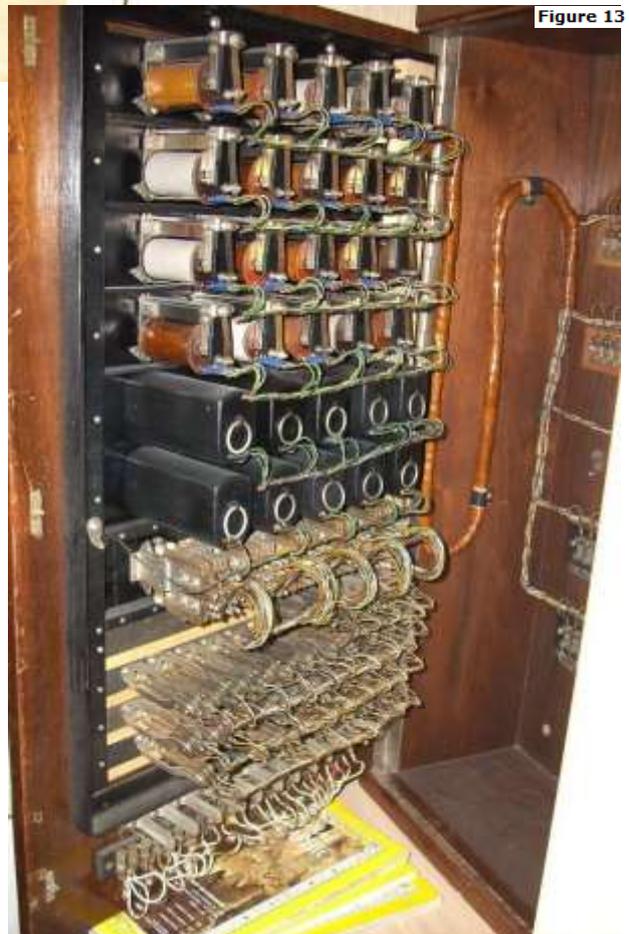
This photograph reveals two interesting facts: 1) the ring-off drops and the drops for the five terminal toll lines are shielded in order to prevent stray magnetic fields from any of these drops from inducing currents in any of the other drops and in order to prevent magnetic cross-talk between toll and local circuits. 2) not all of the drops are originals from 1915 ... those with a wrapping of slate-colored cloth are from 1915, while those with a wrapping of brown paper are units which were refurbished in 1960.

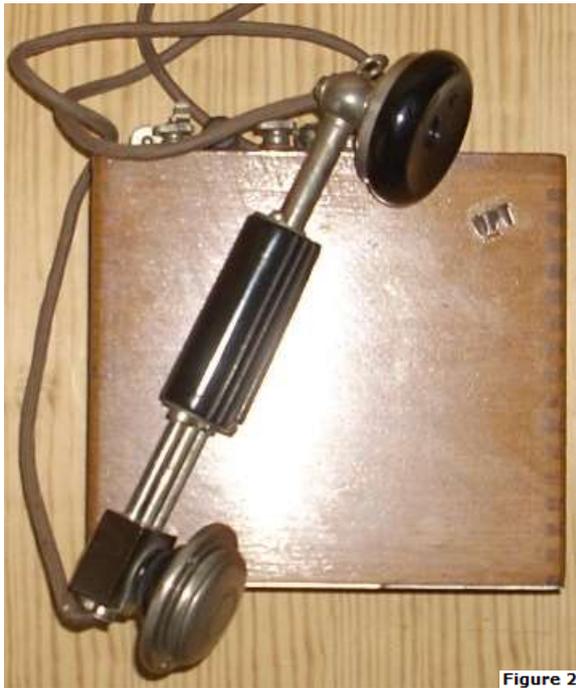
Figure 2

A side view of the LME field phone/test set, showing the handset in its fully extended position.

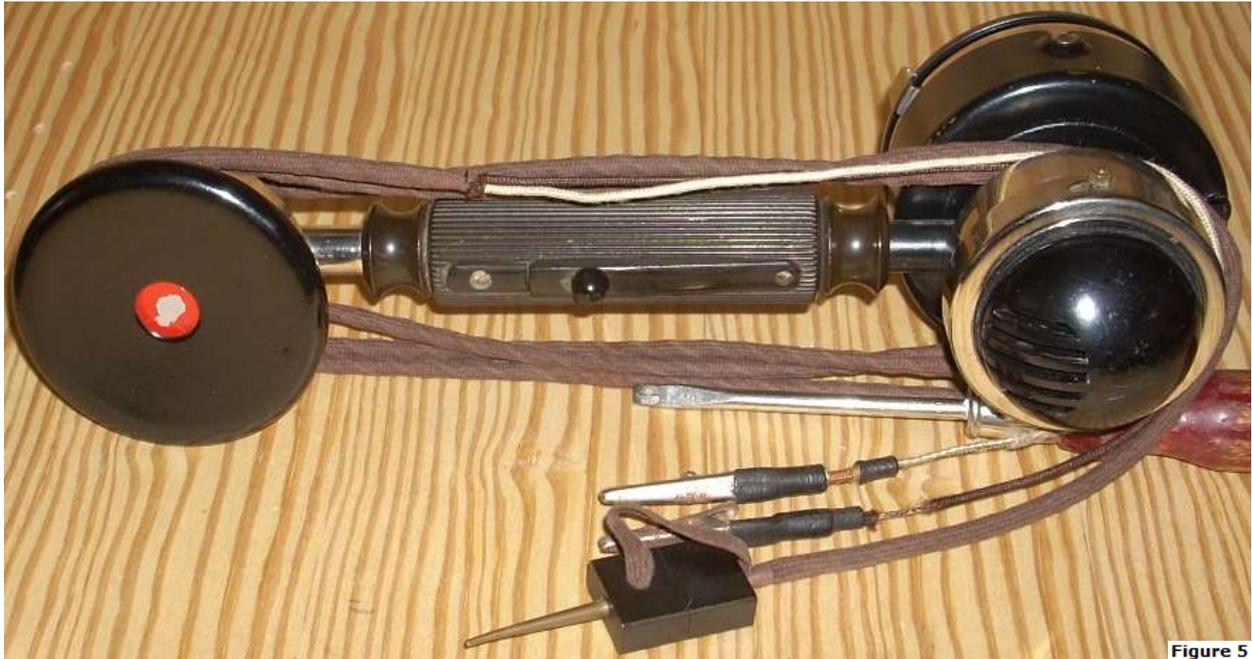
Figure 5

The only component belonging to this old butt set which isn't of the same period as the rest is the hemispherical mouthpiece, which is from a Siemens & Halske dial desk set model 1928. The reason that such a mouthpiece was used, instead of an original, was because the carbon microphone in this butt set was repaired (!) in 1957.

As readers can see, the membrane of the receiver was given a coat of red paint; this wasn't done because it looked pretty, but rather to indicate whether the receiver coils were wound to the resistance necessary for use with a C.B./dial or with a magneto telephone. Red paint meant that the handset was intended for C.B./dial phones, while blue paint was used for magneto phones. The latchable push-to-talk bar is a copy of the one which LME used with the early handsets on their Eiffel Tower magneto desk sets; the only difference here is that the push-to-talk bar is latchable when operated.

The butt set has two separate test cords: one which ends in two alligator clips, and one which ends in a test prod. When testing a single-party (private) line, only the two alligator clips are used, but party-lines required a brief ground on tip to activate the party-line equipment in the CO; the test prod was used to supply this ground. The test prod is built of two pieces: the cord portion and the prod itself. Unplugging the halves of the test prod opened the loop and put the test set in an on-hook condition.

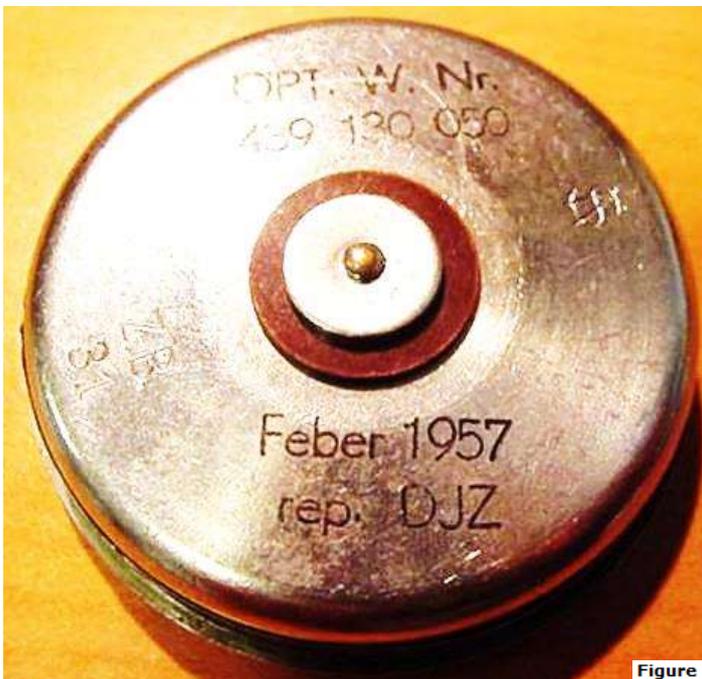
Figure 7

This capsule was originally manufactured by the firm of Kapsch & Sons in 1931 and was intended for use with a C.B./dial telephone (the German abbreviation "ZB" stands for **Zentralbatterie** - a central or common battery).

According to the black, stamped markings, this capsule was repaired in February of 1957, by the firm D. J. Zelisko of Vienna.

The stamped marking on the top lists the 9-digit part number that the PTT assigned to this type of microphone.

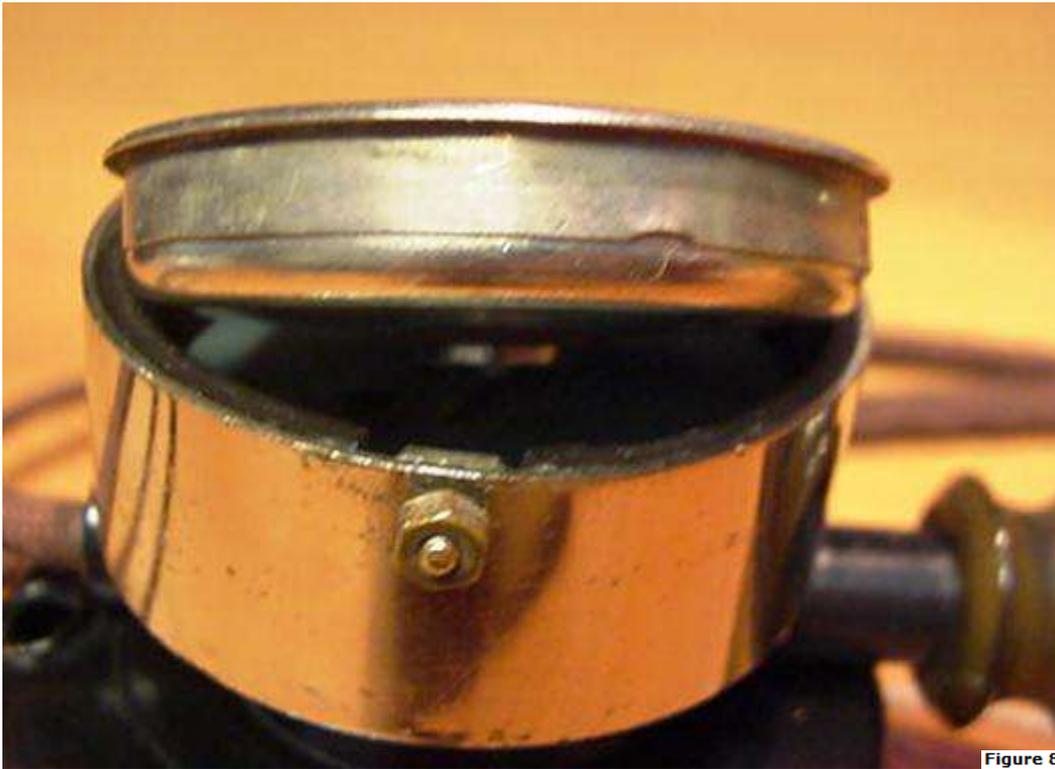
Figure 8

This close-up shows the special ring slipped over the microphone screen to hold the same in place after repairs. The mouthpiece which was used with this particular butt set had a thick rim which applied enough pressure to keep everything in place during use.

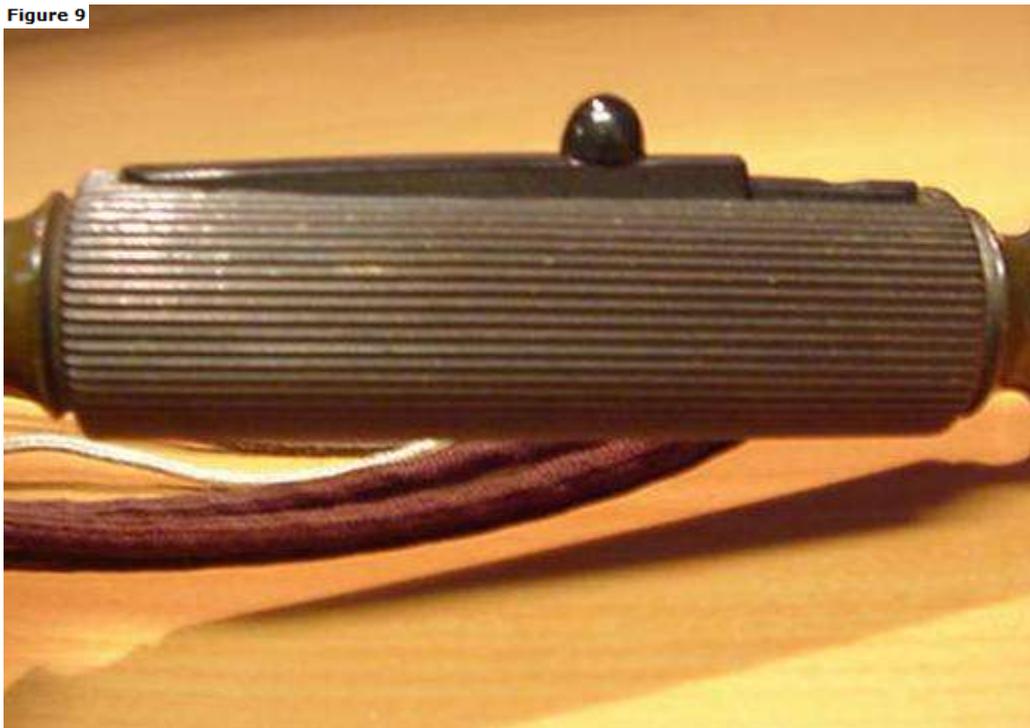
Figure 9

The close-up below shows the push-to-talk switch bar in detail. The small, round knob was pushed fully down (in the direction of the microphone) so the push-to-talk switch functions in the conventional manner. Pushing the knob all the way up (with the push-to-talk switch bar depressed) latches the switch bar in the talking position.

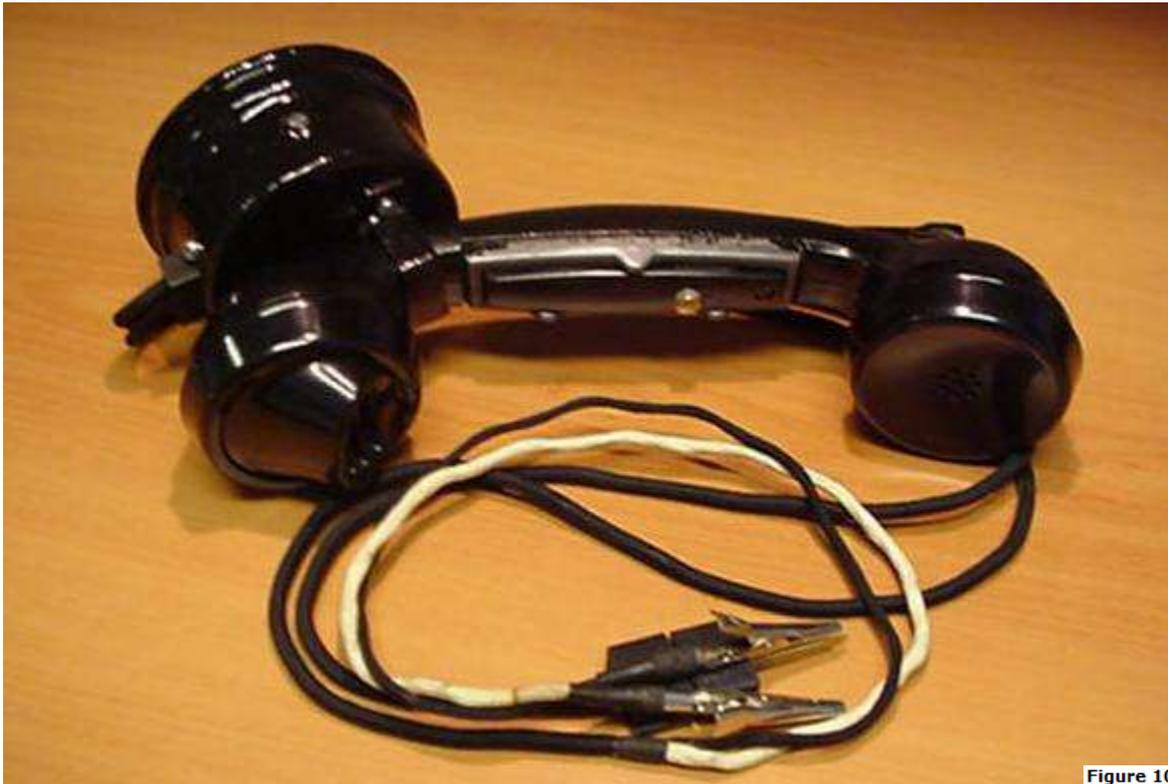
Figure 10

Viewed at this distance, the repainted dial cup doesn't look half bad, and the cords look nice as well. Of course, the wire insulated in black should be insulated in brown, so that we'd have the classic brown/white pair, but I didn't have a proper cord at the time, and I wanted to finally get finished with this restoration project.

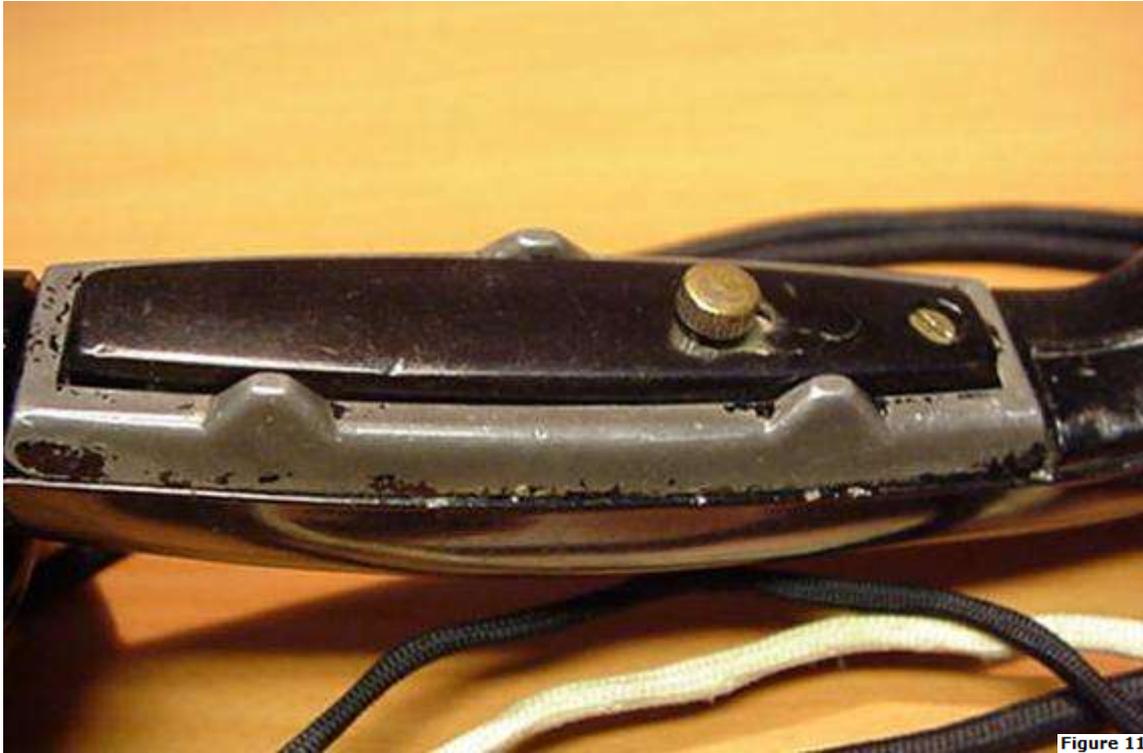
Figure 11

The push-to-talk switch is that of the FF-33 field handset, but with a twist, since it's often necessary to keep the switch in the talking position for extended periods, and the original switch bar didn't have any provisions for latching. What the Austrian PTT did was to punch a not too neat hole into the switch bar, insert a leaf spring below the bar and solder the winding knob from some defunct watch onto the leaf spring in order to make the switch bar latchable.

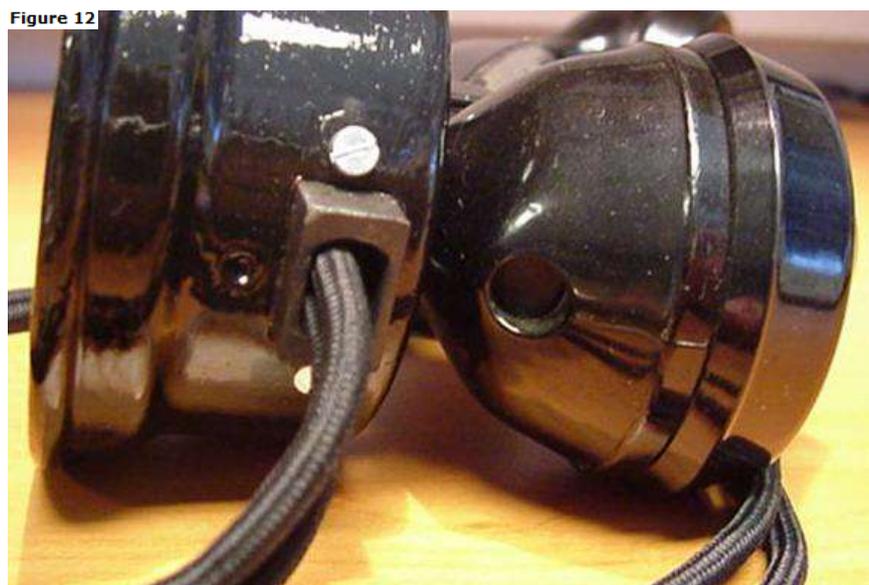
Figure 12

This picture was taken in order to show that the two test cords didn't exit from the handset, but rather from the dial cup, and that the original cord exit on the handset was plugged up to prevent water or dirt from getting inside.

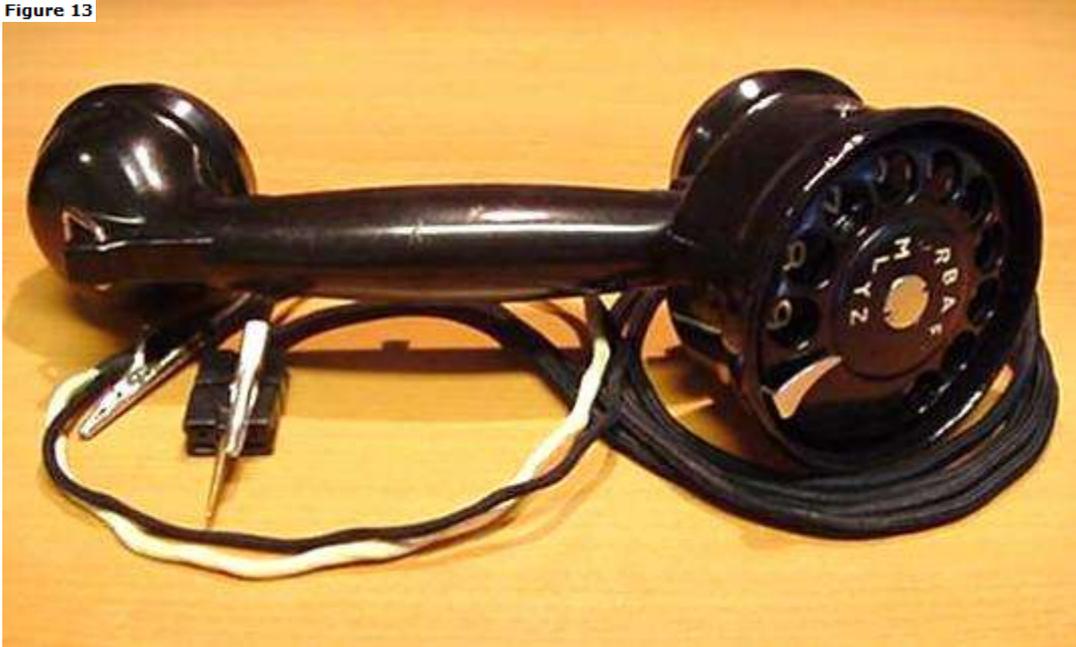
Figure 13

Since this butt set was from shortly after WWII, and I found the remnants at a junkyard in Vienna, it was only natural that the dial would be the old Viennese dial. I opted for a numeral ring and a well-worn finger wheel, both made of an inexpensive thermoplastic, which would've been more readily available after WWII.

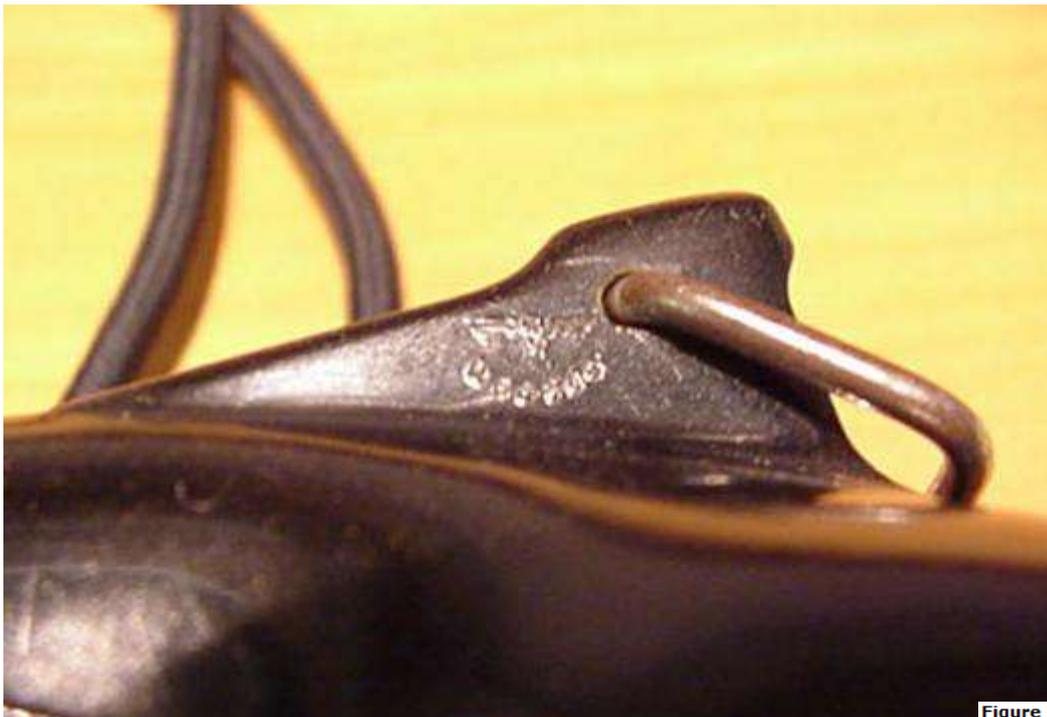
Figure 14

I included the photograph below just to prove that the butt set was made out of a wartime FF-33 handset, and not from some leftover without the Wa.A. hallmark.

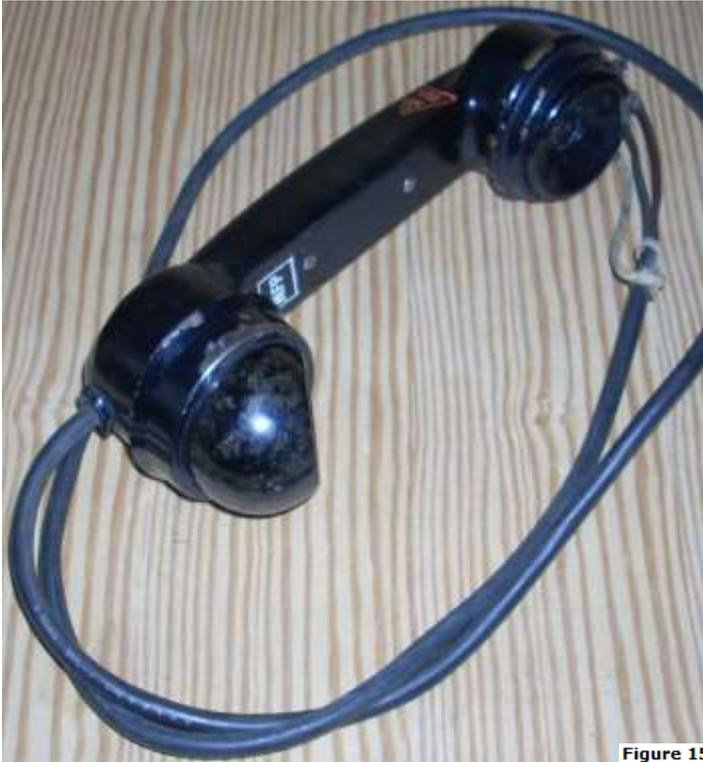
Figure 15

The butt set shown to the left is a sound-powered one left over from the U.S. Army occupation of parts of Vienna and Austria between 1945 and 1955.

The handset handle and the rings which hold the earpiece and the mouthpiece are made of sturdy brass painted black, while the earpiece and mouthpiece themselves are made out of a composition of Bakelite and cloth strips (these make the Bakelite practically indestructible).

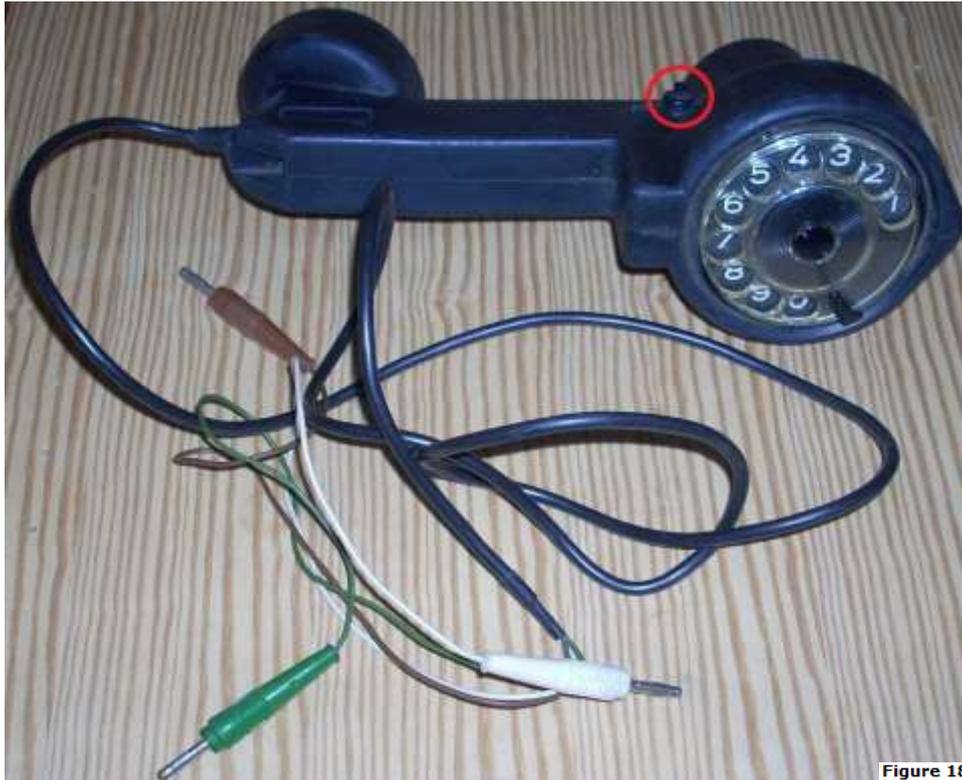
Figure 18

This butt set uses a dial from the Austrian W62 desk telephone and was used throughout Austria during the 1960s and 70s. It was purpose built, and is just about as moisture-proof as the Bell System 1011 style butt set. As can be seen, this unit doesn't have the two-piece test prod some of the earlier Austrian butt sets had; instead, there is just a ground wire (green) which serves the same purpose. However, this ground wire was simply clipped to some local ground and left attached. Any brief grounding of the "tip" lead (necessary in order to activate party-line equipment in the CO) was accomplished by briefly depressing the grounding button (inside the red circle in the picture above).

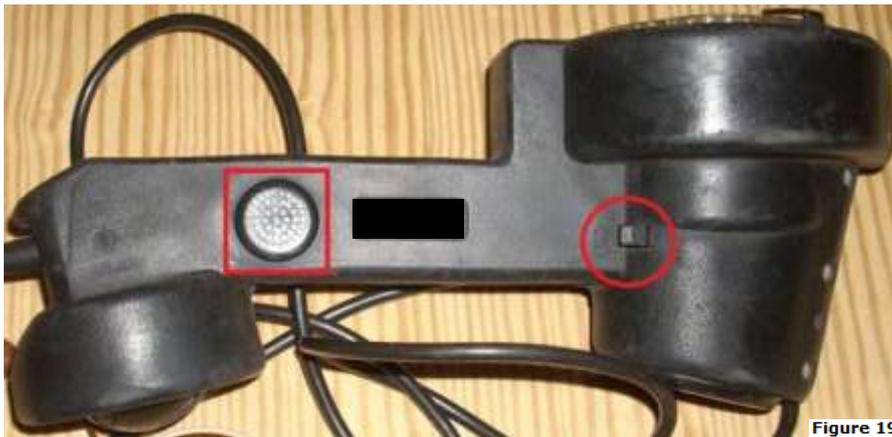
Figure 19

The "talk/monitor" switch is rather difficult to see; this type butt set has one, though, located within the red circle. The switch positions are simply labeled as "on" and "off" in German.

Instead of listening in for ringing current by setting the "on/off" switch to the "off" (= monitor) position, this particular butt set has an electronic ringer; the transducer can be seen within the red square.

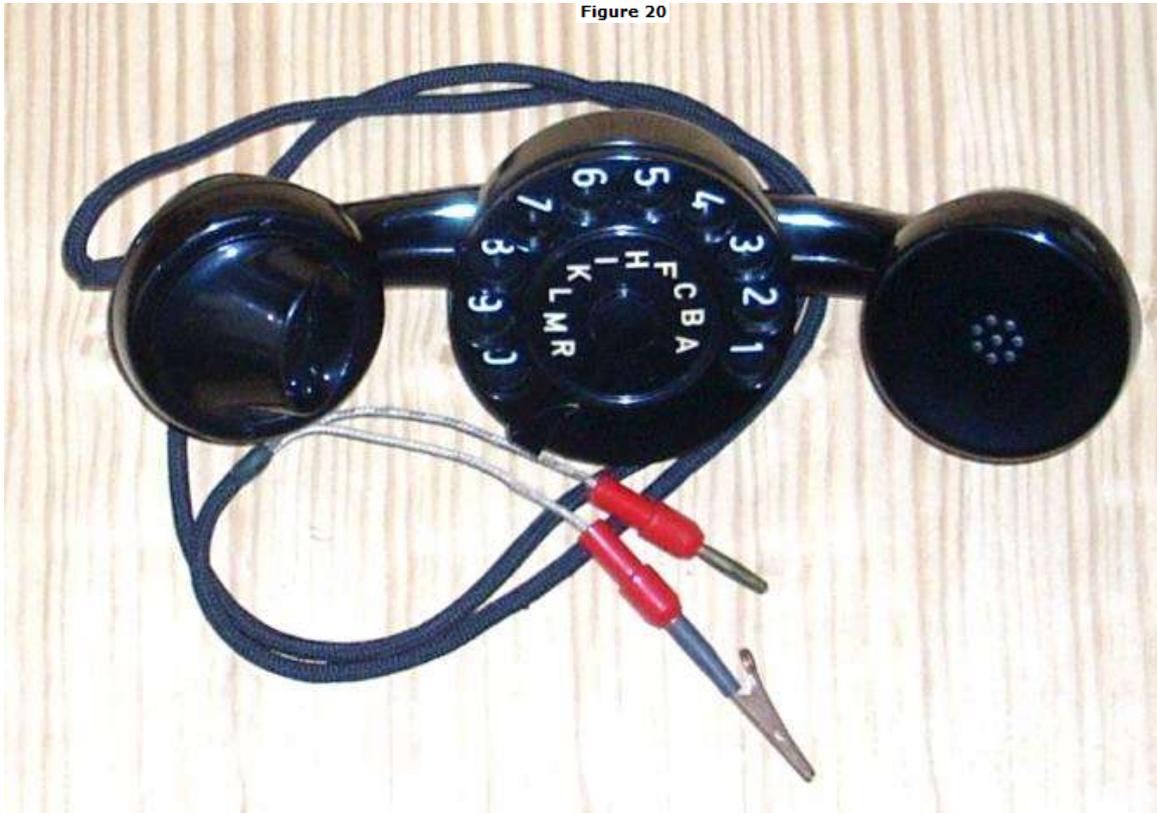
Figure 20

The finger wheel has the lettering which was typical in communist Czechoslovakia, and that is where this particular butt set is originally from. This style of butt set is certainly the most impractical I have ever come across – very difficult to hold in the hand, and when one manages to get a grip on it, the finger wheel will leave an imprint on one's cheek if the butt set is held at an angle which would allow one to speak.

There is a red dot on the dial cup which indicates the "talk" position of the slide switch.

On the previous page I mentioned the fact that I replaced the earpiece with one from Germany ... the reason it fit on this butt set is because the handset itself is an exact copy of the one used with the German W48 type dial telephone.

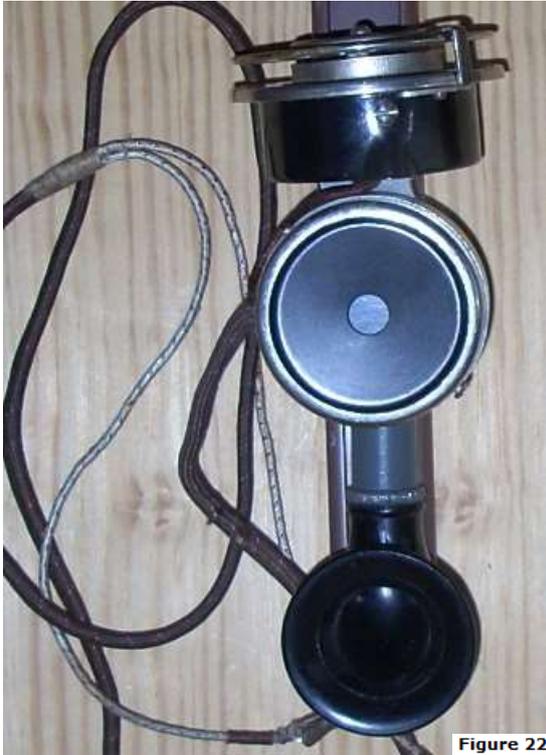
Figure 22

This odd little butt set stands exactly 7½ inches tall from the finger wheel to the lower edge of the mouthpiece; the distance between mouth- and earpiece is so short that the only people capable of using it with comfort are the pygmies of Papua New Guinea. Since the housing is painted battleship gray, I'd guess that this butt set is another one which started out in life as a handset belonging to some field phone or other.

From the look of things, the dial was added at some later point in time. One thing is certain, however, namely that the receiver isn't the one originally installed, because the one now in place comfortably fits inside the housing, *earpiece included*.
