## A Collection of Telephone Tales

written by Herbert Schwarz of Vienna, Austria, European Union

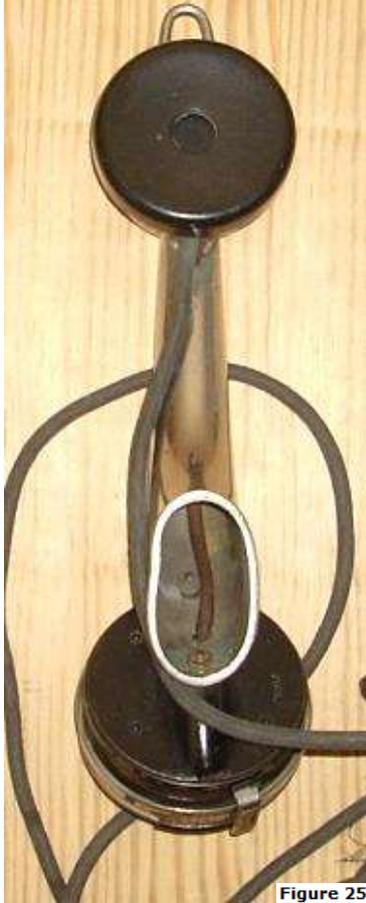
Figure 25

This is the other French butt set that I have in my collection. As usual, I let other people do the travelling and then buy up what they themselves bought elsewhere – so this is yet another eBay® find.

As far as I know, the type of handset this butt set was made out of was popular in France circa 1920. Anyway, this unit is also cobbled together out of pieces of old telephones which were taken out of service, as the loop on the receiver proves; the loop was originally used to hang the handset on its hook-switch.

This butt set saw lots of use by linemen, seeing how dinged up the various bits and pieces are ... the dial has been exposed to enough moisture to allow rust to form, the cord is frayed at the end, and the springs inside the alligator clips are broken (one of the clips has a broken “jaw” as well).

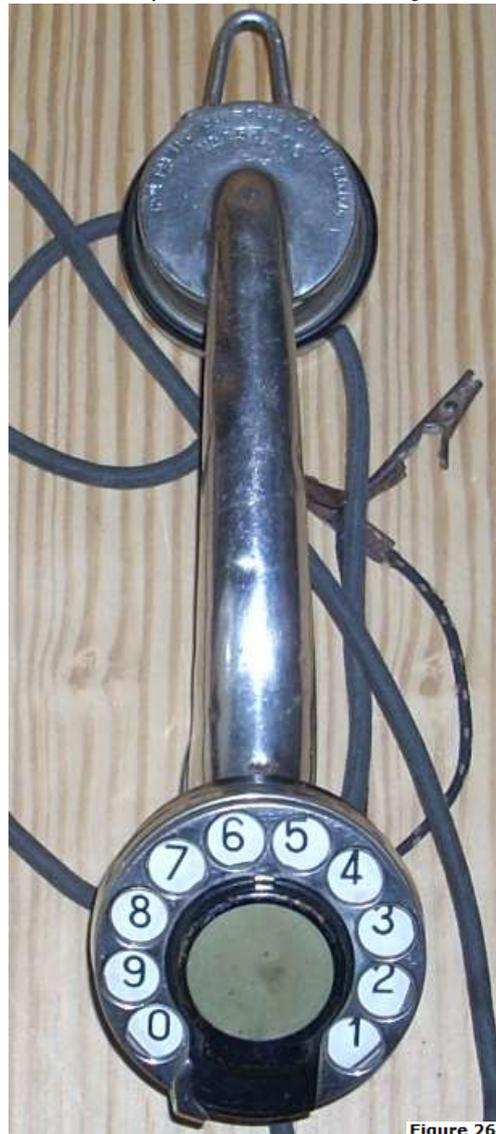
Figure 26

There isn't a lot more I can write about this butt set and its dial, except to mention the fact that the dial is a typical product of the Bell Telephone Manufacturing Company in Antwerp, Belgium, and was their model number 7002B.

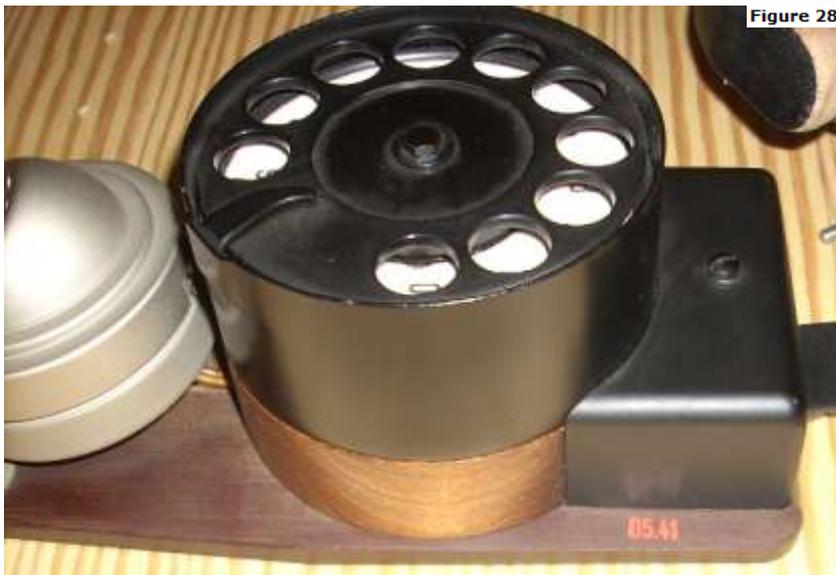
Figure 28

While having been built in May, 1941, this type of butt set was the Reichspost model "Strf. 30." The abbreviation "Strf" stands for the German word "**St**recken-**F**ernsprecher," literally "line telephone," while "30" identifies the year this unit was designed and/or first placed into service.

The little case below the dial cup carries the four banana jacks required to connect the test cords and the headset. The test cords are connected to the jacks "a" and "b" (equivalent to "tip" and "ring"), while the headset is plugged into the two jacks marked "F" (for "**F**ernhörer," literally "distant listener").

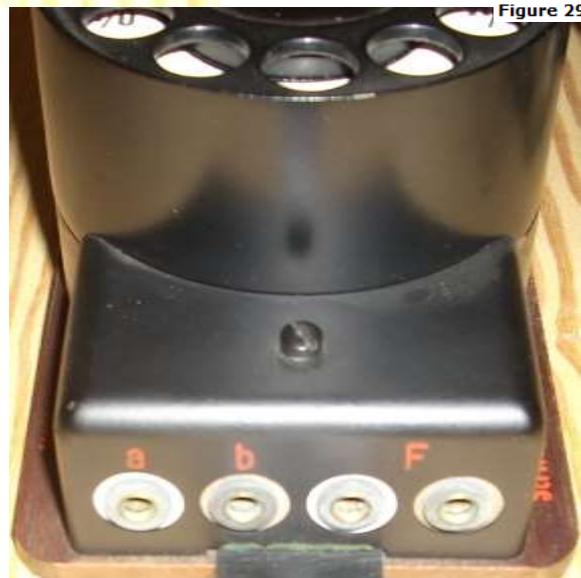
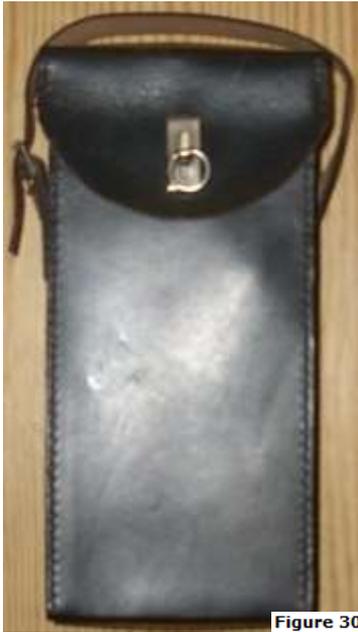
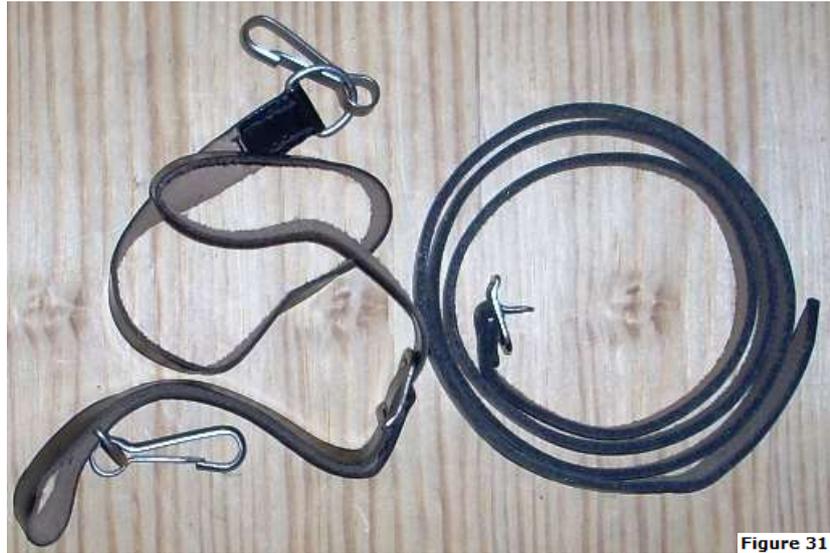
The photographs above show the two leather straps and the carrying case as supplied with this butt set. The leather strap on the left side above was worn around the neck, with the two snaps clipped onto the "D" rings on the baseplate of the butt set, while the one on the right was used to convert the short carrying strap of the leather carrying case into a long one, so that the case could be slung over a shoulder.

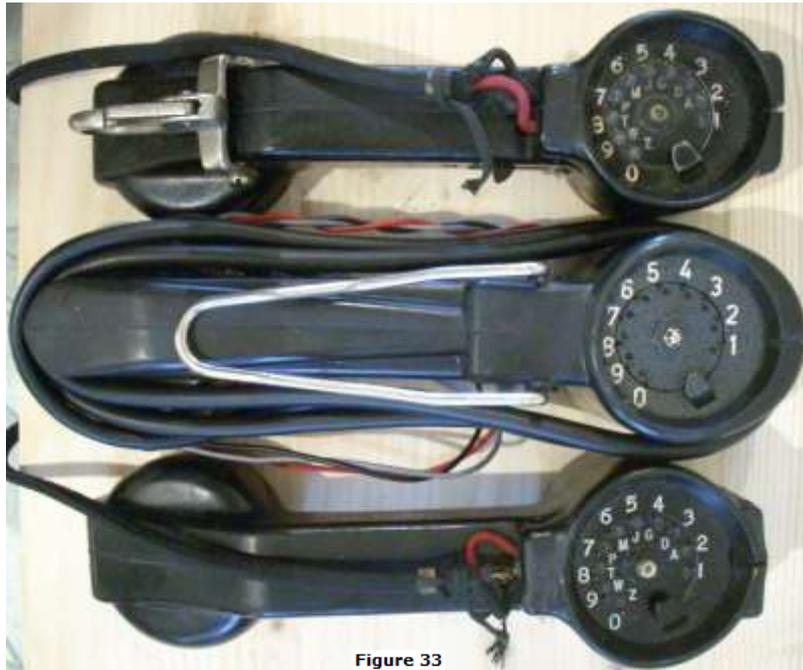
Figure 33

The upper butt set in the photo to the left is the Bell System 1011BW, the one in the middle is (obviously) the one which was used by the Deutsche Bundespost (German Federal Post [Office]) and the lower one is the TS-365/GT from the Signal Corps.

The West German butt set sports an earth (or ground) pushbutton, which is located immediately above the microphone. Another major difference is that the test cord exits the handset handle at the bottom and isn't easily replaceable.

The test cord colors are as follows: tip (a) = slate, ring (b) = black & red = ground.

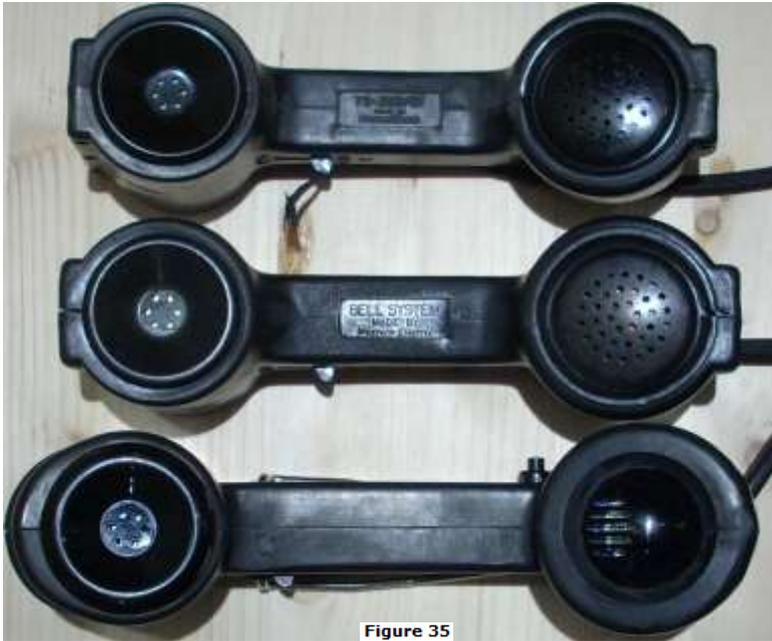
Figure 35

The caps for the microphone and receiver capsules are made of Bakelite in the W.E. butt sets, while those on the West German model are molded from a thermoplastic. The big difference here is that the German one has the cap over the microphone hemispherical in shape and has vertical slits through which sound enters.

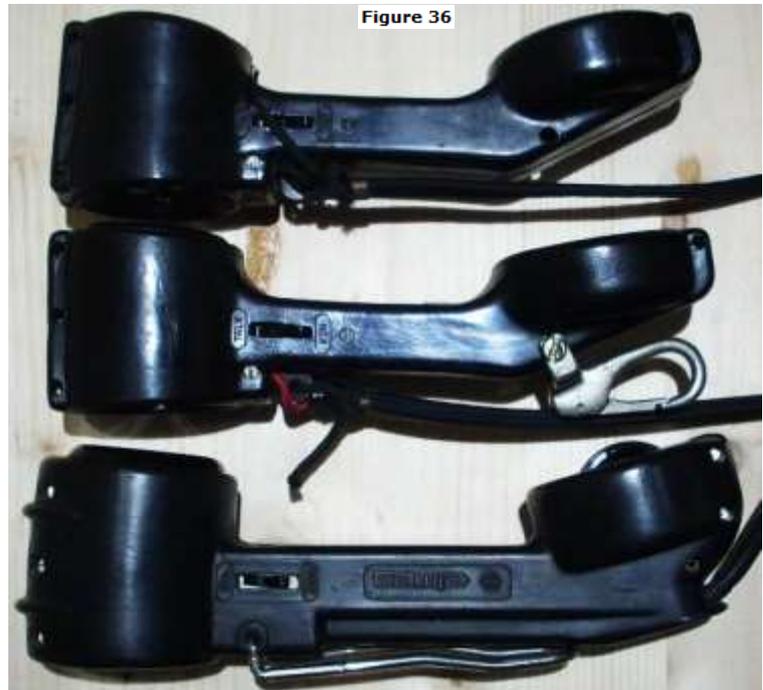
Figure 36

The "talk/monitor" switch of the West German butt set is simply labeled as "on/off;" the "off" position is the equivalent of the "monitor" position on the W.E. butt sets.

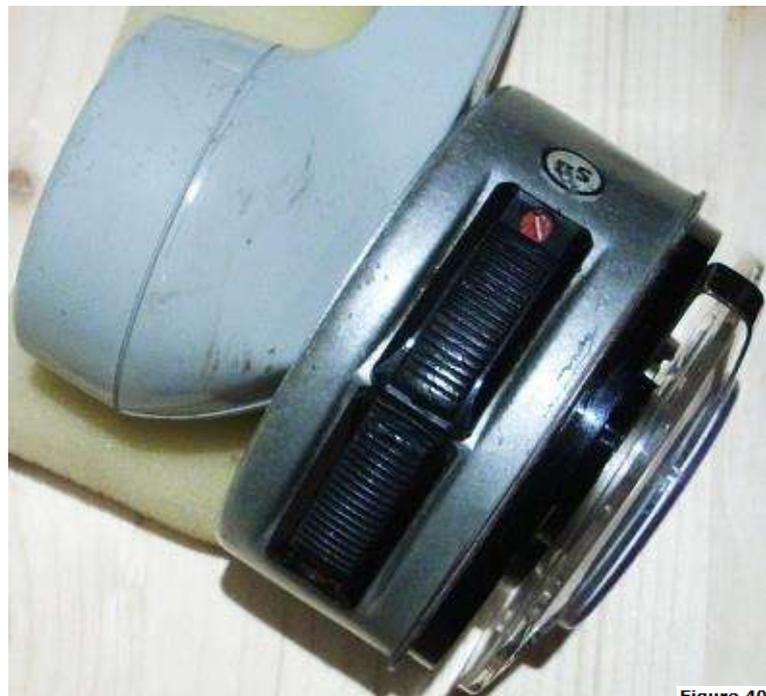
Figure 40

The drawing to the right shows the schematic of the GDR butt set. The unit is set to "monitor" the line if switch "S1" is open and "S2" is closed. In this case, voice currents flow between the blue and brown wires via the normally closed dial pulse contact, the 0.33 uF condenser, the receiver, the voltage dependent resistor "VR" (which is designed to limit the volume in the receiver to a comfortable level) and switch "S2."

As can be seen, there are two S.P.S.T. slide switches on the dial cup, one of which is equal to the “talk/monitor” switch, while the second one (labeled as “S2” in the photo) is used to cut a standard silicone diode in or out of the circuit. This diode was necessary in order for an installer/troubleshooter to be able to simulate either of two subscribers who shared a special type of party-line in which diodes played a most important part. The specific circuitry used with such party-lines is, alas, rather convoluted and won't be covered here.

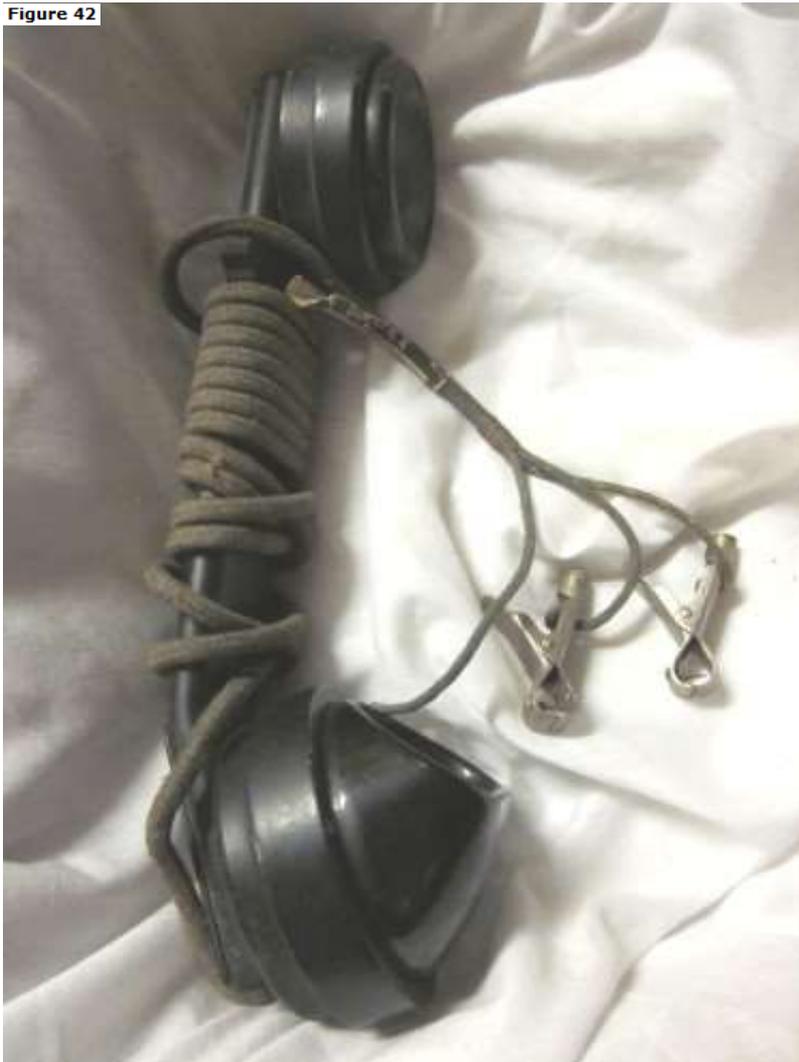
The butt set on the left was one used in connection with central battery (as opposed to dial) offices. It was manufactured by Stromberg-Carlson, and carries the Signal Corps acceptance stamp "SC3962A." The line cord is a SC "Duratex" MC-2-C, and the testing clips are the good, old ones from the Frankel Connector Co. Inc. in New York.

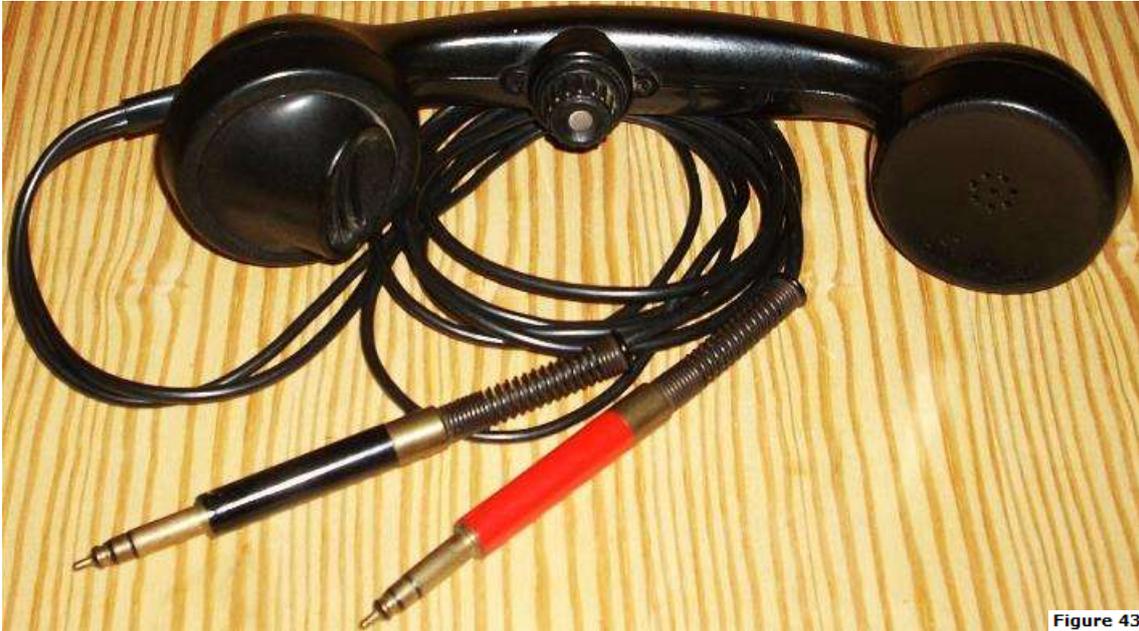
Figure 43

Now we come to four Austrian PTT butt sets which were used for troubleshooting and call tracing in central offices. The first one shown was used in tracing phone calls; it didn't have a dial, because it wasn't used for testing the various switching stages of Strowger type exchanges.

The push-to-talk switch is depressed for talking and rotated while being depressed in order to latch; this is the later of two types of push-to-talk switch which were commonly used by the Austrian PTT.

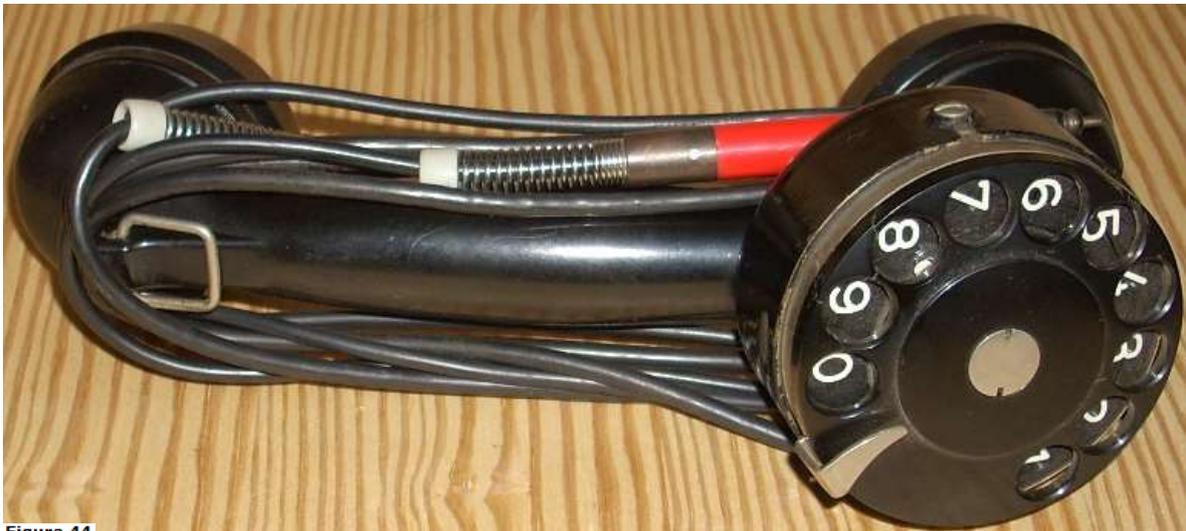
Figure 44

I have previously described a lineman's butt set which was made out of an *original* field handset 33; the butt set shown above was also made from the same type of handset, but the one here *doesn't* have a Wa.A. hallmark. The reason is that there were numerous such handsets still in the factories, but which had not yet passed inspection and thus lack the typical German WWII hallmark.

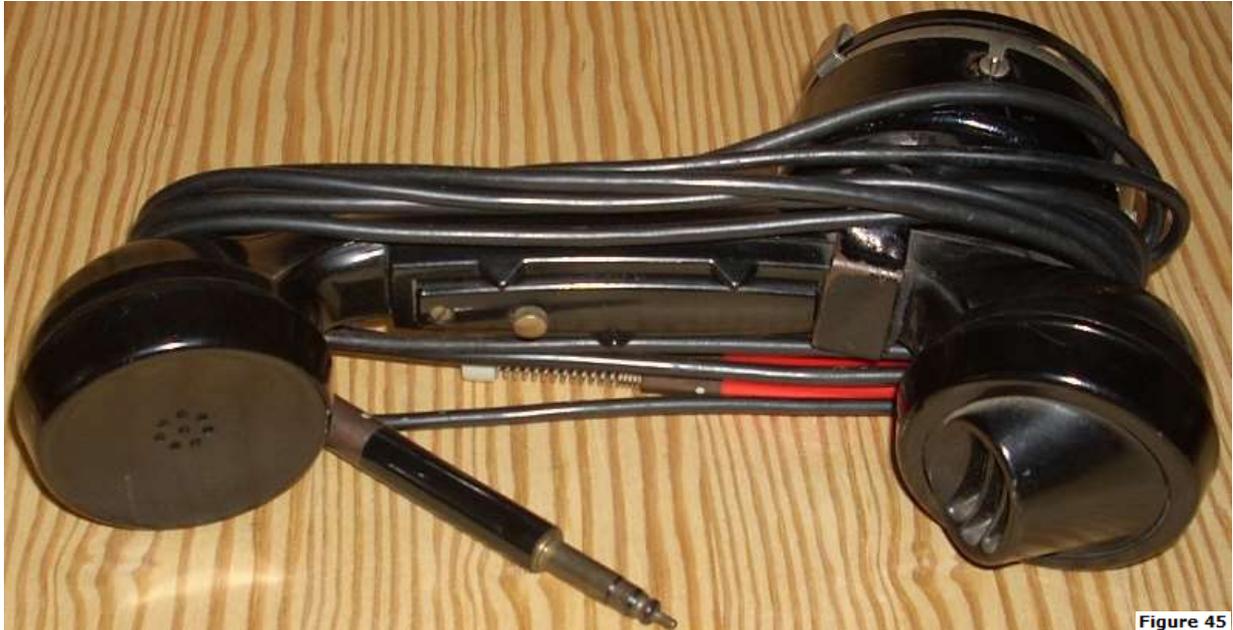
Figure 45

The push-to-talk switch bar on this butt set was modified in the same manner as that of the lineman's butt set mentioned on pages 334ff. The knob of the latch is from some type of wristwatch, because it's ribbed in the same manner as the one on the other unit and this type of knob was simply most common on wrist and pocket watches.

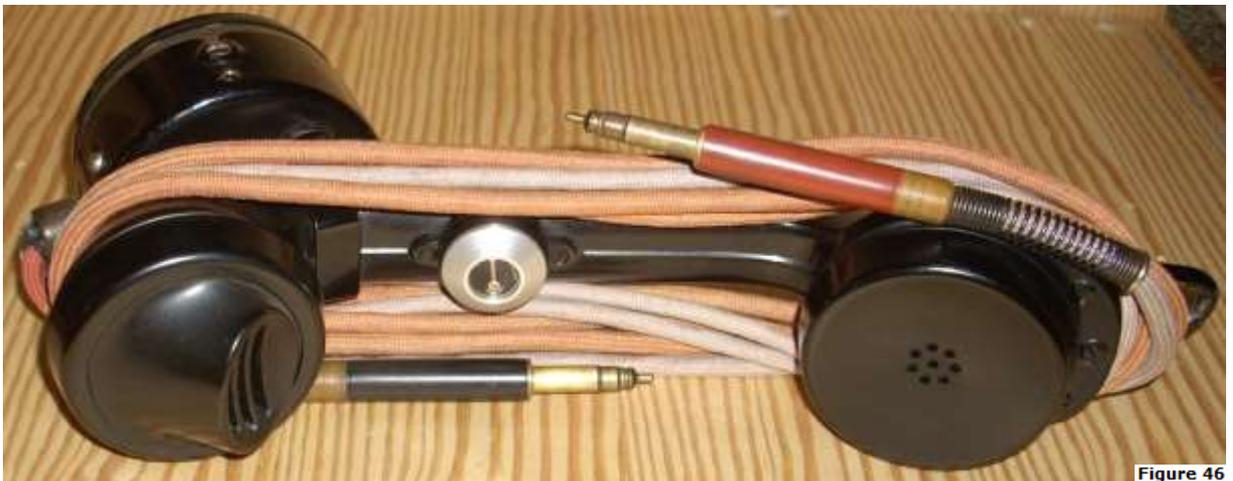
Figure 46

This CO butt set was made out of a handset belonging to an unusual variety of party-line telephone and shows two interesting details: the push-to-talk switch is of the earlier type; it was depressed to talk and was latched by depressing it and pushing it sideways at the same time. The other neat thing is that the sleeves of the plugs are made of Bakelite, instead of a thermoplastic.

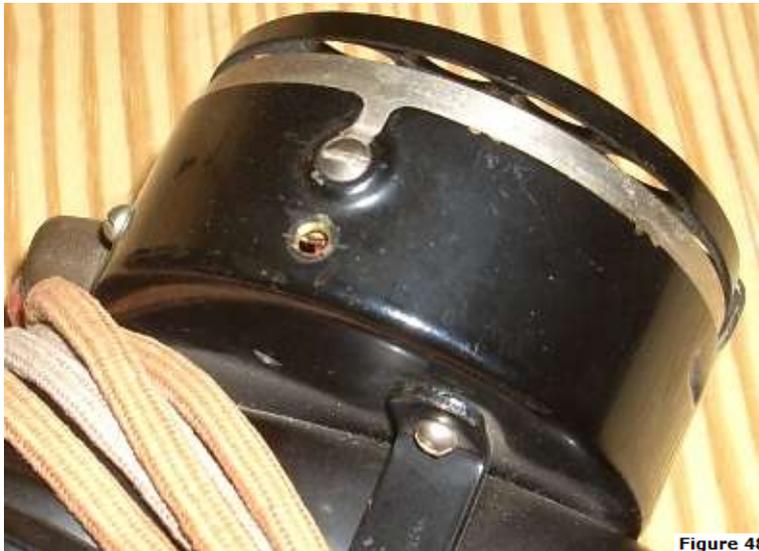
Figure 48

The photograph to the left shows the dial cup in a close-up.

There is nothing spectacular about it – I just wanted to include this picture so that readers may compare it with the one on a dial phone from 1928, which is shown below ....

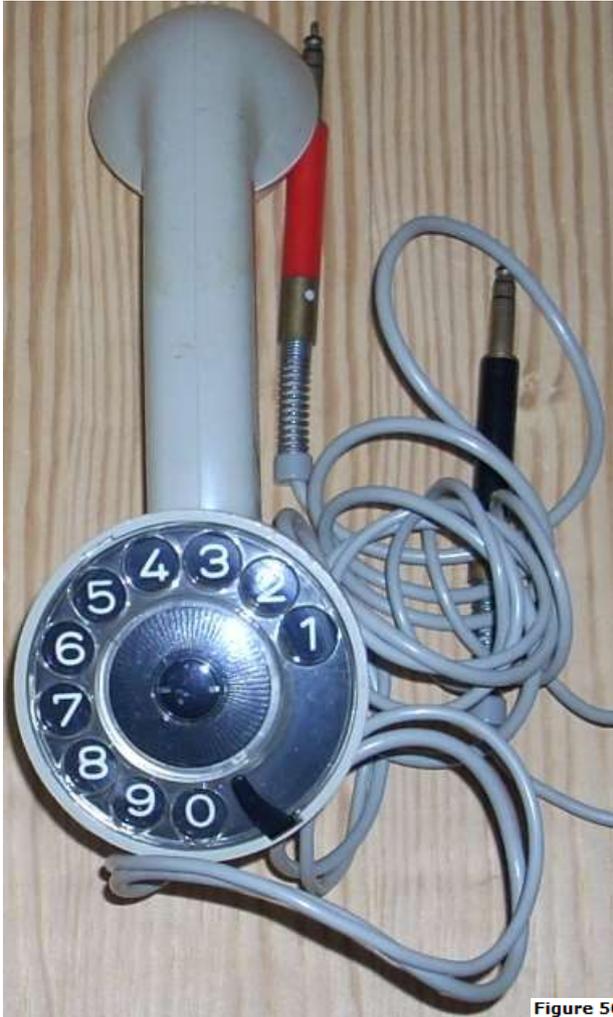
Figure 50

In some cases, the dial cup was purpose-built to fit a particular style of handset; this is the case with the CO butt set shown here ... it's a very late model, built circa 1980, using the handset type which belonged to the Austrian model 1972 dial telephone.

As can be seen, the test cords were wrapped around the handset handle for quite some time before being unraveled for taking the pictures.

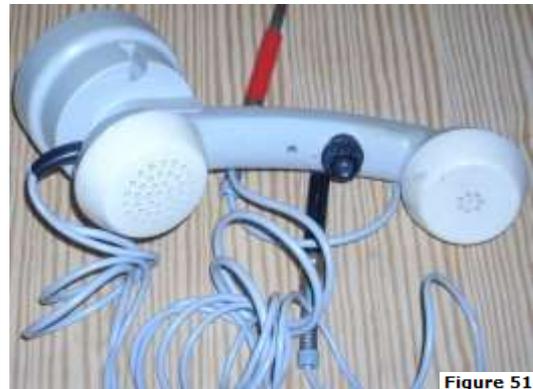
Figure 51

The rear side of the dial cup used was formed to fit the handset at the microphone end. In this case, the dial cup wasn't attached to the handset with screws, but was rather glued to it with epoxy.

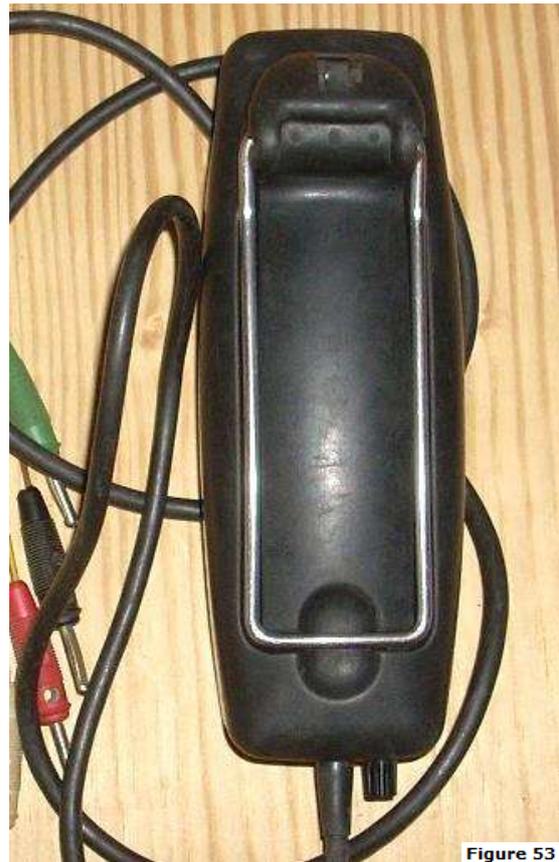
Figure 53

A limited number of butt sets as shown above were tested by linemen of the Austrian PTT, before they were junked as being impractical. Referring to the picture on the left, one can see that there are three pushbuttons above the keypad ... "FL" was a "flash" button, "P" was depressed in order to test the polarity of the line (the LED is located above and to the left of the microphone grille; green indicated correct polarity, red reversed polarity) and "ET" is the grounding pushbutton for testing party-lines.

There is a rotary switch to the right of the line cord, as shown in the picture on the right-hand side. This switch has three positions (off, dial pulses, DTMF tones) and was one of the bones of contention because it became noisy within a short time. If I recall correctly, the Austrian PTT only bought roughly 200 or so of these butt sets; anyway – the one shown here was one of the last ones to be found. This type of butt set was simply known as "Issue 4" in Germany.

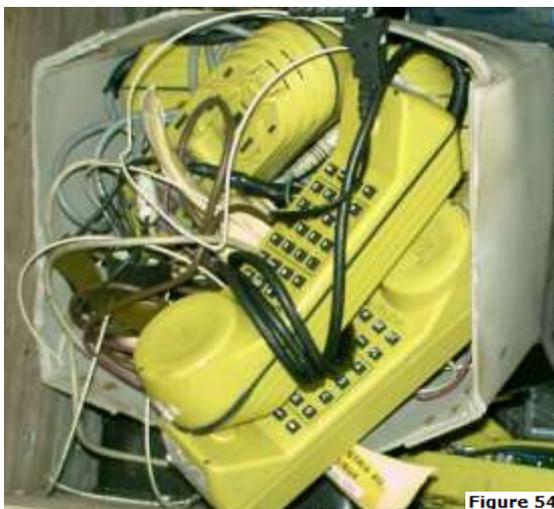
Figure 54

The yellow butt sets in the cardboard box to the left are the type which A1 Telecom Austria finally adopted as their newest butt set. This unit's commonly referred to as either the "Test Handset 90" or by the abbreviation "PrHAp 90."

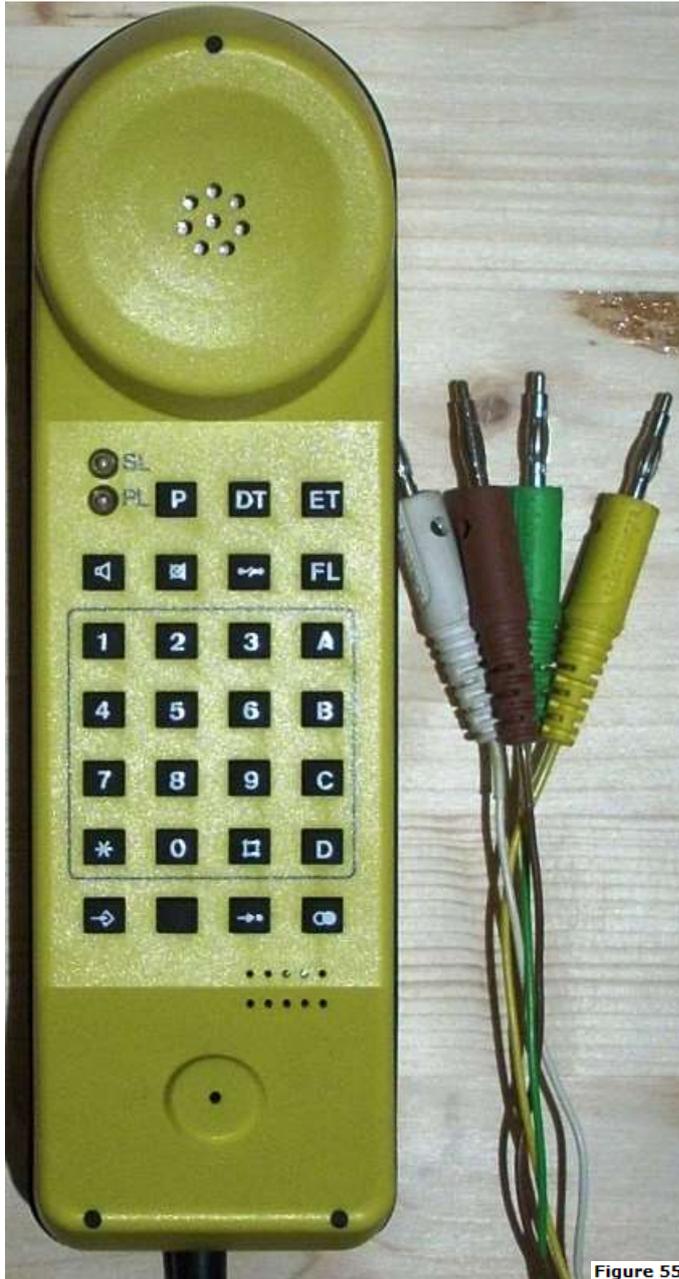
Figure 55

The PrHap 90 has two LEDs: "SL" (= "Schleife") and "PL" (= "Polaritaet"). SL lights up whenever there is a loop circuit through the test set, while PL only lights up when the latching pushbutton "P" is depressed. PL will show green if the line and test set are connected properly and will show red if polarity is reversed (it doesn't matter whether the line pair is crossed out somewhere or if the test set is connected backwards).

"FL" is simply a switchhook "flash" pushbutton as found on many modern-day telephones.

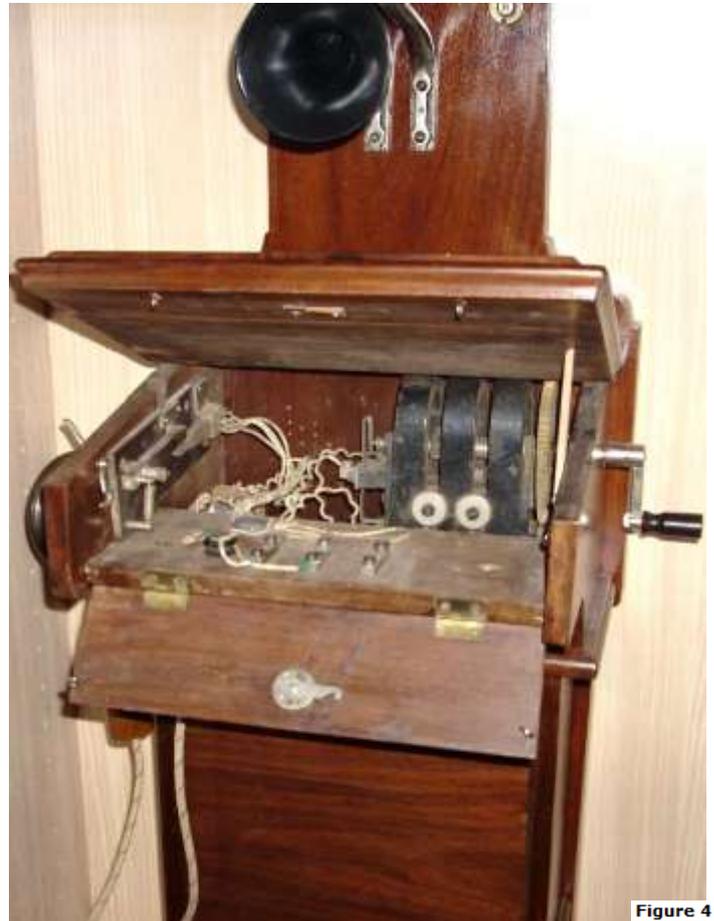
Figure 4

This is the late model state type III magneto wall phone as bought. The major differences to the earliest model are that the silk ribbon lightning arrestor was deleted, as was the second receiver (although the phone has the wiring provisions for a second one).

The transmitter is the famous "universal transmitter" from J. Berliner, complete with the original horn (not to be confused with the one from E. Berliner, who was the brother of Joseph). Alas, the microphone is deaf – at some time in the past, it lost its entire filling of carbon granules. The two parts of the microphone housing are held together with four small screws – but I wasn't able to open it after having removed these screws. After I got the housing open, I saw that there was enough corrosion between the lid and the case to keep the two pieces tightly jammed together, even without the screws.

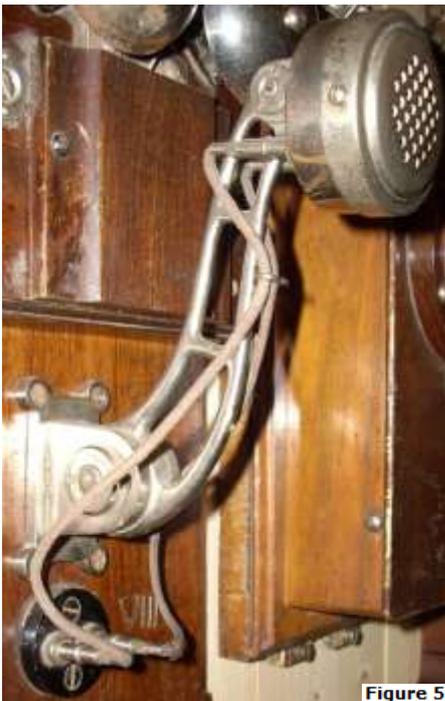
Figure 5

The successor to the state type III, the first truly "common" magneto wall phone (*sometimes* referred to as the state type IV), is shown to the right.

It has a carbon *ball* microphone capsule, mounted in a housing which is attached to an adjustable arm. An interesting design feature of this magneto wall set is that the wires running to the microphone housing are equipped with small, un-insulated, banana-type plugs on both ends; this allowed for easy replacement of these wires, without having to disassemble anything at all.

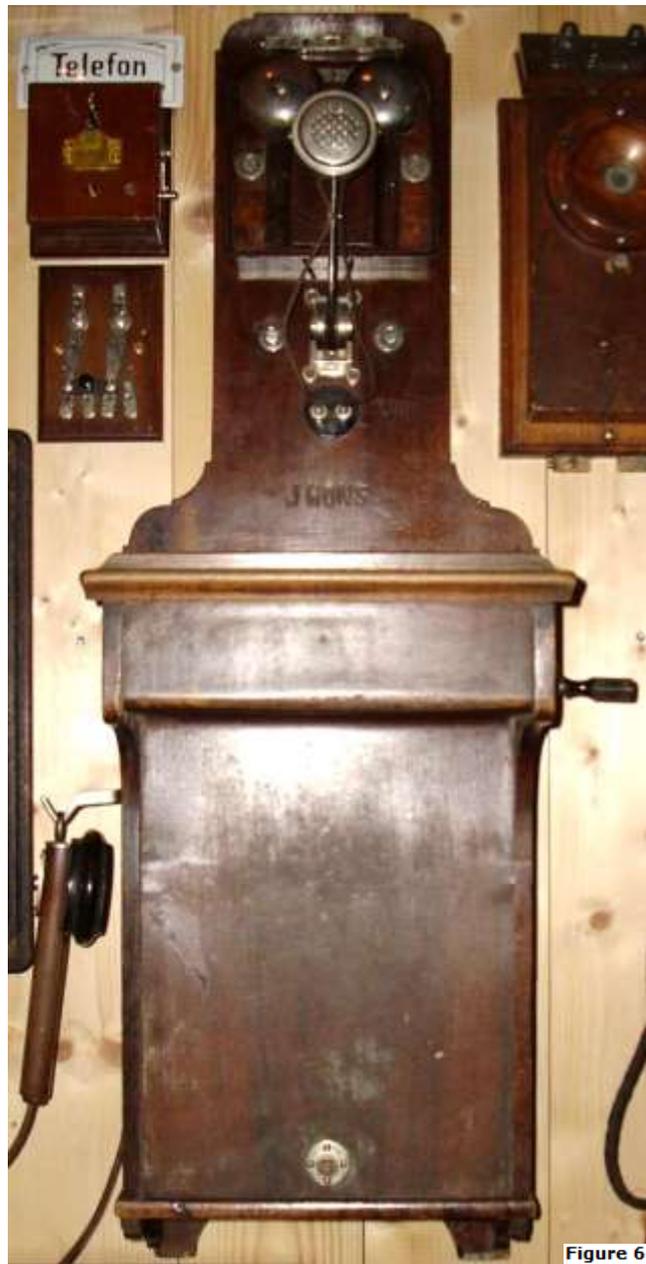
Figure 6

This magneto wall phone existed in two distinct types: the model 1906 and the model 1907. The receiver of the model 1906 is a largish, "paddle" type with a relatively hefty permanent magnet, which is equipped with a Bakelite cap, while the receiver of the model 1907 was of the type introduced concurrent with the Ö10 magneto desk set (more about this desk set later on), which could be styled as a "wand" receiver due to its smaller size and lighter weight.

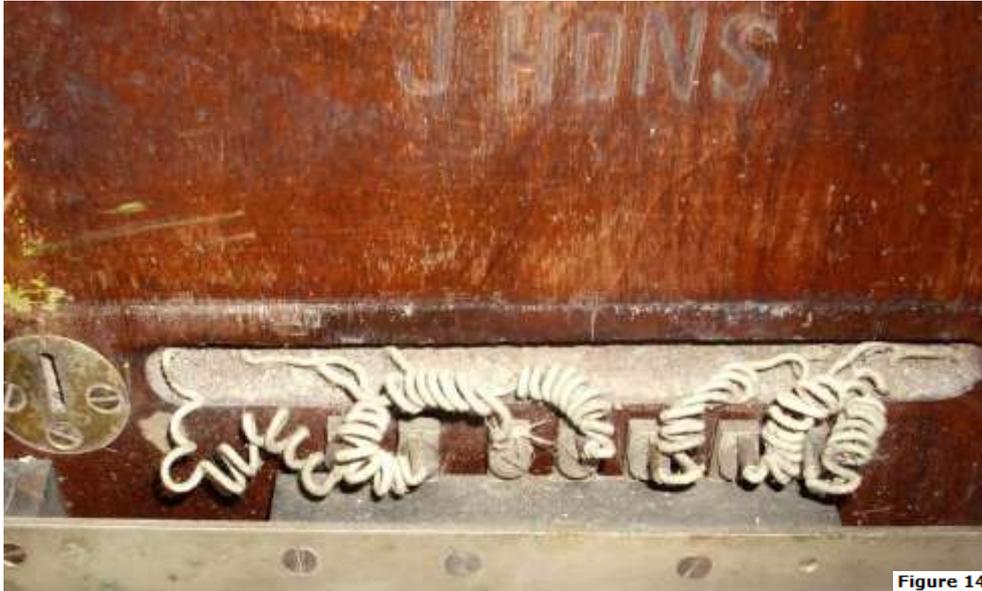
Figure 14

As to the general workmanship with regard to the magneto wall phone, one can only say that the Imperial-Royal Administration of Posts and Telegraphs knew what they were doing when designing and building this phone. The wiring with which the ringer, the line terminals, the microphone and the chassis (which carries the hook-switch, magneto and induction coil) are interconnected, is run inside slots cut into the backboard, the entire backboard then being covered by a thin, second backboard which protects the wiring. As may be seen below, all the connecting wires run through the backboard and are terminated on spade lugs; there is plenty of spare wire in case one of the lugs were ever to break off ...

Personally, I especially like the easily replaceable microphone wires – the idea predates the modular handset and line cord concept that Western Electric cooked up by nearly a century.

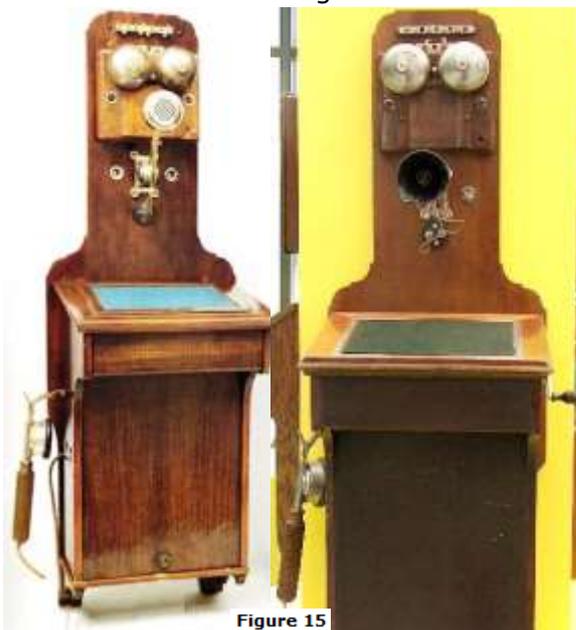
Figure 15

The model 1906 and 1907 magneto wall sets are next to impossible to find on the open market, and if found, are usually defective from an electrical standpoint, are usually missing some parts (large or small) and the milk-white glass writing plate is normally broken to pieces, which means that it's *missing*, leaving an unsightly hole which is often "repaired" by someone having glued a bit of green felt in place of the original glass, as may be seen here.

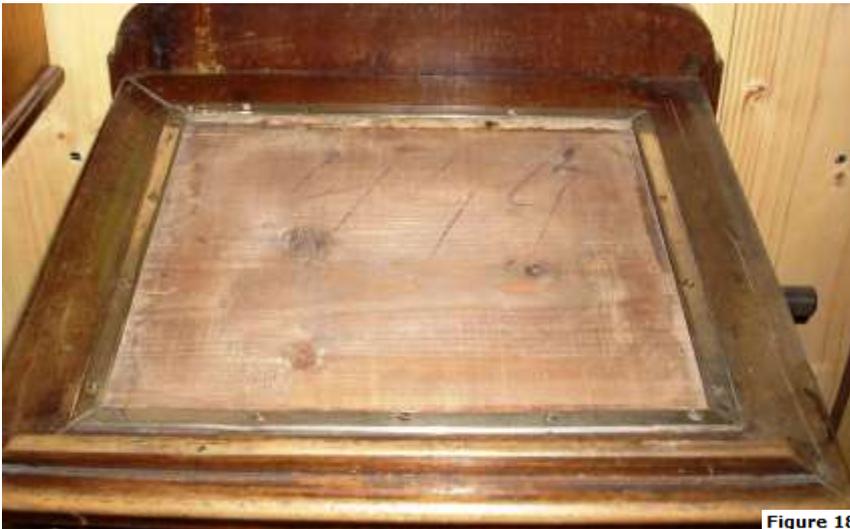
Figure 18

The model 1906 in my collection fits the description well – small mechanical bits are missing inside; notably the flat iron band which held the Léclanché cells in place, and the nickel-plated brass feed-through for the receiver cord(s), as well as having the glass plate missing (although in my case, no one was stupid enough to glue that ugly bit of felt onto the wood), being electrically defective as bought and having some bits of Bakelite missing from the receiver cap. At least the wood is pretty much in its original condition and undamaged.

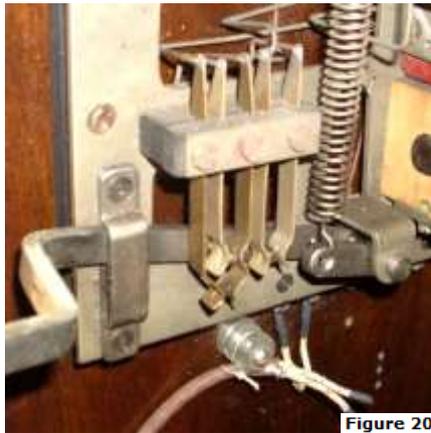
Figure 20

The electrical defects were relatively simple to repair – the primary side of the induction coil had a small, sharp ding in it, which caused the coil to break at the point of contact. The paper wrapping was carefully removed, the break in the wire (which was in the outermost layer) soldered and the wrappings carefully glued back in place (from the front, the coil looks as if it had never been touched). The receiver cord was intermittent, so I replaced it with a more modern, 4 conductor, handset cord from circa 1920 – this is the best I can do until I find an original 2 conductor cord.

The left-hand photograph shown above is a close-up of the hook-switch; one can also see the manner in which the strain relief for the receiver cord was realized. The right-hand photograph gives a general overview of the baseplate which carries the induction coil, the magneto and the hook-switch. The area encircled in white on the induction coil shows where the small, sharp ding was prior to repair.

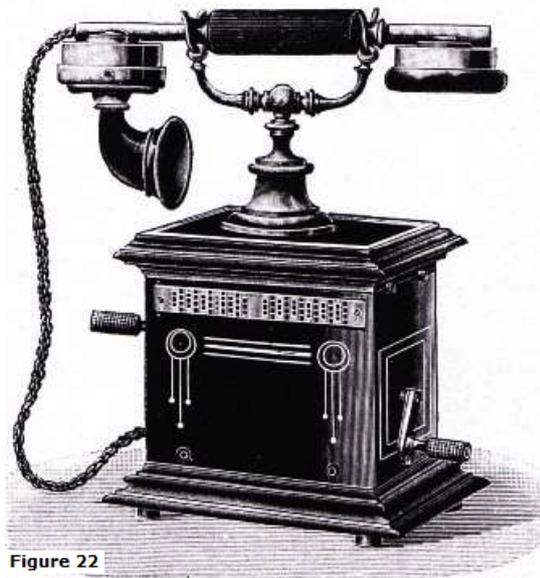
Figure 22

The magneto desk phone to the left is a model 1906, complete with an ornate, art-deco design which was silk-screened onto the housing using gold-colored paint.

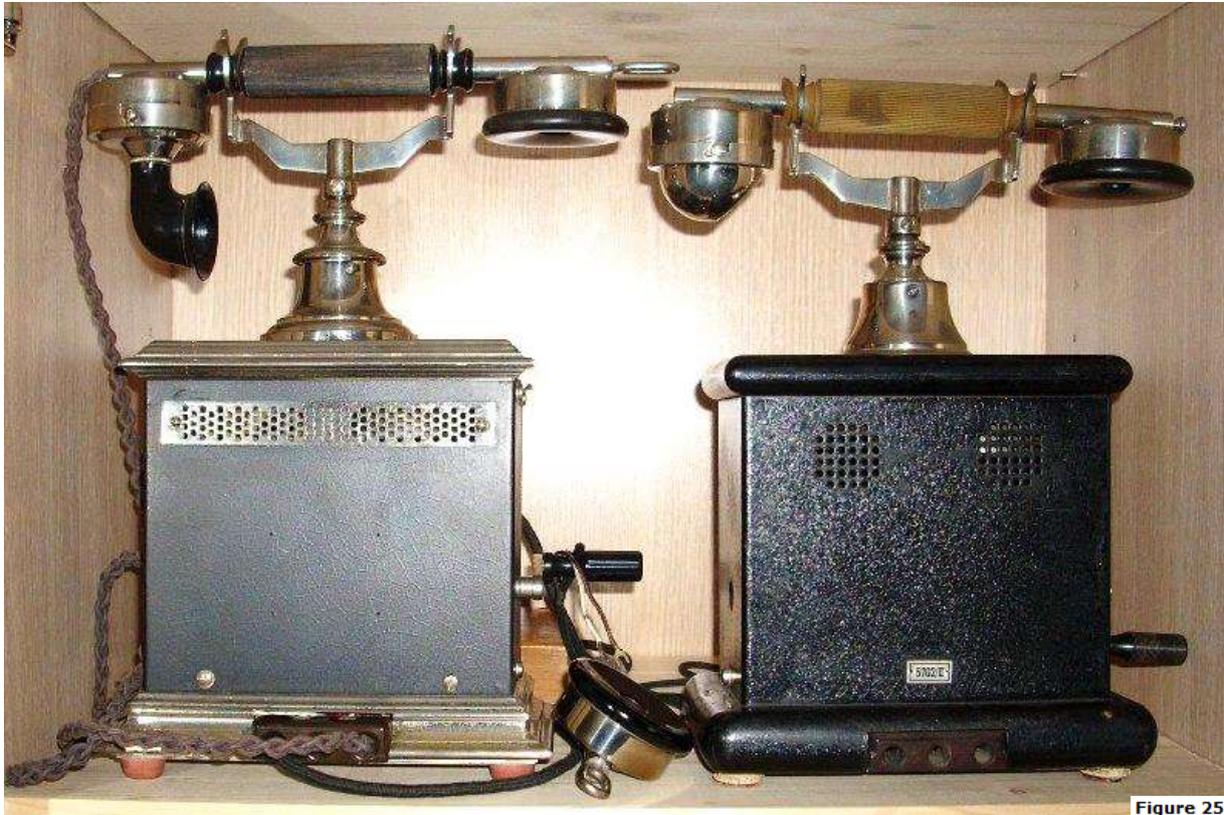
Figure 25

The Ö10 magneto desk set (and its much less decorative successor, built circa 1925-1940 by the firm of Leopolder & Son [L&S] in Vienna – the picture below gives a comparative view of both) was a very long-lived telephone, having seen service from circa 1906 until the demise of magneto service in Austria on December 14<sup>th</sup>, 1972.

The Ö10, and its successor (to the right), were built in two types: those which have a "standard" magneto circuit, with the magneto and ringer wired in series, and those which short-circuited the ringer (which, by the way, also had coils of a higher resistance, and thus of higher impedance, than the standard magneto desk sets) when the magneto was cranked, as shown below.

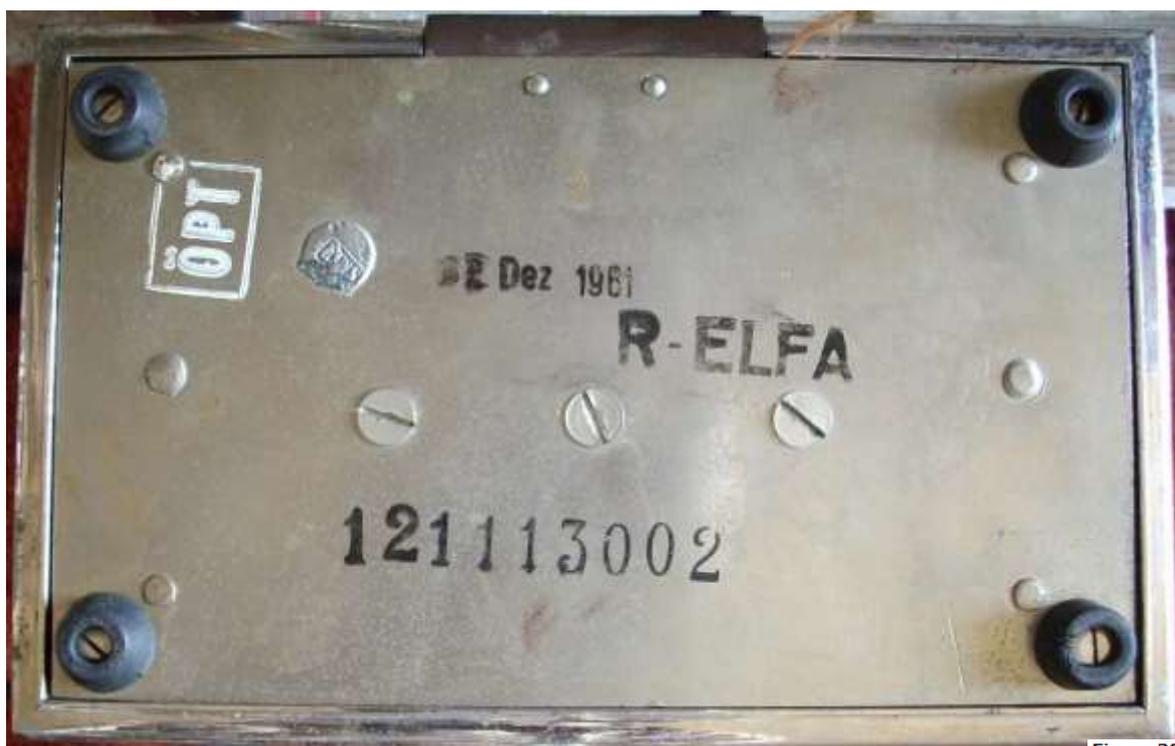
Figure 30

When an Ö10 (or its successor from L&S) was removed from service from circa 1950 onwards, it was refurbished. The Ö10 was upgraded with a new induction coil and a new handset, these being of the same physical design as used in the Austrian W48 dial telephone. The photograph below shows the bottom of one of these refurbished sets, complete with the markings of the refurbisher (ELFA), the delivery date (December 22, 1961), the ownership stamp ÖPT (Österreichische Post- und Telegraphenverwaltung – Austrian Administration of Posts and Telegraphs) and the modern-day, 9-digit, part number under which it was carried by the ÖPT (note that the old ownership mark "KKTV" wasn't defaced on this set).

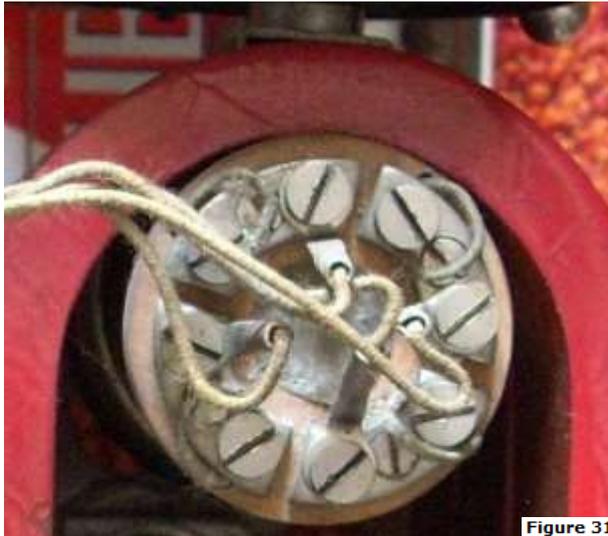
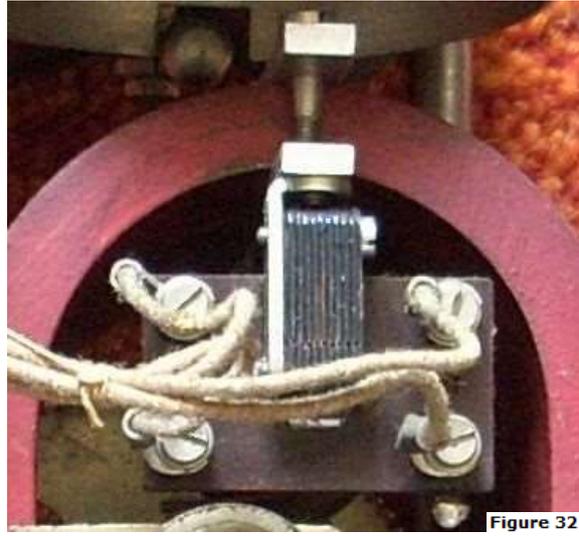
When refurbished, the L&S type only received a Bakelite handset of the same type as used on the upgraded original Ö10s, but the original induction coil was left in place. This is because the coil used by L&S (shown on the right below) was of a more modern design than the one used in the original Ö10 – the L&S coil has a closed magnetic circuit by virtue of its laminated, iron-alloy core, while the original induction coil (shown to the left below) had an open magnetic circuit because the core only consisted of a bunch of annealed iron wires stuffed into the wooden bobbin the coil was wound on.

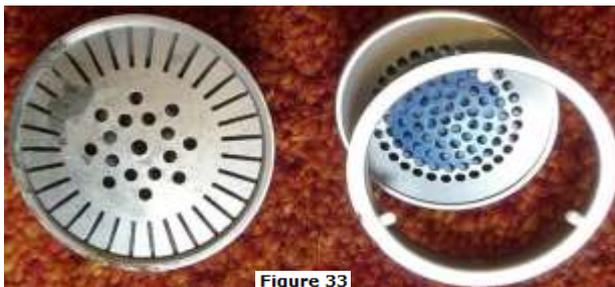
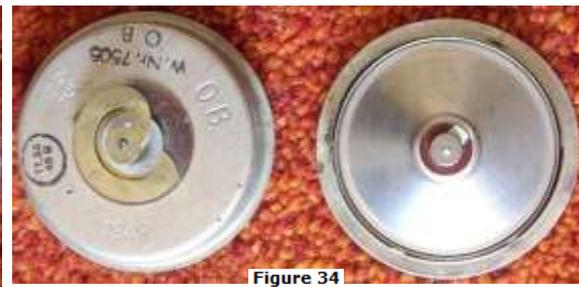
Along the same lines, and as of approximately the same year, wall and desk sets with defective microphone capsules were repaired by replacing the old, larger-sized capsule with a more modern (smaller) one, using a special adapter ring to keep the new capsule centered in the mouthpiece – refer to the pictures below ....
