## A Collection of Telephone Tales

written by Herbert Schwarz of Vienna, Austria, European Union

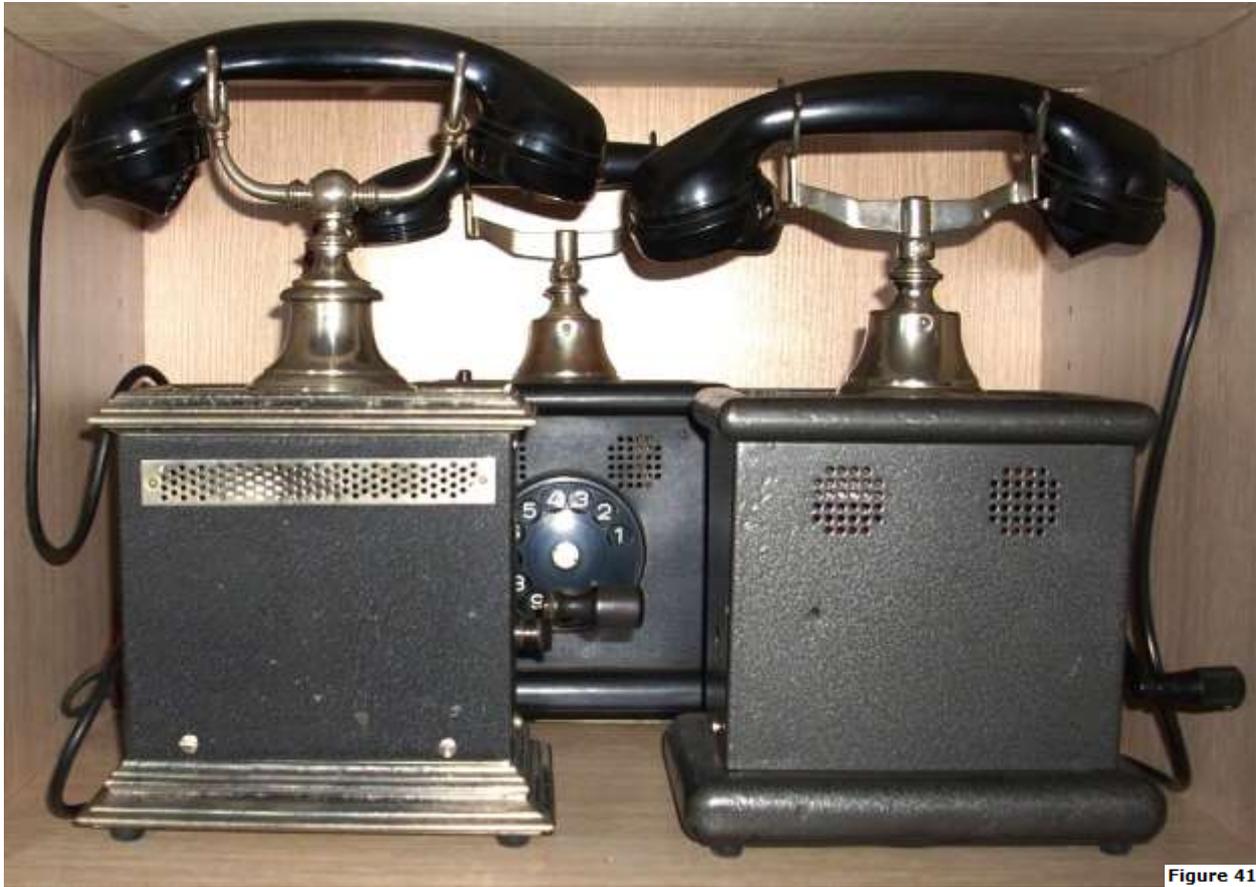
Figure 41

The photograph on the next page shows two Ö10 magneto phones which were upgraded with Bakelite handsets; the one on the left has the original, more ornate cradle, while the one on the right has the typical L&S handset cradle.

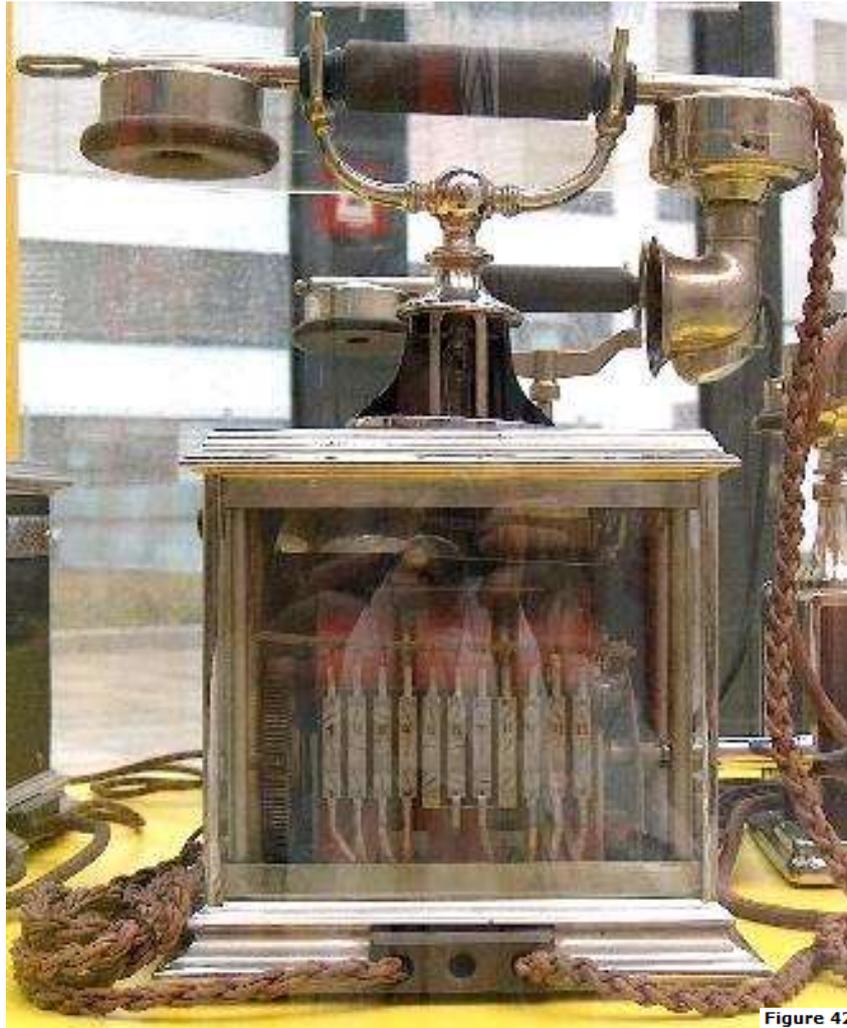
Figure 42

Here we have a demonstration model of the Ö10, which was once used as a teaching aid. It has three plates of glass so that the innards may be seen; the bell-shaped cover on the base of the cradle is also cut open so that the cradle shaft and the cradle return spring are visible.

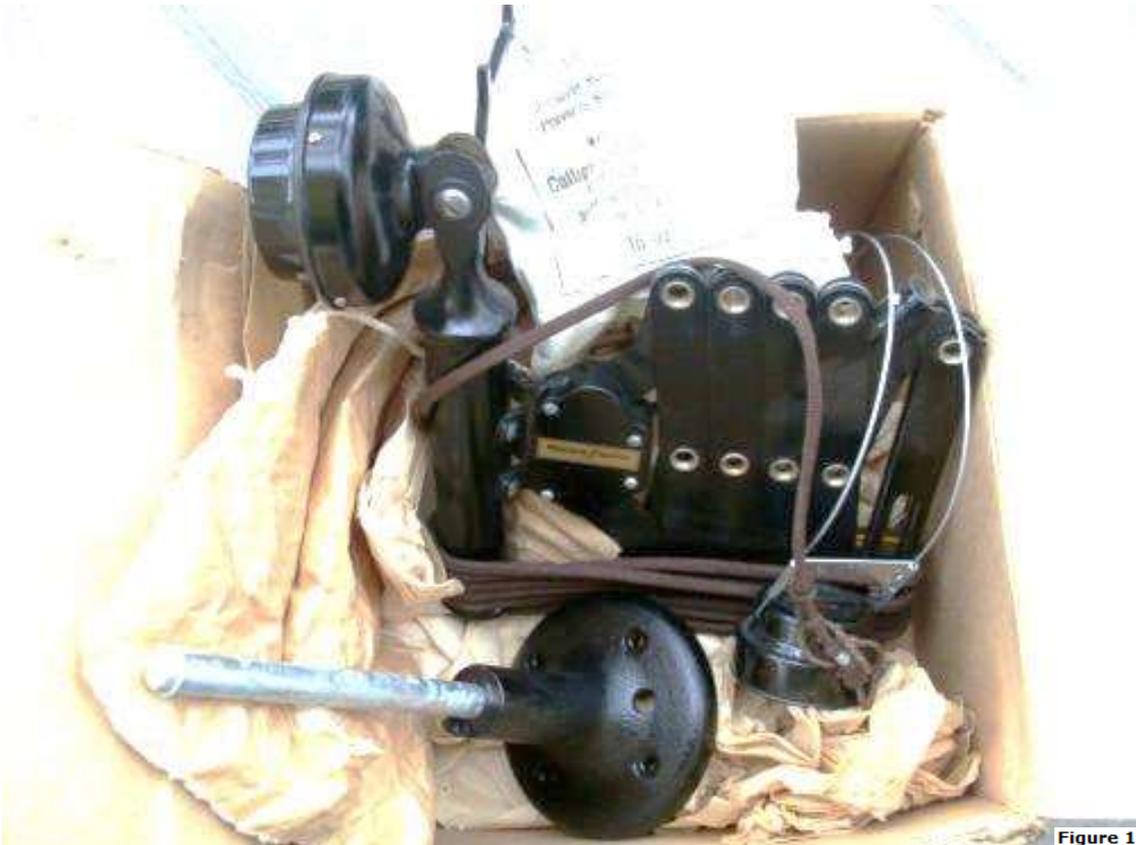
Figure 1

While browsing around at eBay® in Germany, I came across the train dispatcher's phone shown below.

Judging from the photo, I gathered that the phone was in very good condition for its age and decided to bid on it, hoping that such phones wouldn't be in very great demand in Europe.

After it had arrived, I found this dispatcher's phone to be absolutely perfect new old stock – there isn't so much as a single scratch or chip to the paint or on the Bakelite, and even the W.E.Co. Decal is in perfect shape (refer to the two photographs on the next page). I unscrewed the receiver cap and took a look at the unit inside ... yep, a type "HA2," just as it should be. The date of manufacture was interesting: 5-27-44 (just 11 days before D-Day).

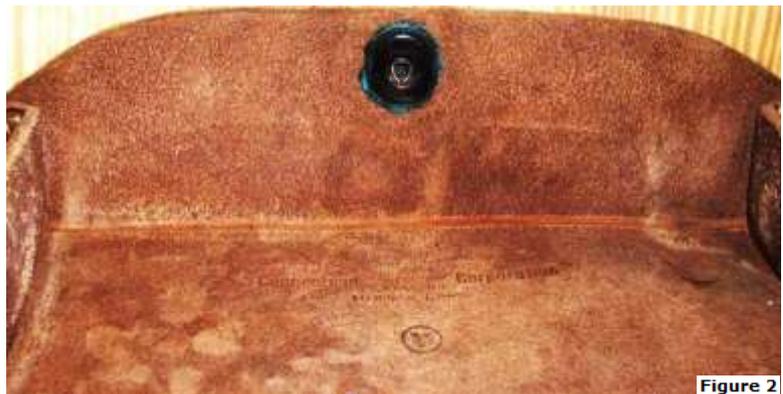
Figure 2

Although only barely visible in the photograph above, the inside of the cover is embossed with the text "Connecticut Telephone & Electric Corporation" (which was originally in silver color). This field phone was built under order number 4044-PHILA-43; hence, this specific unit was built in 1943.

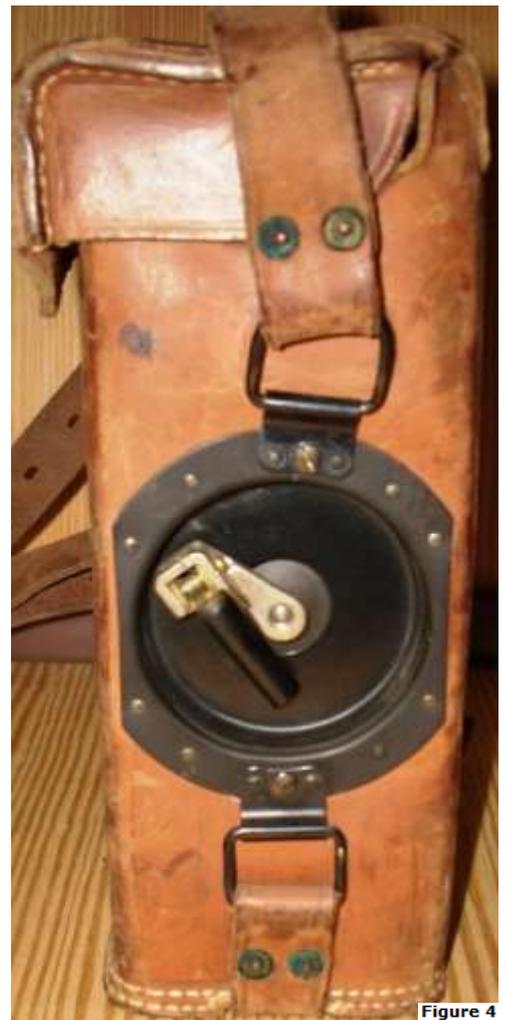
Figure 4

All of the screws which secure the telephone unit inside the case are in the exact same spot as they're on the EE-8 &c. type phones ... even the metal plate surrounding the magneto crank is of the same size and in the same location. The most obvious differences between the EE-108 and the EE-8 are that the EE-108 has a different handset, has a handset cord with only two conductors (instead of three) and that the Bakelite binding post plate doesn't have a L.B./C.B. switch screw. As may be seen, the *back* of the leather case is very splotchy – I wonder if any of those stains are ancient, dried blood?

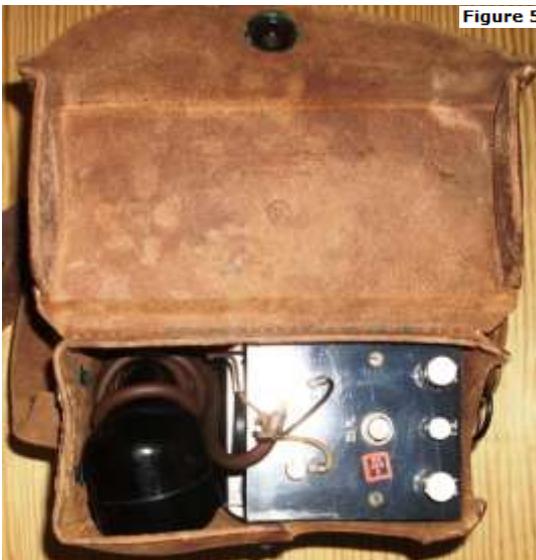
Figure 5

The EE-108 has a separate screw-down terminal for a ground wire as well as a push-to-test switch for the ringer.

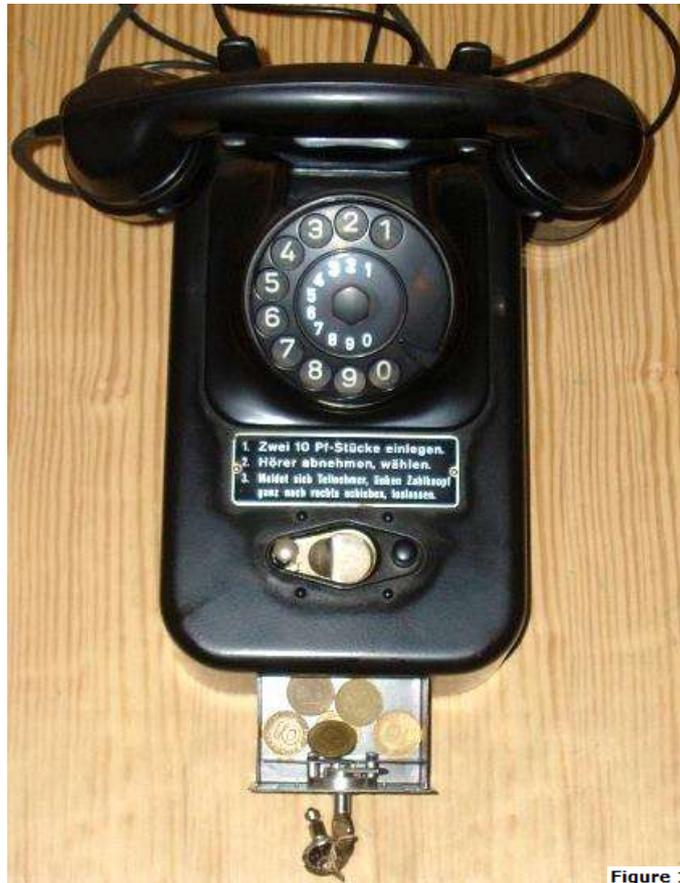
The handset cradle is damped by a dashpot (it takes roughly one second for the handset cradle to move from the on-hook to the off-hook state and vice-versa), so that adept jiggling of the cradle can't be used to dial a telephone number; this method of "dialing" would've bypassed the special dial this pay phone uses.

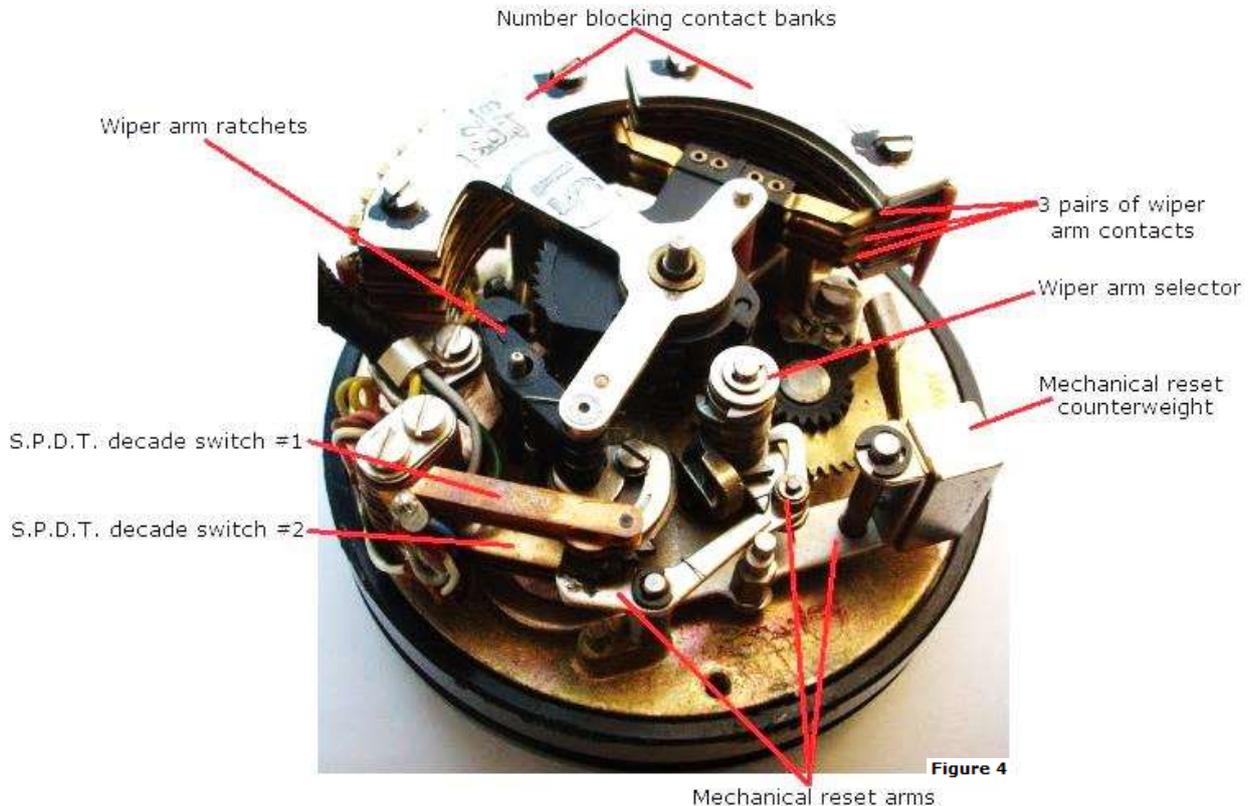
Adjustable metal arc, which can be set so that the #1 decade switch will operate upon the first, second, third or fourth pull of the dial. Here, it is set for the first pull.

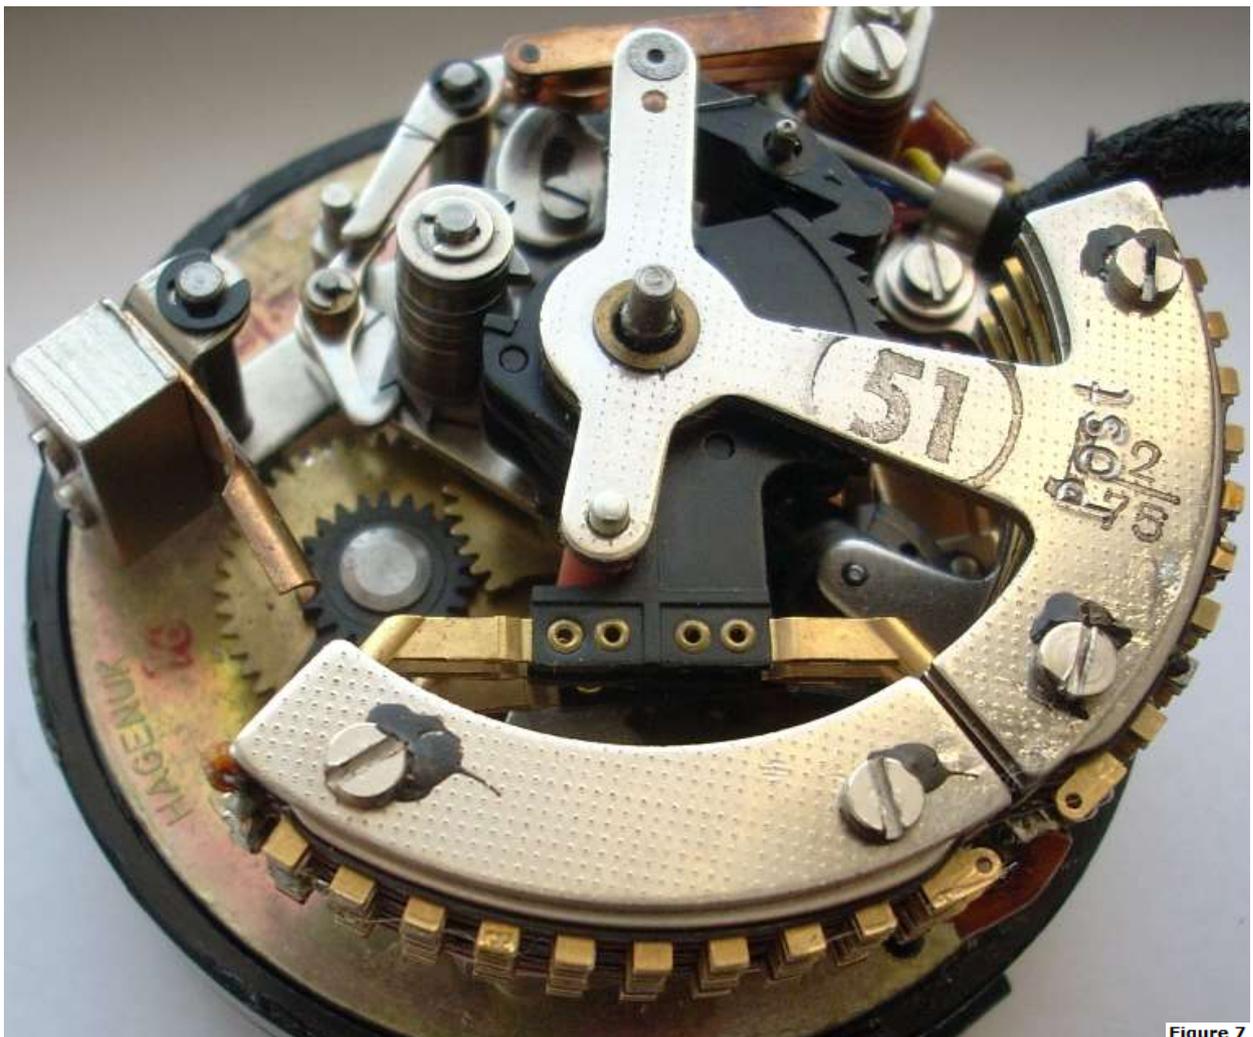
The wipers and the contacts in the two banks are gold-plated in order to prevent corrosion, which could cause the number blocking scheme to malfunction (the longer I look at the underside of the dial, the more I find that it has much more in common with a complicated, mechanical watch than it has with a telephone dial).

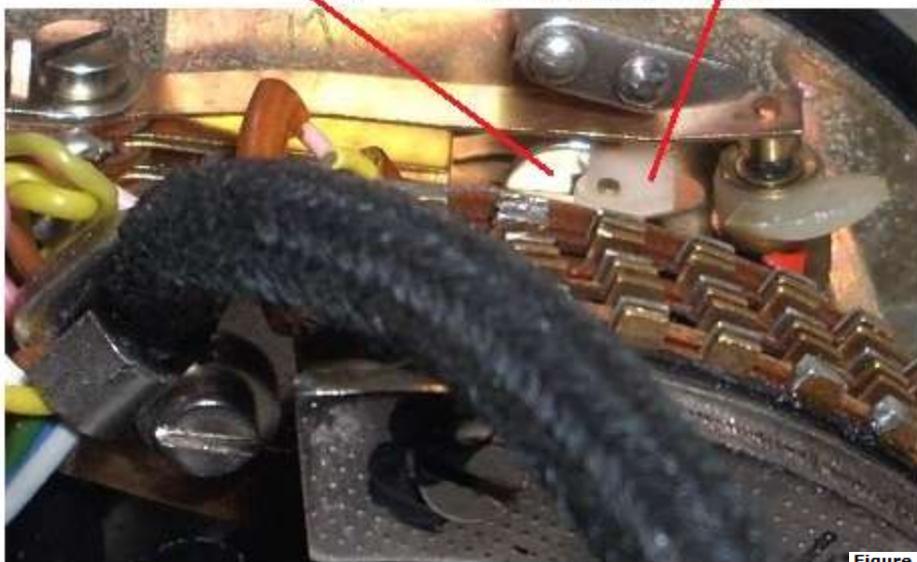
Figure 9

The two bifurcated contacts of the inertia switch have a gap of roughly 40 mils when open; the upper contact has a small bit of white plastic attached to it, so that the latching cam won't cause a short circuit to ground when activated.

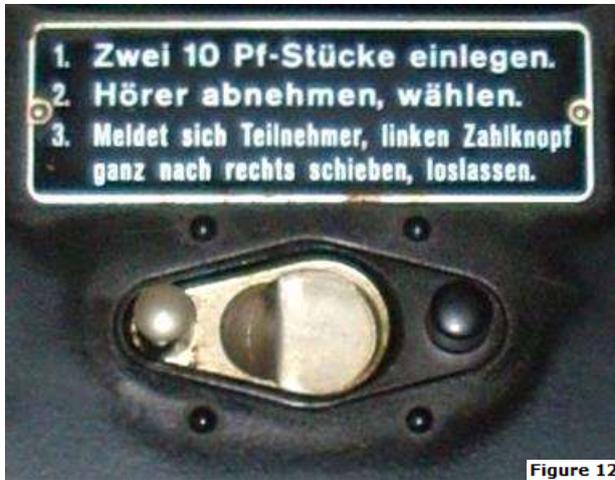
Figure 12

The operating instructions translate as: "Insert 2 coins of 10 Pfennig, remove handset and dial. When the call is answered, push the left knob all the way to the right and then release it."

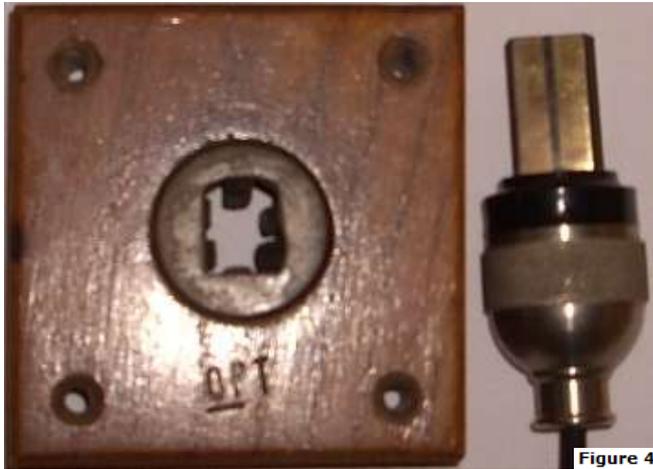
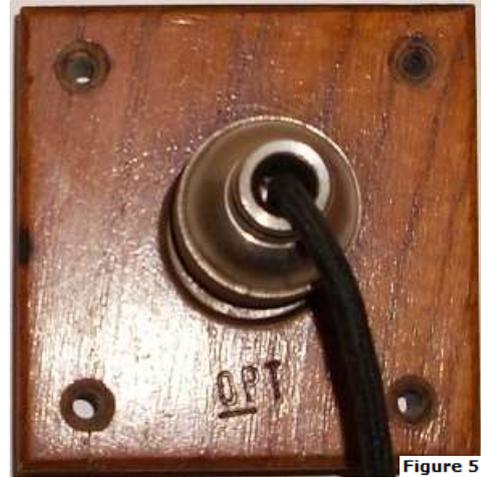
All 6 conductors of the plug and socket were used: 2 for the line wires, two for the battery leads, one for an auxiliary ringer and one ground wire (as required).

This type of plug and jack, as shown above, had one serious drawback – the plug sat very loosely in its jack because there was no latching mechanism to hold it in position. With the advent of semi-automatic telephone service circa 1913, it became necessary to design a jack and plug system for the 3-wire line cords used with semi-automatic telephones; the same basic design was then also used for the 5-wire line cords of desk magneto phones. The photographs below show the jacks used.

Since the advent of the Ö10 magneto desk set as of circa 1906, the Imperial-Royal Administration of Posts and Telegraphs offered wall jacks and plugs, so that the phone could be moved from room to room<sup>[1]</sup>. The wall jack was a 6 conductor affair with a hard-rubber case, mounted in a hollow wooden block. The line cord was terminated on a matching 6 conductor plug made of hard rubber, with strips of brass as contacts. The plug barrel was originally made of nickel-plated brass, which was changed to aluminum at some later point in time.

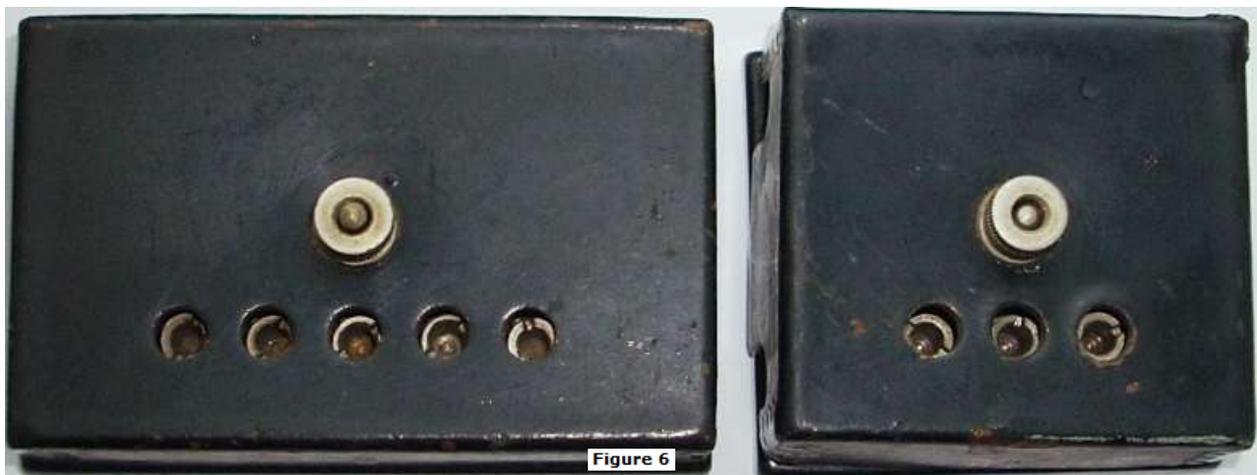
Figure 6

The covers of these wall jacks were made of stiff cardboard, which gained additional stiffness from the thick layer of black paint used and by the use of metallic stiffeners on the corners. An interesting feature of these jacks is that they could also be used as regular, screw-type terminal blocks by loosening or unscrewing the individual jack posts and either wrapping the bare ends of the line cord wires around the screw portion of the jack posts or by pushing the line cord terminal loops over the threaded portion of the jack posts and retightening the posts.

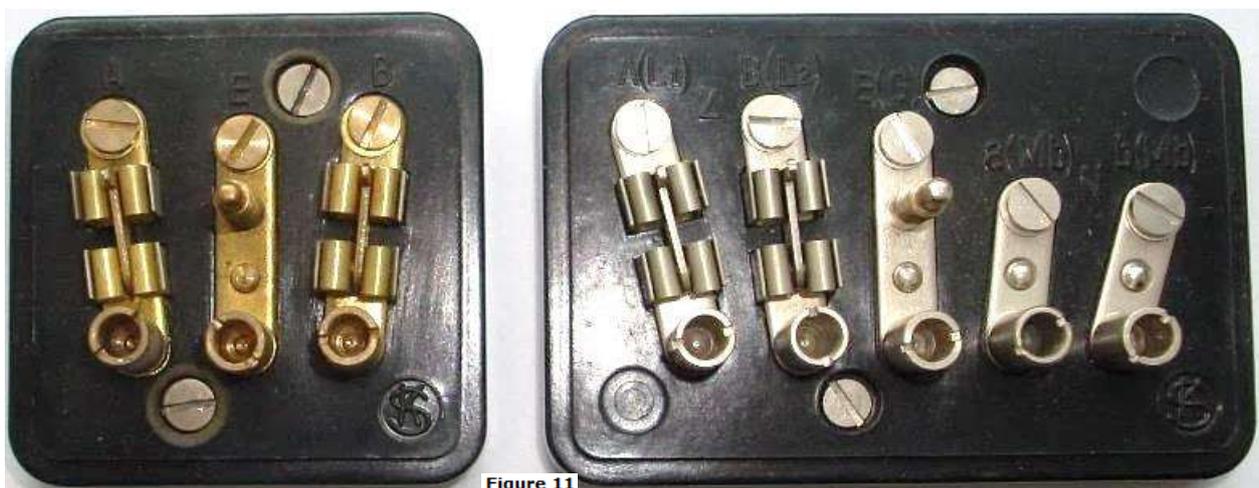
Figure 11

The lettering above the screw terminals on the left-hand wall jack read as "A," "E" and "B" respectively, while the lettering on the right-hand wall jack is practically unchanged from the early version – the only real difference is that the battery terminal designation having changed from "B" to "Mb" ("**M**ikrofon**b**atterie" = microphone battery).

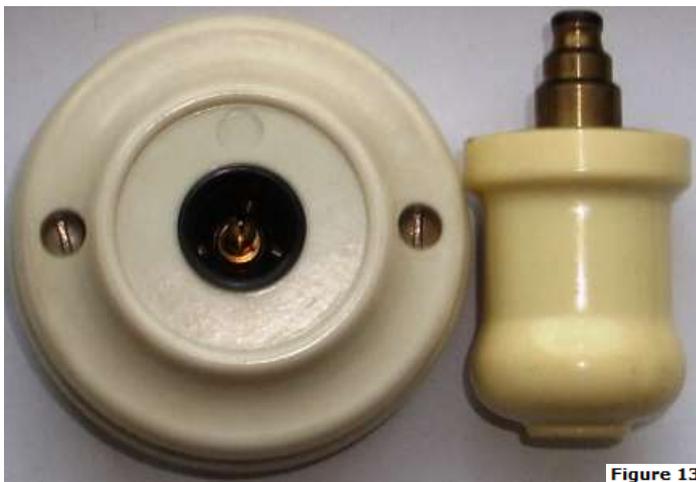
Figure 13

The surface-mounted wall jack shown to the left is of white material, while the housing of the plug is more of an ivory color. "Pure" white was a special color only offered by phone manufacturers in conjunction with privately owned PBXs circa 1950 – it wasn't a color which the Austrian PTT offered its subscribers.

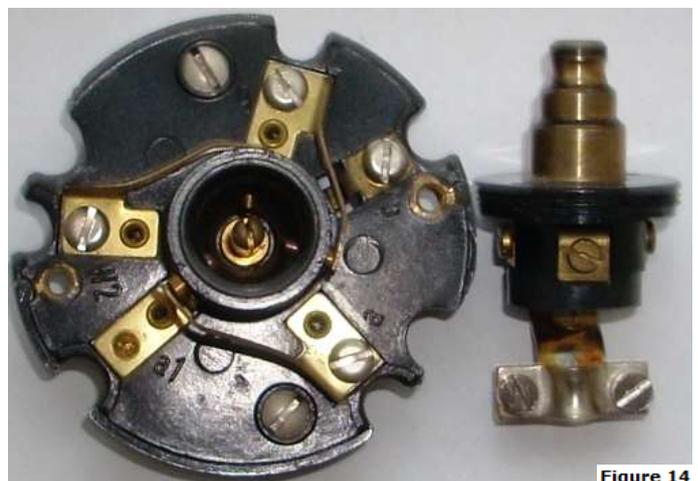
Figure 14

This picture shows the above parts without their housings. The wall jack and plug offer a few new features not found with the older ones.

In addition to the regular "a" and "b" terminals for the line wires there is also a "c" contact, which was used to supply a ground on the jacks, and an "a1" contact which was connected to the "a" terminal as long as there was no plug inserted into the jack.

The "W2" terminal was used with an external ringer, which was switched off from within the telephone (in which case the telephone line cord had four conductors – white, brown, green and yellow – instead of the normal three conductors of white, brown and green).

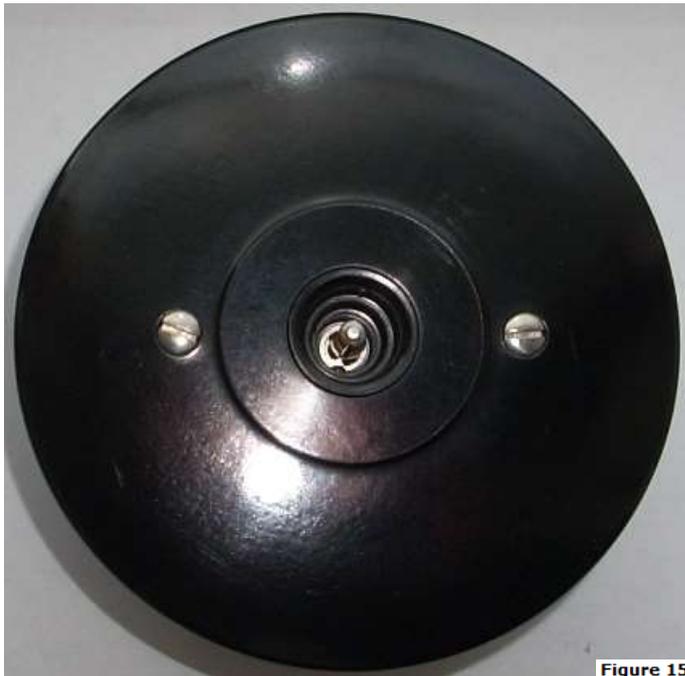
Figure 15

The guts of this type of jack were basically the same as those of the wall-mounted type. The only difference was that the type intended for mounting in a wall box had two small standoffs with separate screws which, when tightened, spread two little "claws" out which held the innards snugly inside the wall box. This type of fastening is still in use for mounting electric switches and sockets inside wall boxes today.

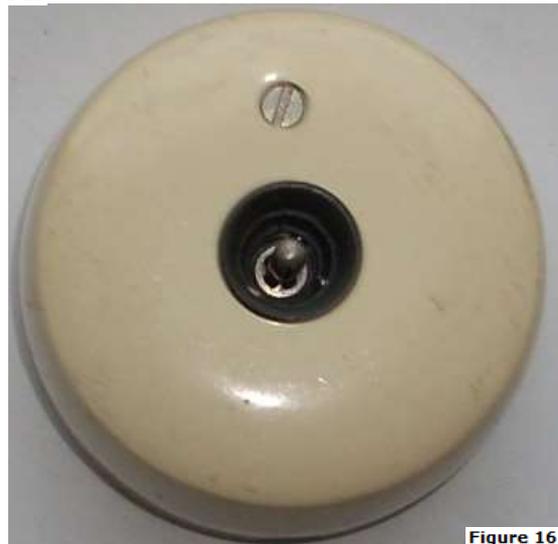
Figure 16

The newest style of wall-mounted jack was of the type shown on the right. The guts are still the same as before, but the housing has been streamlined a bit in order to look modern. The Austrian PTT also had a streamlined plug to match the jack ... I *know* I have at least 30 of the plugs somewhere, but I can't find even one of them at the moment.

This was the most common jack in the late 1960s thru the early 1980s, when a radically different type of wall-mounted jack was placed into service. This new type offered some features intended for use with the new digital exchanges which were just coming into service circa 1983.

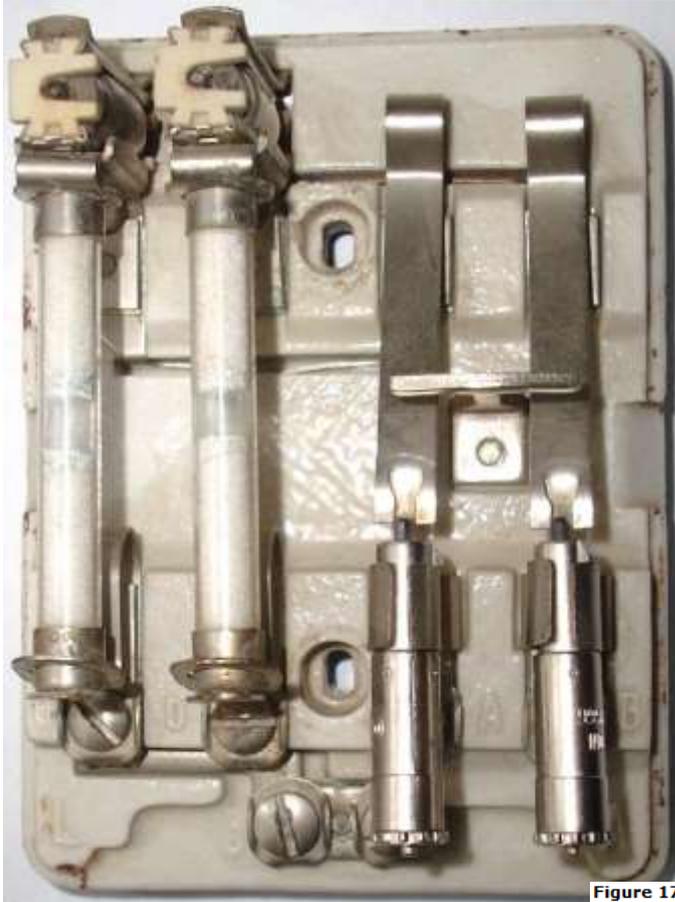
Figure 17

The station protector shown to the left was a late model of what was officially known as the "S-K-Hp" type.

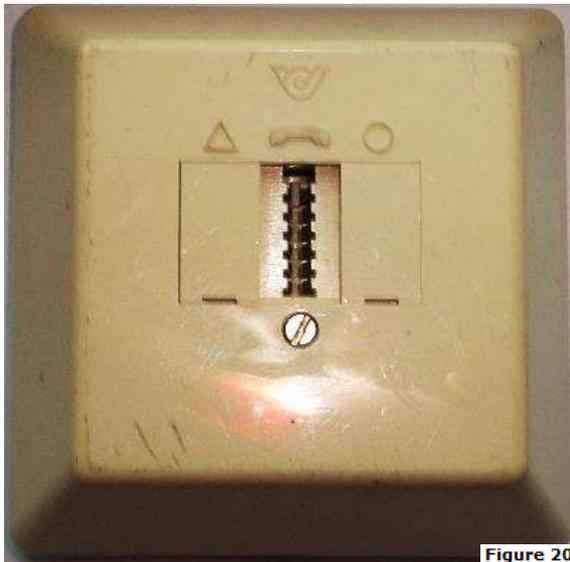
The wall-mounted telephone jack shown on the left is of the type which was commonly installed from the early 1980s onwards.

Only one open jack can be seen, but there are two more, hidden behind the protective caps in the left and right positions. Although the physical dimensions of all three of the jacks are the same, they were used to connect different pieces of telephone equipment.

This particular type of telephone jack caused subscribers much grief the moment they connected accessories, such as an answering machine or a cordless phone. The line cords often had fewer conductors than would've been necessary for proper operation – because the three jacks are connected in a certain sequence (left, right, center); the tip/ring contacts are looped through all three jacks, and these loops are interrupted the moment a plug is inserted into one of the jacks.

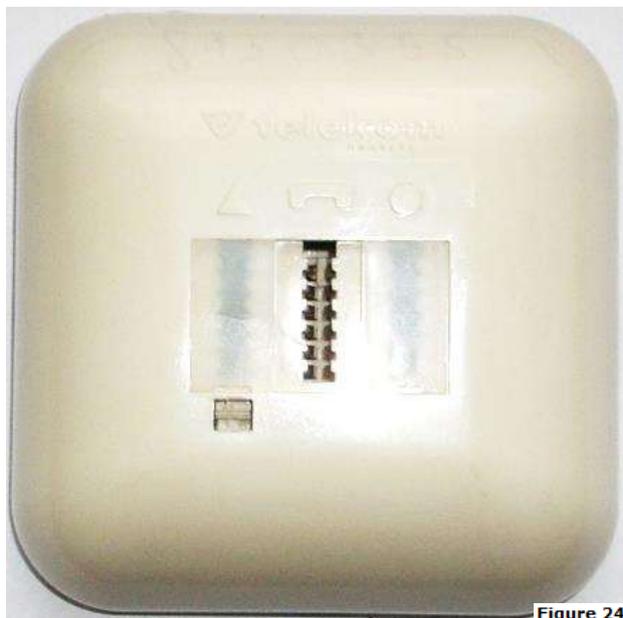
Figure 24

This new type has the cover attached with a small, plastic snap instead of a screw and the wires are no longer attached to the terminals with screws, but are punch-down terminals instead.

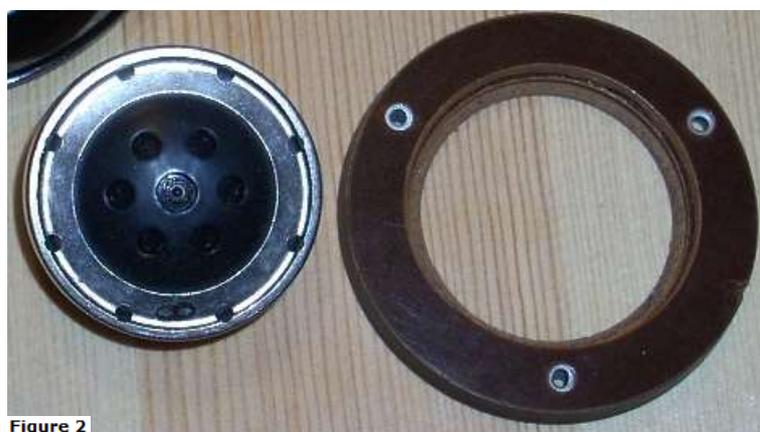
Figure 2

Shown to the right is the transmitter I found in the handset. It’s of much smaller size than is normal, and it was held in place inside the handset with the aid of some phenolic paper rings which are riveted together. This type of microphone was used by the German Wehrmacht in a special headset circa 1942.

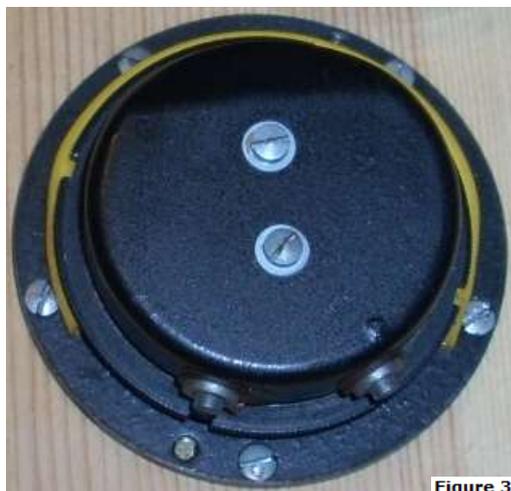
Figure 3

What was hidden under the receiver cap is shown to the left – basically, it’s a headphone unit from a pilot’s headdress used by the German Luftwaffe (also circa 1942).

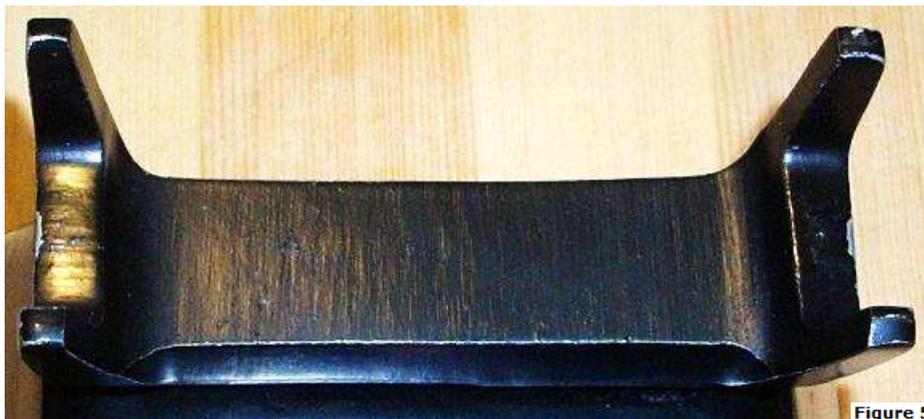
Figure 5

The handset cradle of this particular phone was cast out of aluminum, and apparently only given a rough going-over with a coarse file ... one can still see the scratches left by the file.

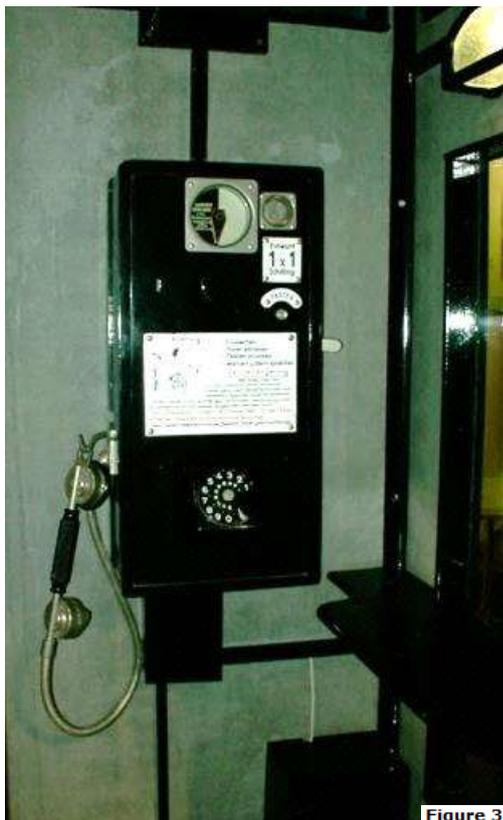
Figure 3

Although the pay phone shown to the left below is slightly younger than the one in the book (the one shown here accepted a single Austrian coin of 1 Schilling for operation instead of two ten Groschen coins [= 0.20 Schilling]), the basic mode of operation and the text of the operating instructions are the same. The translated operating instructions read as:

- 1) Insert coin
- 2) Lift handset from hook
- 3) Depress pushbutton
- 4) Dial & then speak

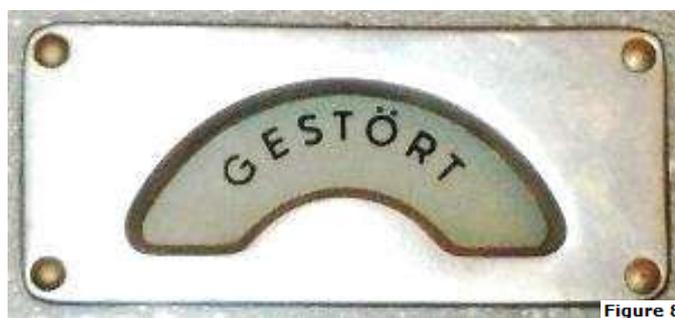
Figure 8

Why was something like this possible? Well, the glass plate which covers the clock face was designed to be movable. The upper half was clear glass, while the lower half was painted white, with the German-language text "GESTÖRT" (literally: "disturbed", out of order) printed in black, in an arc to match the curvature of the window on the housing. If the pay phone was out of order and not immediately repairable, the repairman unlatched a spring on the slide which held the glass plate in place and pushed the glass up – there was no need for a separate "out of order" sign (which some wag might steal).

Despite the efforts to make stealing the coin box more difficult, redesigning the clock mechanism in order to prevent fraud and replacing the coin return chute with an "anti-stuffing" type, the model 1958 pay phone was *highly* prone to another form of fraud, namely placing local calls of practically *unlimited* duration for the cost of a single, 5 minute call. The method was simple, highly effective and anyone with two hands was capable of doing it ... one simply tore a 1" wide by 5" long strip off of the stiff paper cover of the phone book in the booth, folded the top 1½" over to form a flap, smoothed the crease of the flap with a coin and slipped the strip, creased end up and short end below, between the glass plate covering the clock face and the housing, until the flap sprang open.

One then gently pulled the strip back until the crease was resting on the top edge of the glass plate, and pushed the strip over until it was wedged into the right-hand corner. When the clock pointer hit the flap, it jammed and the clock didn't time out; this left the connection intact for as long as one pleased. It was naturally also possible to place several consecutive local calls, simply by depressing the payment button and dialing a new number.

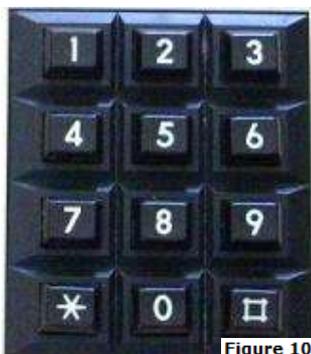
The last two lines of text in the exhibit state that "The pound (#) button is square, not with four crossed lines" – sorry, it just isn't so. The keypad shown to the left is of the exact same type as that on the phone shown in the exhibit.

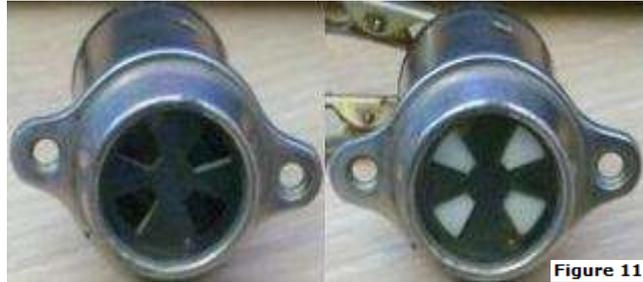
Figure 11

The English-language translation of the German telephony term "Sternschauzeichen" is simply given as "visual display" in the exhibit. The term is better translated as "star indicator."

Such electromagnetic star indicators were commonly used to show whether the exchange line the indicator was assigned to was in use or not (black = not in use, white = in use). In Austria, such indicators were also used on some party-line telephones to indicate whether or not the party-line was busy. These indicators were low-current devices, operating on 6 to 10 milliamps at 3 volts D.C.

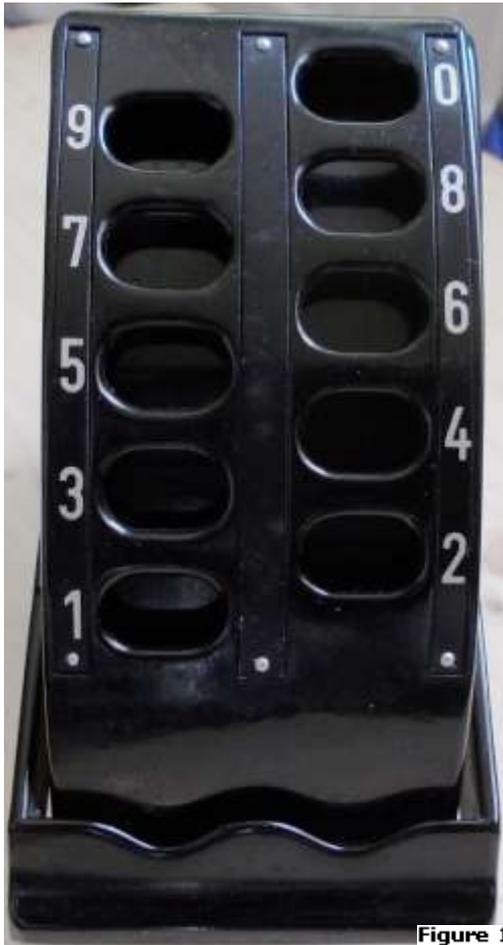
Figure 1

At some later date, Siemens redesigned this dial type, so that the digits (and eventual letters) were all on the finger-hole arc. The following photographs show such a revised "pull-down dial," manufactured by Siemens at Vienna, Austria, during April of the year 1943.

As can be seen, the non-movable portion of the drum no longer carries the digits, which are now on strips of electrically oxidized aluminum, riveted along the outside edges of the finger-hole arc.

This had the advantage that the digits were no longer subject to the everyday wear & tear of dial use, and thus could not be scratched off over time.

If it were necessary to add lettering to this style of dial, then the *middle* strip of blackened aluminum would have been replaced with one bearing the requisite letters.

As I previously wrote, this particular dial was manufactured at Vienna, Austria, but it was certainly used somewhere else, because (back then) Viennese dials began with the digit zero and the numbers 0-9 were associated with the letters "iFABRUMLYZ."

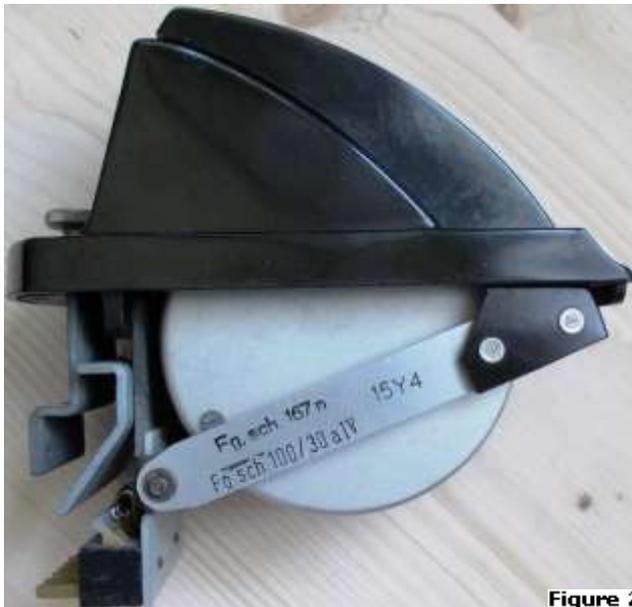
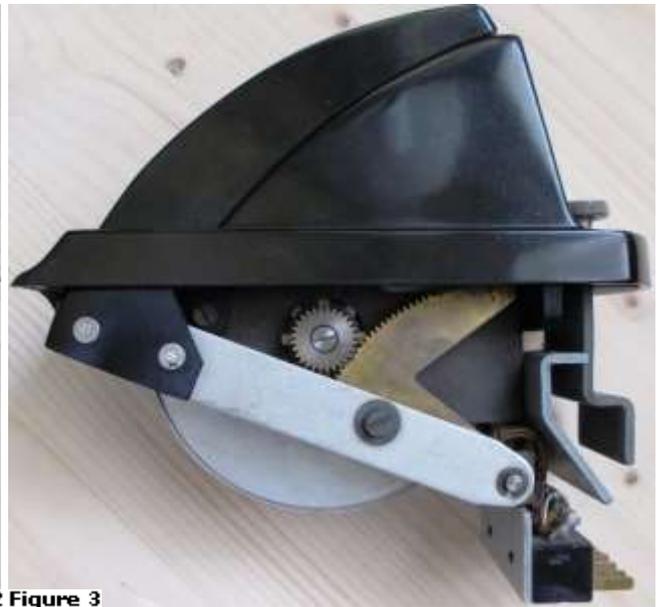
Figure 2 Figure 3

Part of the text belonging to exhibit 3-6-4B states that "... the insides [are] partially uncovered, so as to reveal some of the operating mechanism inside." This is incorrect, in that, since these dials were installed on switchboards, only the portion up to, and including, the finger stop, was visible. The rest of the dial was below the surface of the switchboard keyshelf, and required no further (dust) protection other than a round, aluminum case for the dial mechanism itself.

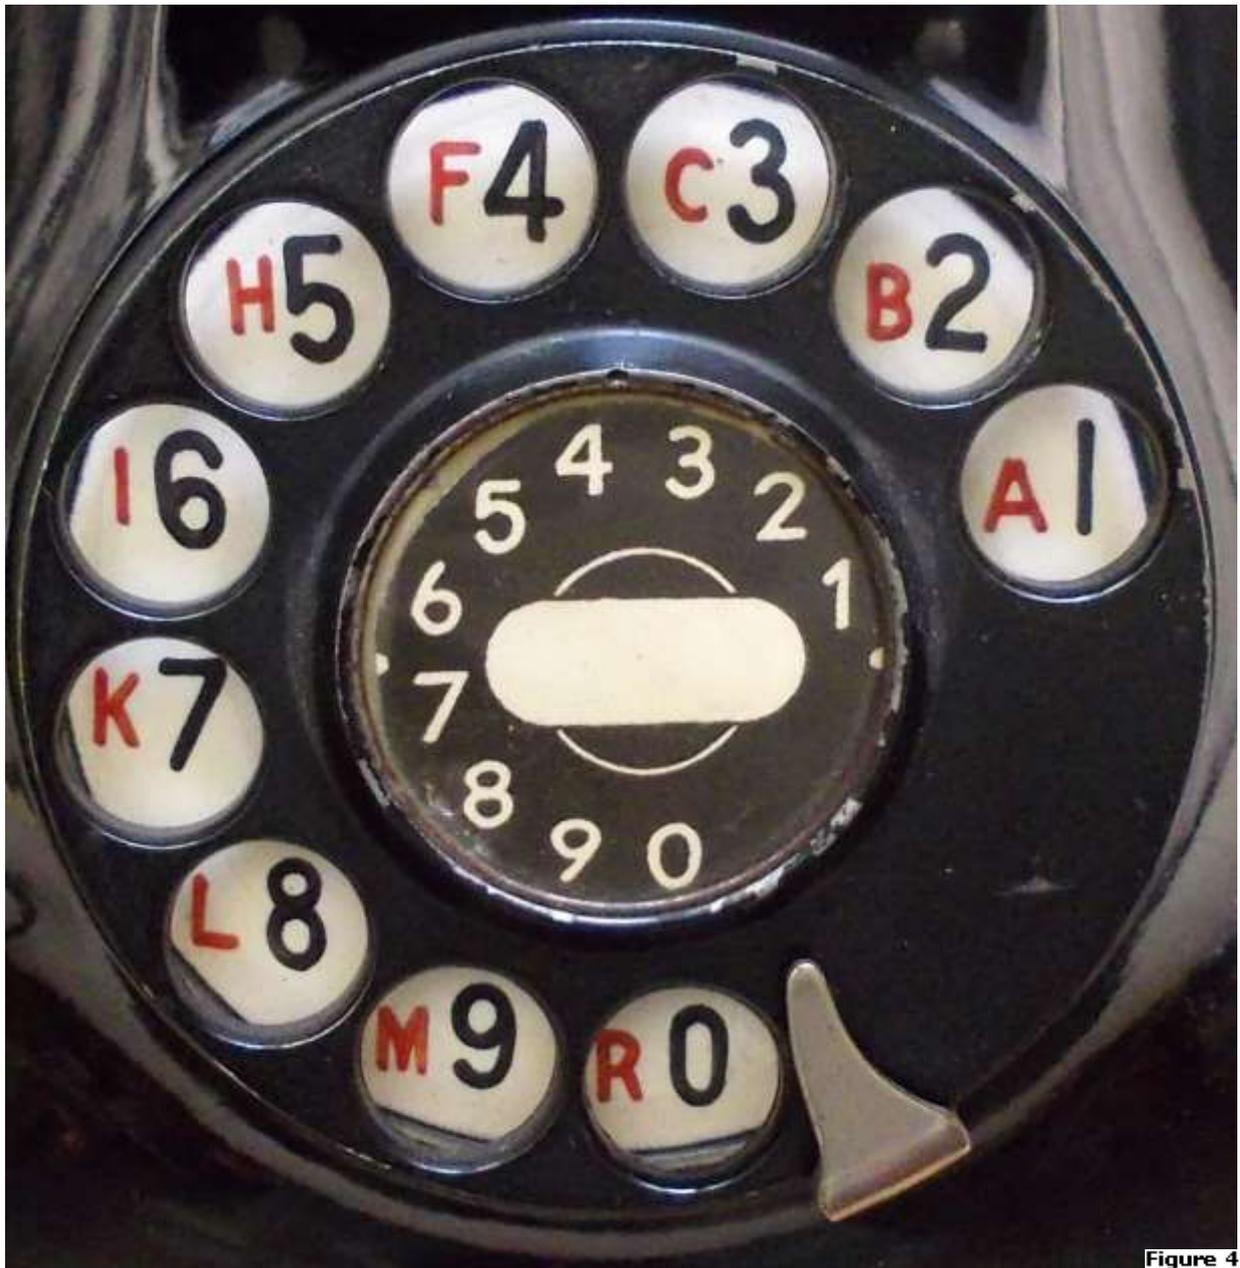
Figure 4

The exhibit referred to above shows two different versions of the style of dial used at Prague (the former capitol of Czechoslovakia, now the capitol of the Czech Republic). The dial shown below belongs to a PBX telephone, manufactured by Standard Electric (ITT) Prague circa September, 1946. The enameled ring with the letters and numerals is interesting, in that it was hand-painted (I have intentionally left the photograph so large, so that it is easier to see the ring).

One may easily see the ends of the strokes in the red enamel paint, since these are darker than the rest – proof positive that the letters and numerals were **not** printed.

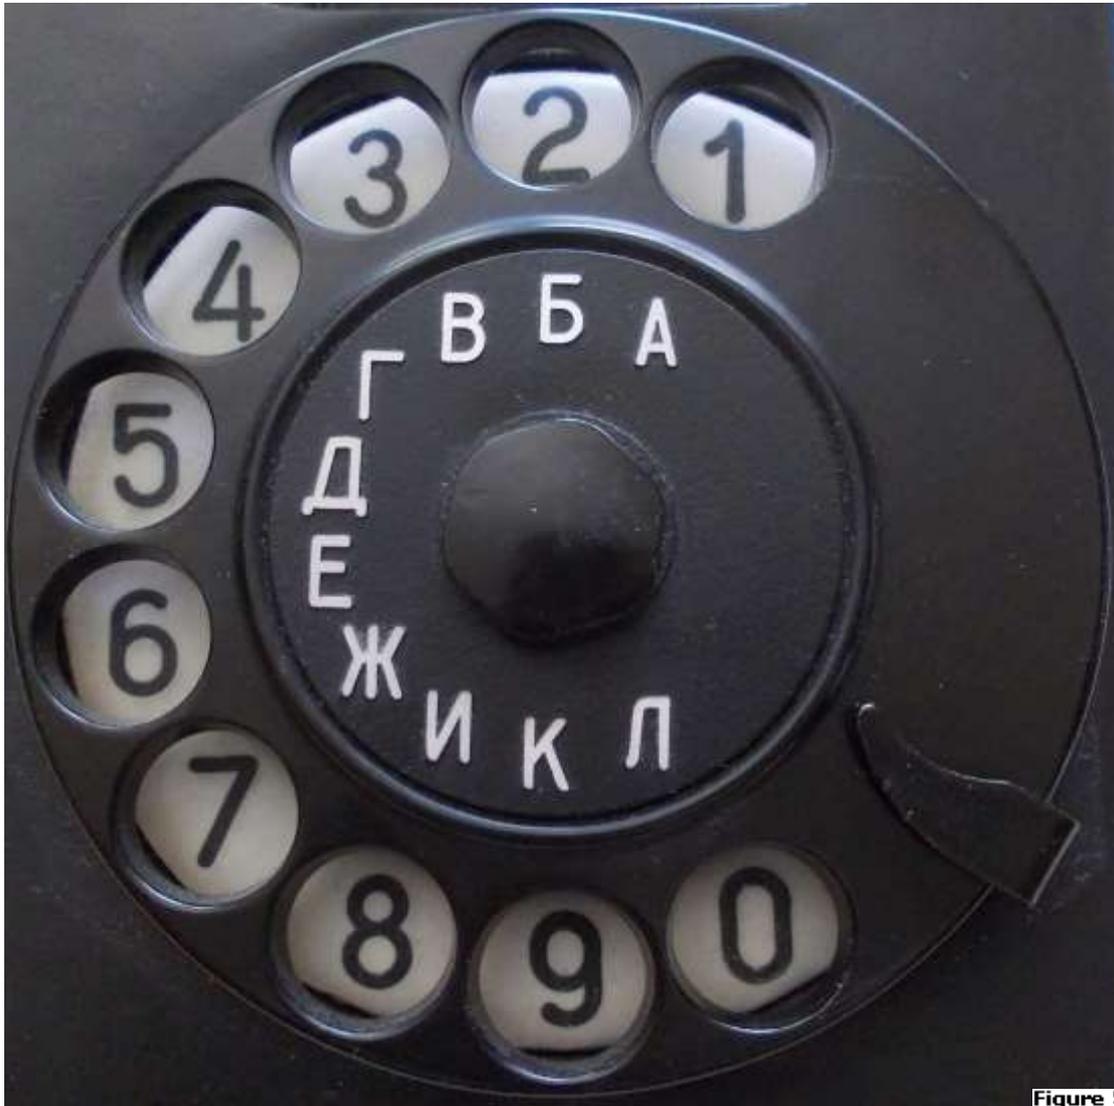
Figure 5

All of the above exhibits are of poor quality, especially exhibit 5-8-1C (very poorly cropped, if not to say chopped-up). I happen to own a NOS Soviet telephone, manufactured by the company "VEF," at Riga, Latvia, dated 1953, and the large photograph below shows the dial clearly.

The most unusual thing about the telephone with the above dial is that it incorporates design features from several different phones from different eras. The body is a two-part design like the German W 28 (lower portion of stamped metal, the upper portion formed of Bakelite), the handset cradle has the classic "wings" of Ericsson PBX telephones from the 1930s, and the finger-wheel of the dial (including the screw which holds the central aluminum disk) are wholly interchangeable with those of the Siemens W 48 telephone.
