## A Collection of Telephone Tales

written by Herbert Schwarz of Vienna, Austria, European Union

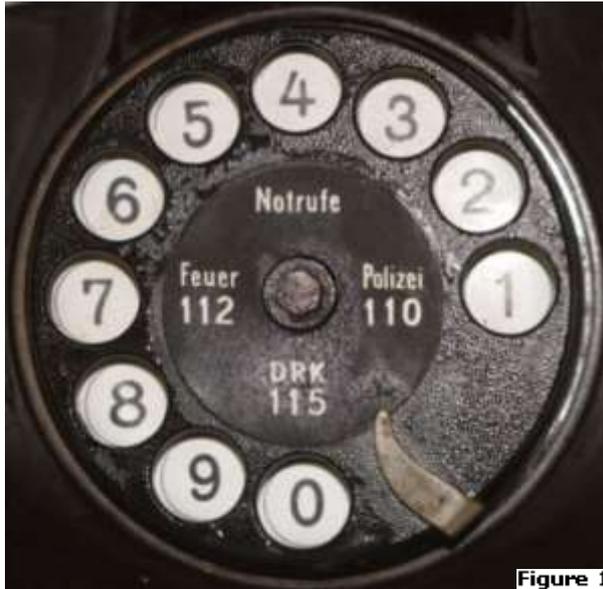
Figure 1

This dial is from a GDR W38 desk set from 1952; physically, it is a carbon copy of the standard German Reichspost style "N30" dial, which was in use as of circa 1930.

The inner disk shows the emergency numbers ("Notrufe") for the fire department ("Feuer", 112), the police ("Polizei", 110) and the Red Cross of the GDR ("DRK" – Deutsches Rotes Kreuz, 115; ambulance service).

The finger-wheel is made of Bakelite, while the inner disk is of electrically oxidized aluminum. The numeral ring is enameled iron.

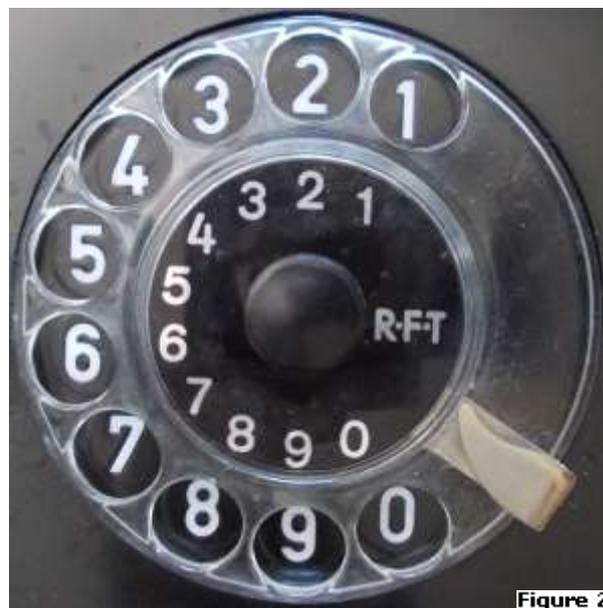
Figure 2

This dial belongs to the GDR Bakelite desk set model W63a.

The lettering "RFT" refers to the GDR umbrella corporation which manufactured and sold all manner of telecommunications equipment, such as telephones, teletypes, personal computers, commercial and other types of radio transmitters & receivers, as well as electrical and electronic components.

RFT stands for the German expression "Rundfunk- und Fernmeldetechnik," which literally translates to "broadcast and telecommunications technology." The RFT itself was called a "Volkseigener Betrieb" (publically owned company) – this being the German communist designation for all factories (large and small), according to the tenant that the means of production must be placed in the hands of the people, so that only such products are manufactured as are planned by the number of units to be sold, and their usefulness to the society at large.

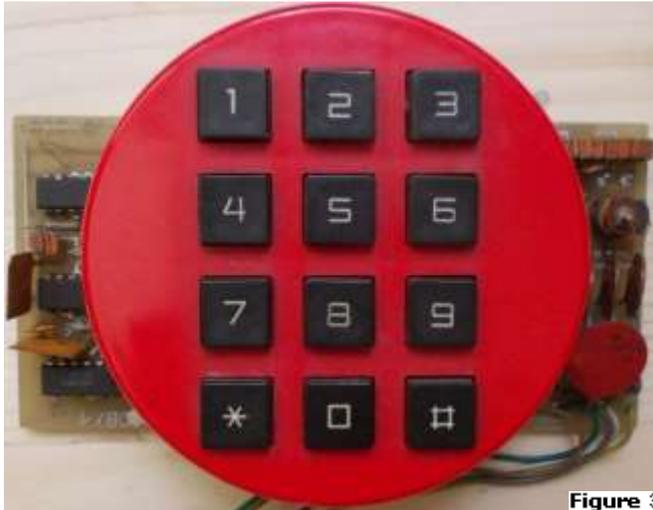
Figure 3

This was the GDRs first attempt at a telephone keypad (from the early 1980s), based on a 40 pin soviet microcontroller ... it is believed that this keypad was only produced in small numbers and was intended to be the prototype for following keypads.

This keypad had five wires to connect it to the rest of the phone; two were directly connected to tip and ring of the line, while the three others were a combination of the dial pulse and "off-normal" contacts. Since the keypad was permanently connected across tip and ring, this style of keypad would retain the last number dialed for as long as the line was powered.

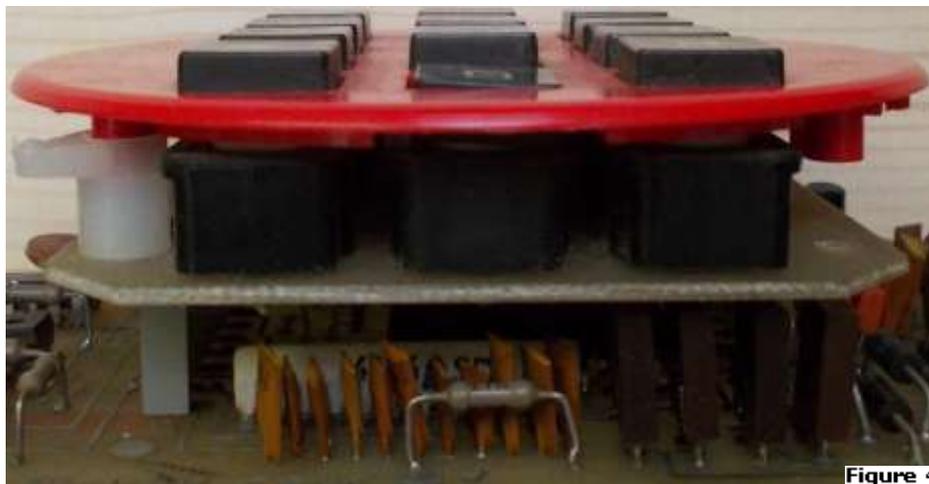
Figure 4

This style of keypad had three columns of four pushbuttons each, and they were true pushbuttons – which caused mechanical trouble in the form of stuck keycaps, as can be seen in the photograph shown below.

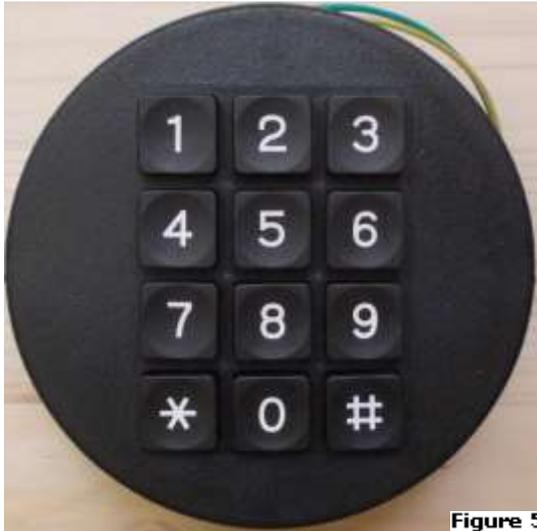
Figure 5

This is the final version of the GDR dial-pulse keypad; the one shown here is a drop-in replacement for rotary dials.

The "features" of the "star" and "pound" keys remained the same, with the exception that the last number redial only worked for circa half an hour after hanging up – after that, the number was simply lost.

This keypad no longer uses mechanical pushbuttons and keycaps, but rather employs an elastomer-based pad with short-travel keys. The photograph below shows a side view of this keypad; one can see that it is much thinner than the prototype was.

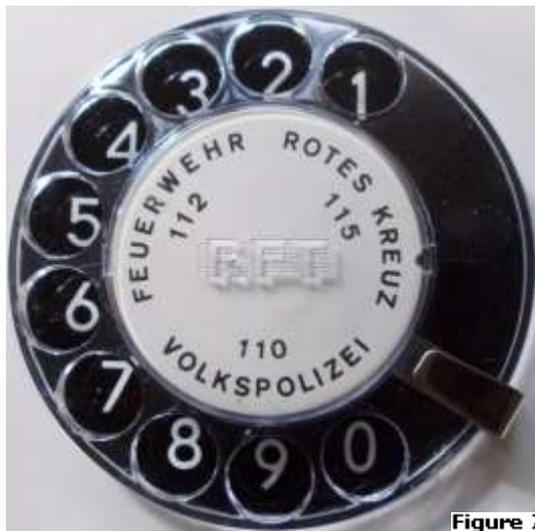
Figure 7

This is the mechanical dial of a GDR desk set (model "Alpha Ferro") from the mid-1980s, approximately the same time the drop-in keypad was placed into service.

The phone numbers on the central disk are the same as on the dial from the GDR W38 telephone, but the exact designations have changed ... "Polizei" became "Volkspolizei" (people's police), "Feuer" became "Feuerwehr" (fire brigade) and "Deutsches Rotes Kreuz" simply became "Rotes Kreuz" (Red Cross).

Note the modern "RFT" logo in the middle of the central disk.

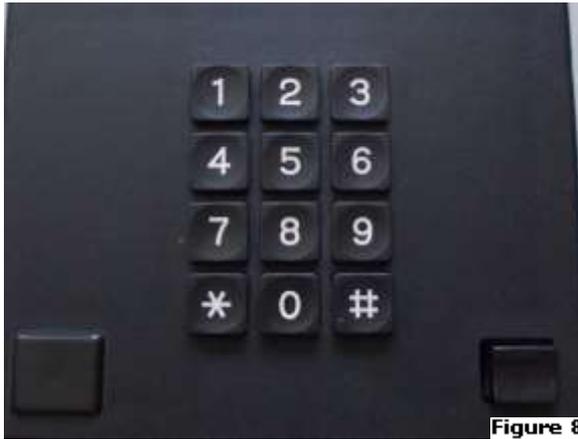
Figure 8

This integral keypad design was used on the GDR "Alpha" series of desk phones, namely on the "Alpha Ferro Quick" and the "Alpha Tast."

On the DTMF keypad, the "star" and "pound" keys generated the standard frequency pairs assigned to them; the "extra" key in the lower right-hand corner is an "earth" or "ground" key, required if the phone were a PBX extension.

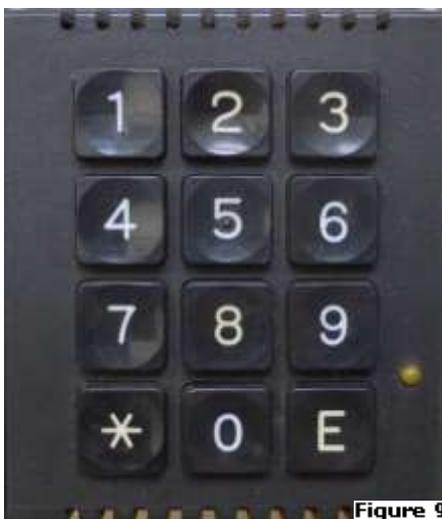
Figure 9

This is the keypad of the "Apart 2001;" it is of the GDR standard dial-pulse type, but its operation is slightly different: the "star" key is dead (there is no redial function), and the "E" key is an "earth" or "ground" key.

The East Germans even produced a telephone with a concept similar to that of the U.S. "Trimline®" – it had an electronic 2-4 wire hybrid (and a hearing amplifier) integrated into the handset, while the keypad and the electronic ringer were mounted in the base of the telephone. This desk set was called the "Apart 2001" (my German-English dictionary defines the German word "apart" as: uncommon, singular, odd, remarkable or cute.) This type of phone stops working if the line voltage drops below 8 VDC.

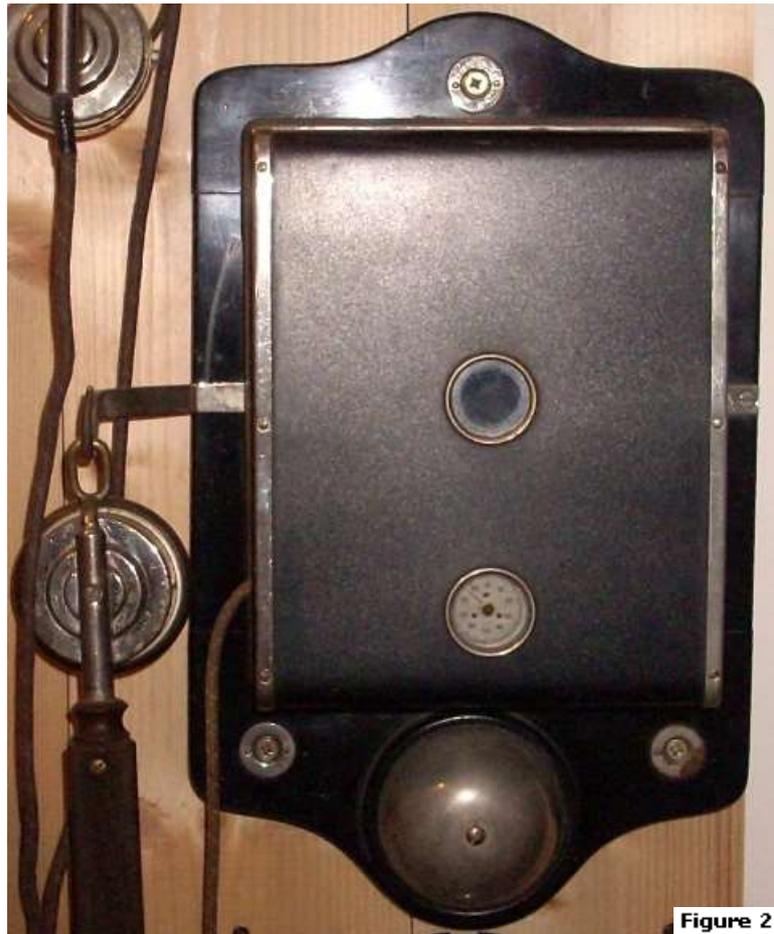
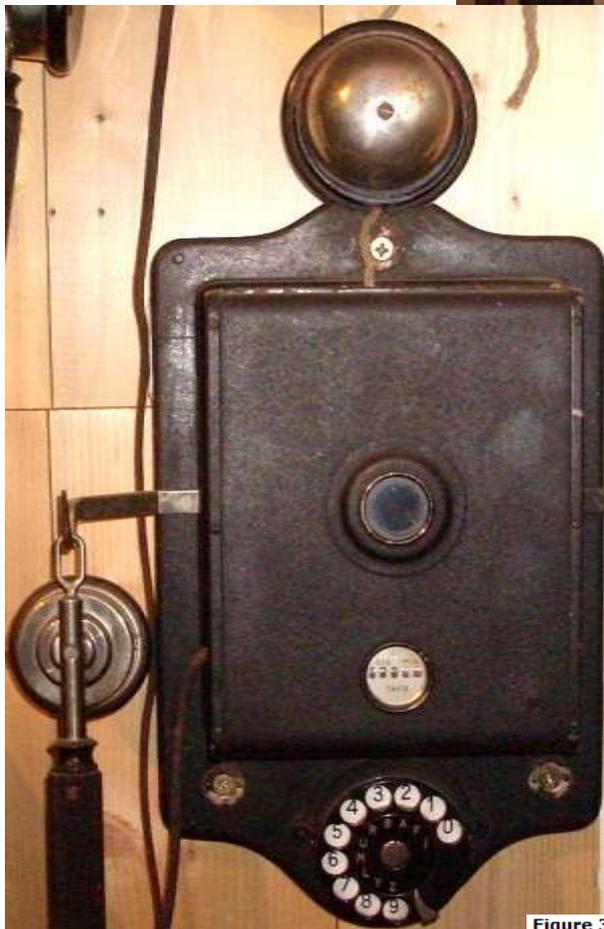
When it became time to convert these party-line phones to dial service, the original backboards were modified and reused ...

The dial was mounted in the space which previously held the D.C. ringer, while the upper curve of the original backboard was reworked and a round piece of wood was added for the bell.

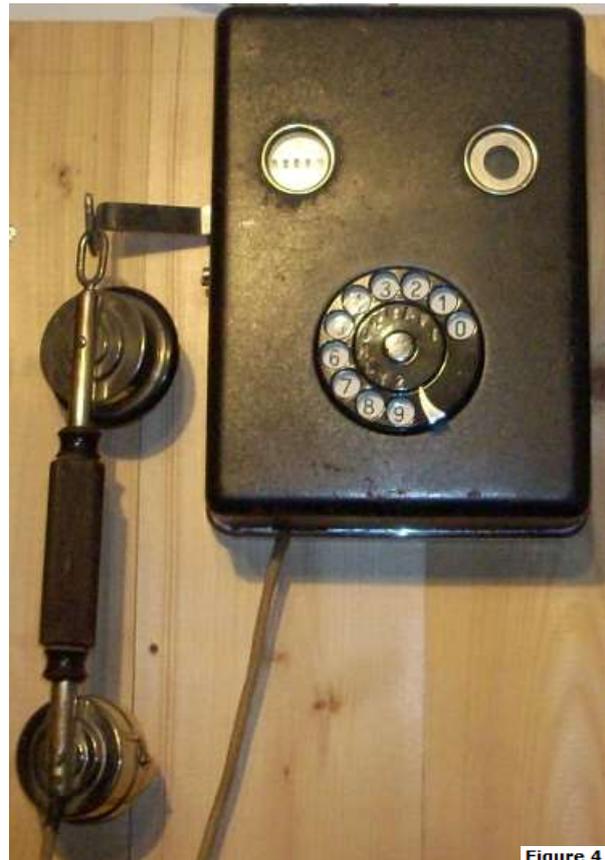
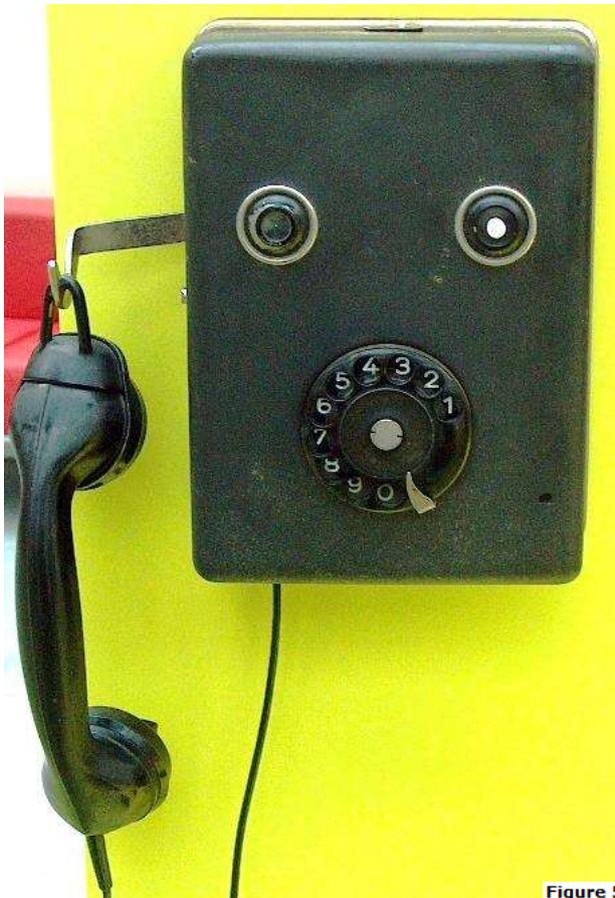
The clock is the rolling digit type as used with the dial version shown on the previous page, and the principle of indicating the status of the party-line by using a black/white mechanical flag has remained unchanged.

BTW: the "black" flag was an integral part of the white flag, and not a separate unit. Movement of both the switch-hook and the flag were damped by a dashpot.

The housing of the party-line phone shown immediately above was recycled for use with party-line phones belonging to the model 1948 generation of telephones.

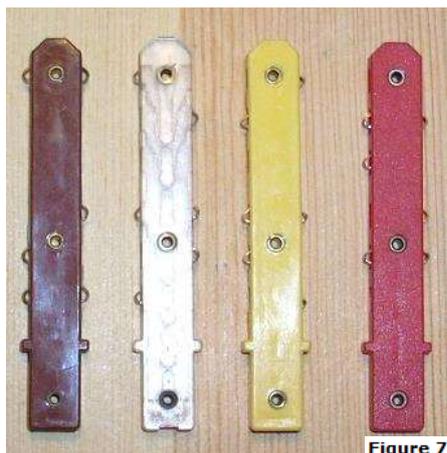
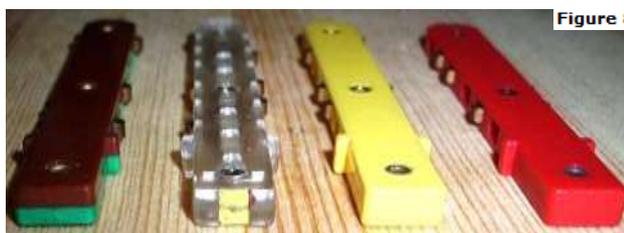
These two photographs show a total of three different programming plugs<sup>[1]</sup> ... as can be seen, they have side contacts in varying combinations. I only recall that the one coded green/brown was most commonly used, since it programs the individual subscriber for full party-line service, including outgoing toll calls.

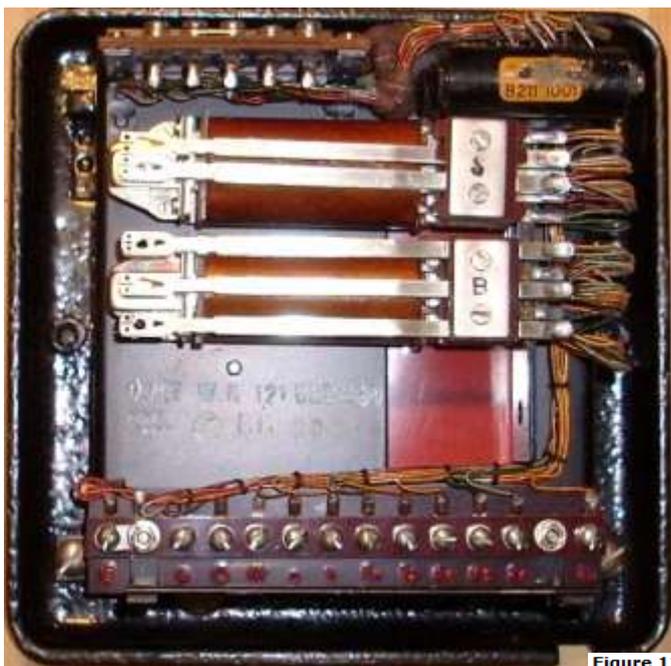
Figure 11

The photograph to the left shows the innards of an early model W48 party-line subset. The bridging and selective relays are visible and, fancy that, they carry the first letter of the words "bridging" and "selective" – the German equivalent words for these relays is "Brückenrelais" and "Selektivrelais."

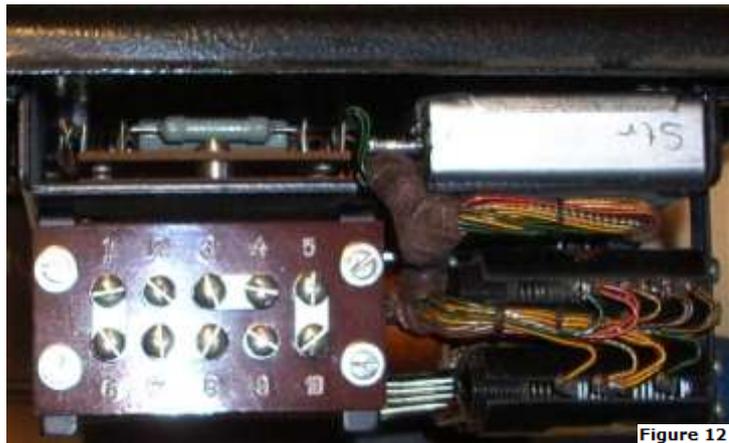
Figure 12

The picture to the right is a top view of the subset shown on the previous page. The terminal strip on the left in the photo was used to program the selective portion of the equipment to react to the proper sequence of pulses from the CO.

The scan below the picture shows the strapping options for the four possible subscribers: subscriber 1 = end digit 2, 2 = end digit 3, 3 = end digit 4 and 4 = end digit 5 of the phone number; the German word "subscriber" is "Teilnehmer" (literally someone who partakes) abbreviated in German as "Teiln."

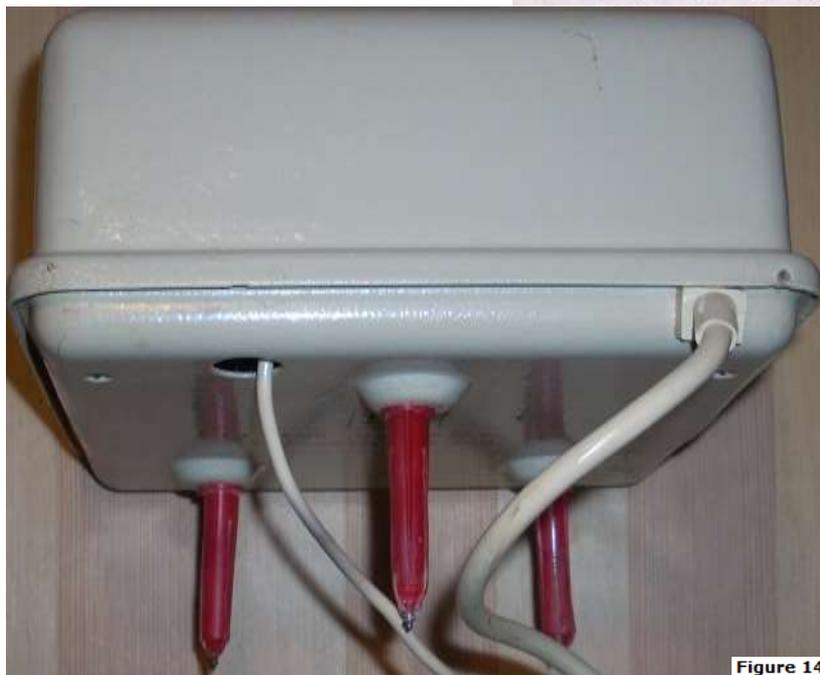
Figure 14

The picture to the left is included so that readers can gain an idea of how thick the subset originally was: four inches deep and six and a half inches square.

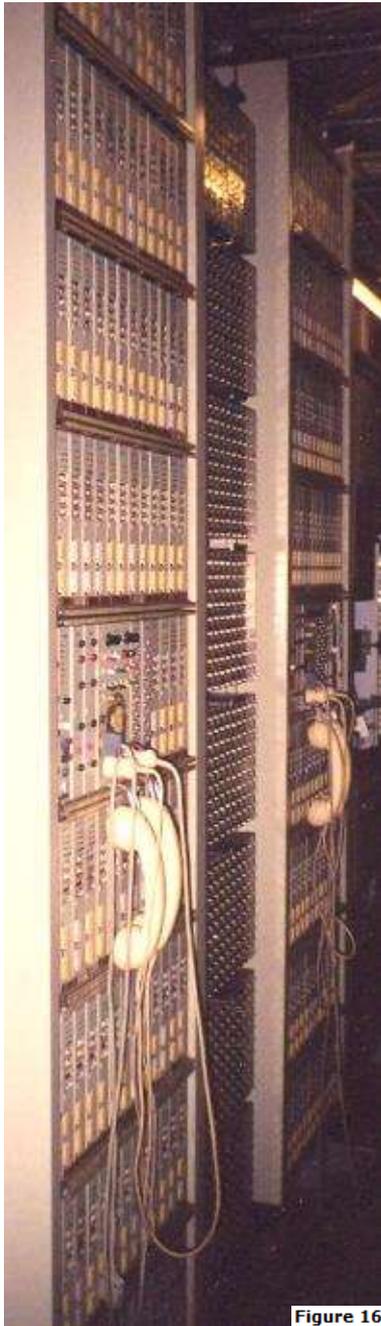
Figure 16

The photograph to the left shows two frames of GA78 equipment in an exchange on the outskirts of Vienna. The frames each have eight card cages, seven of which are equipped with twelve cards for two four-party party-lines each – hence one card cage serves a maximum of 96 individual subscribers, and a single frame of GA78 senders can support up to 672 individual subscribers.

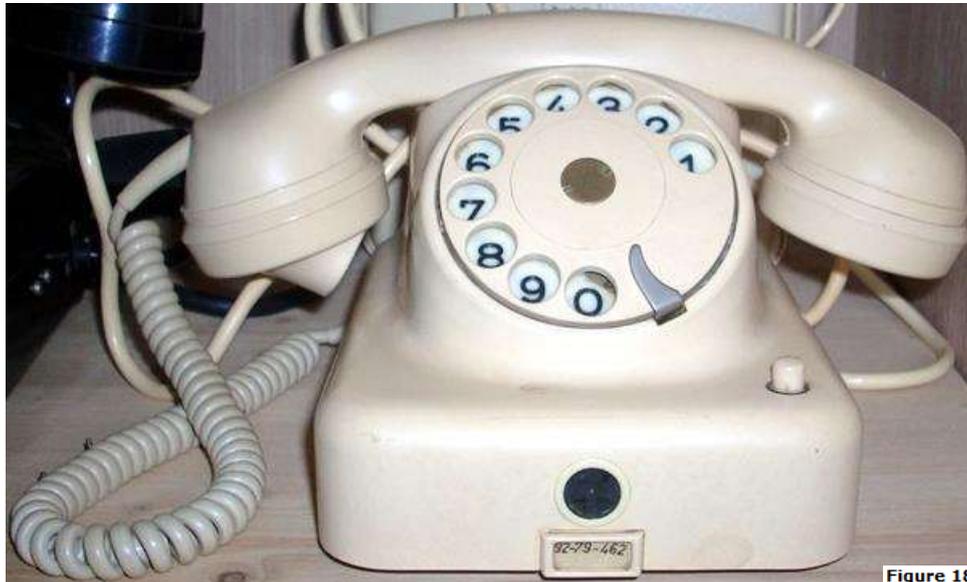
Figure 18

The ivory-colored Bakelite desk telephone shown above was used with the GA48 subsets, and this one is still attached to its subset. Unfortunately, the phone itself isn't sealed, but it at least carries the small reminder card with the subscriber's phone number written on it ... 92-79-462. Back when this phone was in use, the office prefix "92" belonged to an exchange in the 15<sup>th</sup> district of Vienna.

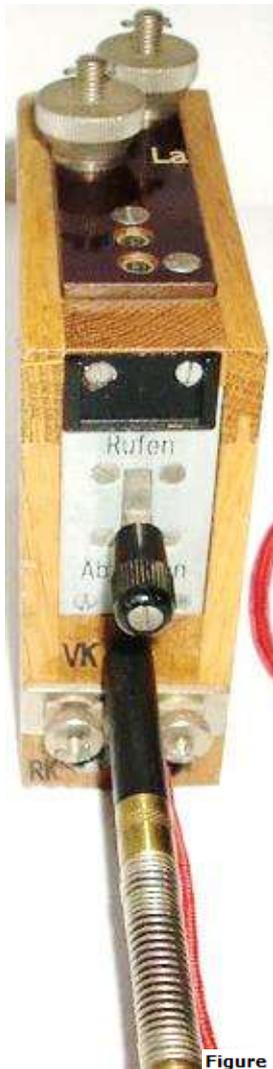
Figure 1

There is a small frame above the Kellogg switch; this held a small, plastic card which was white on the one side and red on the other. White indicated that the line was a loop circuit, red that the line had a ground return. If the modules weren't all connected to the same type of line, then a ring-through, talk-through induction coil (as described at the end of the tale concerning the German WW II FF-33 field phone) was used.

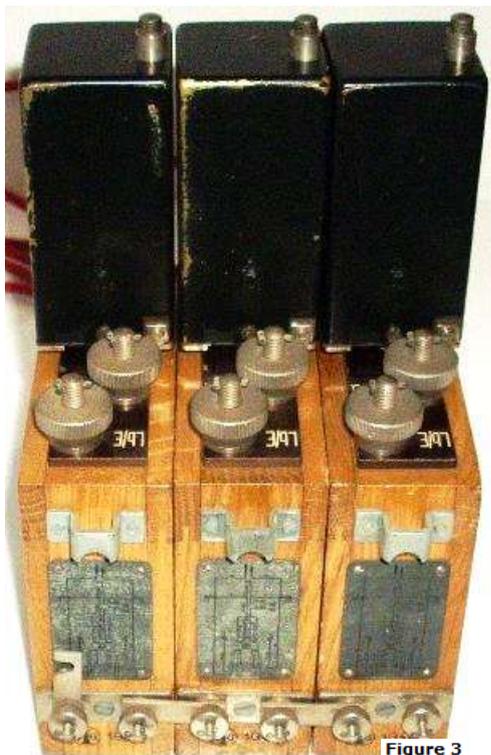
Figure 3

This is the rear view of the same switchboard. It's possible to see the small tab of the second terminal of the night alarm circuit in the lower, right-hand corner on the rear of the drops.

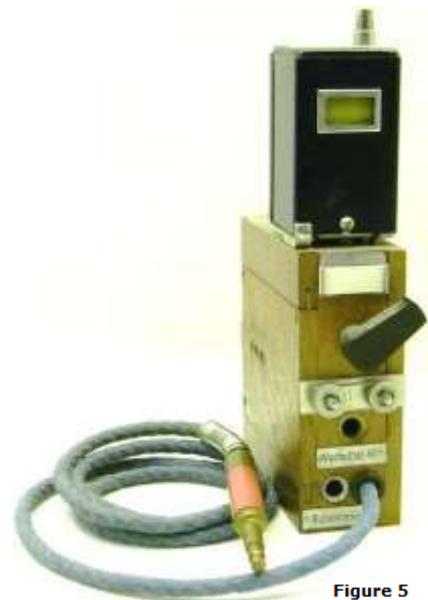
Figure 5

The schematic for both the Swiss and the German modules (those equipped with a rotary switch) is shown below.

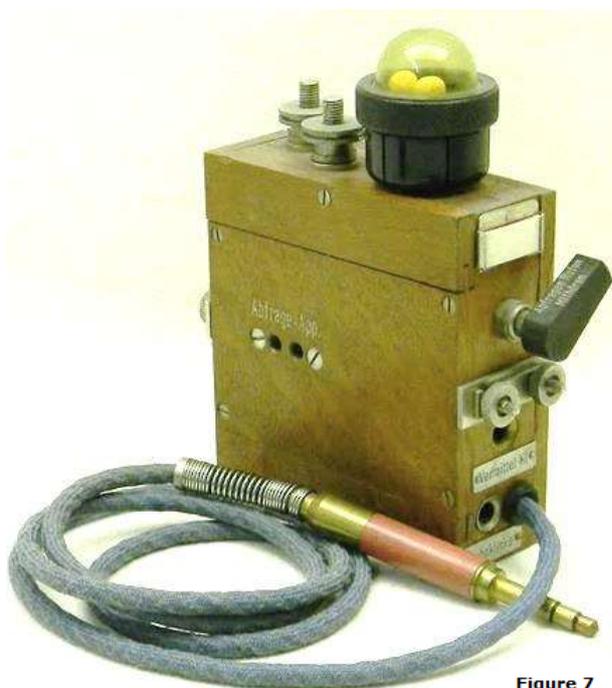
Figure 7

This type of indicator wasn't intended for use with magneto field phones, but rather for use with the type of field phone much favored during WW I, which used an entirely different method for signaling.

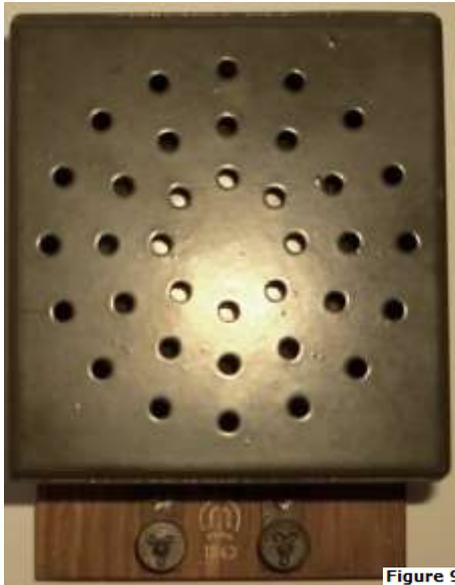
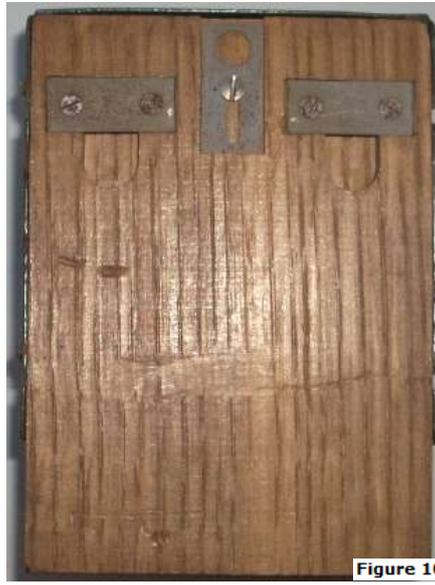
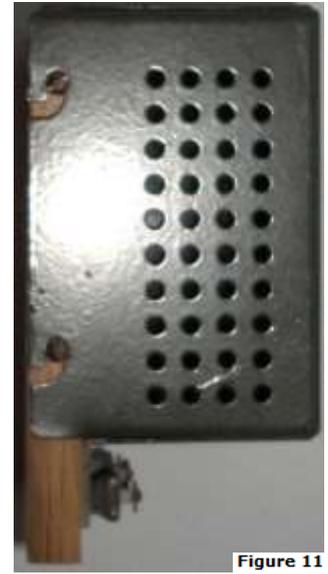
The three photographs above show a NOS WW II German switchboard night alarm D.C. ringer; the pictures are about two-thirds of the natural size ... this D.C. ringer was used in conjunction with all German field switchboards, except for the one designed for 20 lines – which had an internal D.C. ringer.

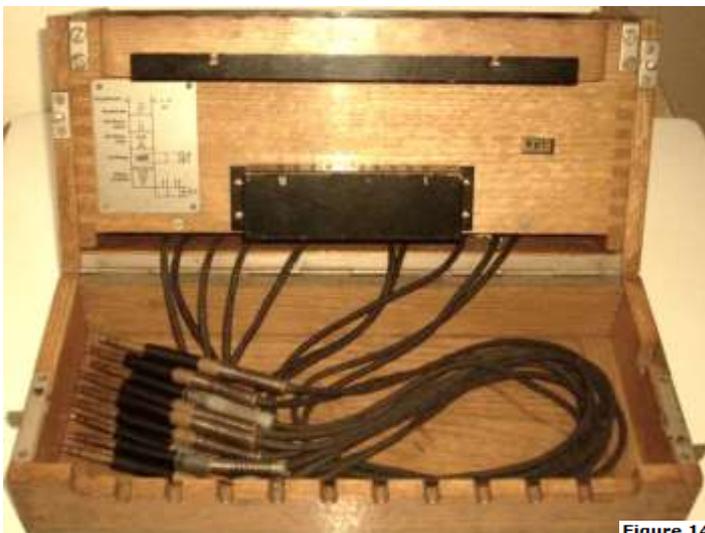
Figure 14

When one opens the latches on the sides of the switchboard, the top of the board may be swung back to allow access to the stowed cords and plugs.

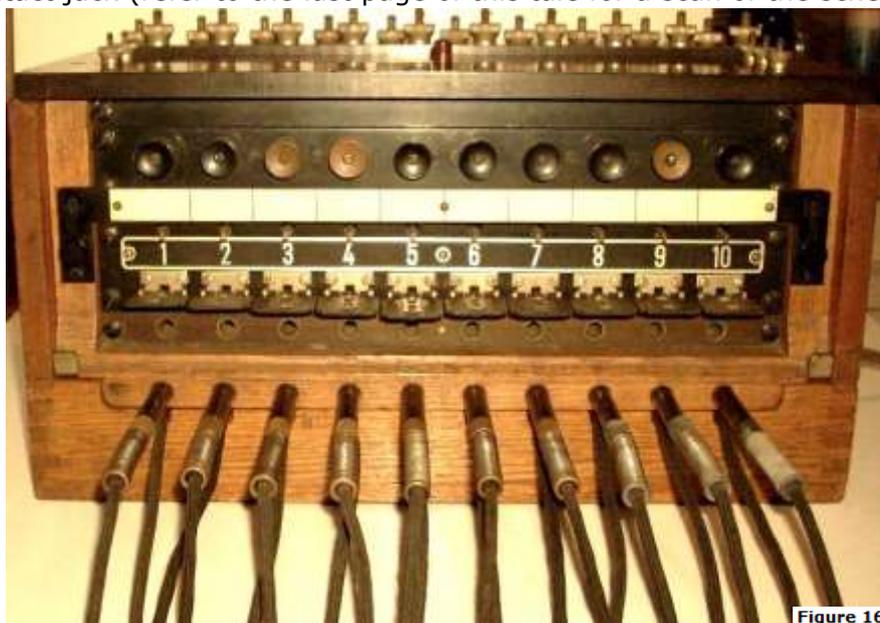
Figure 16

Here, the cords have been unstowed and lain into the proper slots so that the board can be closed without pinching the cords. A connecting cable is plugged into the 30-contact jack; it exits through a special cutout on the right-hand side of the case. Electrically, this small field switchboard is nothing more than ten switchboard modules wired together.

The lower photograph on the previous page shows the small field switchboard with all ten plugs in their stowage jacks ... early switchboards of this type didn't have these stowage jacks, and the ten cords were simply allowed to dangle down as they may. The problem with that was that crosstalk could occur if the plugs touched moist or wet ground. All ten of the drops were placed into their actuated position to show that there is a line numbering strip behind the drops. The white plastic strip above the drops is attached to a flat metal bar which may be raised or lowered – when lowered, the drops were locked (this was done when the board was being readied for transport).

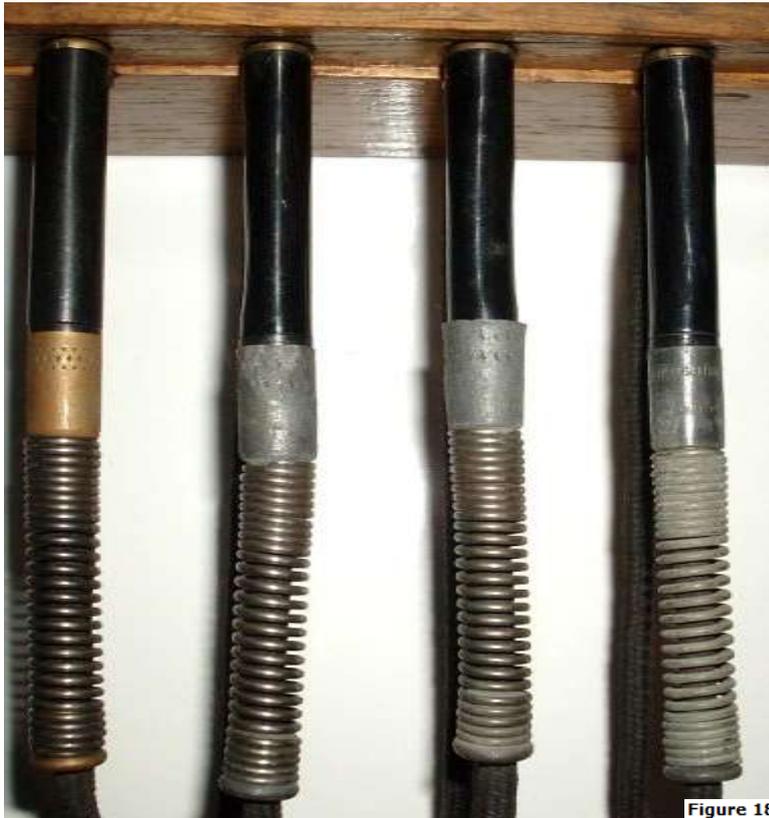
Figure 18

As can be seen, the sleeves made out of thermoplastic are deformed after 70 years and the zinc collars cracked and loose.

As can be seen, the first seven of the plugs have brass collars, while the last three have collars made of a zinc alloy – this was one of the German's moves to get war-critical metals out of equipment which didn't require them. The problem with the zinc alloy only surfaced after decades, but surface it did: the zinc collars cracked and got loose, while those made of brass are all still as good as new. It isn't all too noticeable, but even the sleeves of the plugs are different ... those of the first seven plugs are made out of sturdy Bakelite, while the last three sleeves were made out of a cheap, black thermoplastic.

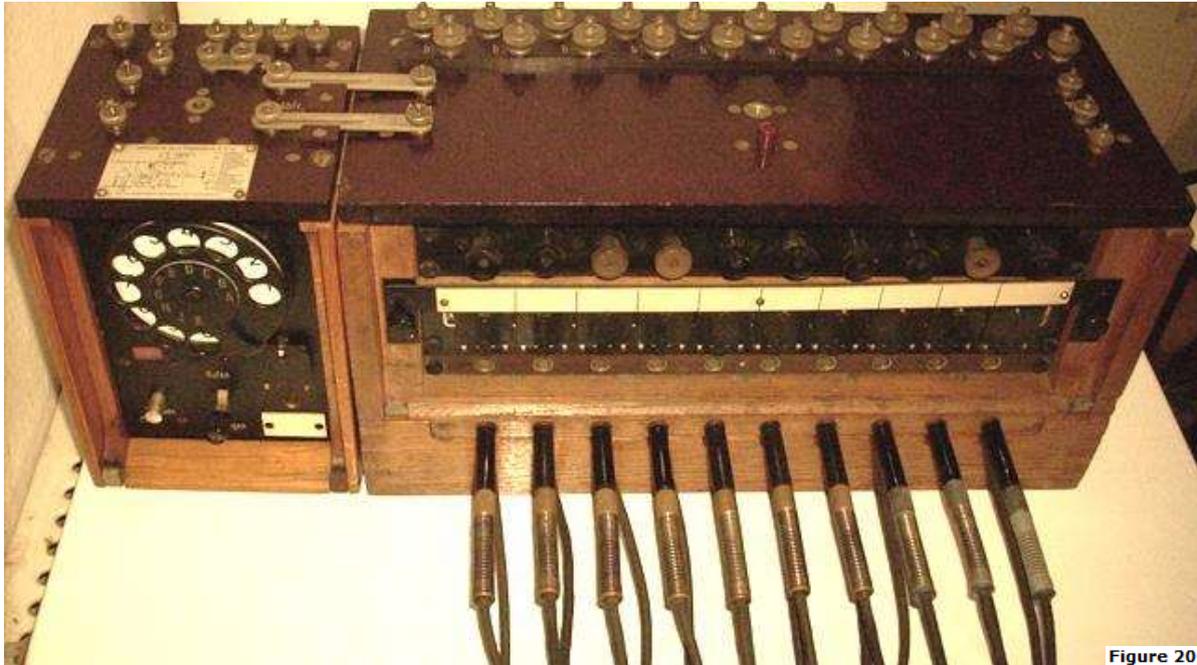
Figure 20

A standard German telephone dial of the type "N30," a single drop with a line jack beneath it and Kellogg switch (spring-loaded for the ringing position and latching for answering an incoming call) are on the front panel of the adapter. The last item is a round, nickel-plated pushbutton with a small red flag above it.

Naturally, the small field switchboard had its own special adapter with which it could be connected to a dial or C.B. exchange line.

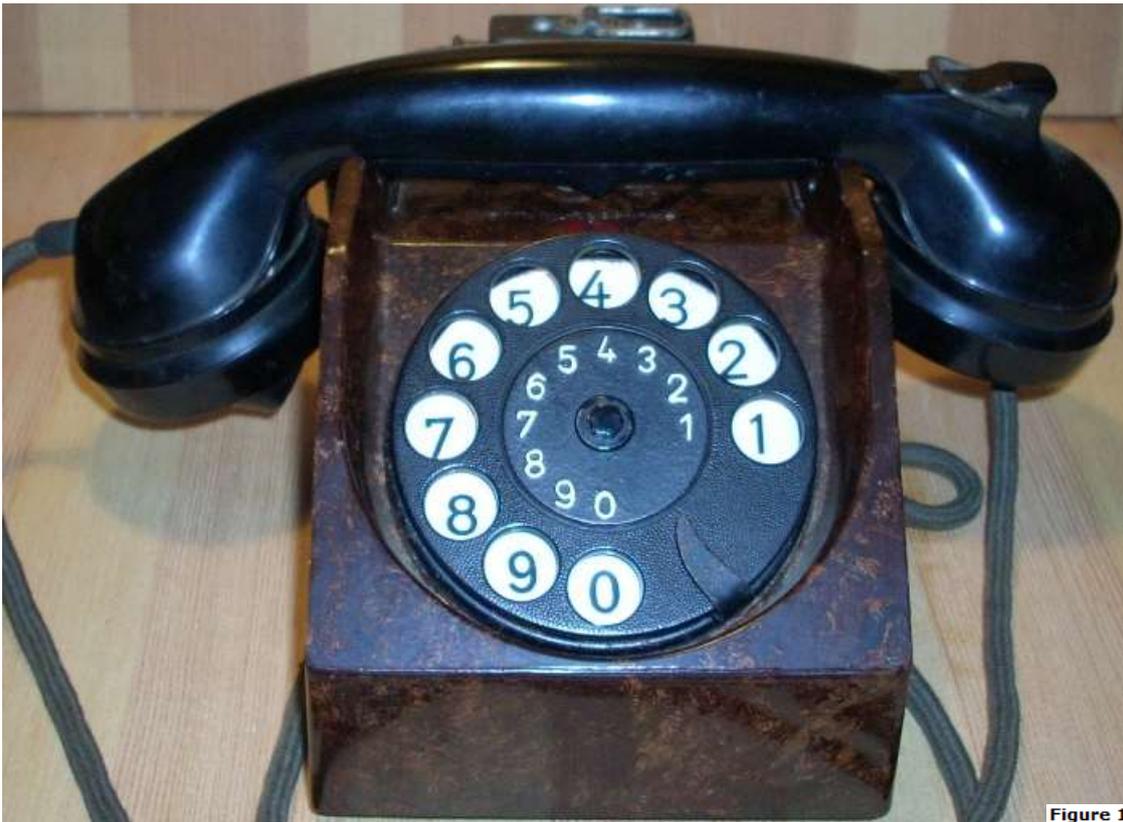
Figure 1

An interesting design feature of this telephone is that, when the handset is disconnected and removed, the basic unit doesn't have any protrusions, so that it's very easy to pack away (the phone and the handset had their own leather storage cases, which are next to impossible to come by).

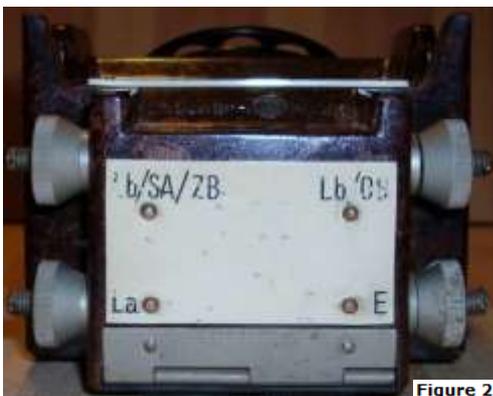
Figure 2

The picture to the left shows the binding posts on the rear of the phone. Tip (La) is only present once, while the binding post for the ring lead (Lb) is present twice – one for connecting the phone to a C.B. or dial exchange, and an electrically independent Lb terminal for connecting the phone to an magneto exchange, where it fulfills the role of a SB-33 accessory for the FF-33 field phone. The terminal marked "E" is for a ground connection, for use with dial exchanges which worked using grounded dial pulses on tip and ring.

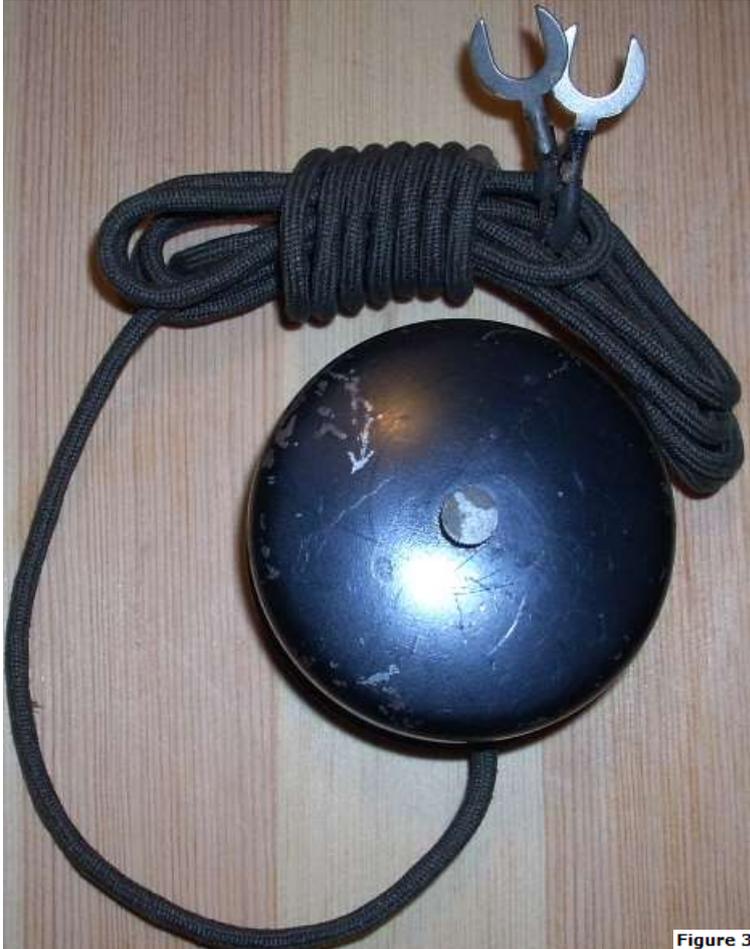
Figure 3

When used in the role of a “plain Jane” Wehrmacht desk telephone, the exchange interface was connected to the phone line via a special line cord, as shown below.

This particular type of line cord and terminal block are pretty rare, especially when in NOS condition.

Yes, I know that the cover of the terminal is scratched and is missing some paint, but the cord is still wrapped up the way it was when delivered to the Wehrmacht; the oversized spade lugs were designed to fit the binding posts on the phone.

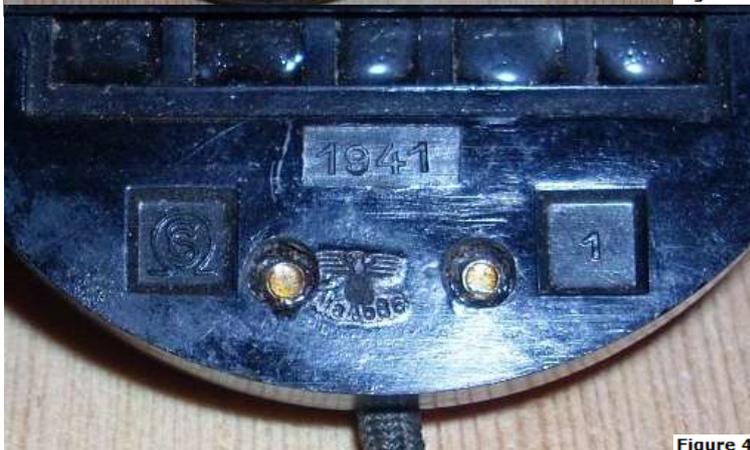
Figure 4

The terminal block has removable links for the tip and ring leads; this is another instance where the basic design of a piece of equipment didn't change over a timespan of a few decades (compare with the terminal block shown on page 397).

This terminal block even has a Wa.A. hallmark, proving that it's a piece of military equipment, just the same as any rifle, machine gun or field cannon.

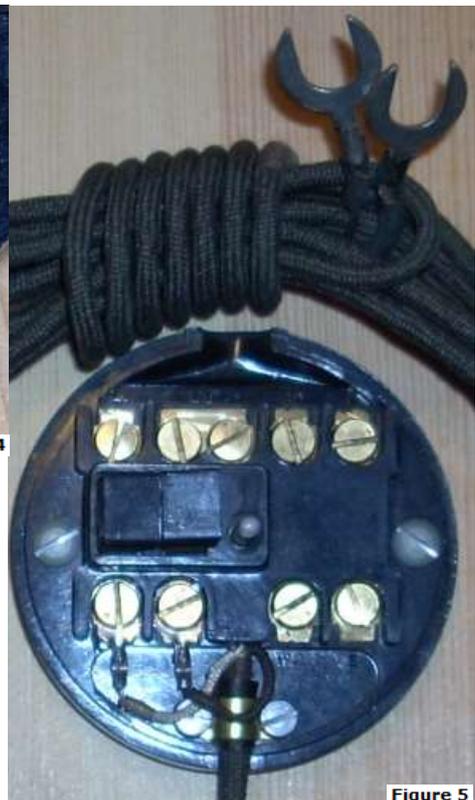
Figure 5

The exchange interface 1933 has two jacks which allow connection of a FF-33 field phone – both of which are placed so that incorrect connections and handling are prevented. The jacks are labeled “Vermittlungsklinke” (German for “exchange jack”) and “Induktorklinke” (German for “magneto jack”) – the former was used to connect a FF-33 field phone line to a C.B. or dial exchange, the latter when the interface was used as an alternative to the SB-33 accessory.

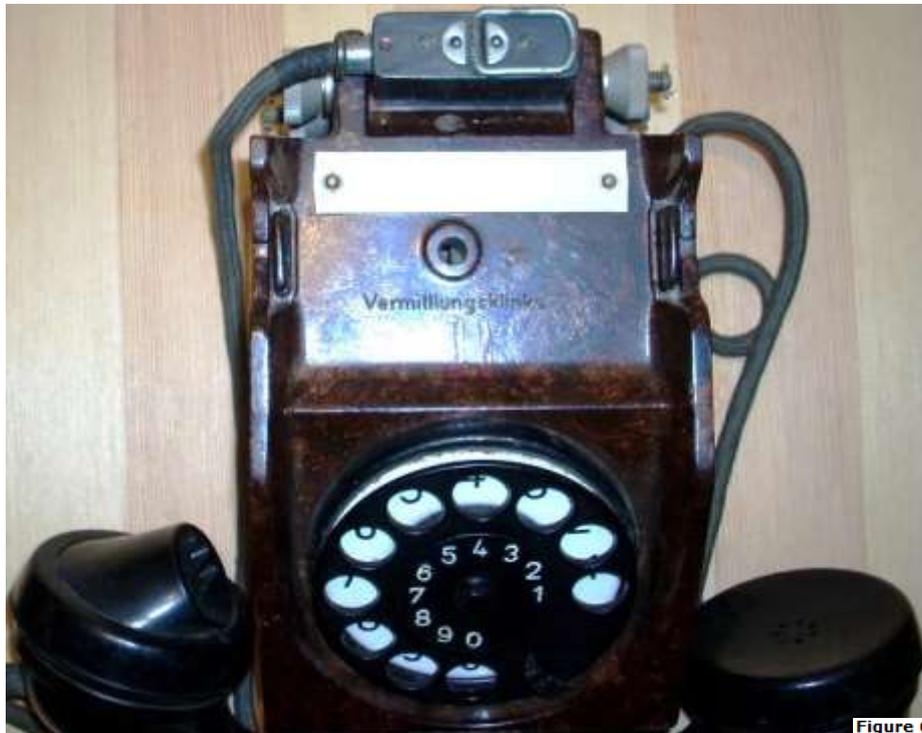
Figure 6

The exchange jack is located between the cradle plungers, so that it's impossible to hang the handset of the exchange interface up while there is a conversation in progress. The question arises as to how the soldier who connected the interface to the FF-33 would know when the conversation had ended ... simple: the distant end of the field phone line (another FF-33 or a switchboard) simply rang off as normal (listening in on the conversation was strictly “verboten”).

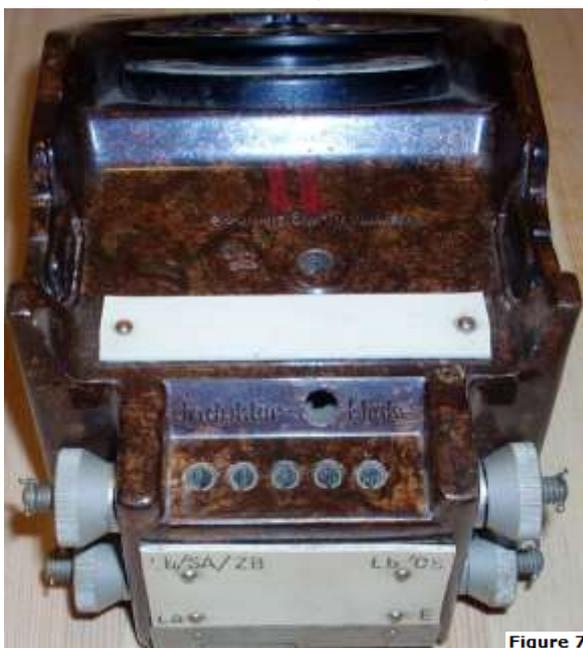
Figure 7

To use the exchange adapter as an ersatz SB-33, the FF-33 was connected to the interface via the magneto jack – which is only accessible when the handset is unplugged from the unit.

When not in use, the handset of the FF-33 rested on the cradle, just as it would on the genuine SB-33, with the incoming line connected to the terminals La and Lb/OB.

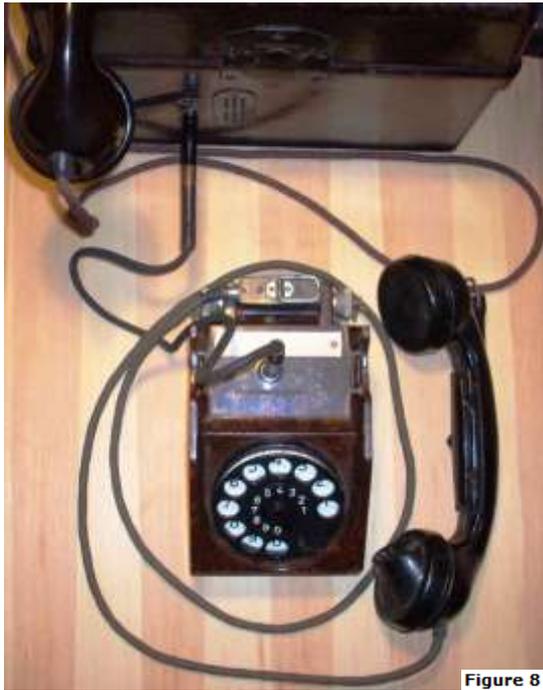
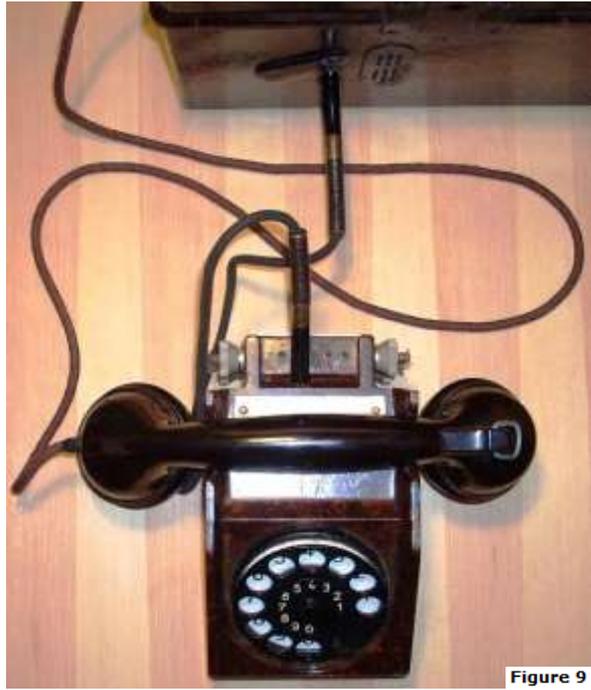
The photographs above show the exchange interface and the field handset(s) in the two possible configurations as explained on the previous page. For those who'd like to try and decipher European telephone schematics, I've included the schematic for the exchange interface below ...

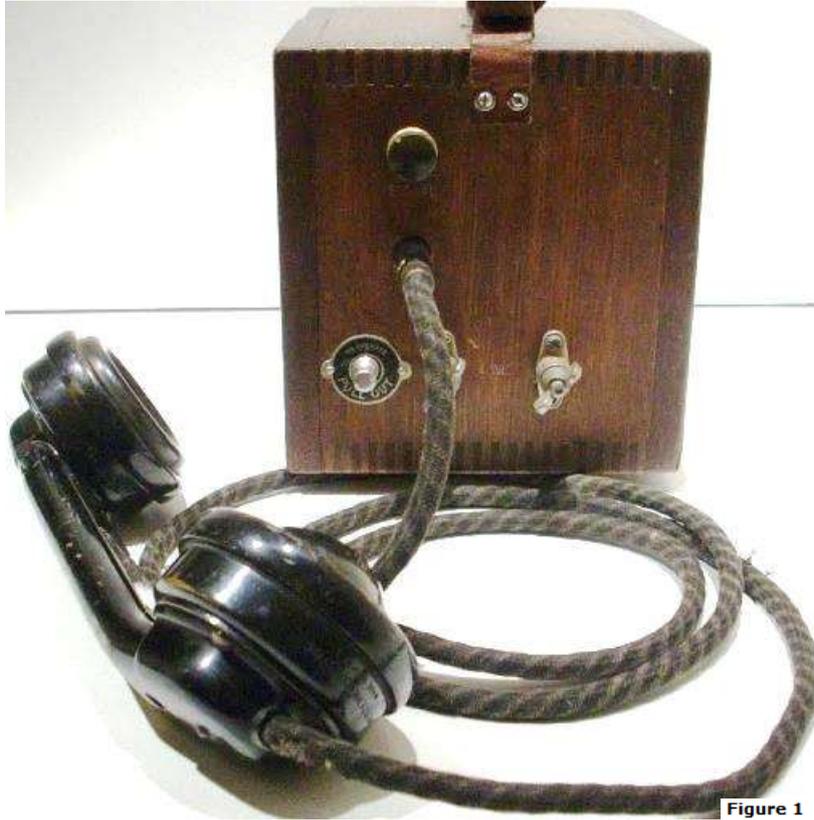
Figure 1

It was also in the year 1996 that I discovered a very unusual "subscriber set" which, according to the metal tag attached to the wooden case, was manufactured in the USA and which sported a black painted, metal handset. The wording on the tag specifically stated that this phone was a *subscriber set* with the model number 521-A.

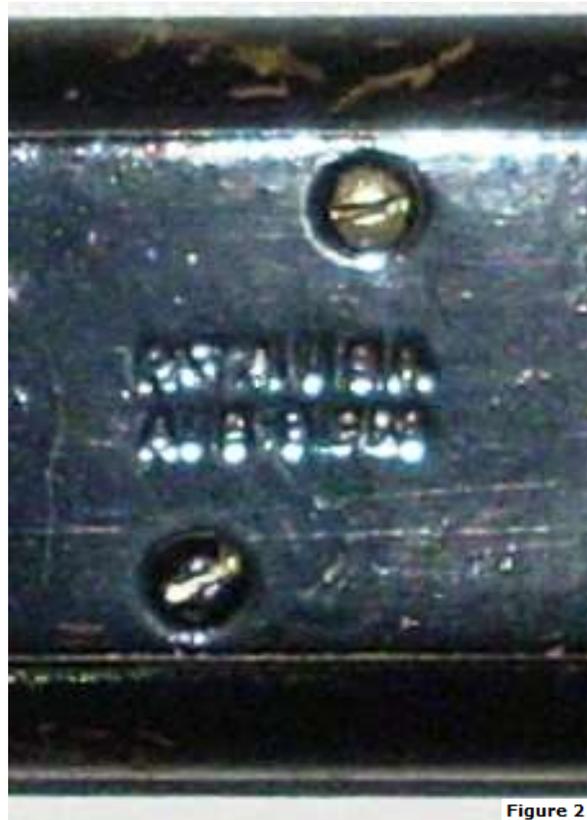
Figure 2

Another interesting bit of information is to be found in the ERPI document: the handset handle, sans transmitter & receiver, officially carried the Western Electric type designation "1E" (and one of the handsets belonging to my 521-A's actually carries this number).

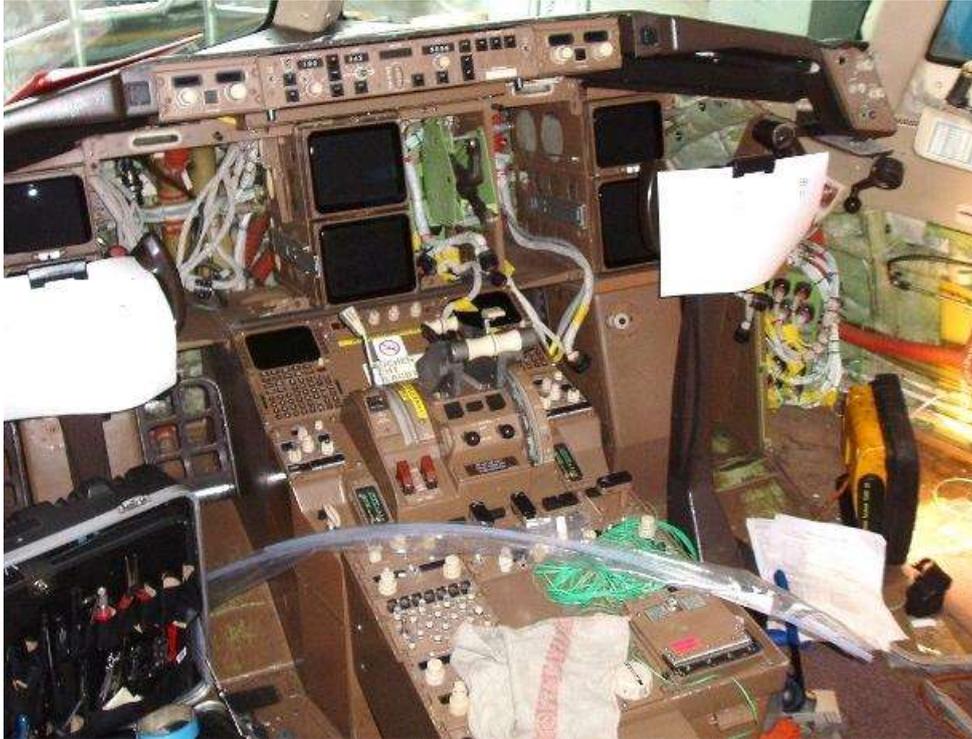
Usually, you only see such stripped-out cockpits in planes standing around somewhere in Arizona ... in this case, however, it's the cockpit of the same Boeing 767 that I was working on; and all this to add four measly wires from certain electronic units in the electrics/electronics bay (*and* a whopping two relays) and run the wires up to switches on both the pilot's and copilot's side panels.
