M1A AND N1A RINGER

IDENTIFICATION AND MAINTENANCE

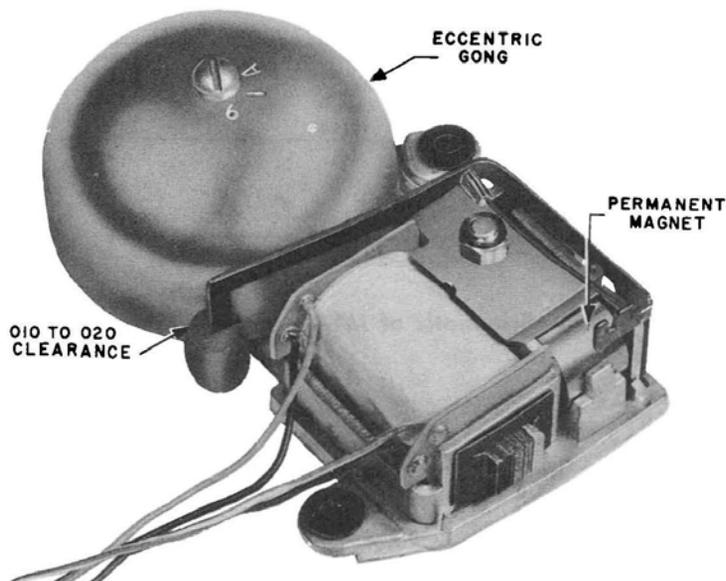
Fig. 1 — M1A Ringer

2.02 The M1A (Fig. 1) and N1A (Fig. 2) ringers are single-coil, single-gong ringers. The coil is tapped, making party identification possible. The ringers are designed to operate in series with an 0.45-mf capacitor.

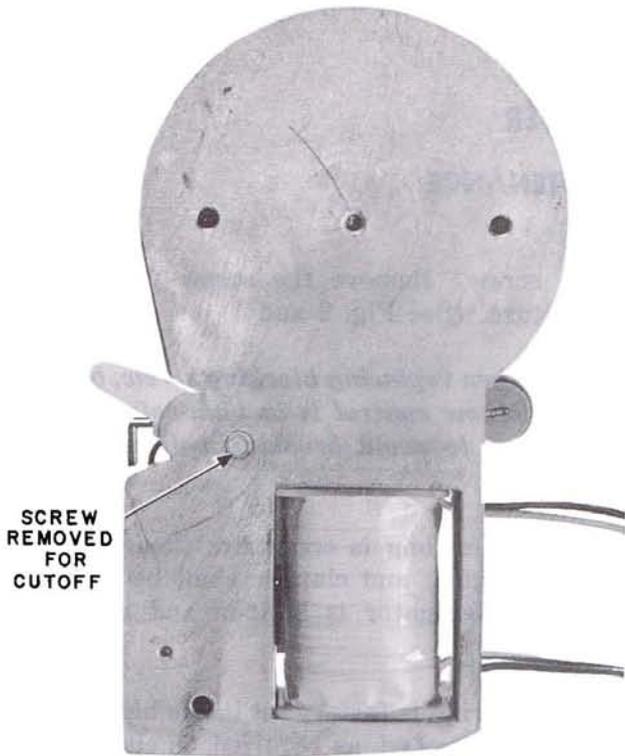
Fig. 3 – N1A Ringer, Rear View

2.03 These ringers differ only in their mounting and volume-control facilities. There are three positions of volume control; high, low, and off. The off position is blocked by a factory placed

machine screw. Remove the screw for ringer-cutoff feature. (See Fig. 3 and 4)

When replacing blocking screw, be sure volume control is in high-volume position to avoid breaking volume-control arm.

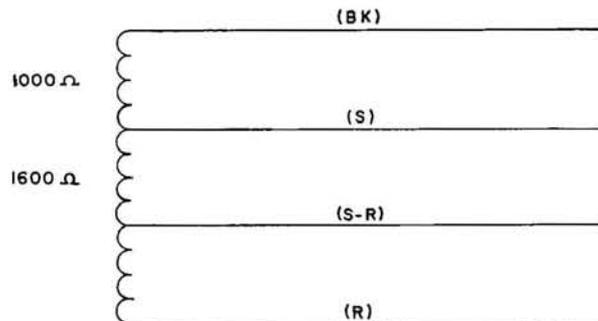
Fig. 5 – Schematic of M1A and N1A Ringer

- Volume control is not in off position.
- All leads are dressed away from movable parts or ringer gong.
- All leads are tight and on their proper terminals.
- Bias spring is correctly positioned.
- Armature airgap is free of dirt or foreign material.
- Ringer coil is not open or shorted. (See Fig. 5.)
