COIN TELEPHONE—1A- AND 2A-TYPE OPERATION TESTS AND TROUBLE ANALYSIS

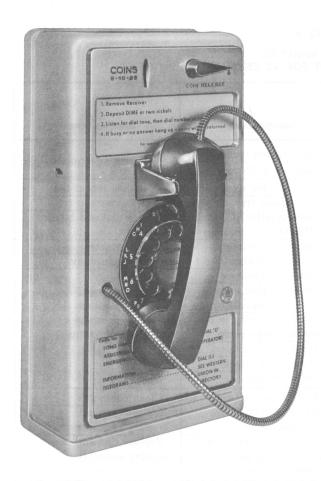
Fig. 1—Cover Unit With Handset Inverted (Typical of 1A-Type)

1 Invert handset on switch hook (Fig. 1) (1A-type only).

Note: Prevents armored cord from pushing handset off switch hook when cover is removed.
