RINGER — D TYPE

MAINTENANCE

1.01 This section contains requirements and procedures for maintenance of the D1A ringer.

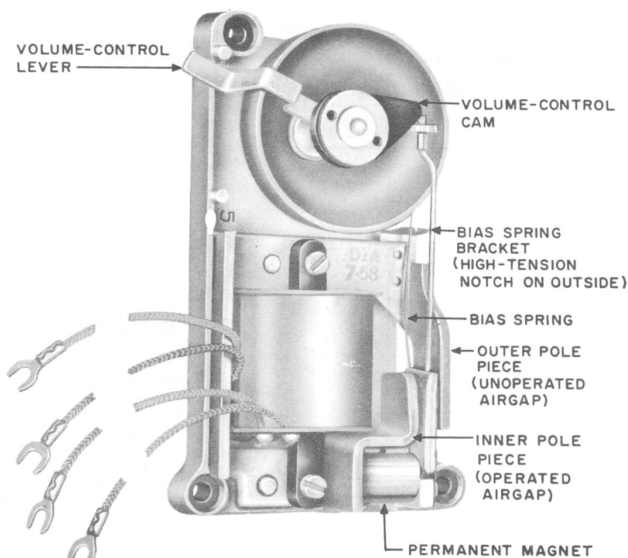
Fig. 1 — D1A Ringer

3.00 MECHANICAL REQUIREMENTS, Fig. 1

3.01 With bias spring in low-tension position, the armature should restore to nonoperate side of airgap when operated manually.

3.02 Clearance between clapper and gong should be minimum 1/64 inch.

3.03 Volume-control lever should operate smoothly over entire range.

Correct bias spring tension has been set at the factory. Do not bend bias spring. Do not use tools when relocating bias spring.

4.01 The ringer is shipped with the bias spring in the high (outside) notch. Table A indicates the proper position of the bias spring for the various classes of service.

4.03 If bell taps with bias spring in low notch and the ringer properly connected, move bias spring to high notch. Repeat ringing test. If ringer fails to operate properly, change ringer.
