# 9924 2400/2600Hz International Line Signaling Tone Disabler Subassembly

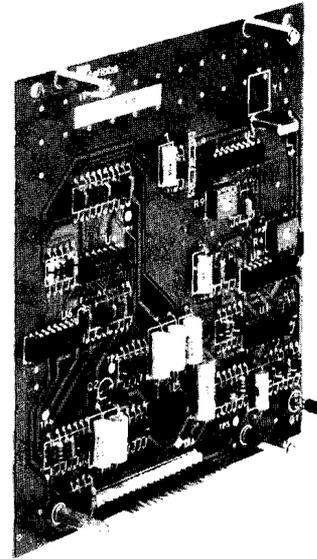
figure 1. 9924 2400/2600Hz International Line Signaling Tone Disabler subassembly

1.01 The 9924 2400/2600Hz International Line Signaling Tone Disabler plug-on subassembly (figure 1) is designed for optional use with Tellabs 6921A, 6921B, and 6921H Echo Canceller modules to render the transmit and receive channels of these modules transparent to 2400/2600Hz multi-frequency (MF) tone transmission in MF signaling environments.

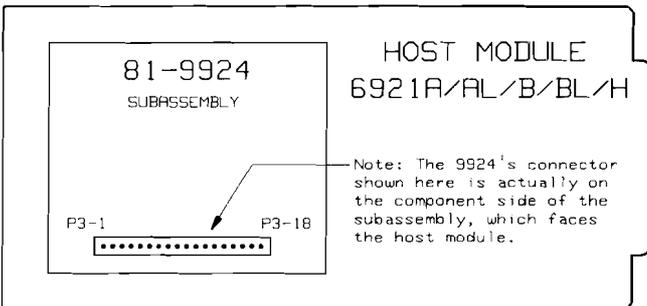
figure 2. 9924 connector location and positioning

figure 2a. Component side of 9924

figure 2b. Orientation of 9924 on host 6921X module (9924's component side down, 6921X's component side up).

2.03 Then install the 9924 on the host module by plugging 18-pin male connector *P3* on the 9924 into 18-pin female connector *J3* on the host module. (See figure 2 for the locations of *P3* and *J3*.) After plugging the 9924 onto the host 6921X, visually check the *P3*-*J3* connection to ensure that no pins are bent and, as a result, not properly inserted into their correct receptacles. Then install and tighten the four screws that secure the subassembly's standoff posts to the host module's main board. The 9924 has no option switches and requires no alignment.
